# PHASE II GEOENVIRONMENTAL SITE ASSESSMENT

| Site: | Wilson Road, Huyton |
| References: | 18-824-R2-1 |
| Client: | DJL Construction NW Ltd |

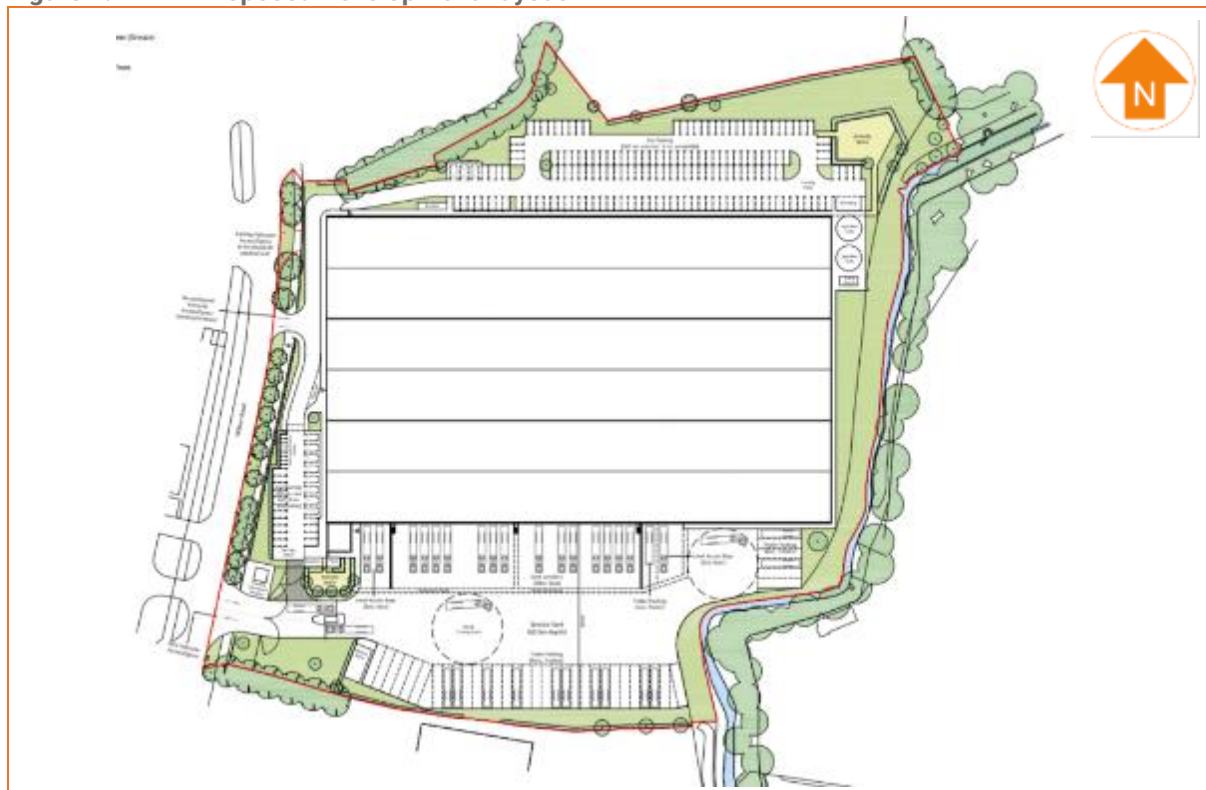
Figure 1.1 Proposed Development Layout

A snapshot of the proposed development layout is indicated in Figure 1.1.

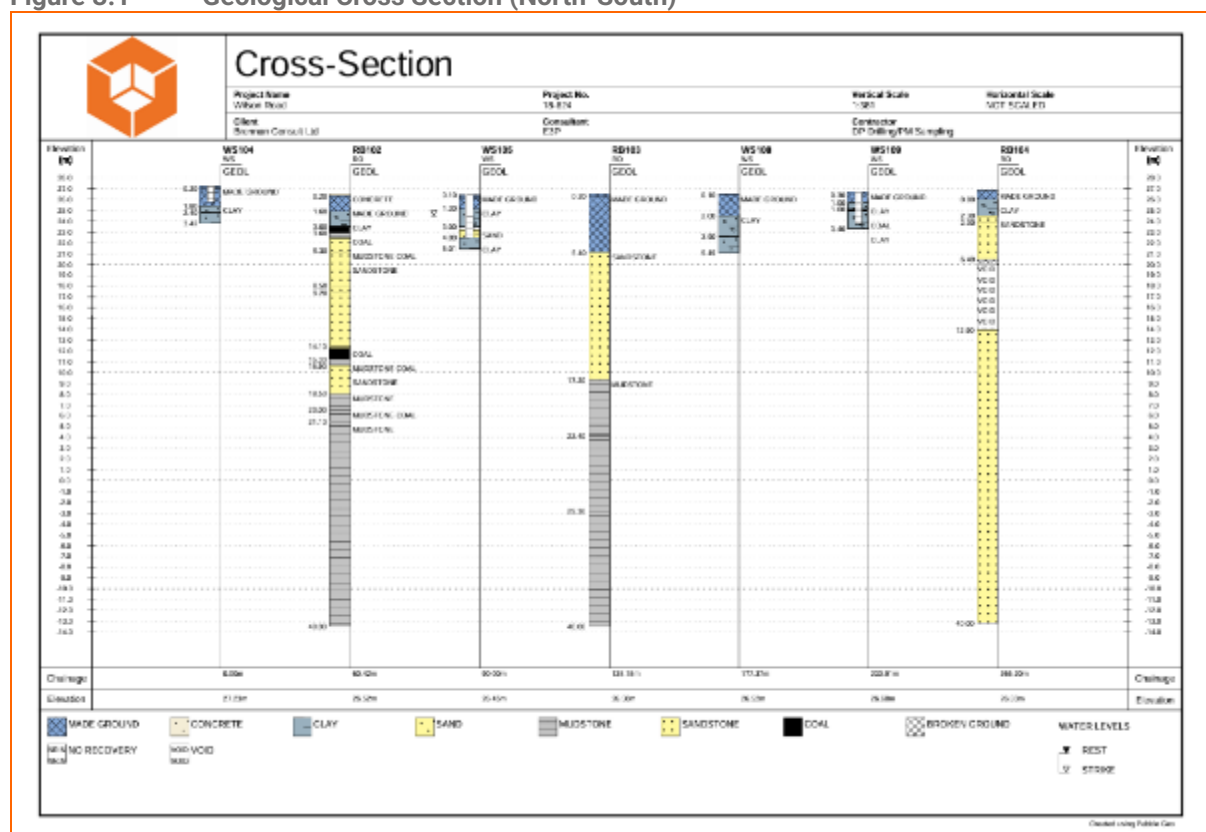
**Figure 3.1 Geological Cross Section (North-South)**

Geological cross-section is included in APPENDIX IV, and snapshots are shown in Figure 3.1 and Figure 3.2.

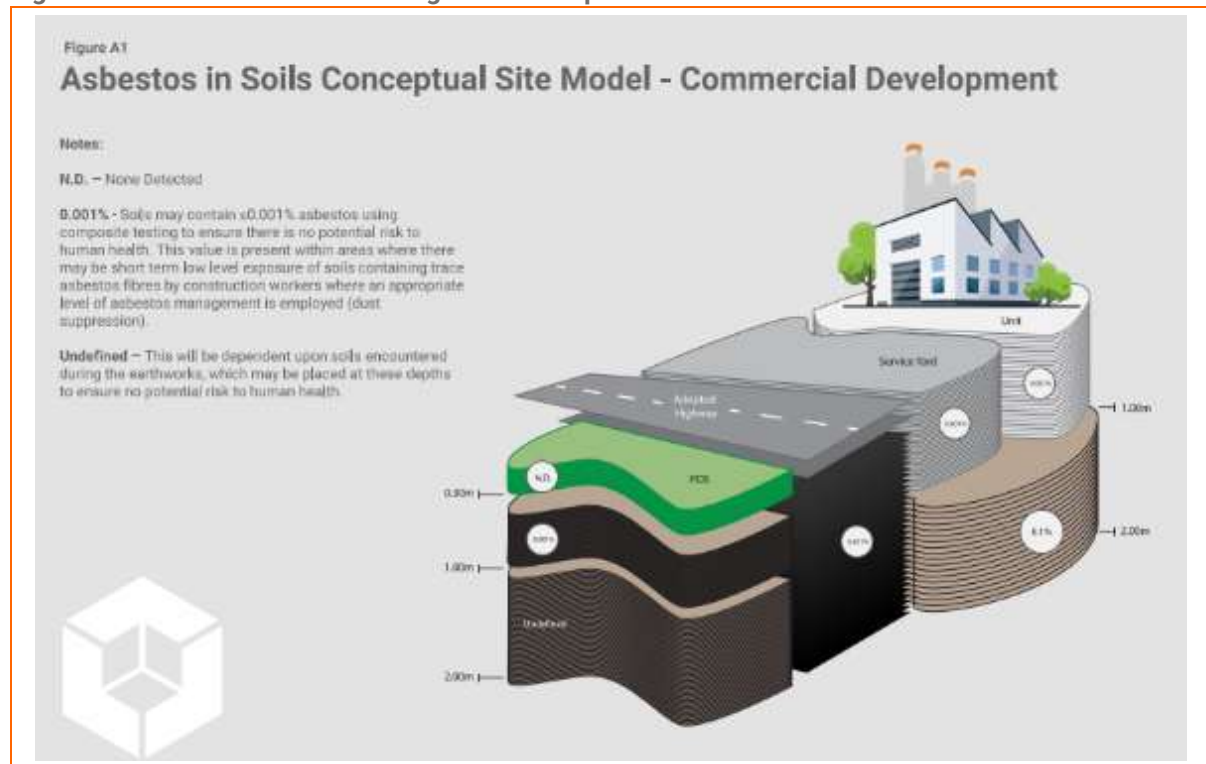
Figure 4.1 Asbestos Risk Mitigation Conceptual Site Model

Impacted soils should be managed in accordance with the asbestos risk mitigation conceptual site model presented in Figure 4.1. It should be assumed that asbestos fibres are present throughout the Made Ground, therefore it is recommended that any enabling works resulting in ground disturbance be completed in accordance with an asbestos management plan with suitable control measures implemented (e.g. appropriate PPE, RPE and air monitoring).

- **ND None Direct**
- **0.001% Soils may contain <0.001% asbestos using composite testing to ensure there is no potential risk to human health. This value is present within areas where there may be a short term low level exposure of soils containing trace asbestos fibres by construction workers where an appropriate level of asbestos management is employed (dust suppression) 0.1% Soils at a depth of > 1.00m bgl may contain <0.1% asbestos using composite testing where they will not be likely to be disturbed in the future and will therefore be in an area of low sensitivity. Risk assessment completed in accordance with Asbestos JIWG risk assessment tools.**
- **Undefined – this will be dependent upon soils encountered during earthworks, which may be placed at these depths to ensure no potential risk to human health.**

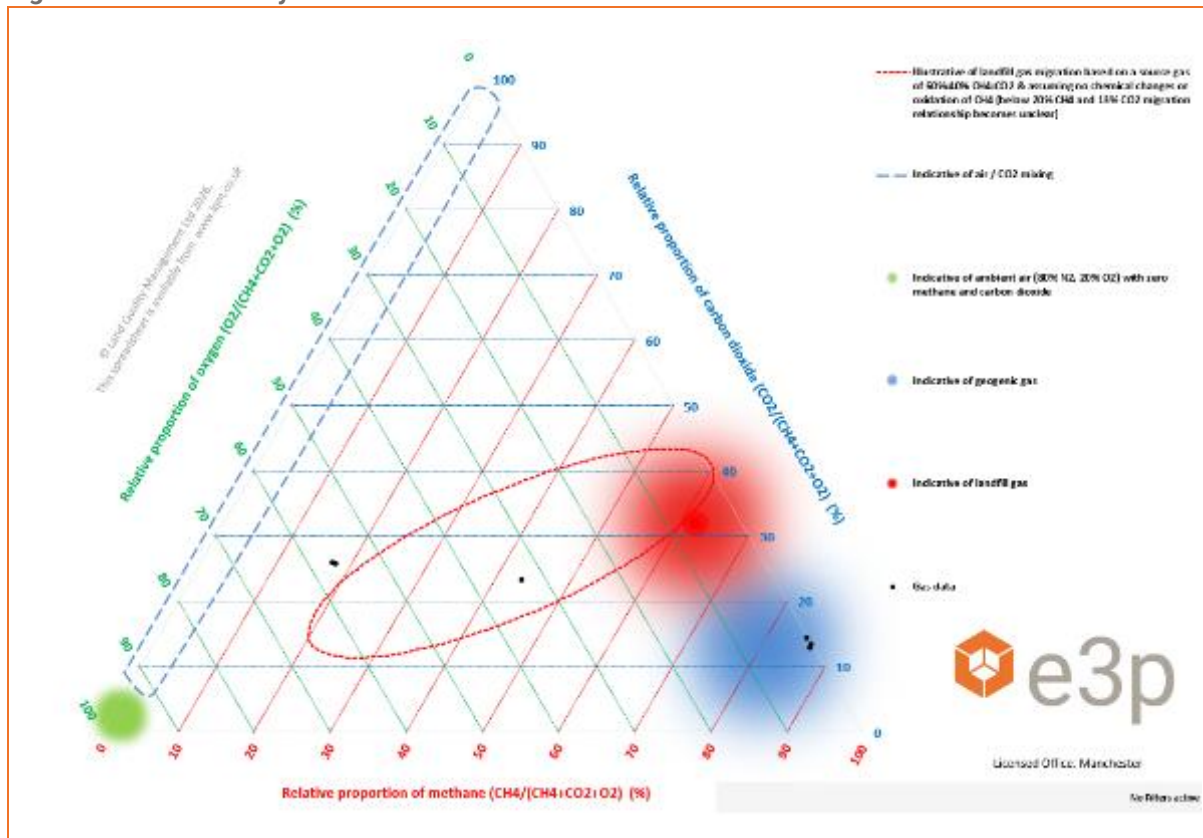
Figure 4.2 Ternary Gas Plot

The ternary gas plot suggests that the significantly elevated methane recorded in WS103 is indicative of a geogenic gas source.

The gas monitoring data for WS109 may be indicative of landfill gas migration, however the closest historical landfill is recorded 88 m northwest of the site for inert waste.

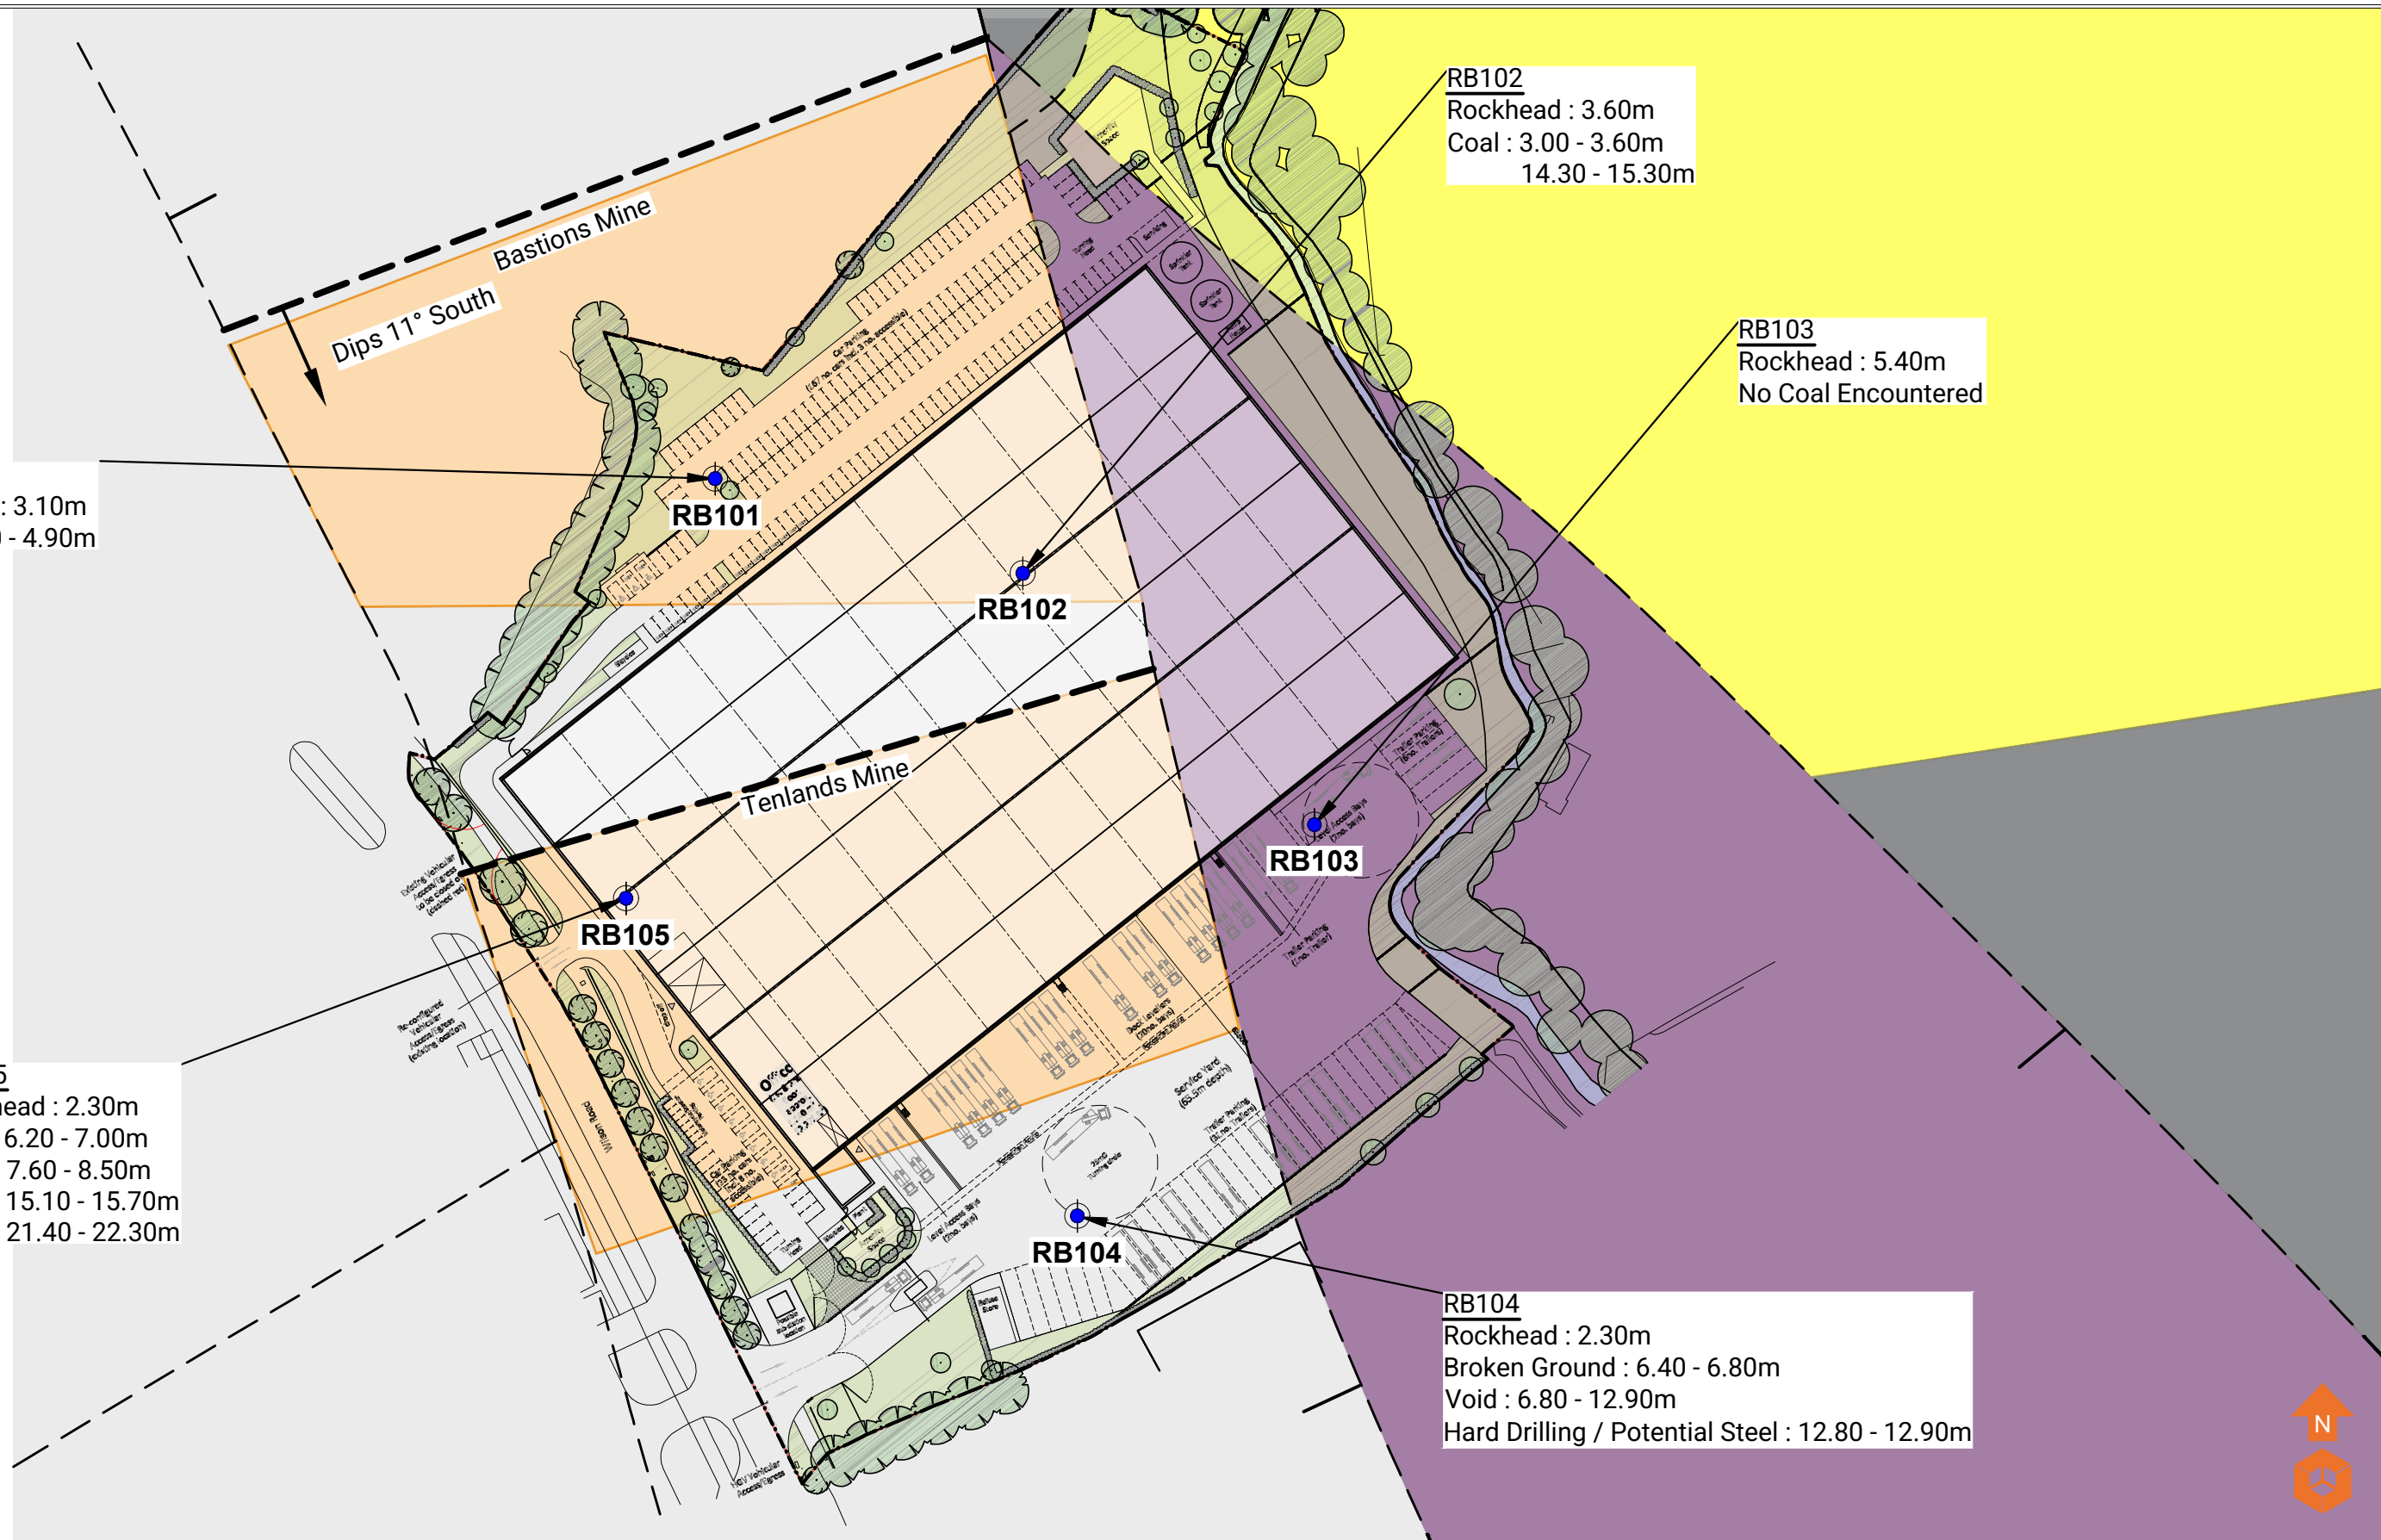
**RB101**  
Rockhead : 3.10m  
Coal : 3.80 - 4.90m

**RB102**  
Rockhead : 3.60m  
Coal : 3.00 - 3.60m  
14.30 - 15.30m

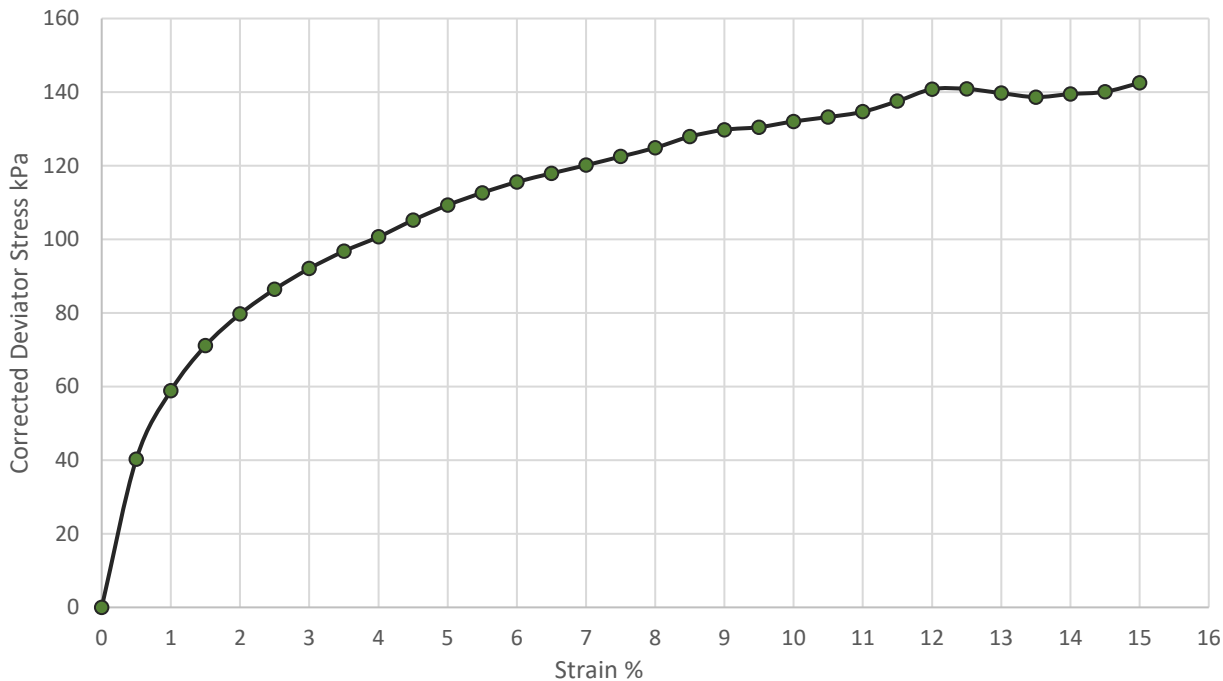
### CORRECTED DEVIATOR STRESS vs AXIAL STRAIN

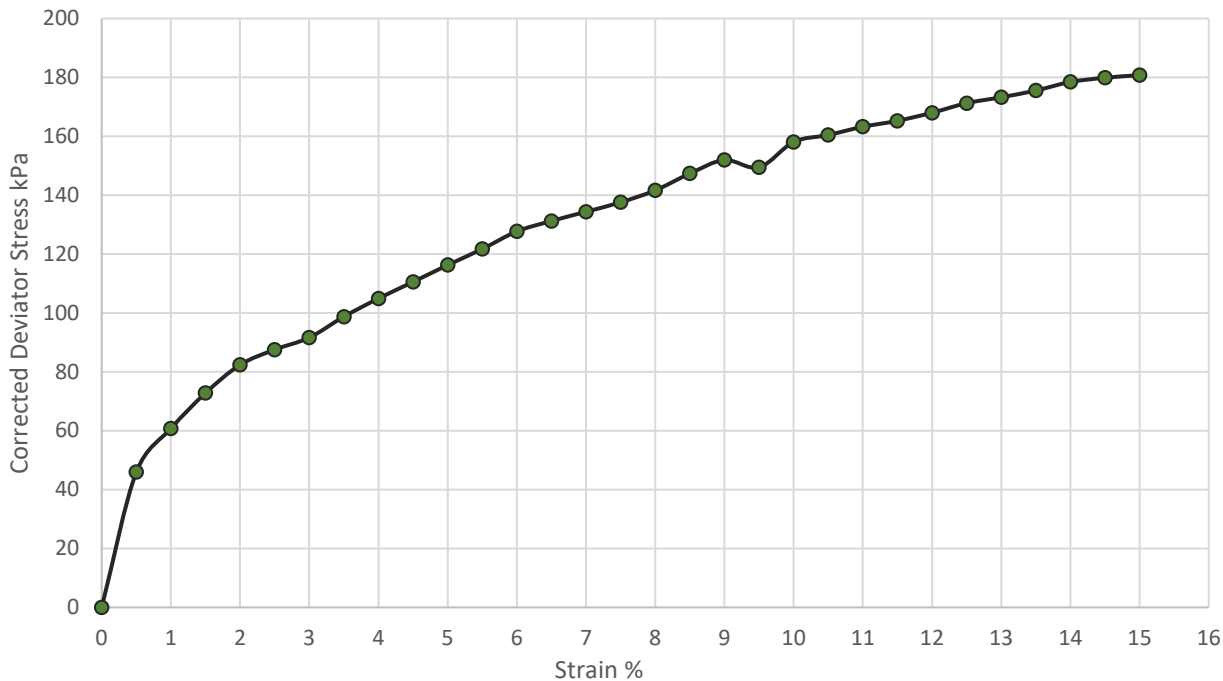
### CORRECTED DEVIATOR STRESS vs AXIAL STRAIN

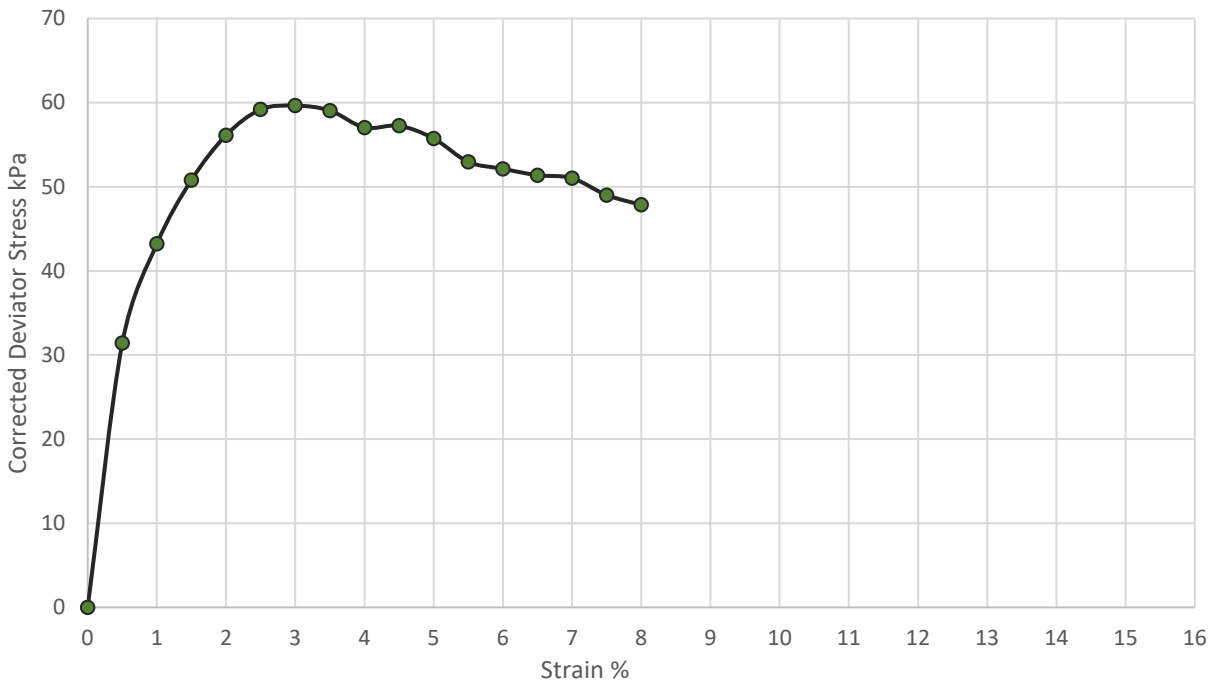
### CORRECTED DEVIATOR STRESS vs AXIAL STRAIN
