## **Level 2 Building Recording**

**Wheathill Riding Centre,  
Naylors Road, Knowsley,**

**September 2021**

| Report type | Level 2 Building Record | |

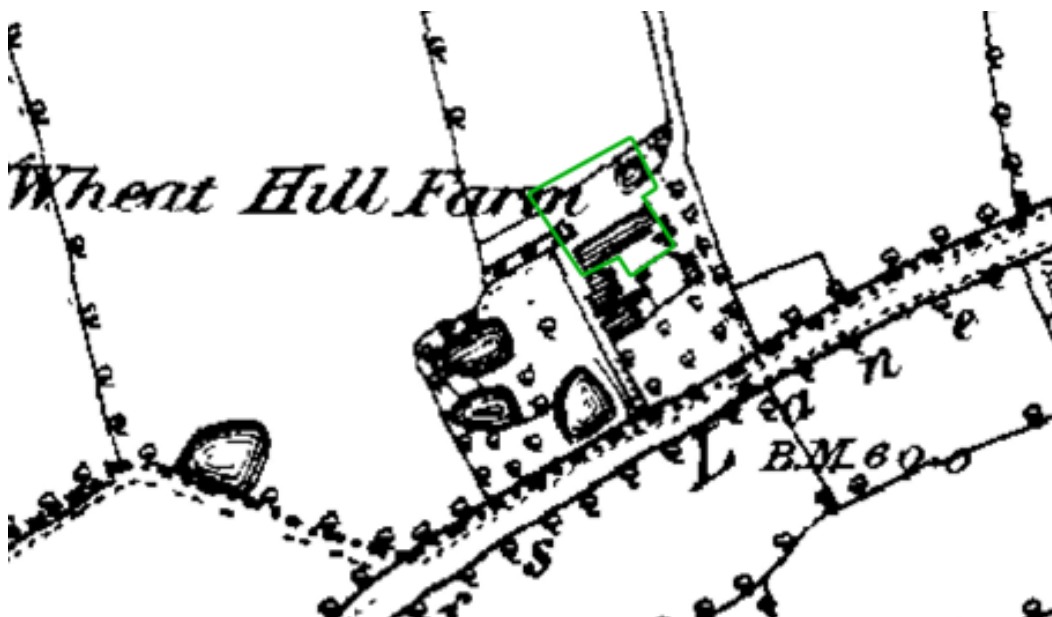
Figure 3: 1849 Ordnance Survey County Series, Lancashire, 1:10,560

| Map sequence | Building F6 (small barn) | Building F7 (pigsty) | Building F8 (combination barn) | Additional comments |
|---|---|---|---|---|
| 1849 Tithe Map and<br><br>1849 Ordnance Survey | Not shown | Not shown | Shown with a simple rectilinear form and attached farm house to south, in an 'L' shaped courtyard arrangement | Orchards are shown between the farmyard and Naylors Lane and in the adjacent land 'the pits' on the Tithe Map. A single drive from Naylors Lane leads to the front (west) of the farm house |

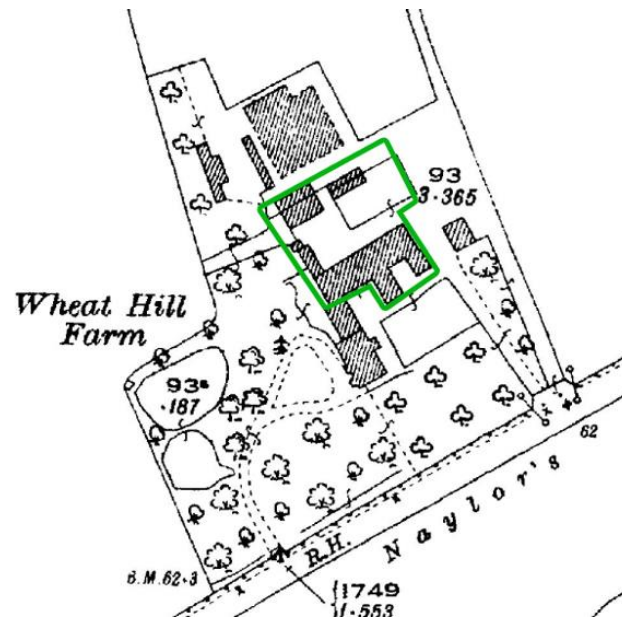
Figure 6: 1927 Ordnance Survey County Series, Lancashire, 1:2,500

| Map sequence | Building F6 (small barn) | Building F7 (pigsty) | Building F8 (combination barn) | Additional comments |
|---|---|---|---|---|
| 1927 Ordnance Survey | Still shown as a two-bay building, as above | Still shown as two bays with yard to south, as above | Still shown with the three barns and farmhouse attached to the south and barn attached to north, the latter being formed of two bays, as above | The farm is generally as described above although an additional building is shown to the north of buildings F6, 7 & 8 |

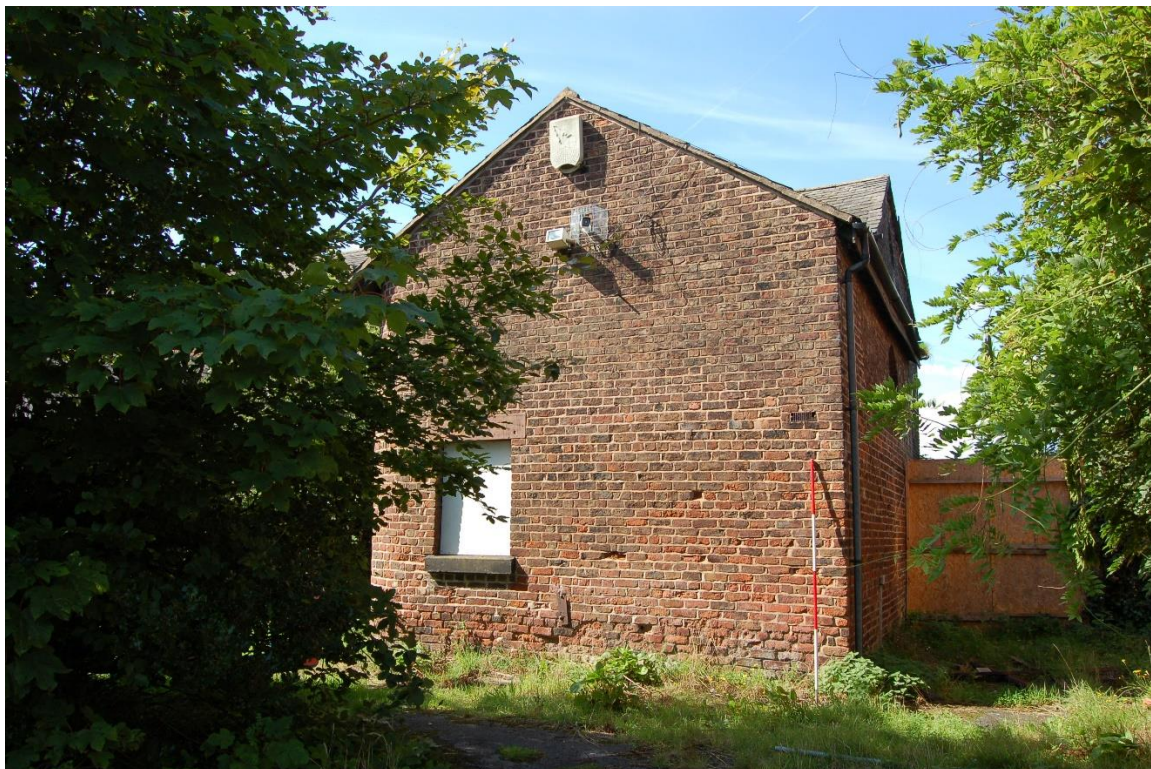
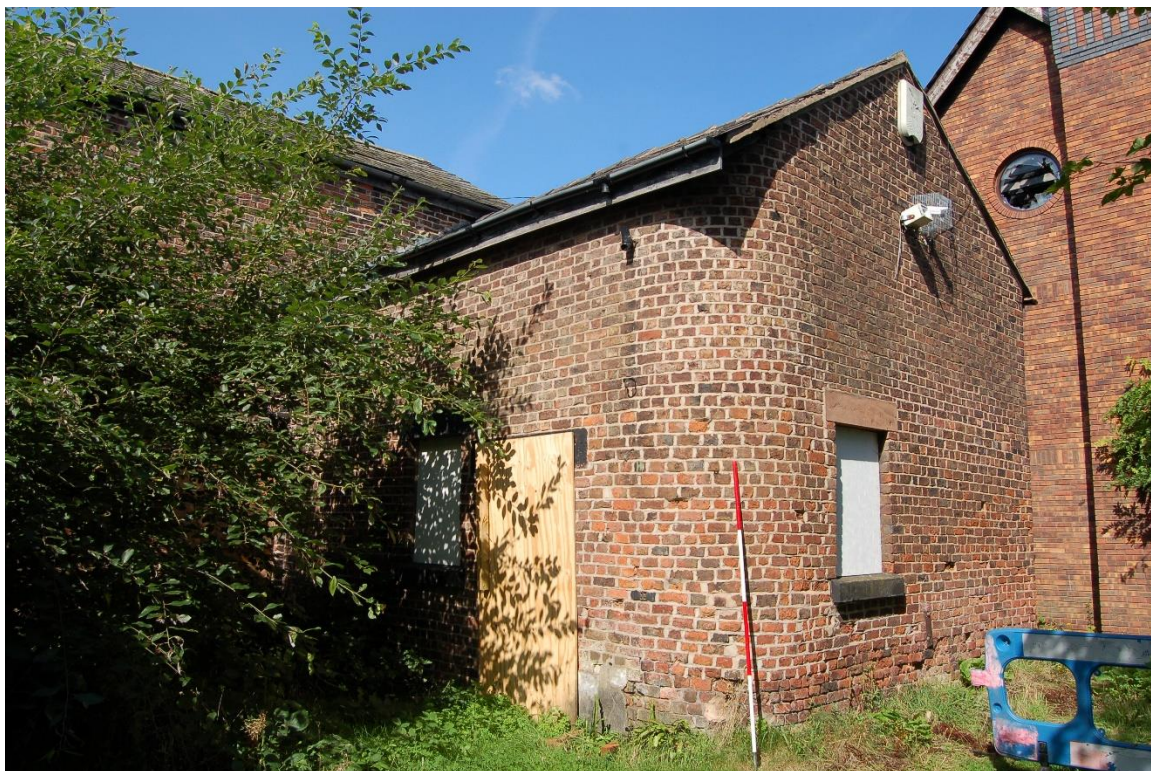
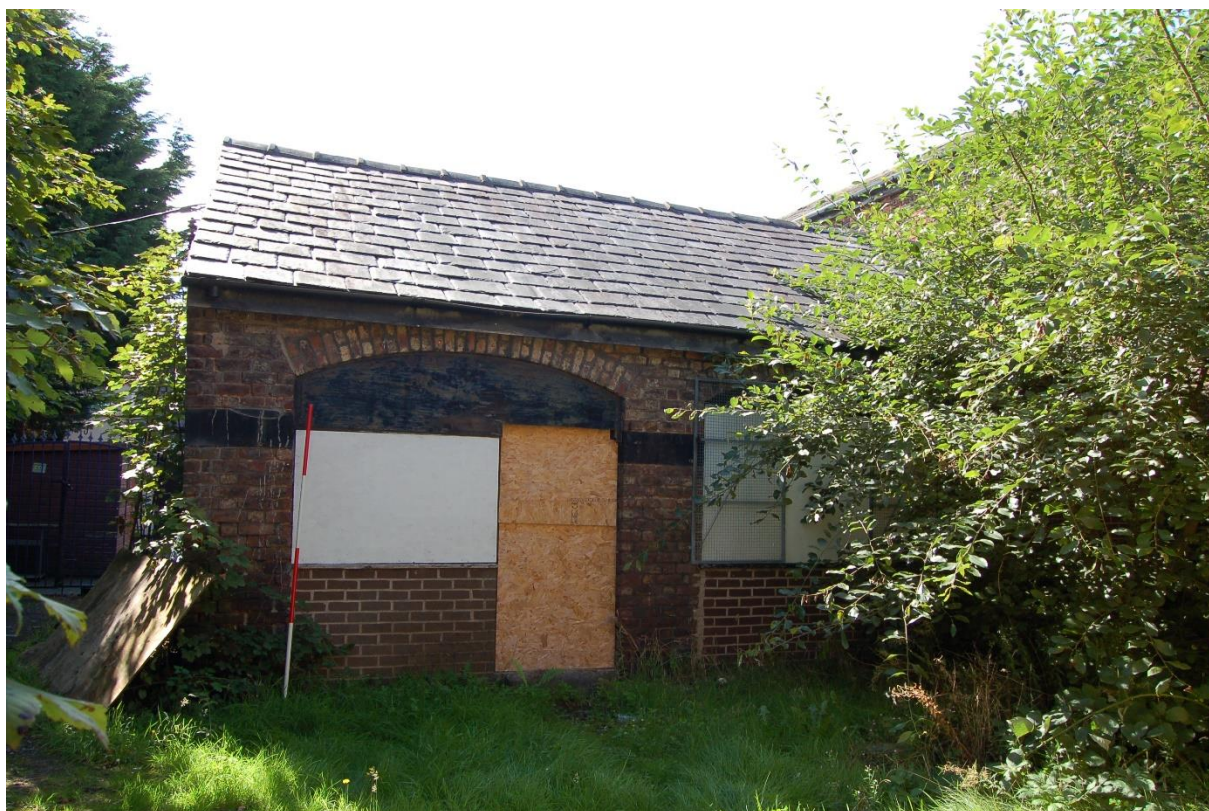
- 4.16. The south facing elevation has three attached single storey barns (two within the proposed development site and one within the existing school grounds); a further pitching eye is evident in the eastern end of this elevation and two brick infilled pitching eyes and diamond brick patterned ventilation openings; a door leading into the presumed cow house was observed in the south facing elevation up against the south-eastern attached barn. An infilled former cart door is evident as a brick-filled archway in the south facing elevation.

1. Main barn, south facing elevation of south-eastern adjoining single storey barn (F8D)

2. Main barn, west facing elevation of south-eastern adjoining single storey barn (F8D)

3. Main barn, east facing elevation of middle adjoining single storey barn (F8B)

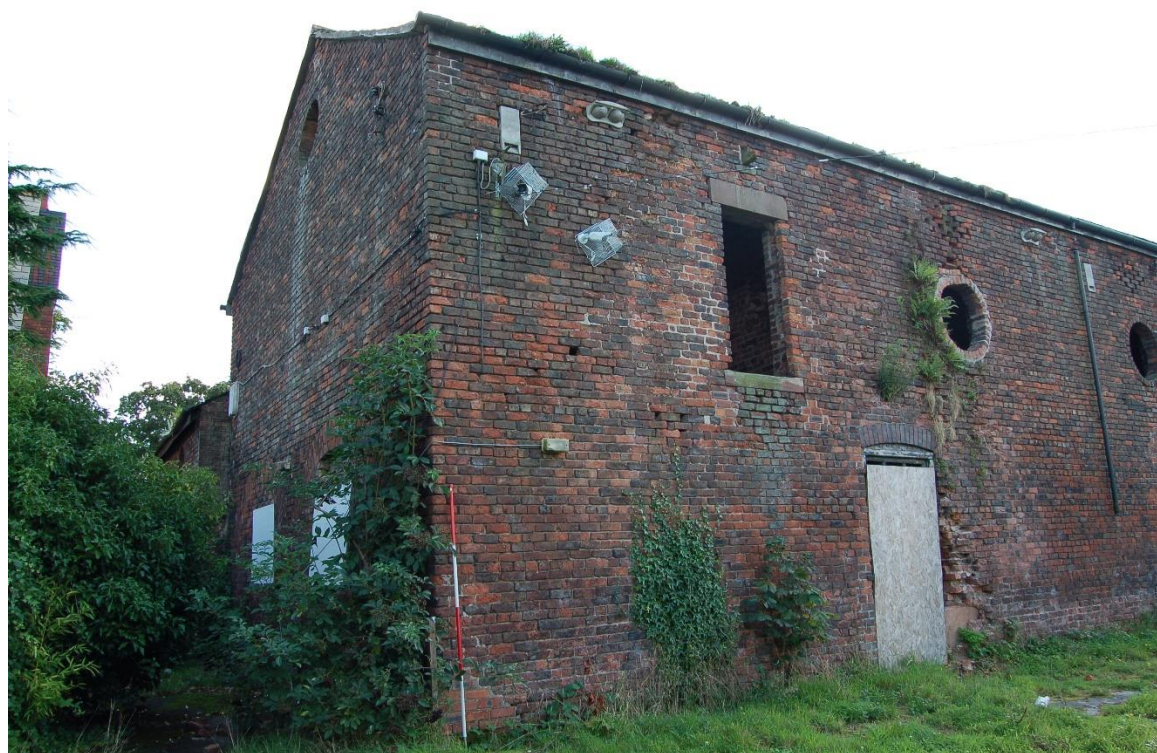
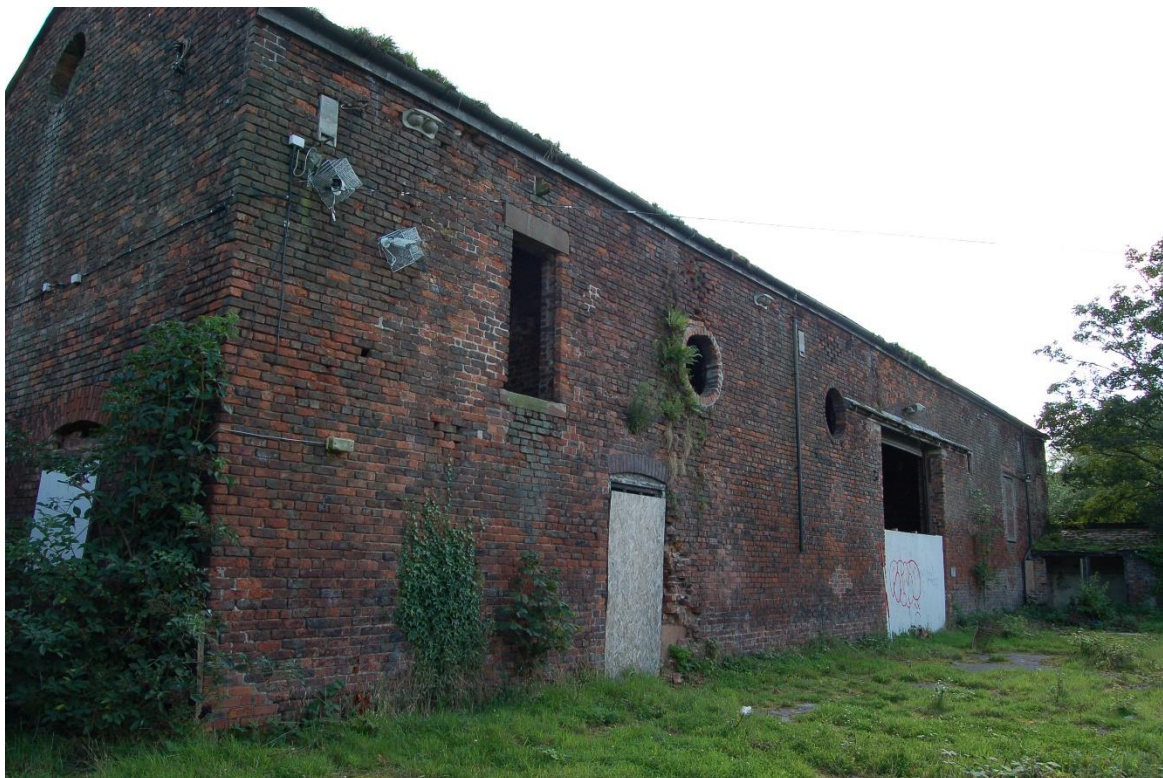
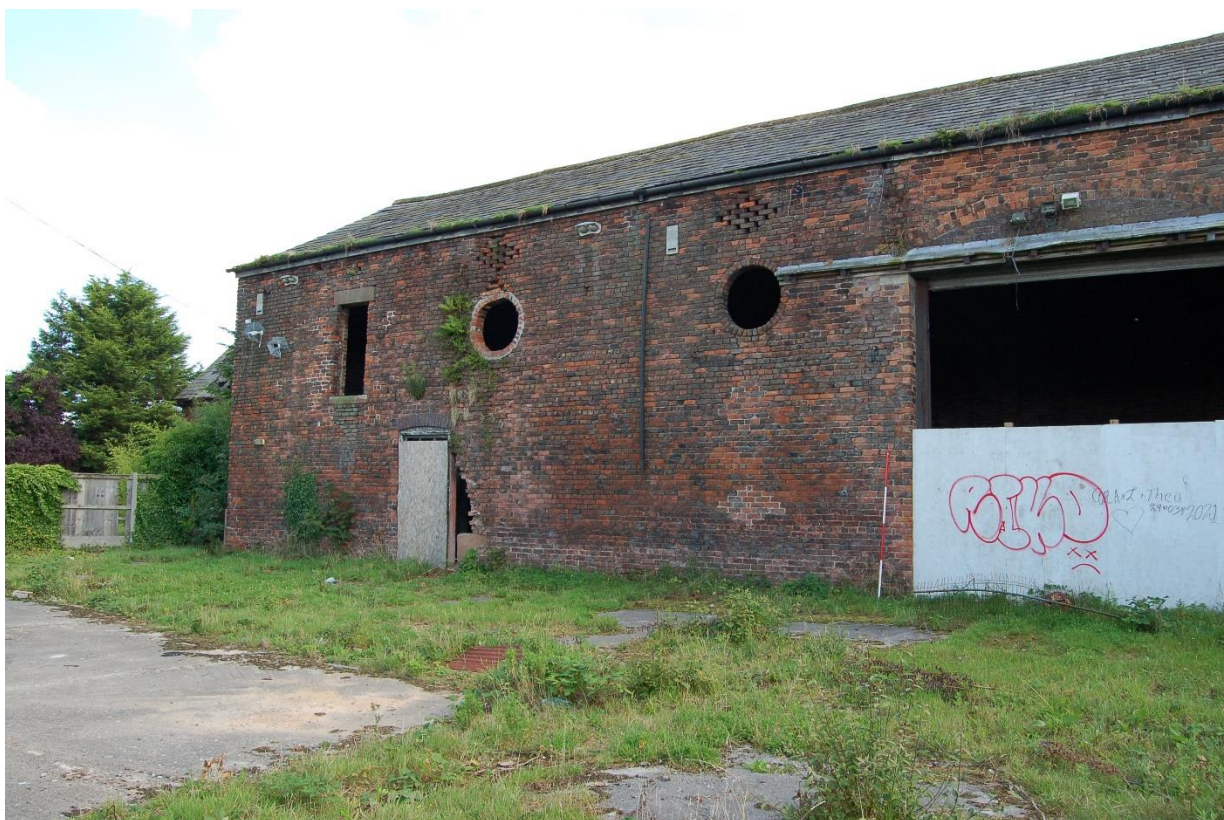
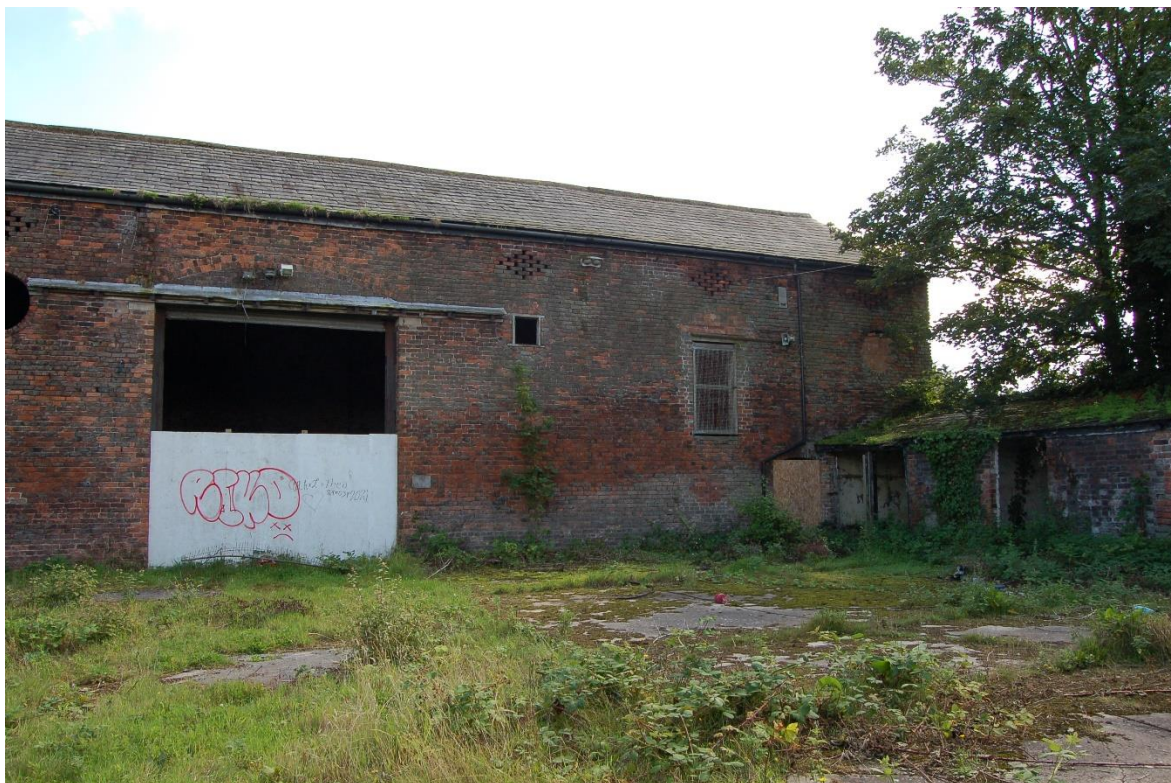
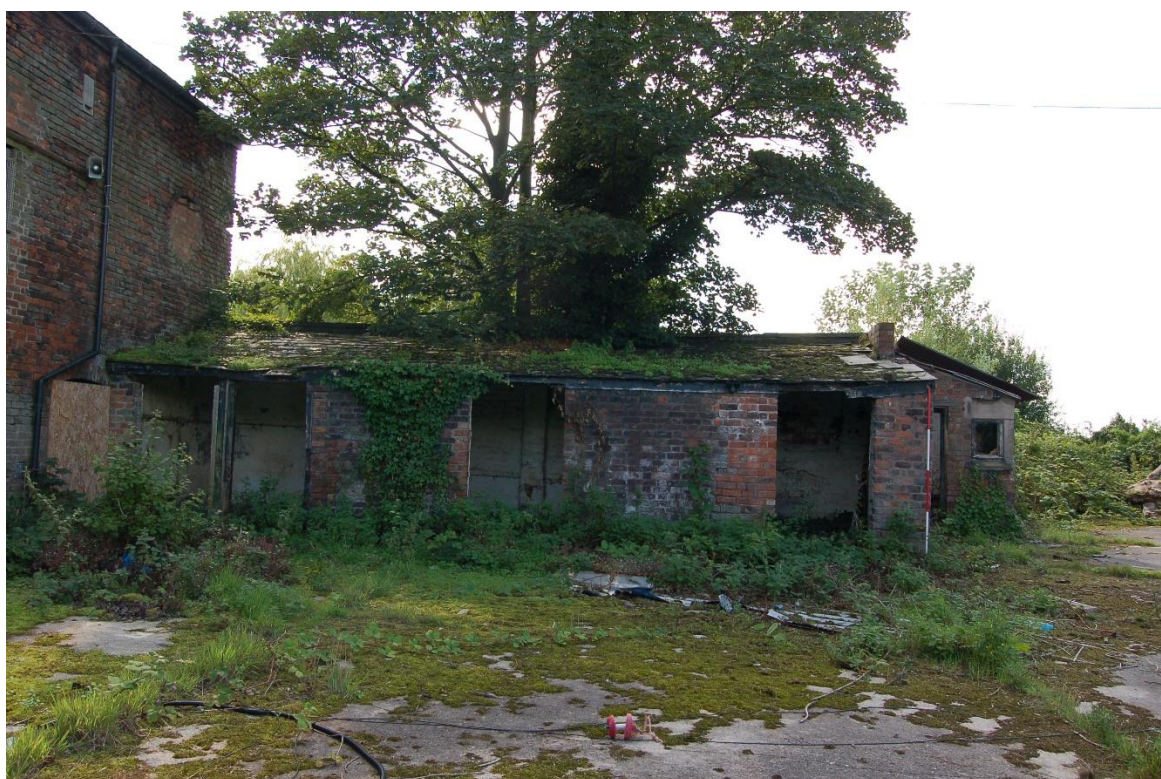
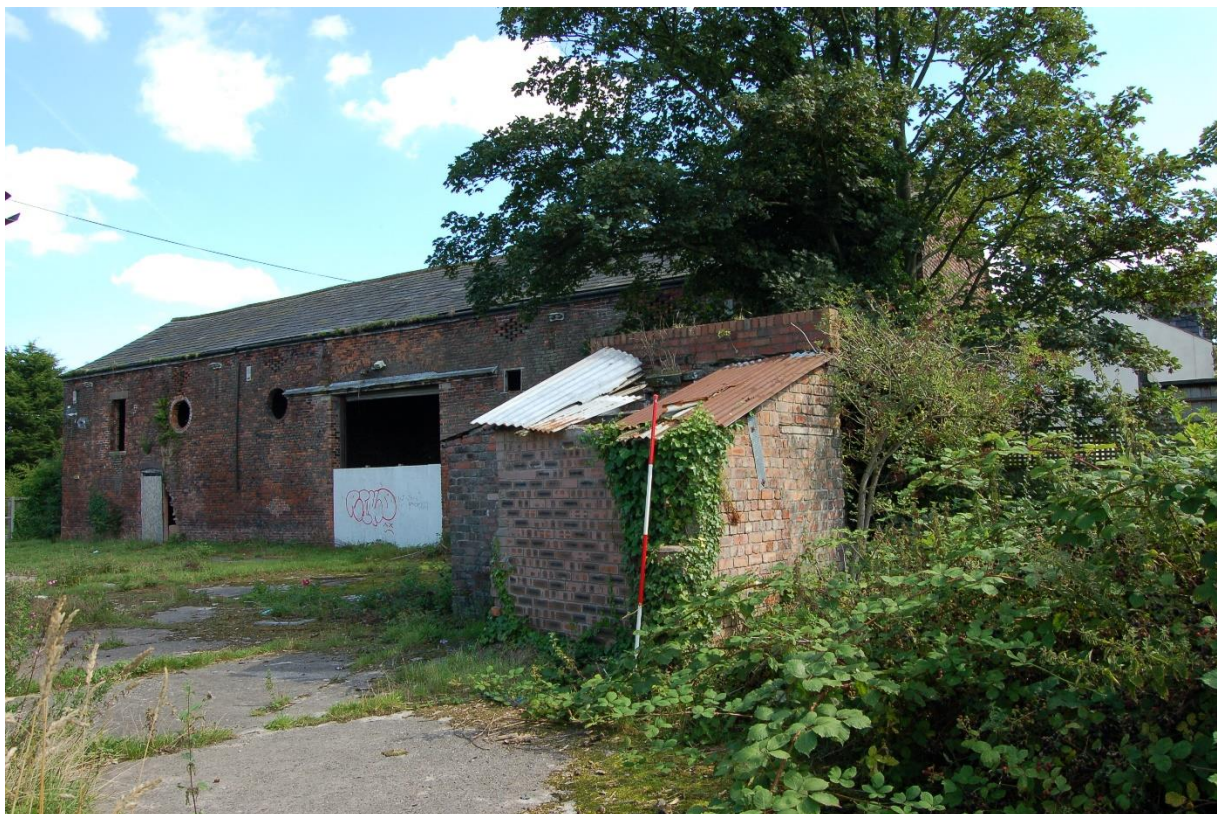
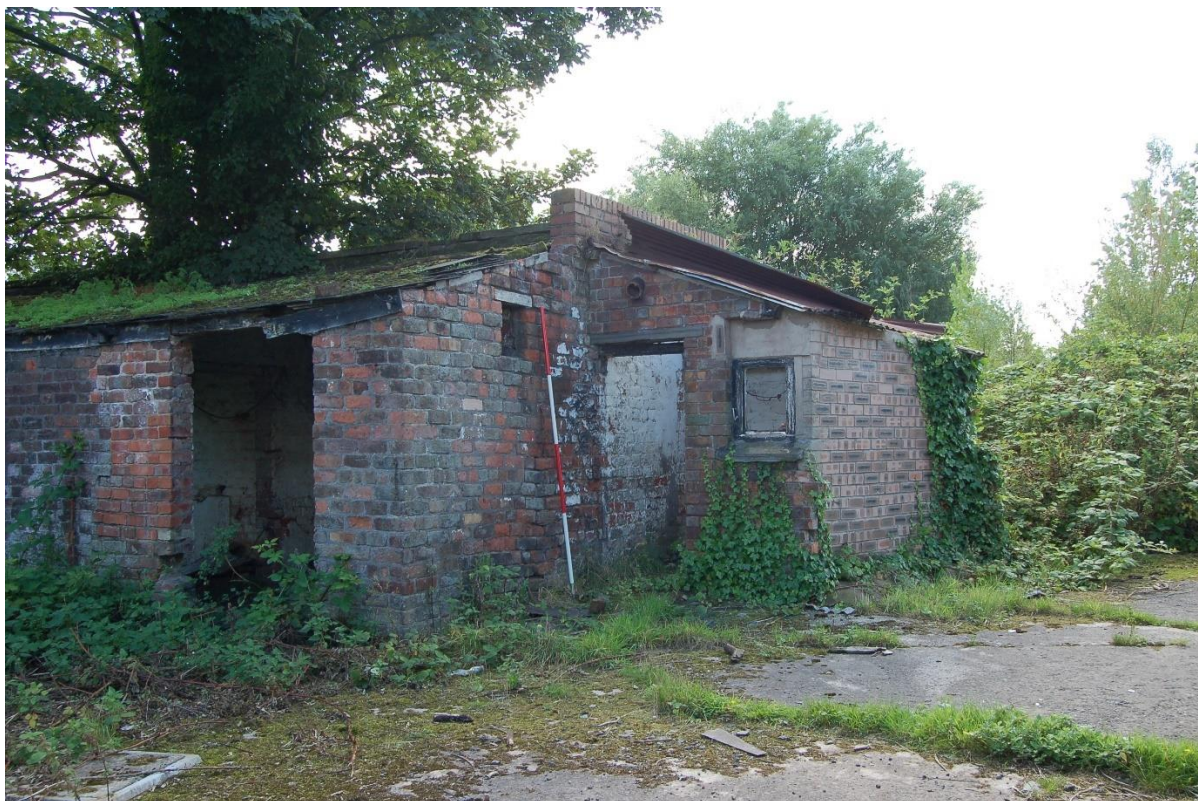
4. East facing elevation, and north facing elevation (eastern end)

5. North facing elevation

6. North facing elevation

7. North facing elevation, western end and attached barn (F8C)

8. Attached single story lean-to (north side of main barn) (F8C)

9. Main barn, north facing elevation and northern end of attached barn (F8C)

10. Northern end of attached barn (F8C)

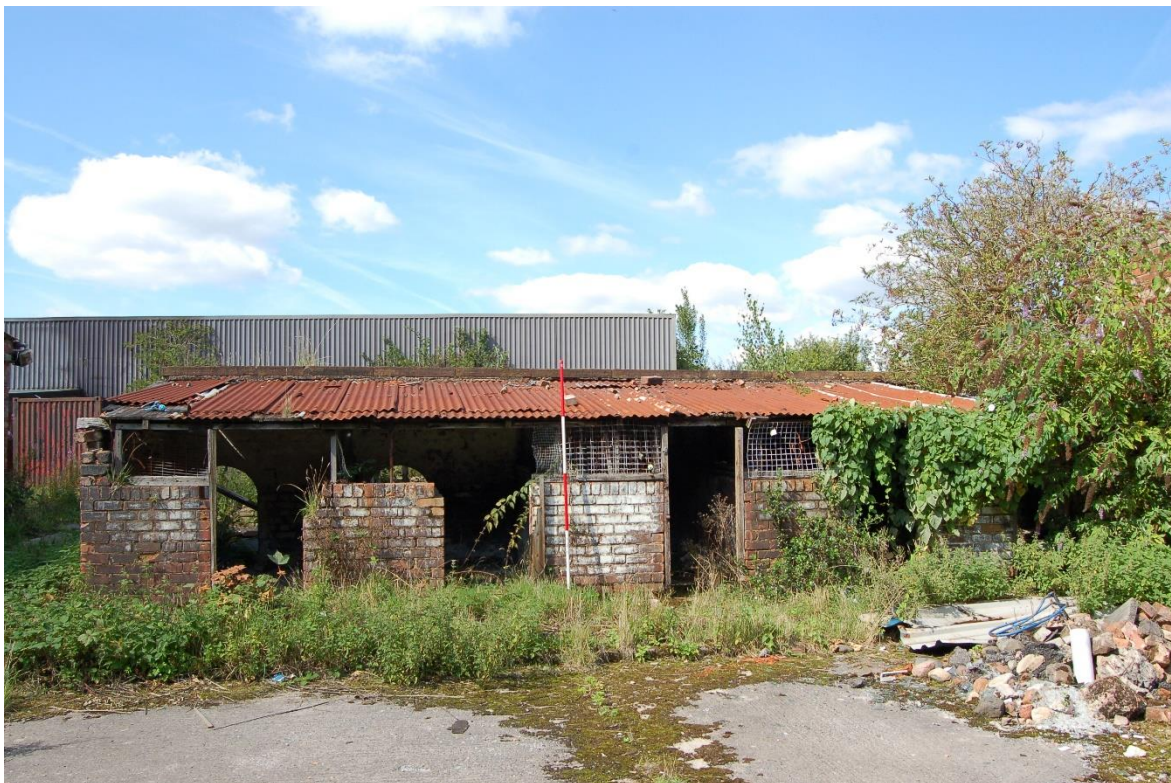
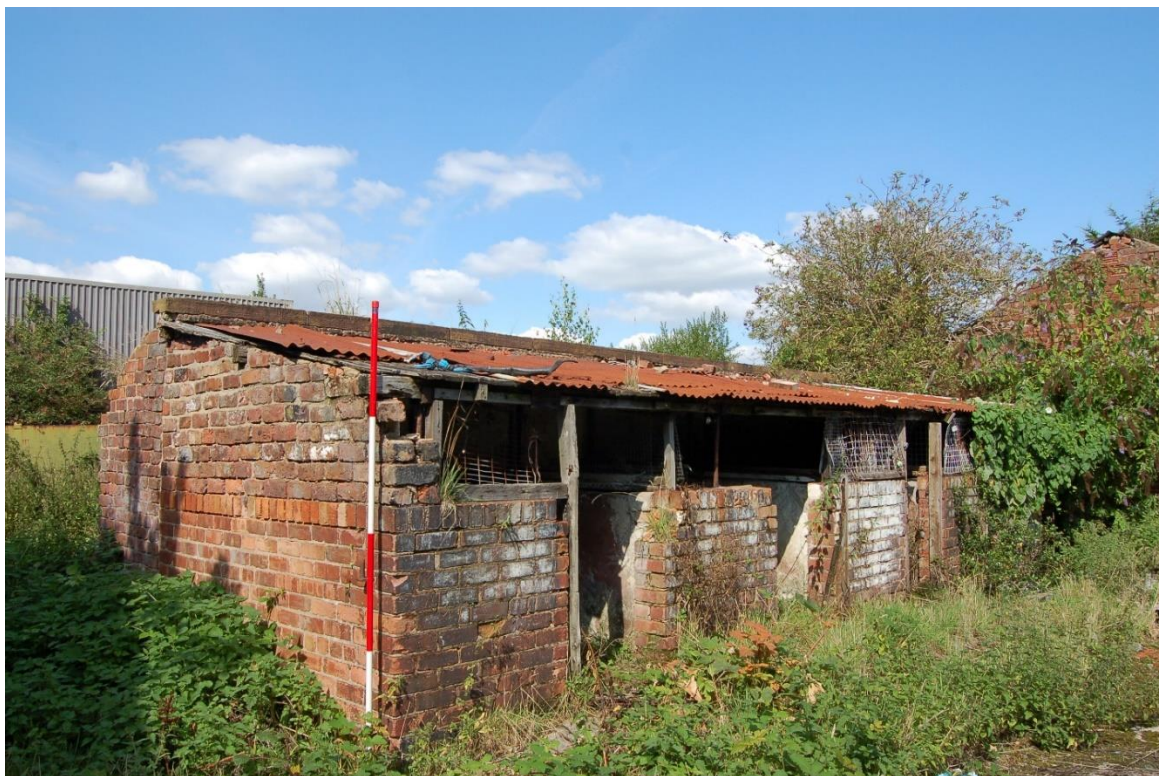
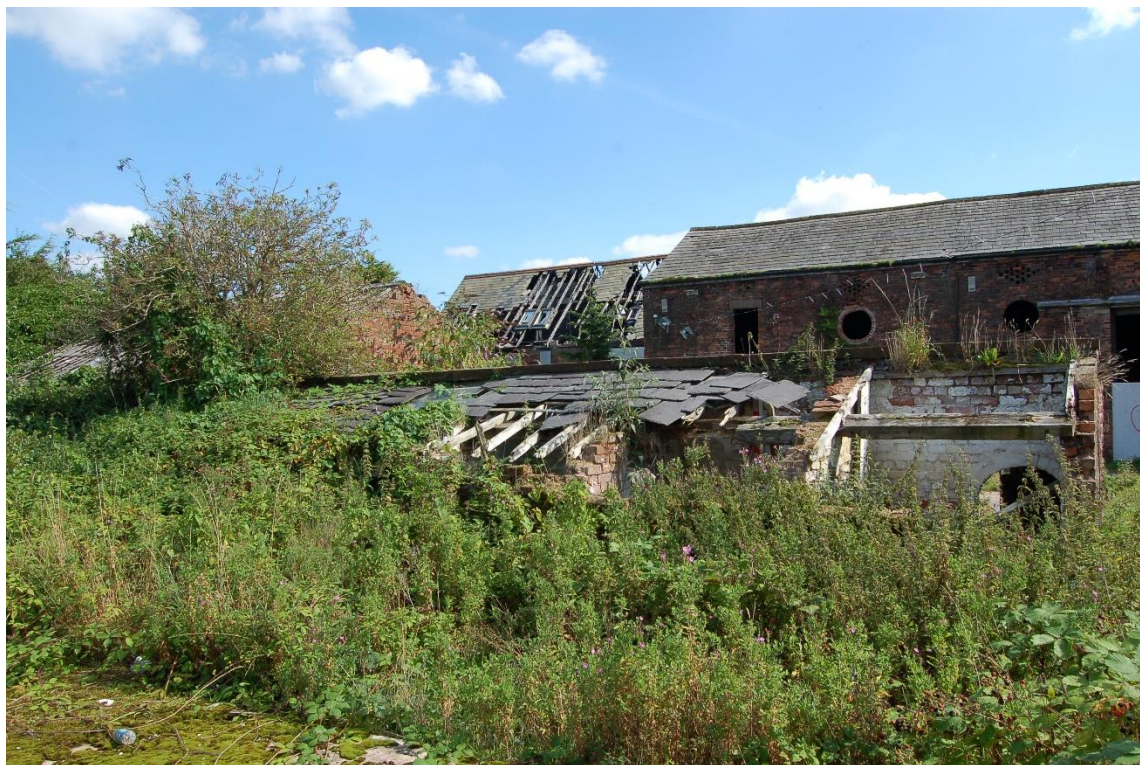
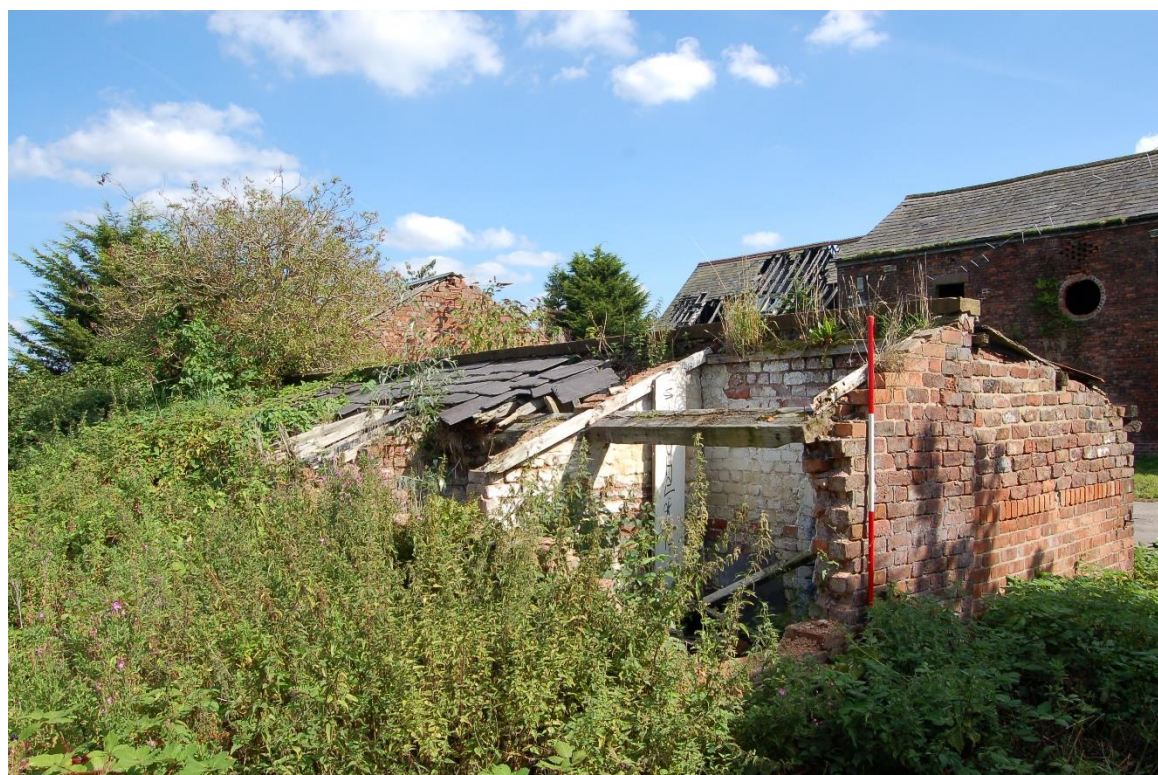
- 4.10. The building comprises a single storey loose box style pigsty with attached modern barn. The pigsty is brick with slate roof. The rear part (northern bay) would have formed the animal stalls, with an arch giving access to an open yard to front (southern bay). The attached yard

has a tall wall. That yard has subsequently been roofed with a corrugated metal roof, possible for reuse as a dog kennel.

- 4.11. Externally there is evidence for a further yard surrounding the pigsty and attached barn. A concrete yard surface is evident on the ground in the area depicted as a yard on historic mapping, although any surrounding wall is no longer extant and no underlying floor surface was evident. The observed concrete surface suggests that the yard was used in conjunction with the modern attached barn, although this is in the area of a previous yard as shown on historic mapping from the late 19<sup>th</sup> century.

11. South facing elevation of pigsty

12. South and west facing elevations of pigsty

13. North facing elevation of pigsty

14. West facing elevation of pigsty

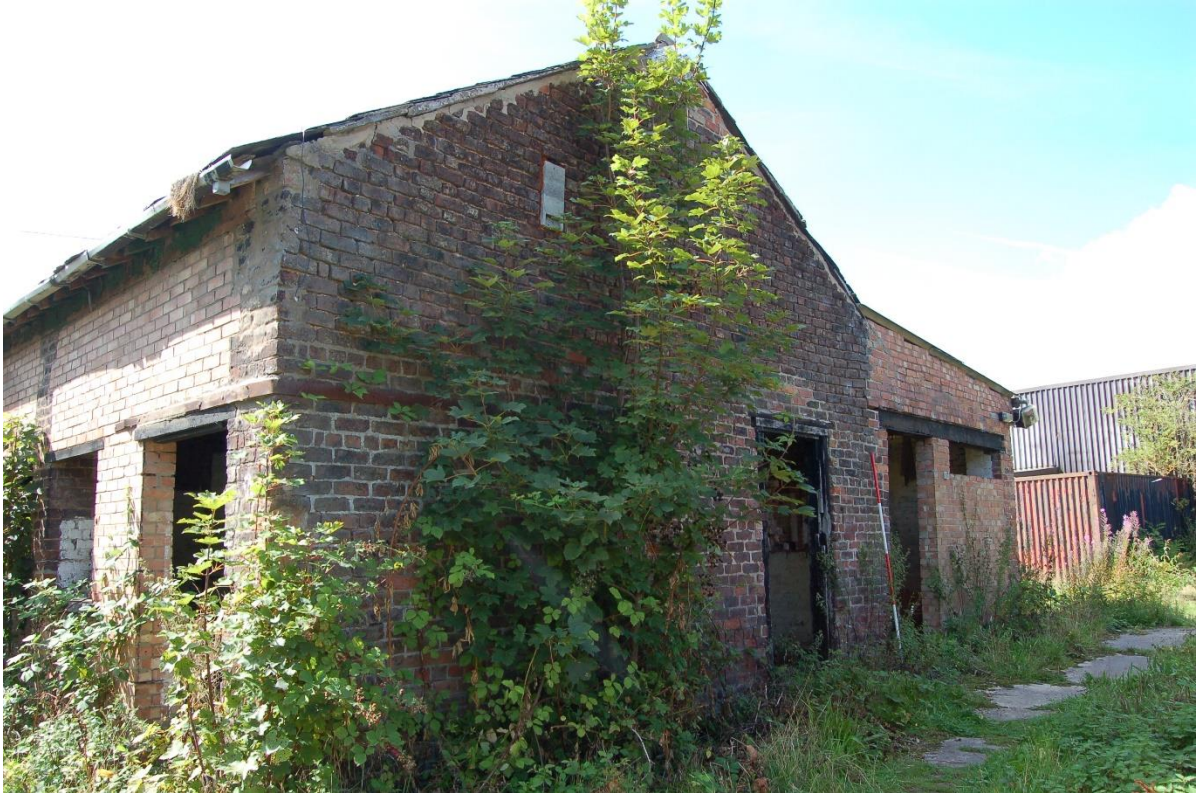
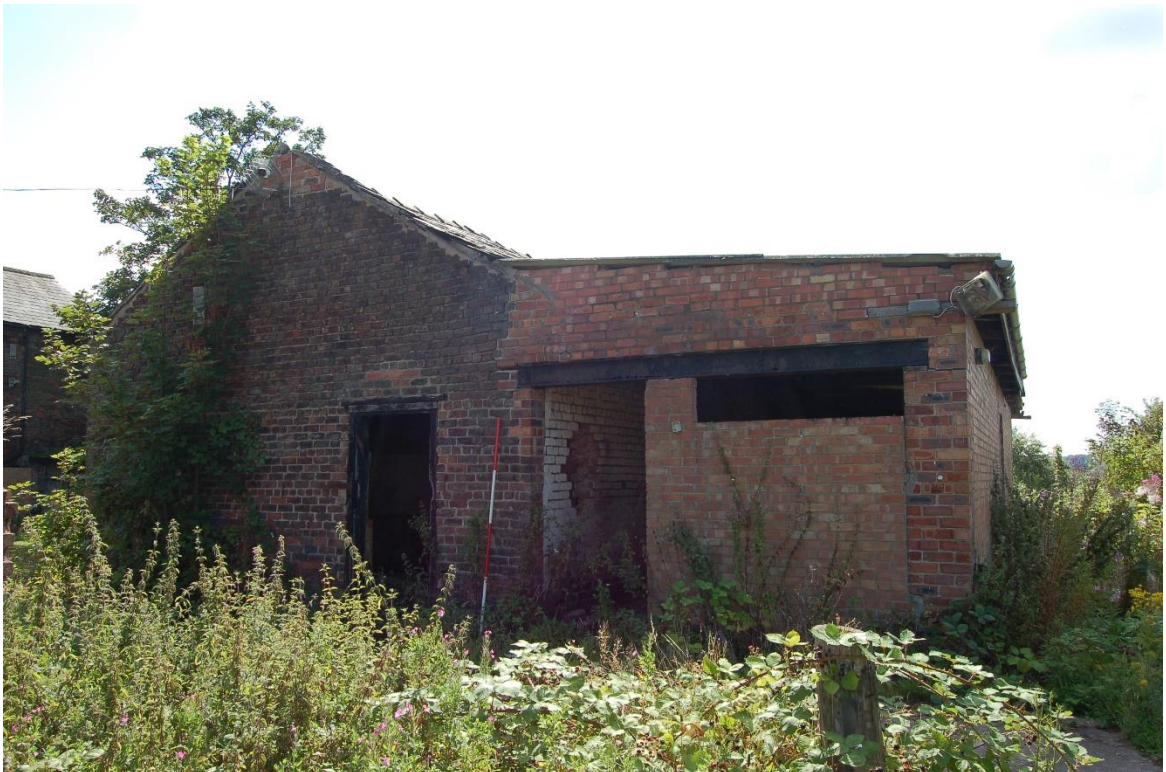
- 4.6. The eastern gable end has a single door into the southern bay and the brick infilled opening into the northern extension, presumably to allow access for farm machinery.

15. East facing elevation of storage barn

16. East facing elevation of storage barn with modern lean to

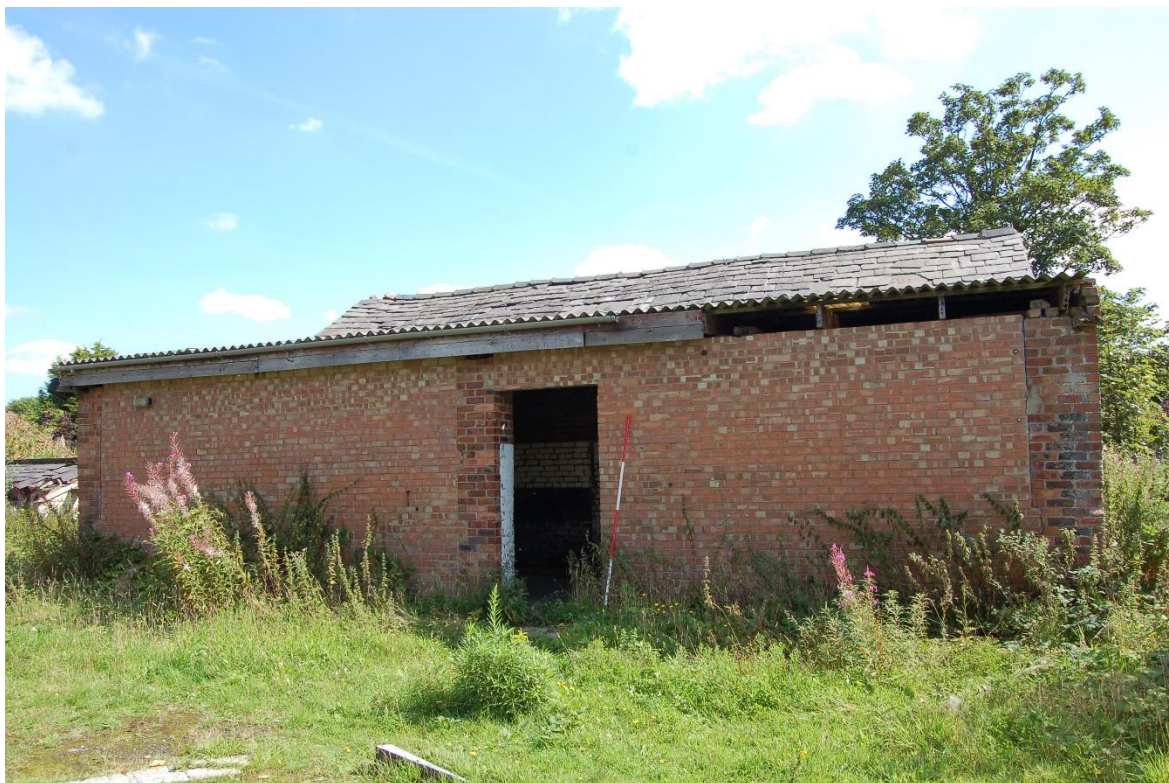
- 4.7. The north facing elevation of the lean-to extension is in modern brick with a single door and concrete composite roof. There are two styles of brick, one similar to the 1960s buildings on site and one more modern style of brick (as used to block the machine door on the western gable end).

17. North facing elevation of storage barn (modern lean-to extension)

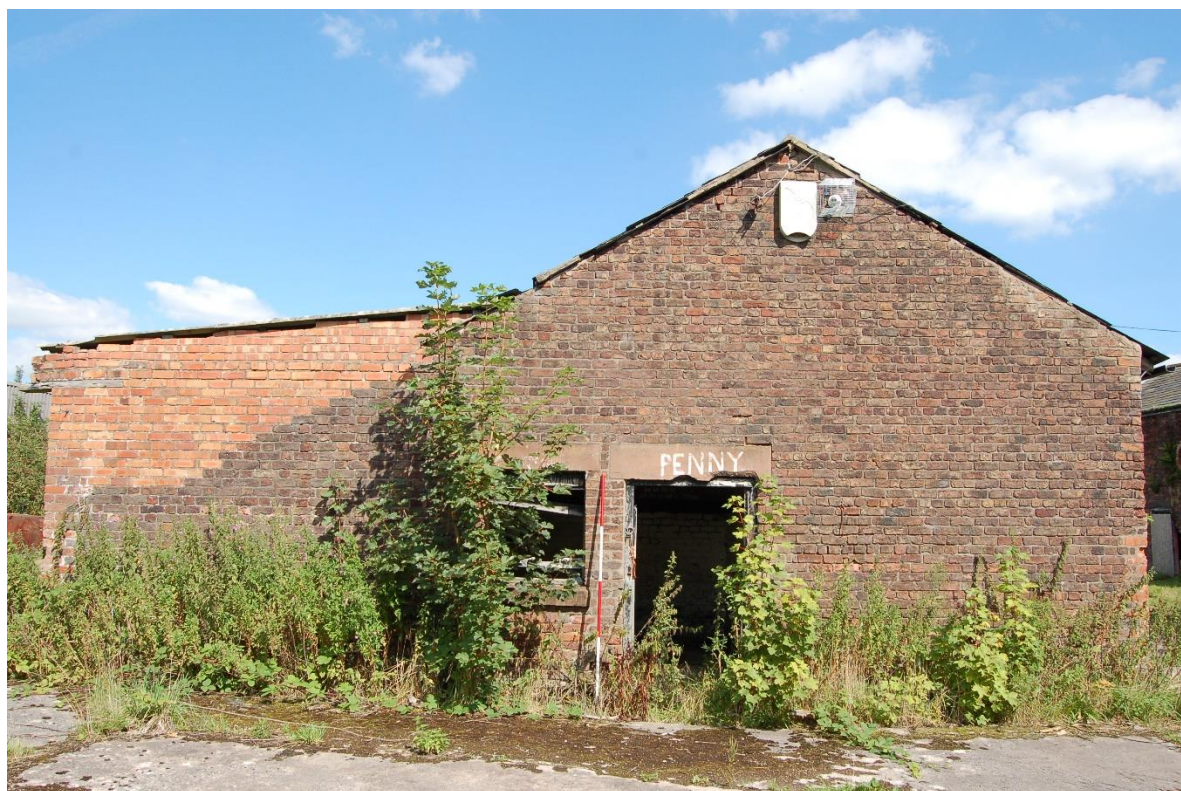
- 4.5. The western gable has a door and window and shows the profile of the original lean-to northern bay, that was later heightened and altered to form the current modern extension.

18. West facing elevation of storage barn

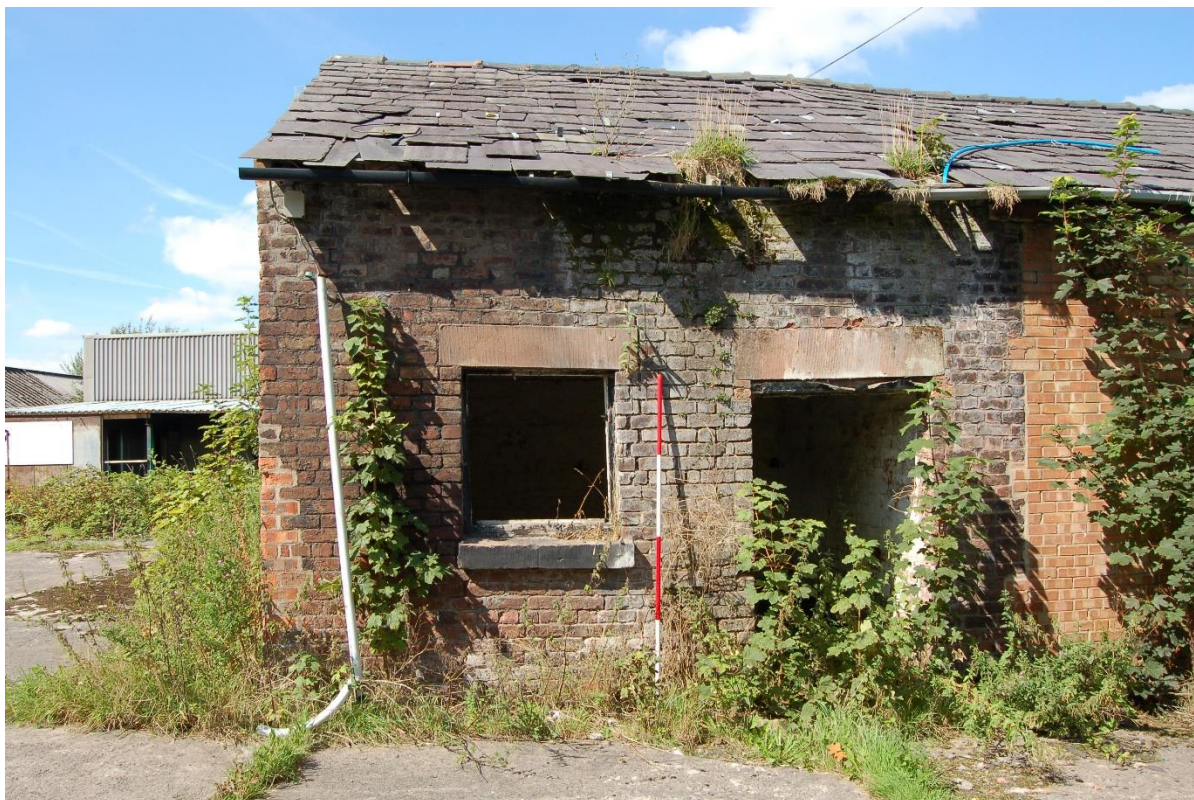
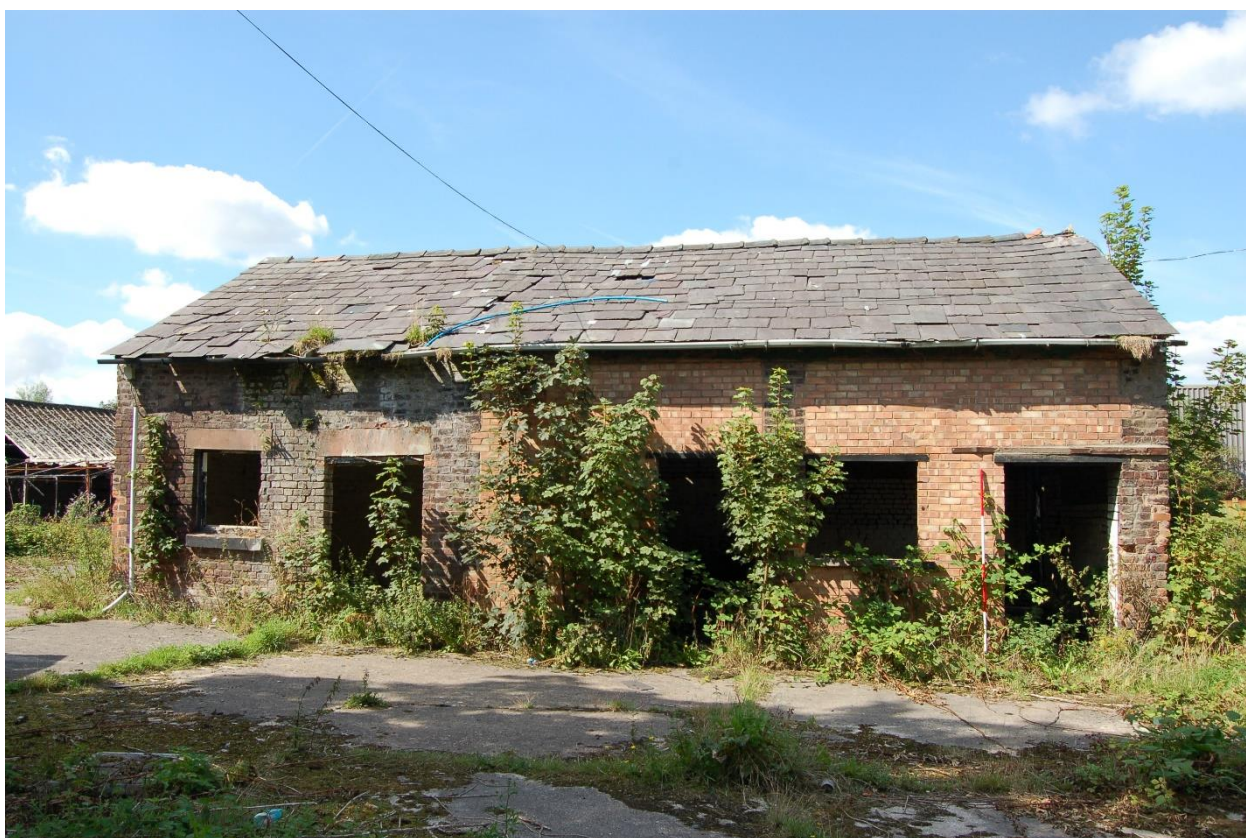
- 4.4. The southern elevation has three doors and three windows. There are two distinct styles of brick, with a greyish brick in the western end (the original 1890s construction); there is a central and end pillar in the same brick running through the eastern end of the building. On historic mapping, it is depicted as having a half-open front from 1951; it would appear that part of the barn was open at that point but then later bricked up.

19. South facing elevation of storage barn

20. South facing elevation of storage barn

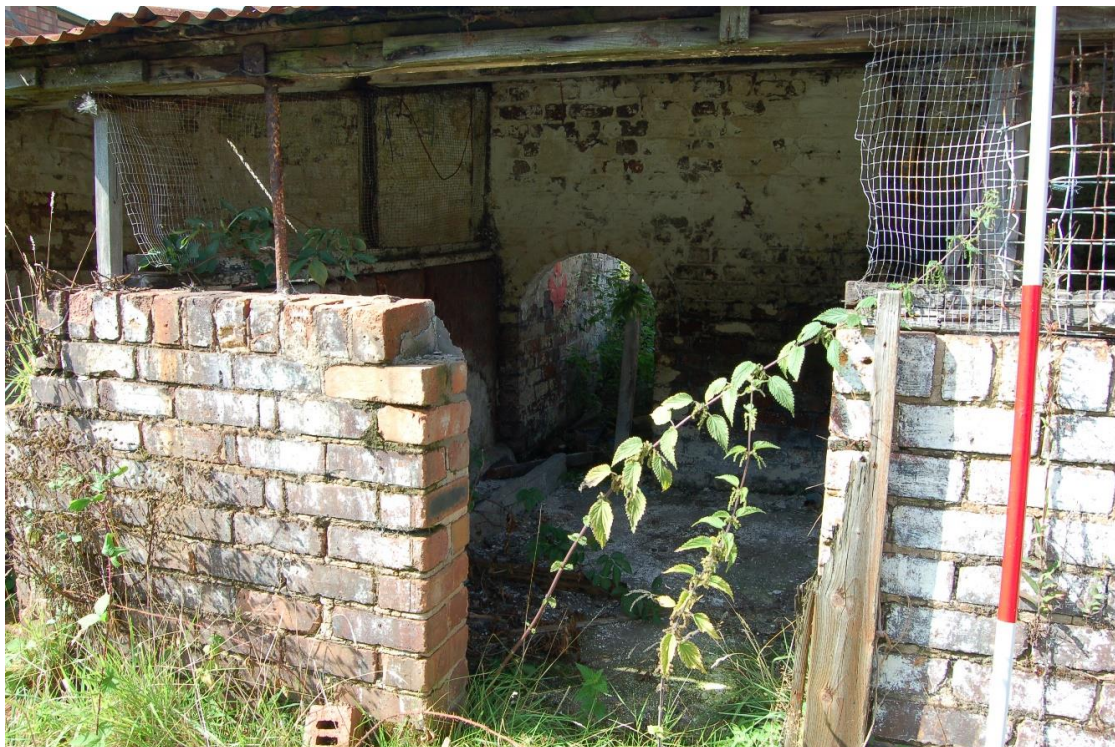
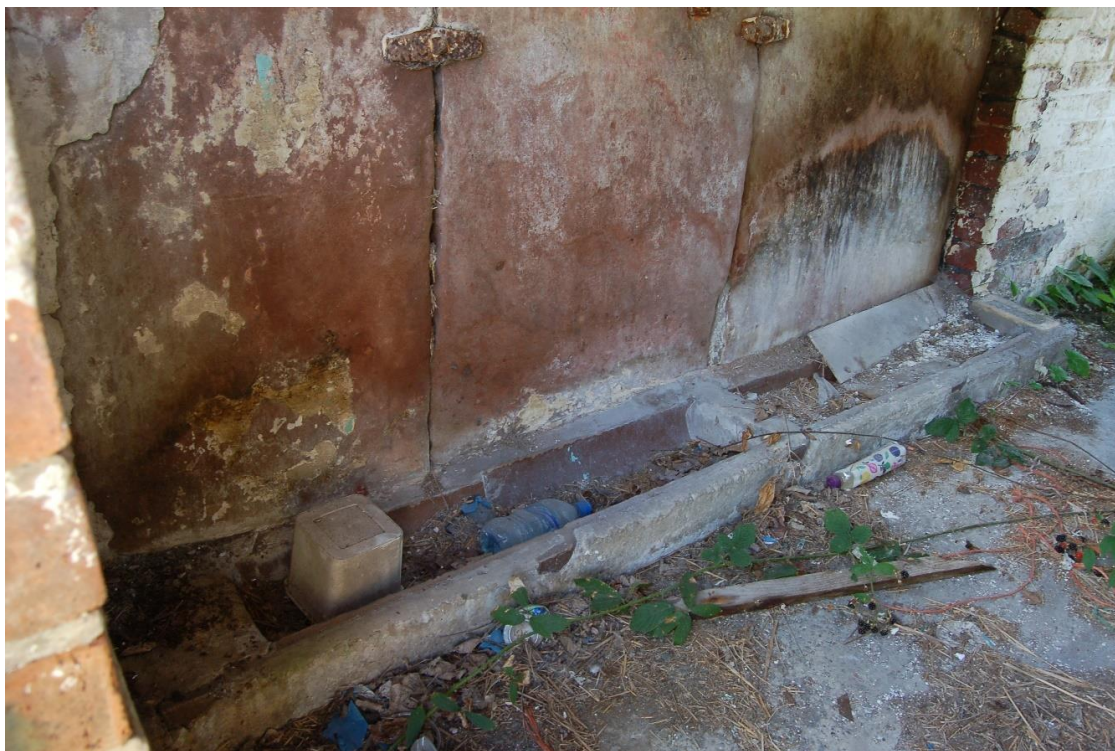
- 4.12. Internally, metal feeding troughs are still evident. The walls subdividing the stalls are also in situ and are formed of slabs with metal pins and brick.
- 4.13. The building has two phases of construction and later alterations. The main phase relates to the late 19<sup>th</sup> century pigsty comprising stalls and yard, which was later covered. An attached barn was built in the mid-20<sup>th</sup> century.

i. Interior, pigsty (F7) (south facing elevation)

ii. Pigsty (F7) trough and wall between stalls
