## **Level 2 Building Recording**

**Wheathill Riding Centre,  
Naylors Road, Knowsley,**

**September 2021**

| Report type | Level 2 Building Record | |

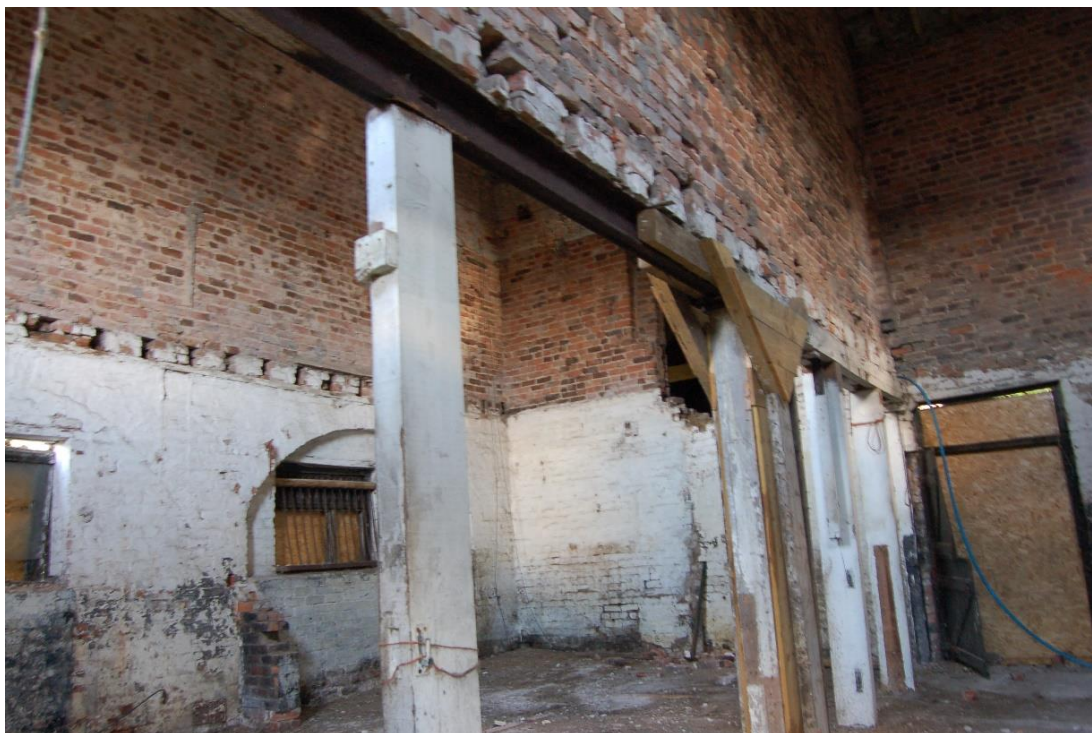
- 4.20. The timber frame roof structure is evident, although the good condition of the joists, purlins and rafters relative to the rest of the building suggests that this is not the original roof structure. There are also structural steel beams in situ. The westernmost end has internal evidence for brick arches and may have been open ended. Empty joist holes are evident suggesting that the barn had a first floor hay loft. Detailed internal inspection was not possible, but the barn appears to have been formed of three bays, with internal brick partition walls connected by doors at ground and first floor level. There do not appear to be any internal accesses from the main barn into the barns attached to its north and south facing elevations.

iii. Interior main barn (F8) (showing bays and arches in east facing elevation)

iv. Interior main barn (F8), showing internal partition wall

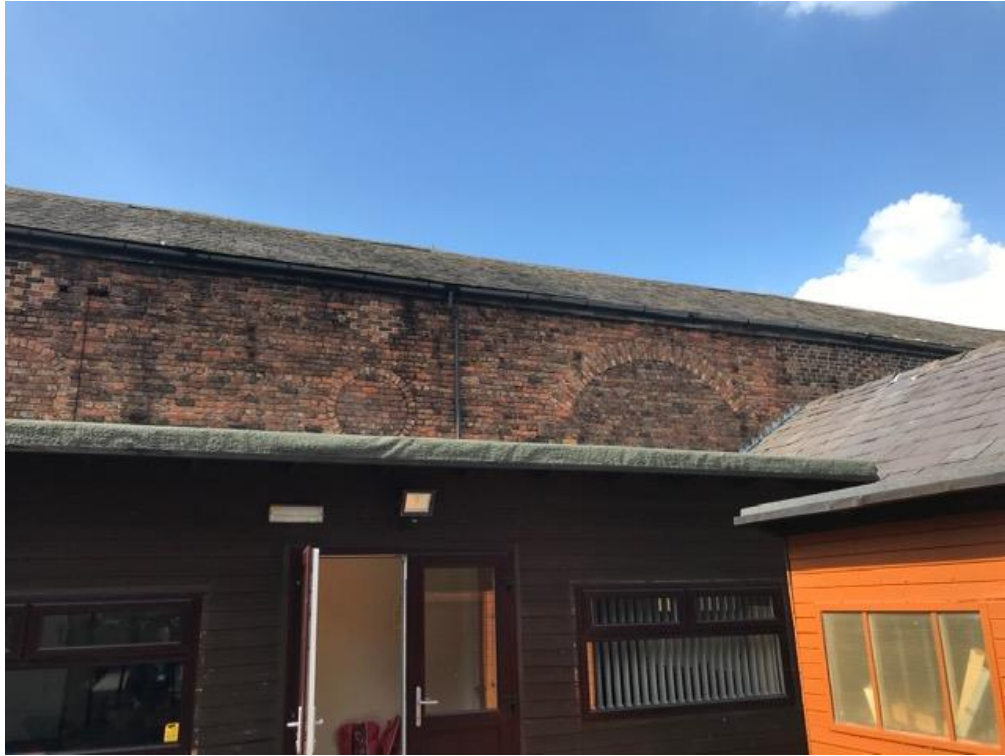
- v. Main barn (F8) south facing elevation (photograph from within the existing school premises, the elevation is obscured by the attached barns and school buildings)

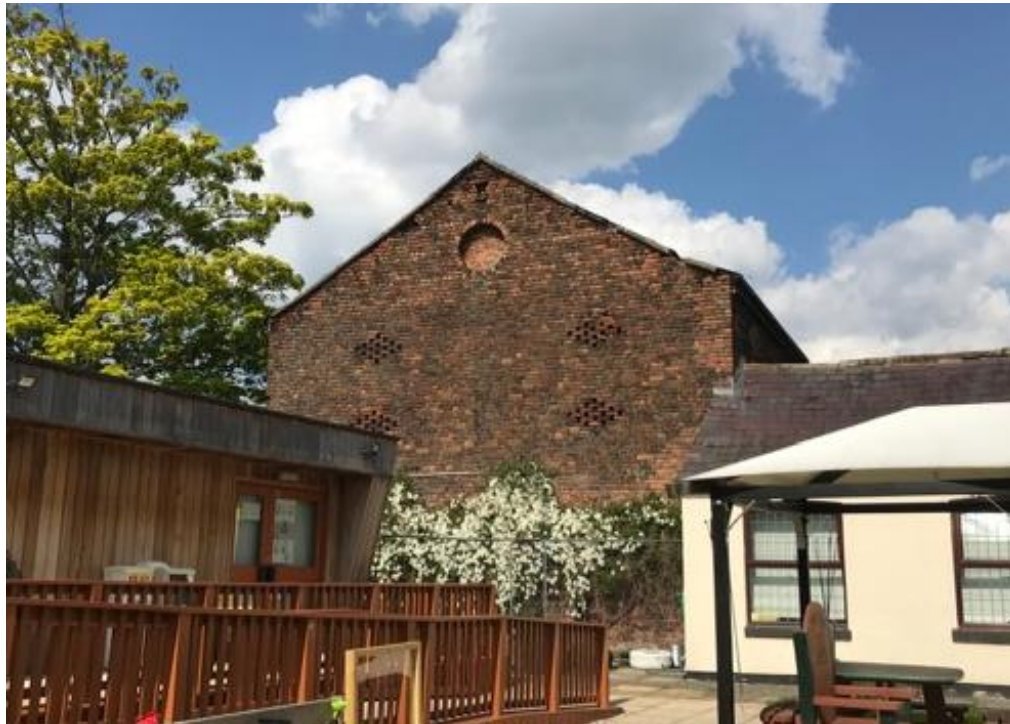
- vi. Main barn (F8) west facing elevation (photograph from within the existing school premises)

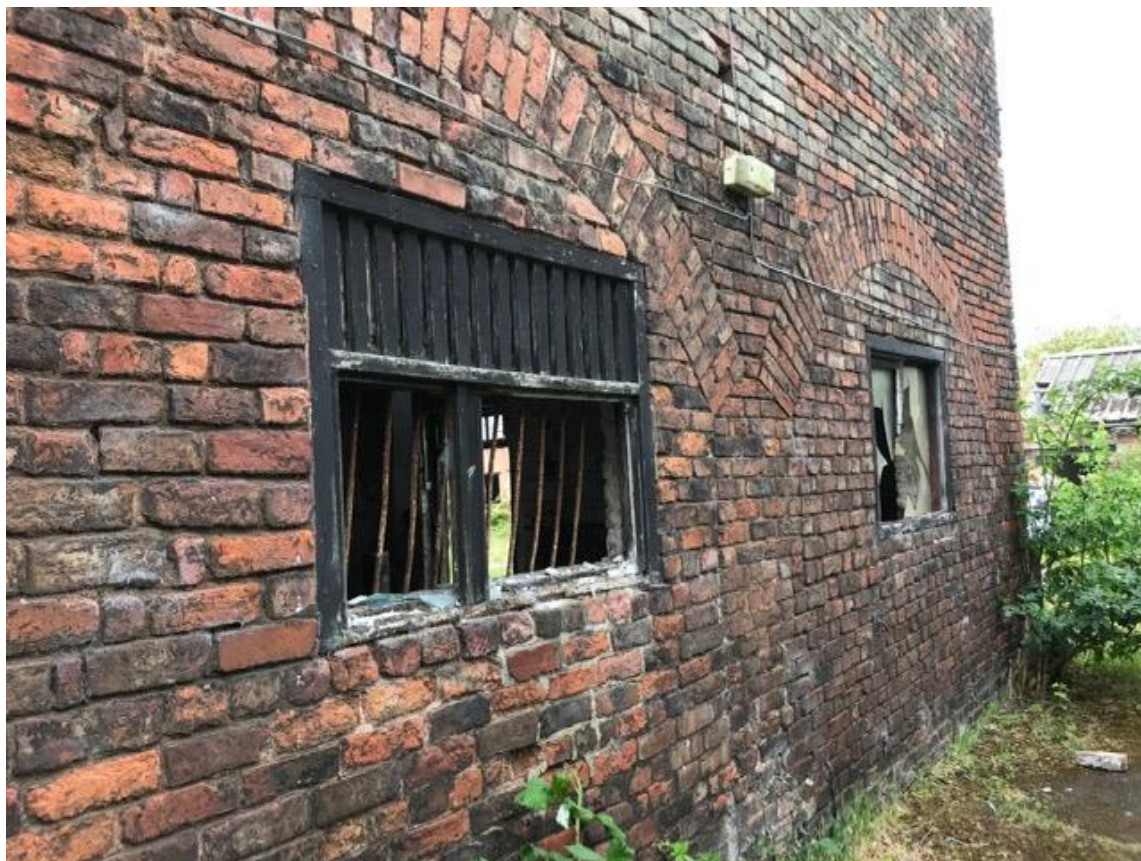
- vii. Main barn (F8) east facing elevation – client archive photograph, this elevation is currently obscured by scrub and site security fencing. Note infilled brick arches with inserted windows with ventilation grills

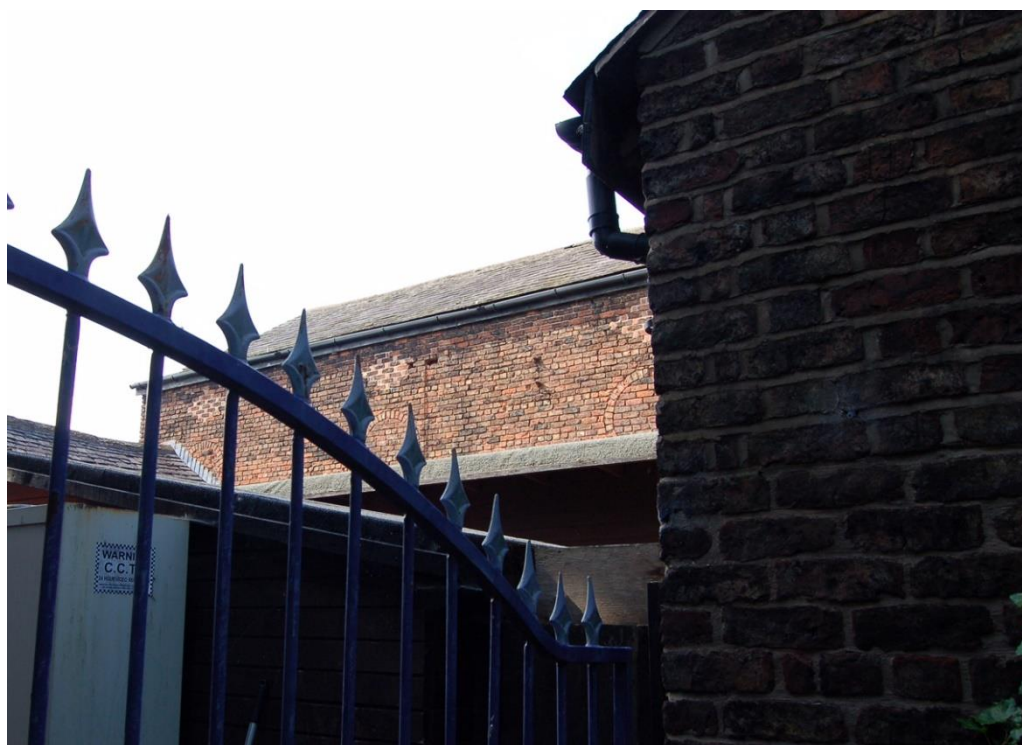
- viii. South facing elevation of main barn with south western attached barn (within school grounds) and central attached barn in foreground

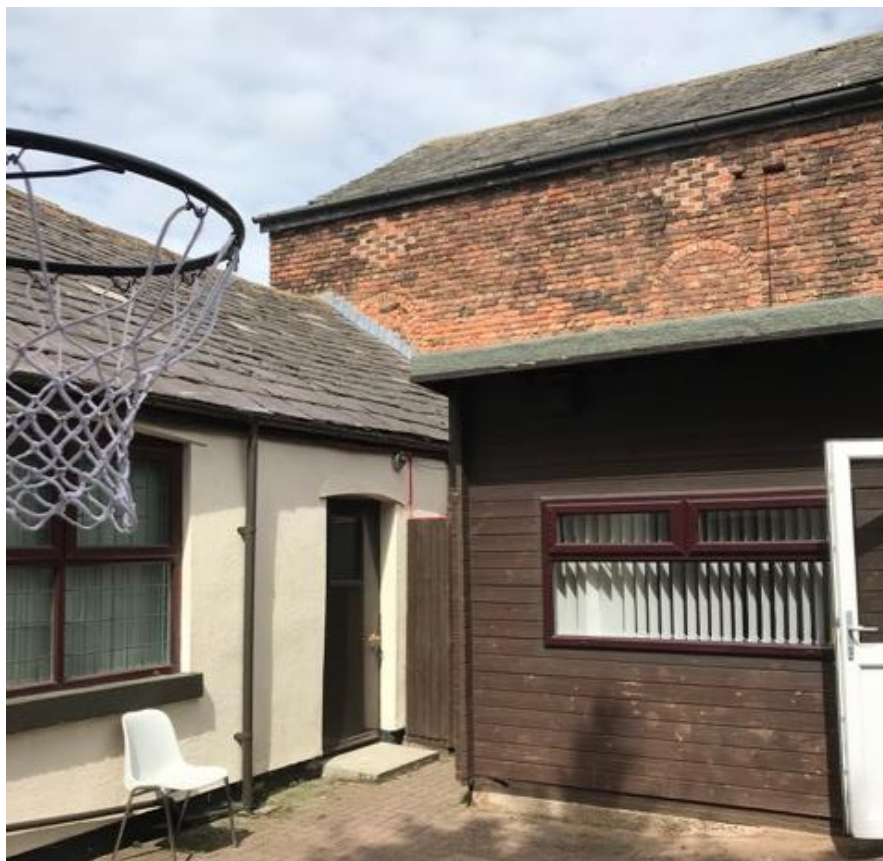
ix. Main barn south facing elevation from within the school grounds, with the attached southern eastern barn and modern wooden lean-to (Building B1)
