Overarching Geo-Environmental Site Summary

Parcel C, Prescott Miller  
13-158-R1  
October 2020

Parcel C  
Carr Lane  
Prescot  
L34 1JZ

**Report Ref: 13-158-R1**  
**Date Issued: October 2020**

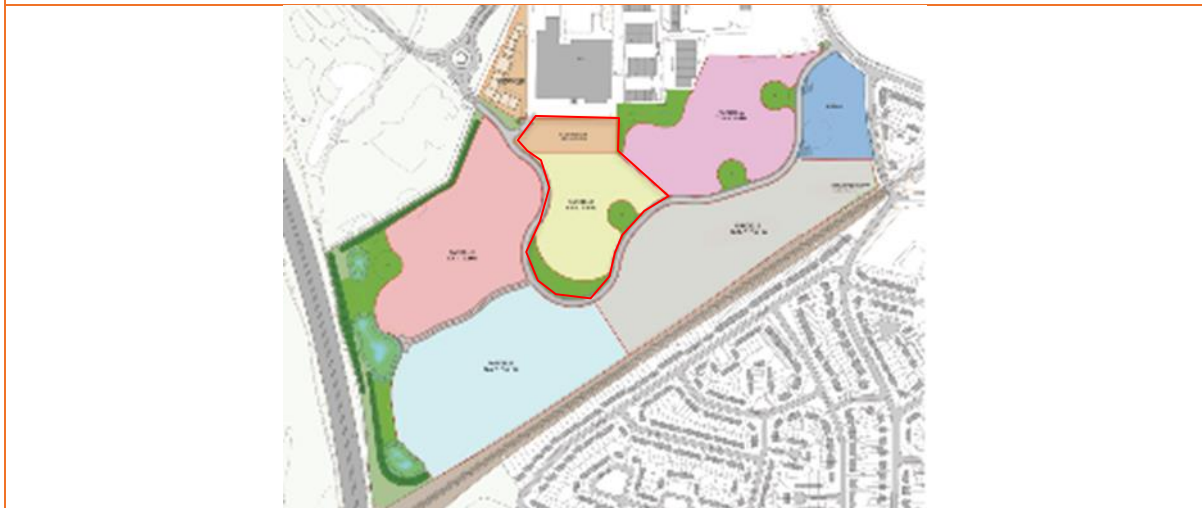
FIGURE 1.1 SITE PARCEL PLAN

For the avoidance of doubt, E3P can confirm that the parcel of land refers to the red-line boundary as indicated in Figure 1.1 below:

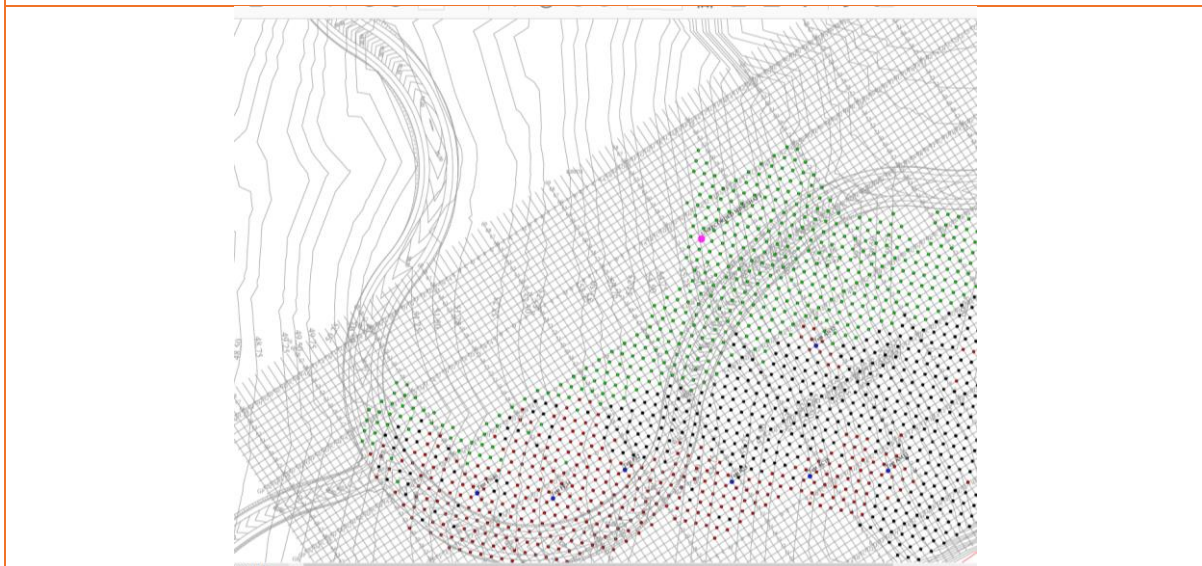
FIGURE 5.1 AREA OF DRILL & GROUT PERTINENT TO PARCEL C

Rotary open hole drilling was undertaken on a grid system to identify the presence of the seam and any shallow workings. Coal was identified in the south west and south west of Parcel C with broken ground in the southern sector of the parcel.

The Groundshire, Mineworks Remediation Report (Ref:MSJ/LME 180515 Dated Jan 2016) details the full shallow mine workings and mine entry treatment for the wider development. It is considered that the stabilisation works within Parcel C have been completed satisfactorily with no risk to future development remaining.

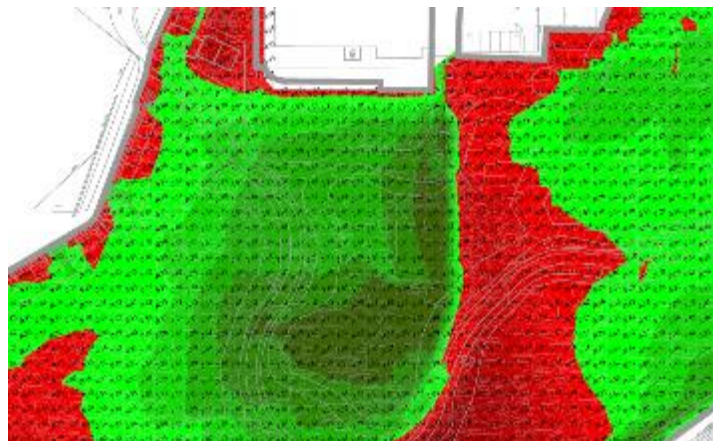
FIGURE 6.1 EXTRACT OF CUT/FILL DRAWING

With reference to Figure 2.1, the eastern sector (area shaded red) of Parcel C was generally subject large earthwork exercise that required the removal of between 2-3 meters of historically placed fill that formally comprised a large earth embankment that sub-divided the upper and lower plateau. Subsequent to the cut operation, a turn-over of 3.0m was instigated with subsequent replacement of re-engineered material. In the western sector the landform was upfilled by circa 3.0 - 4.0 at the south west boundary to facilitate the construction of the appropriate road grade (area shaded green).

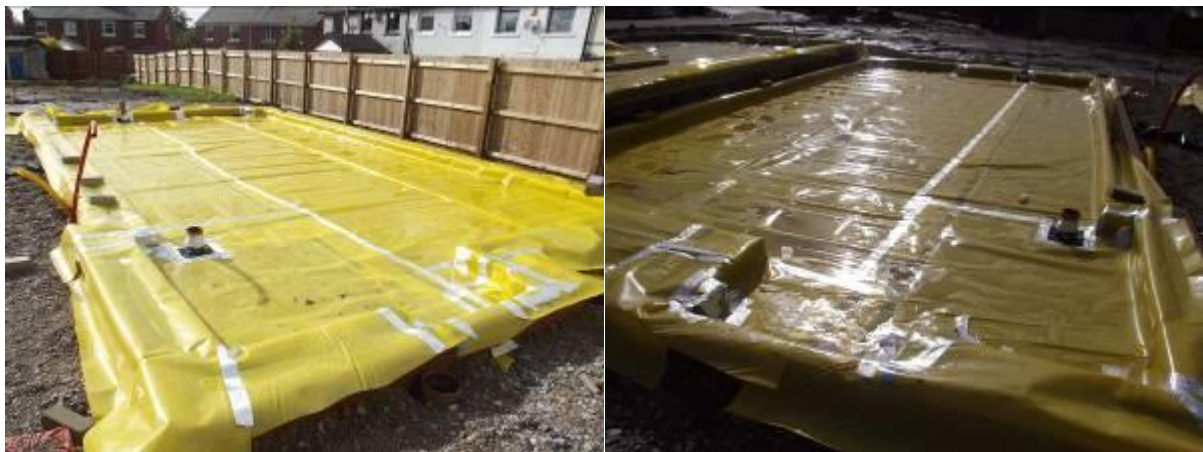
*Photographs 1 and 2: Check general condition of membrane for punctures / tears etc*

Examples of gas membrane verification (photographs include different membrane types for demonstrative purposes only – gas membranes are site specific):

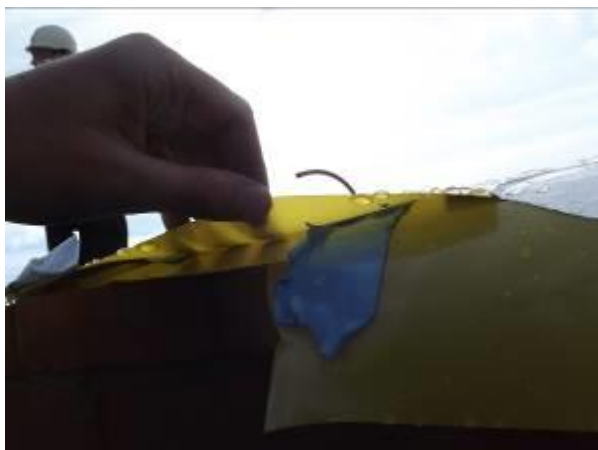
*Photograph 3: Confirm membrane product type and check joints between rolls of membrane to ensure 150mm overlap and presence of double sided butyl tape (by touch – may not be visible) and girth jointing tape.*

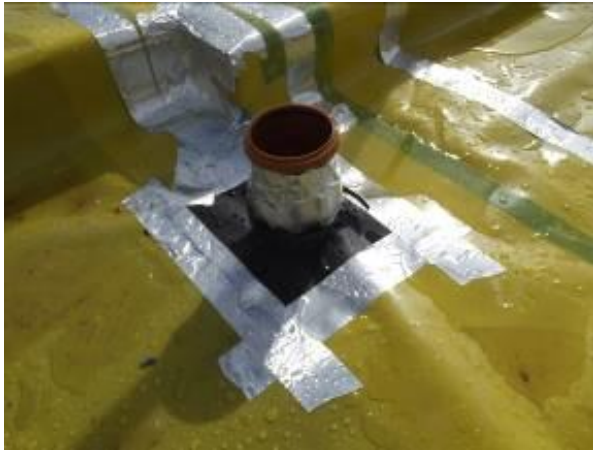
Photograph 4: Check top hat is sealed to membrane and pipework. If the formed top hat is not tight to the pipework then also confirm presence of jubilee clip beneath butyl tape.

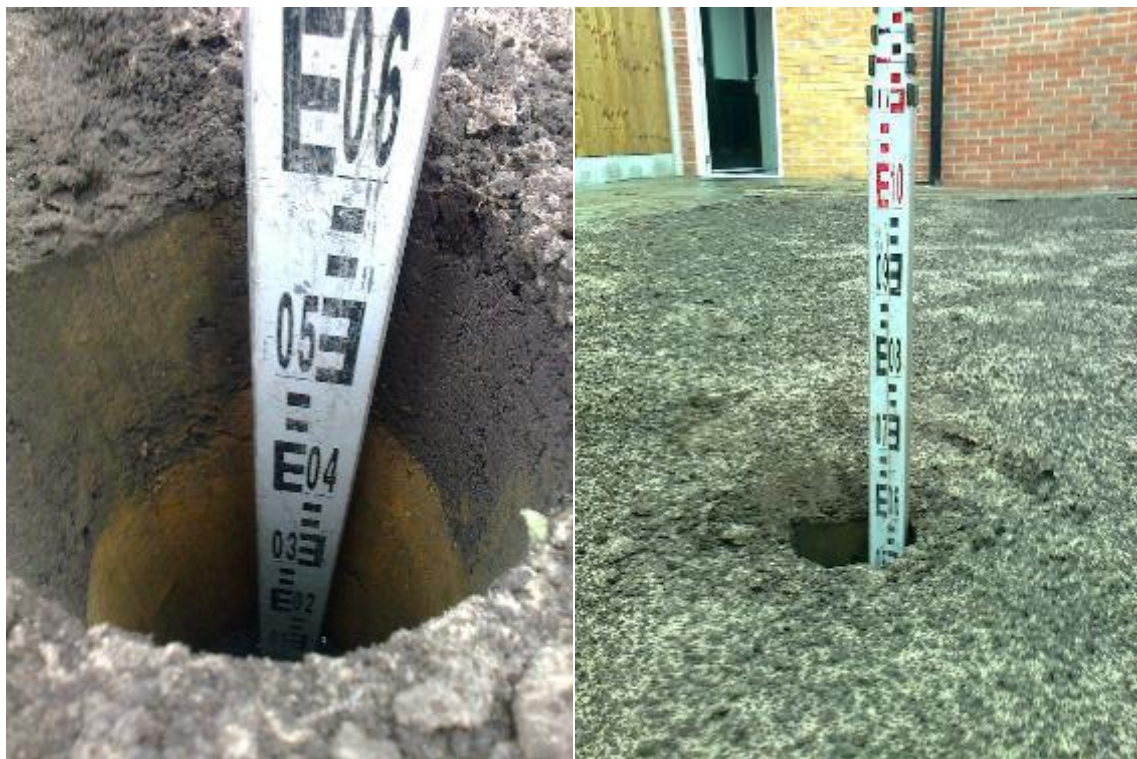
Photographs 1 and 2: Examples of validation photographs demonstrating clean cover.

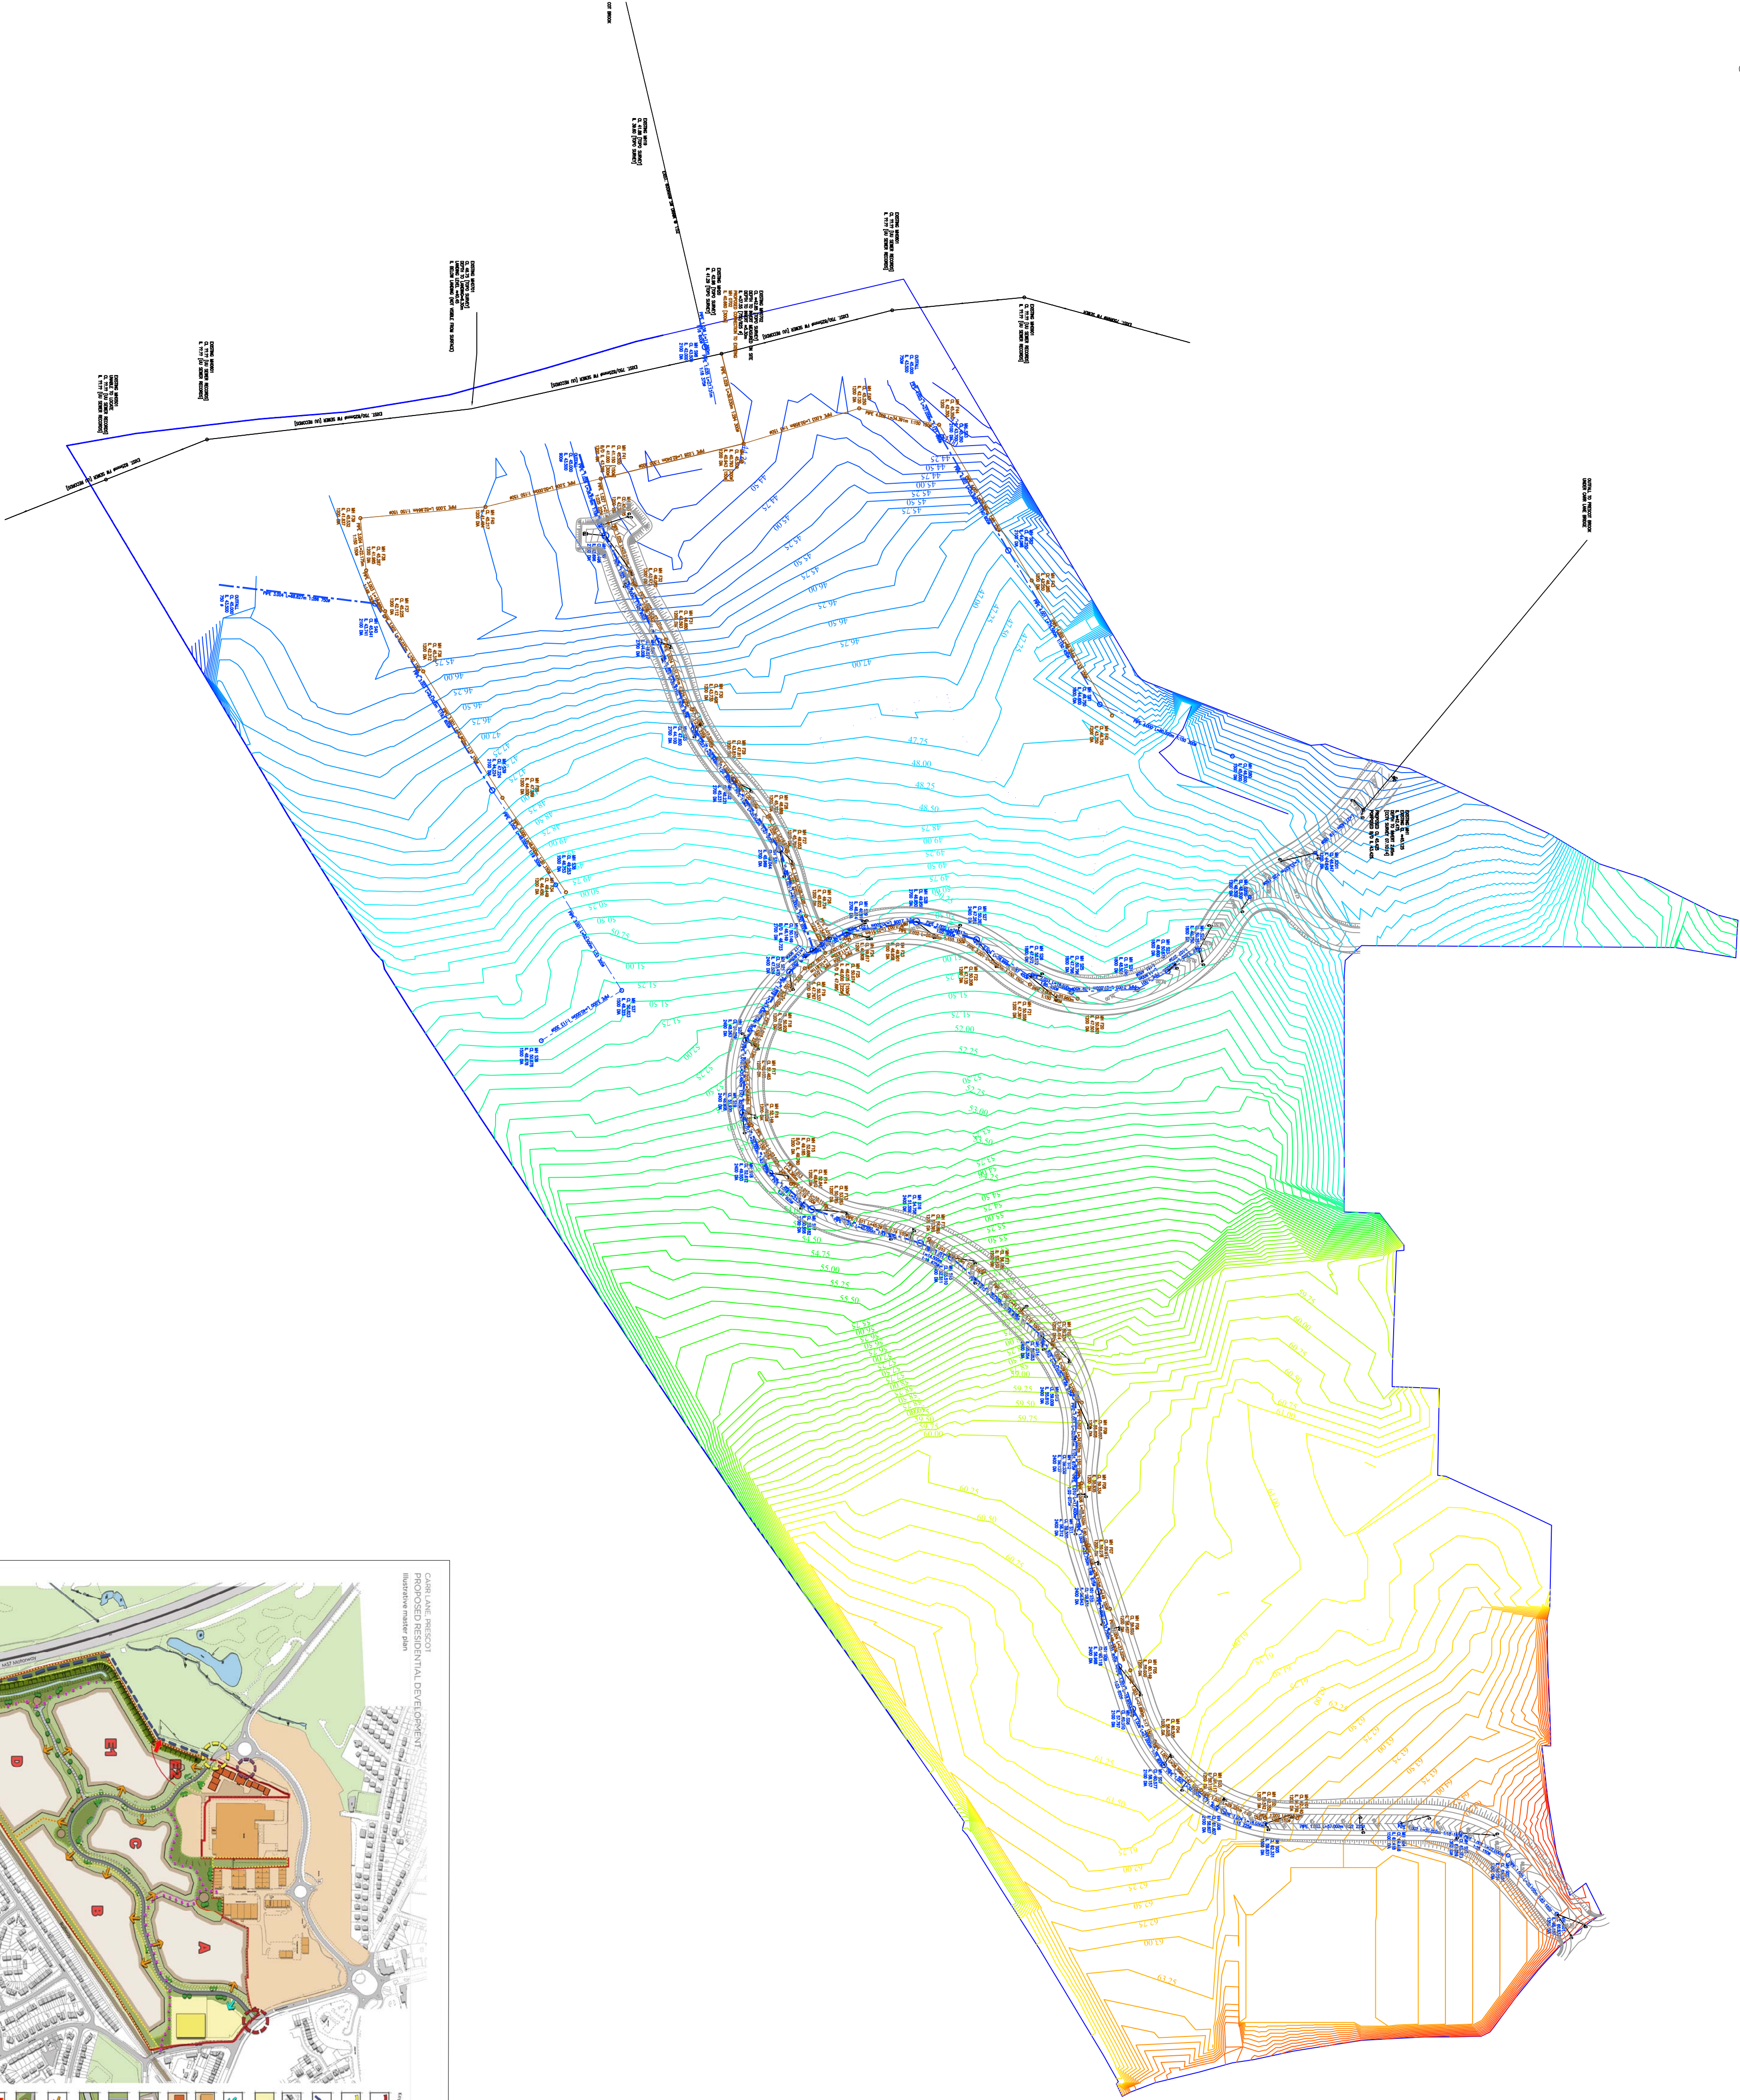
| Job Title: | Prescot Business Park | Drawing Title: | Remediation Master Plan |

- XX.XX Indicative Regrade Level (500mm Construction Allowed for in Volumetrics)
- Designed Gradient/Assumed Gradient Direction
- Fill from OGL to Formation Level
- XX.XX Cut from OGL to Formation Level

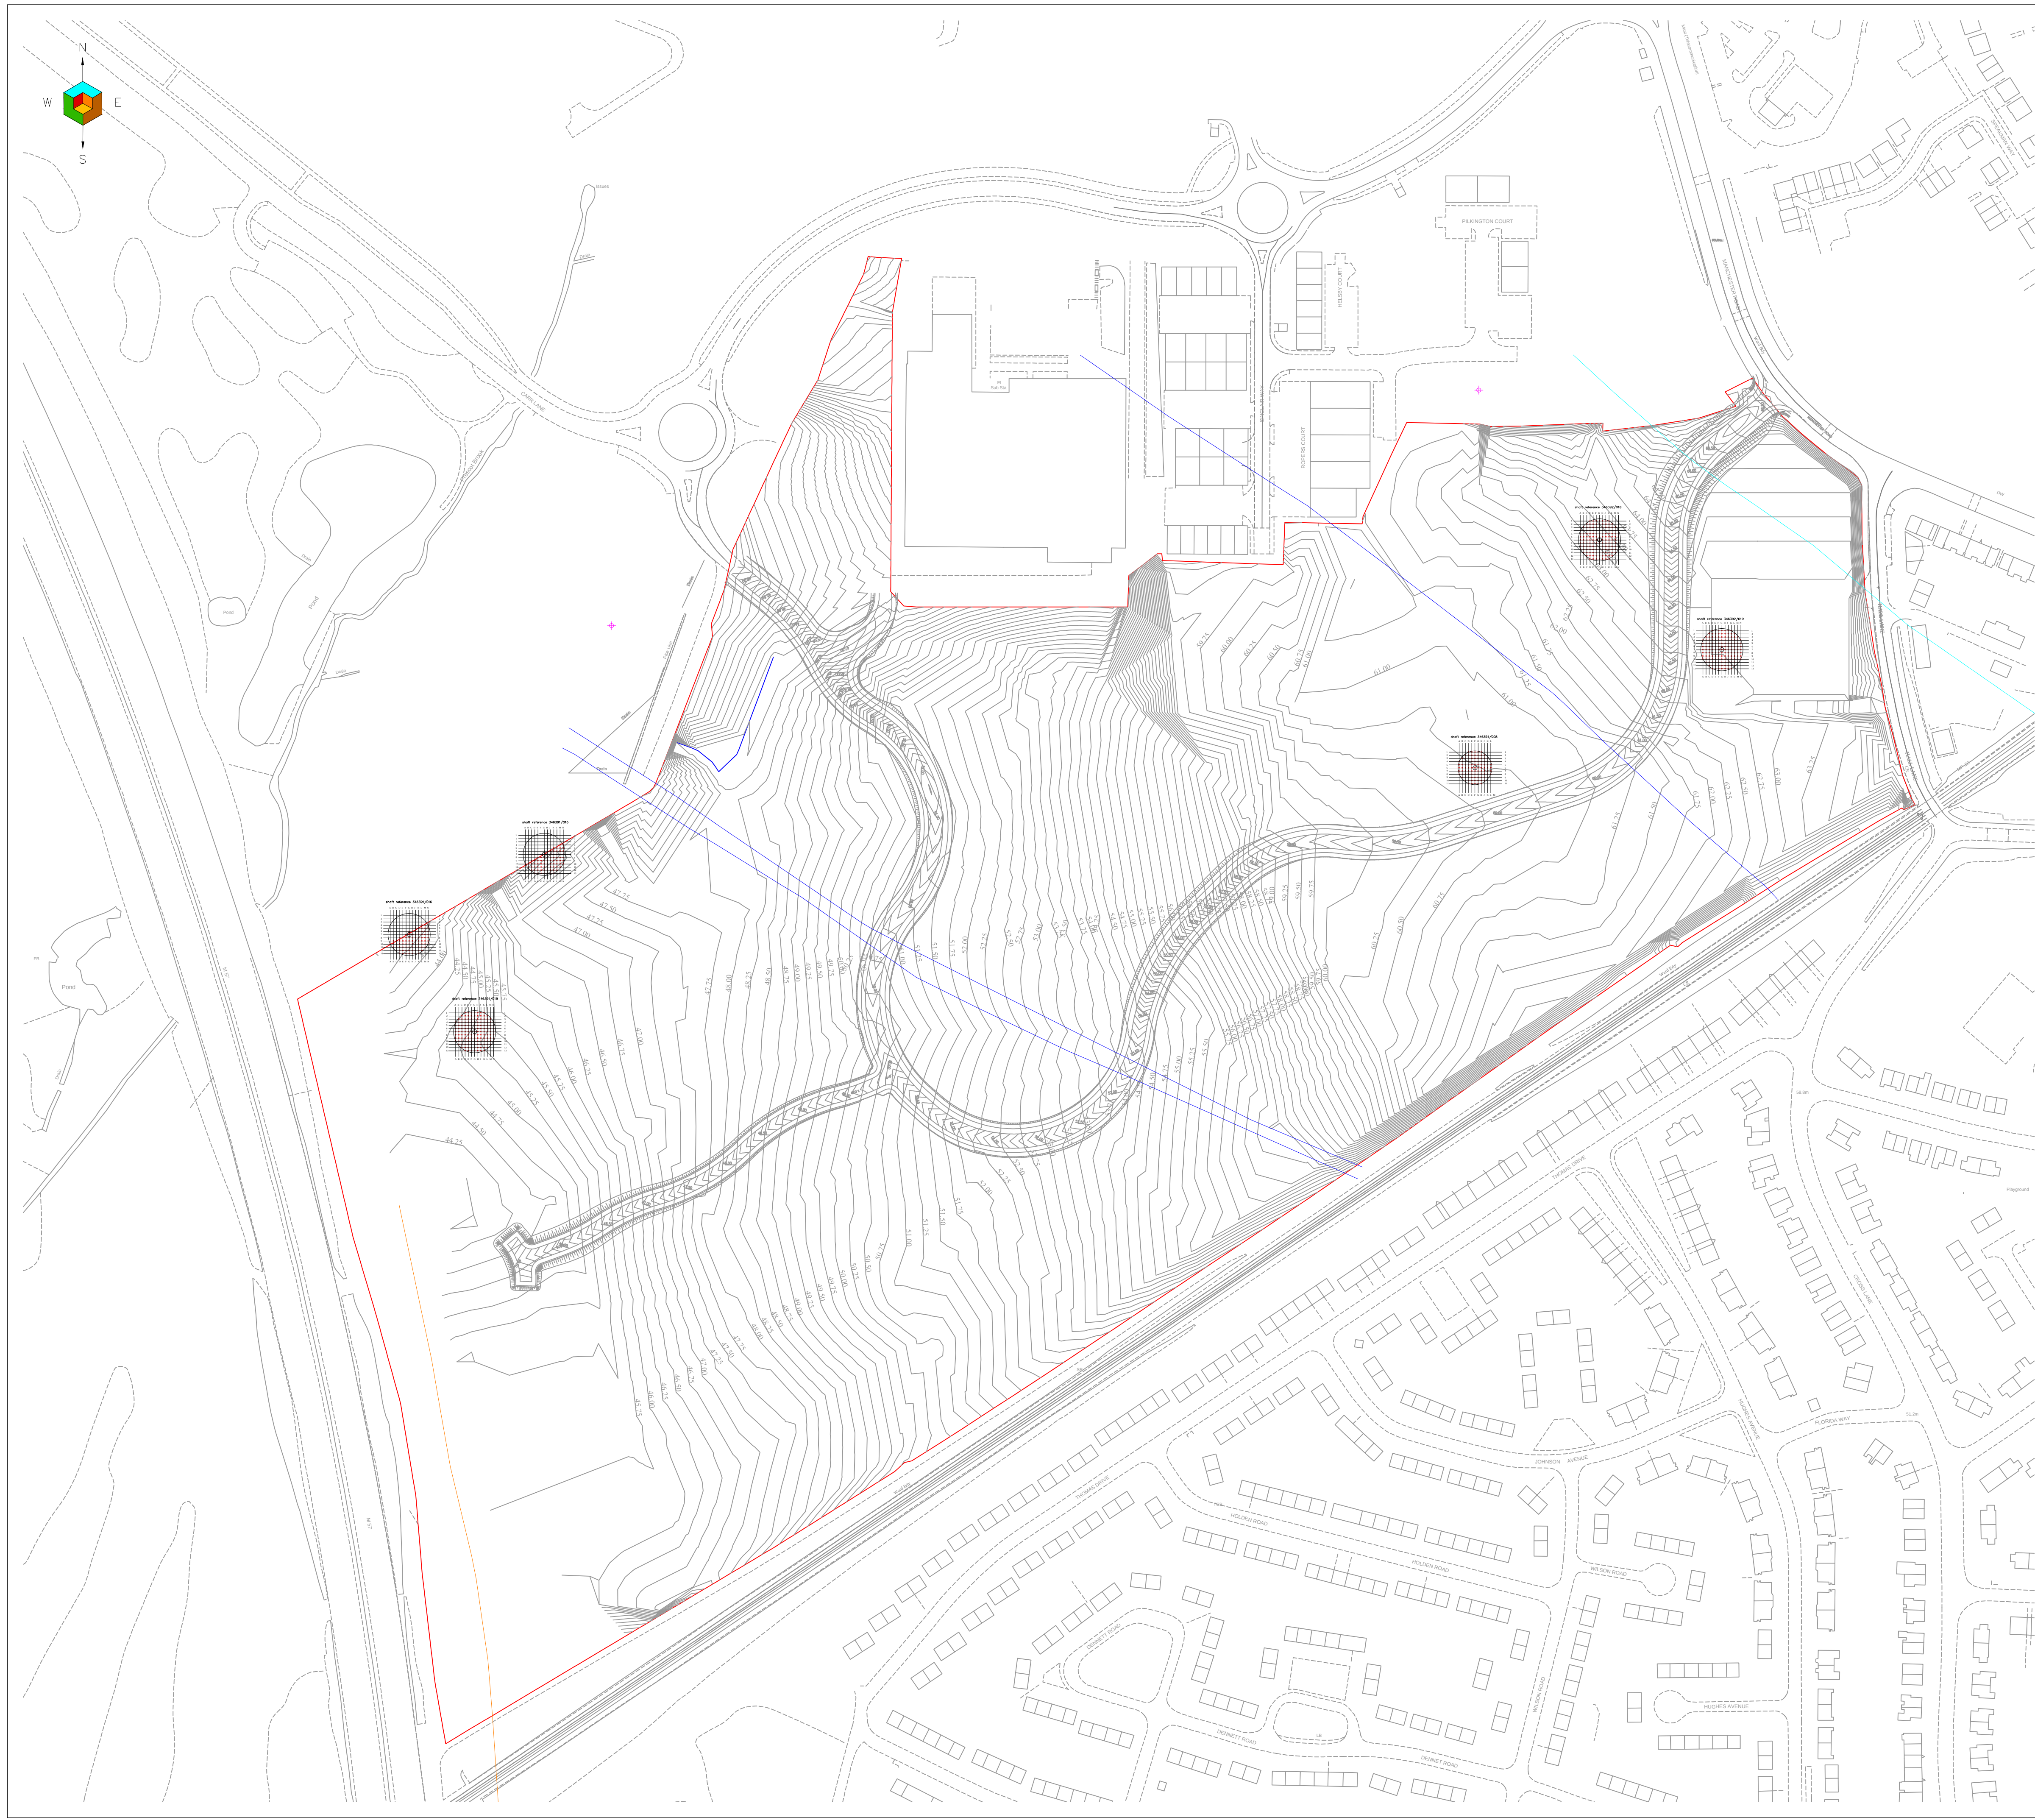
| Prysmian Cables,<br>Prescot | | | Coal Mining<br>Location Plan | | |

- Key:
- Approximate Location of Disused Mine Shaft
  - Approximate Location of Coal Seam
  - Approximate Location of Fault at Surface
  - Approximate Location of Fault Underground

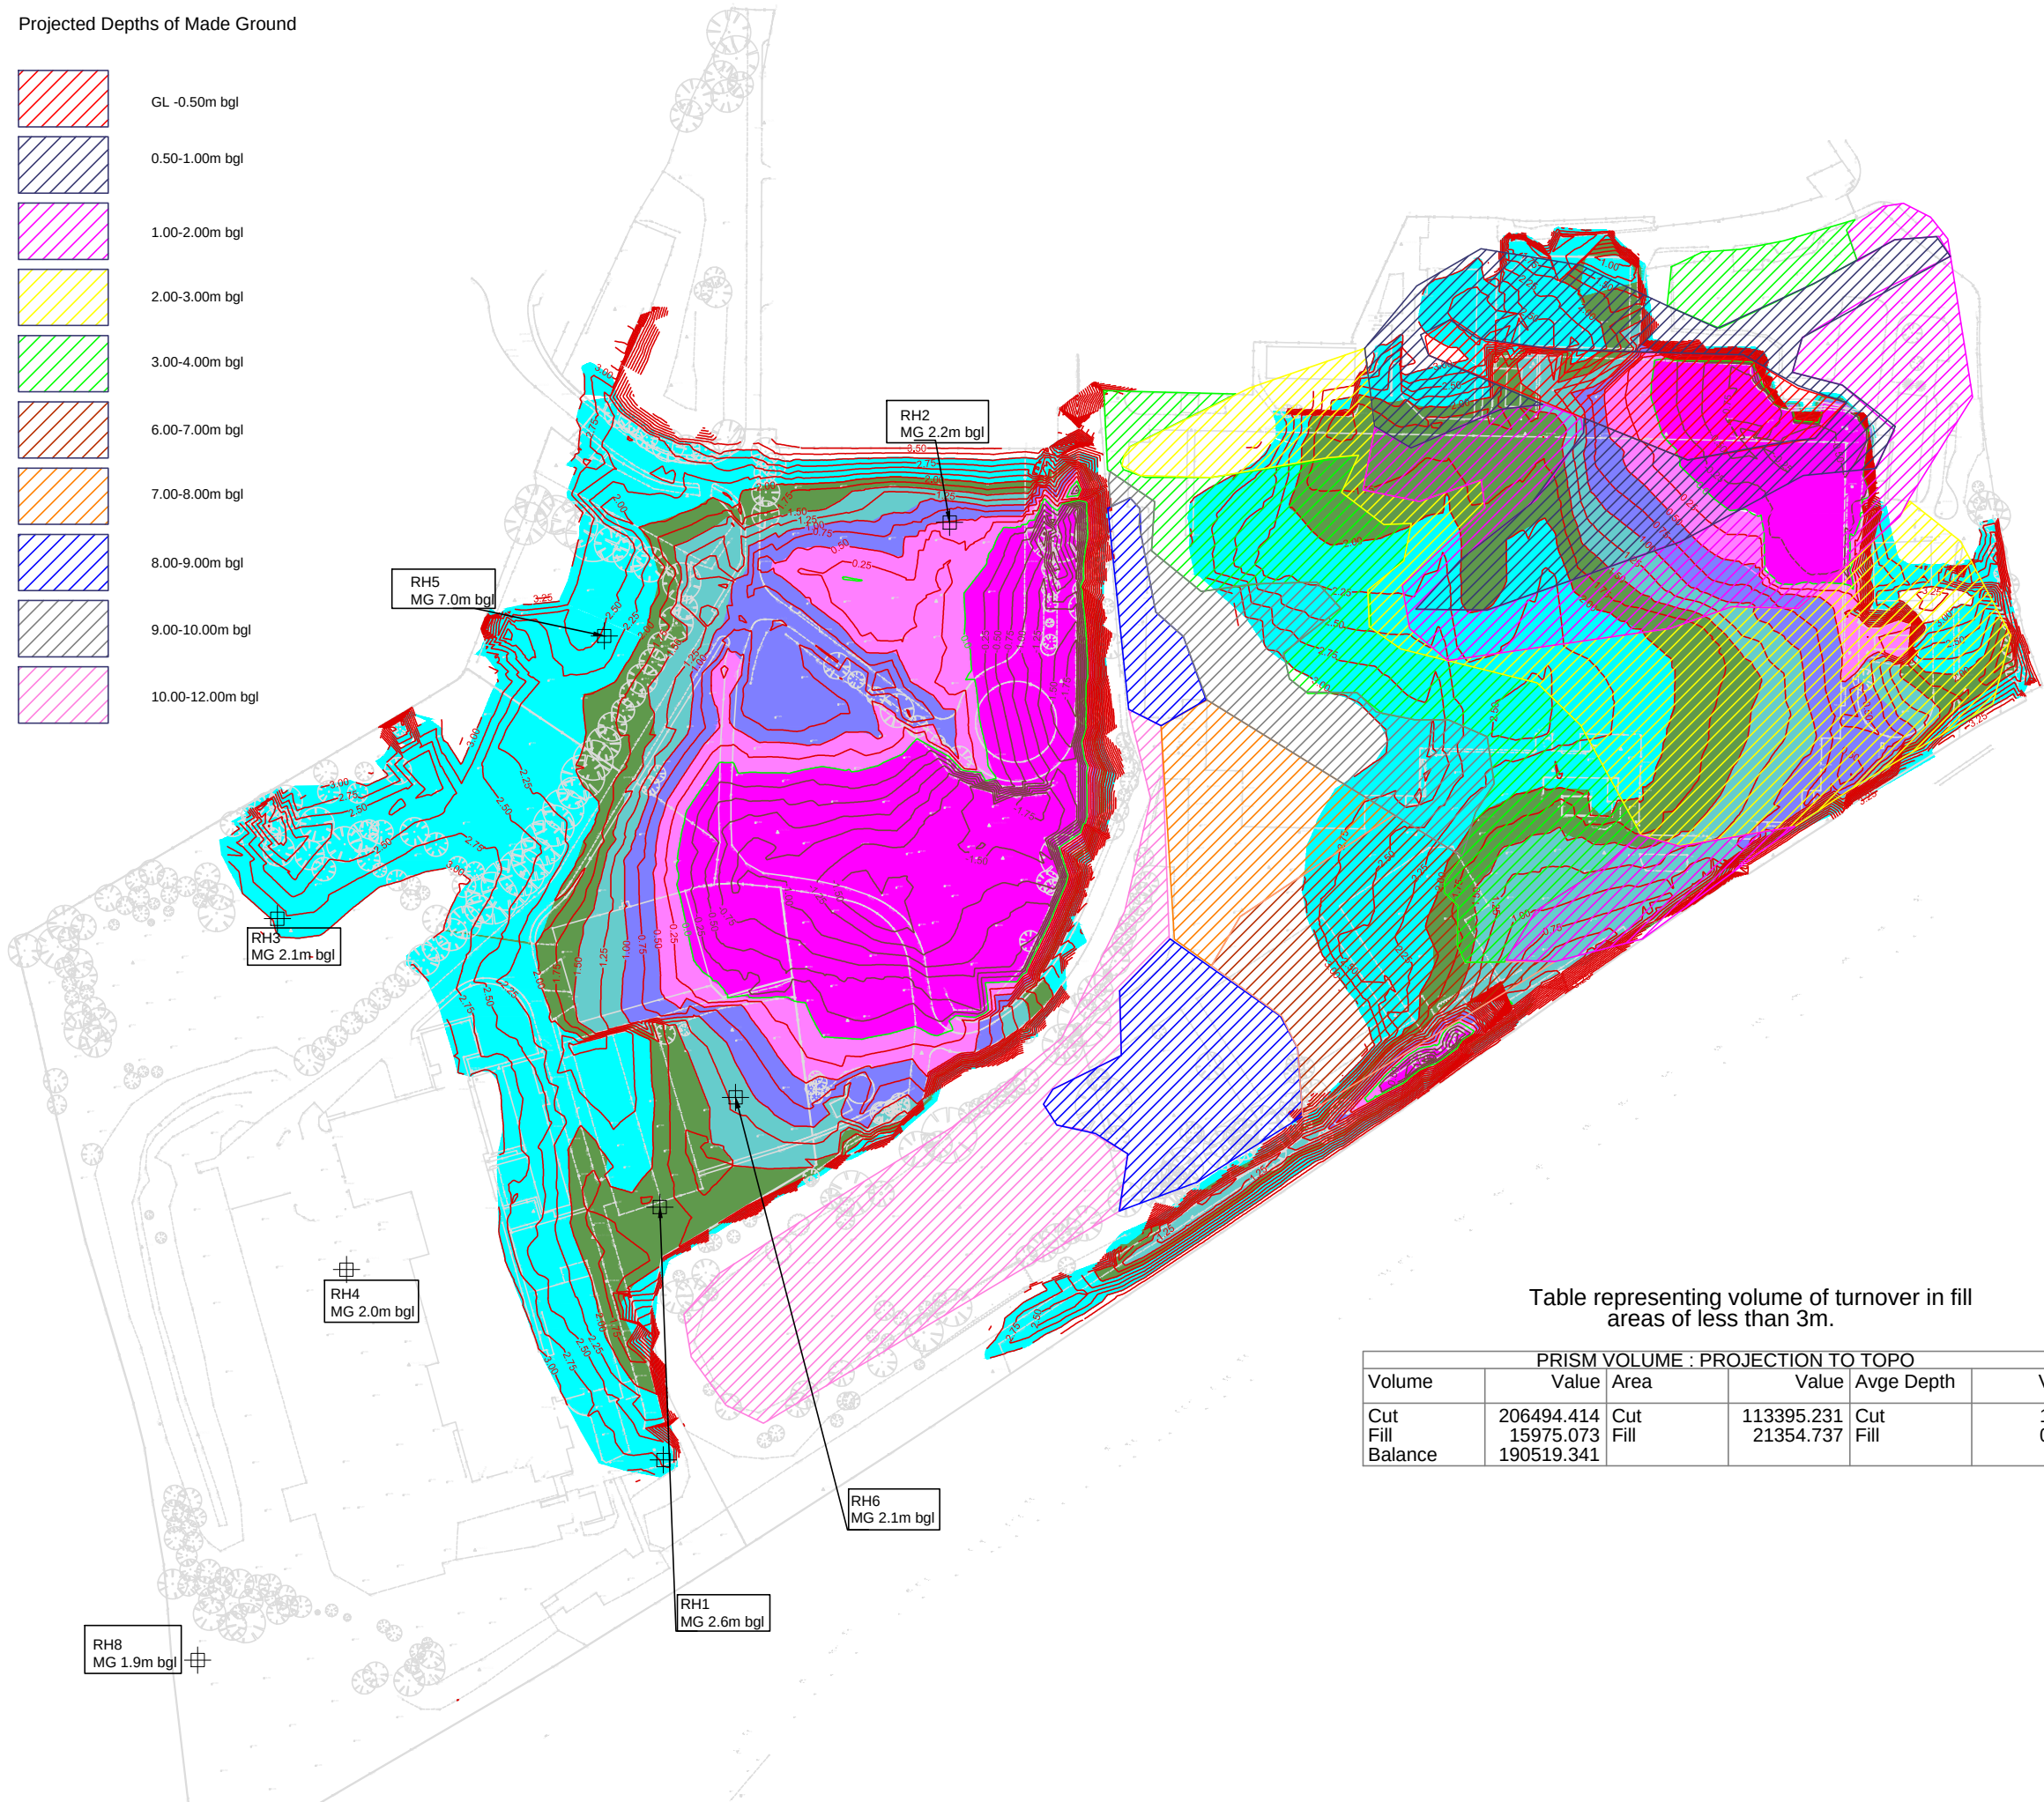
Projected Depths of Made Ground

Table representing volume of turnover in fill areas of less than 3m.

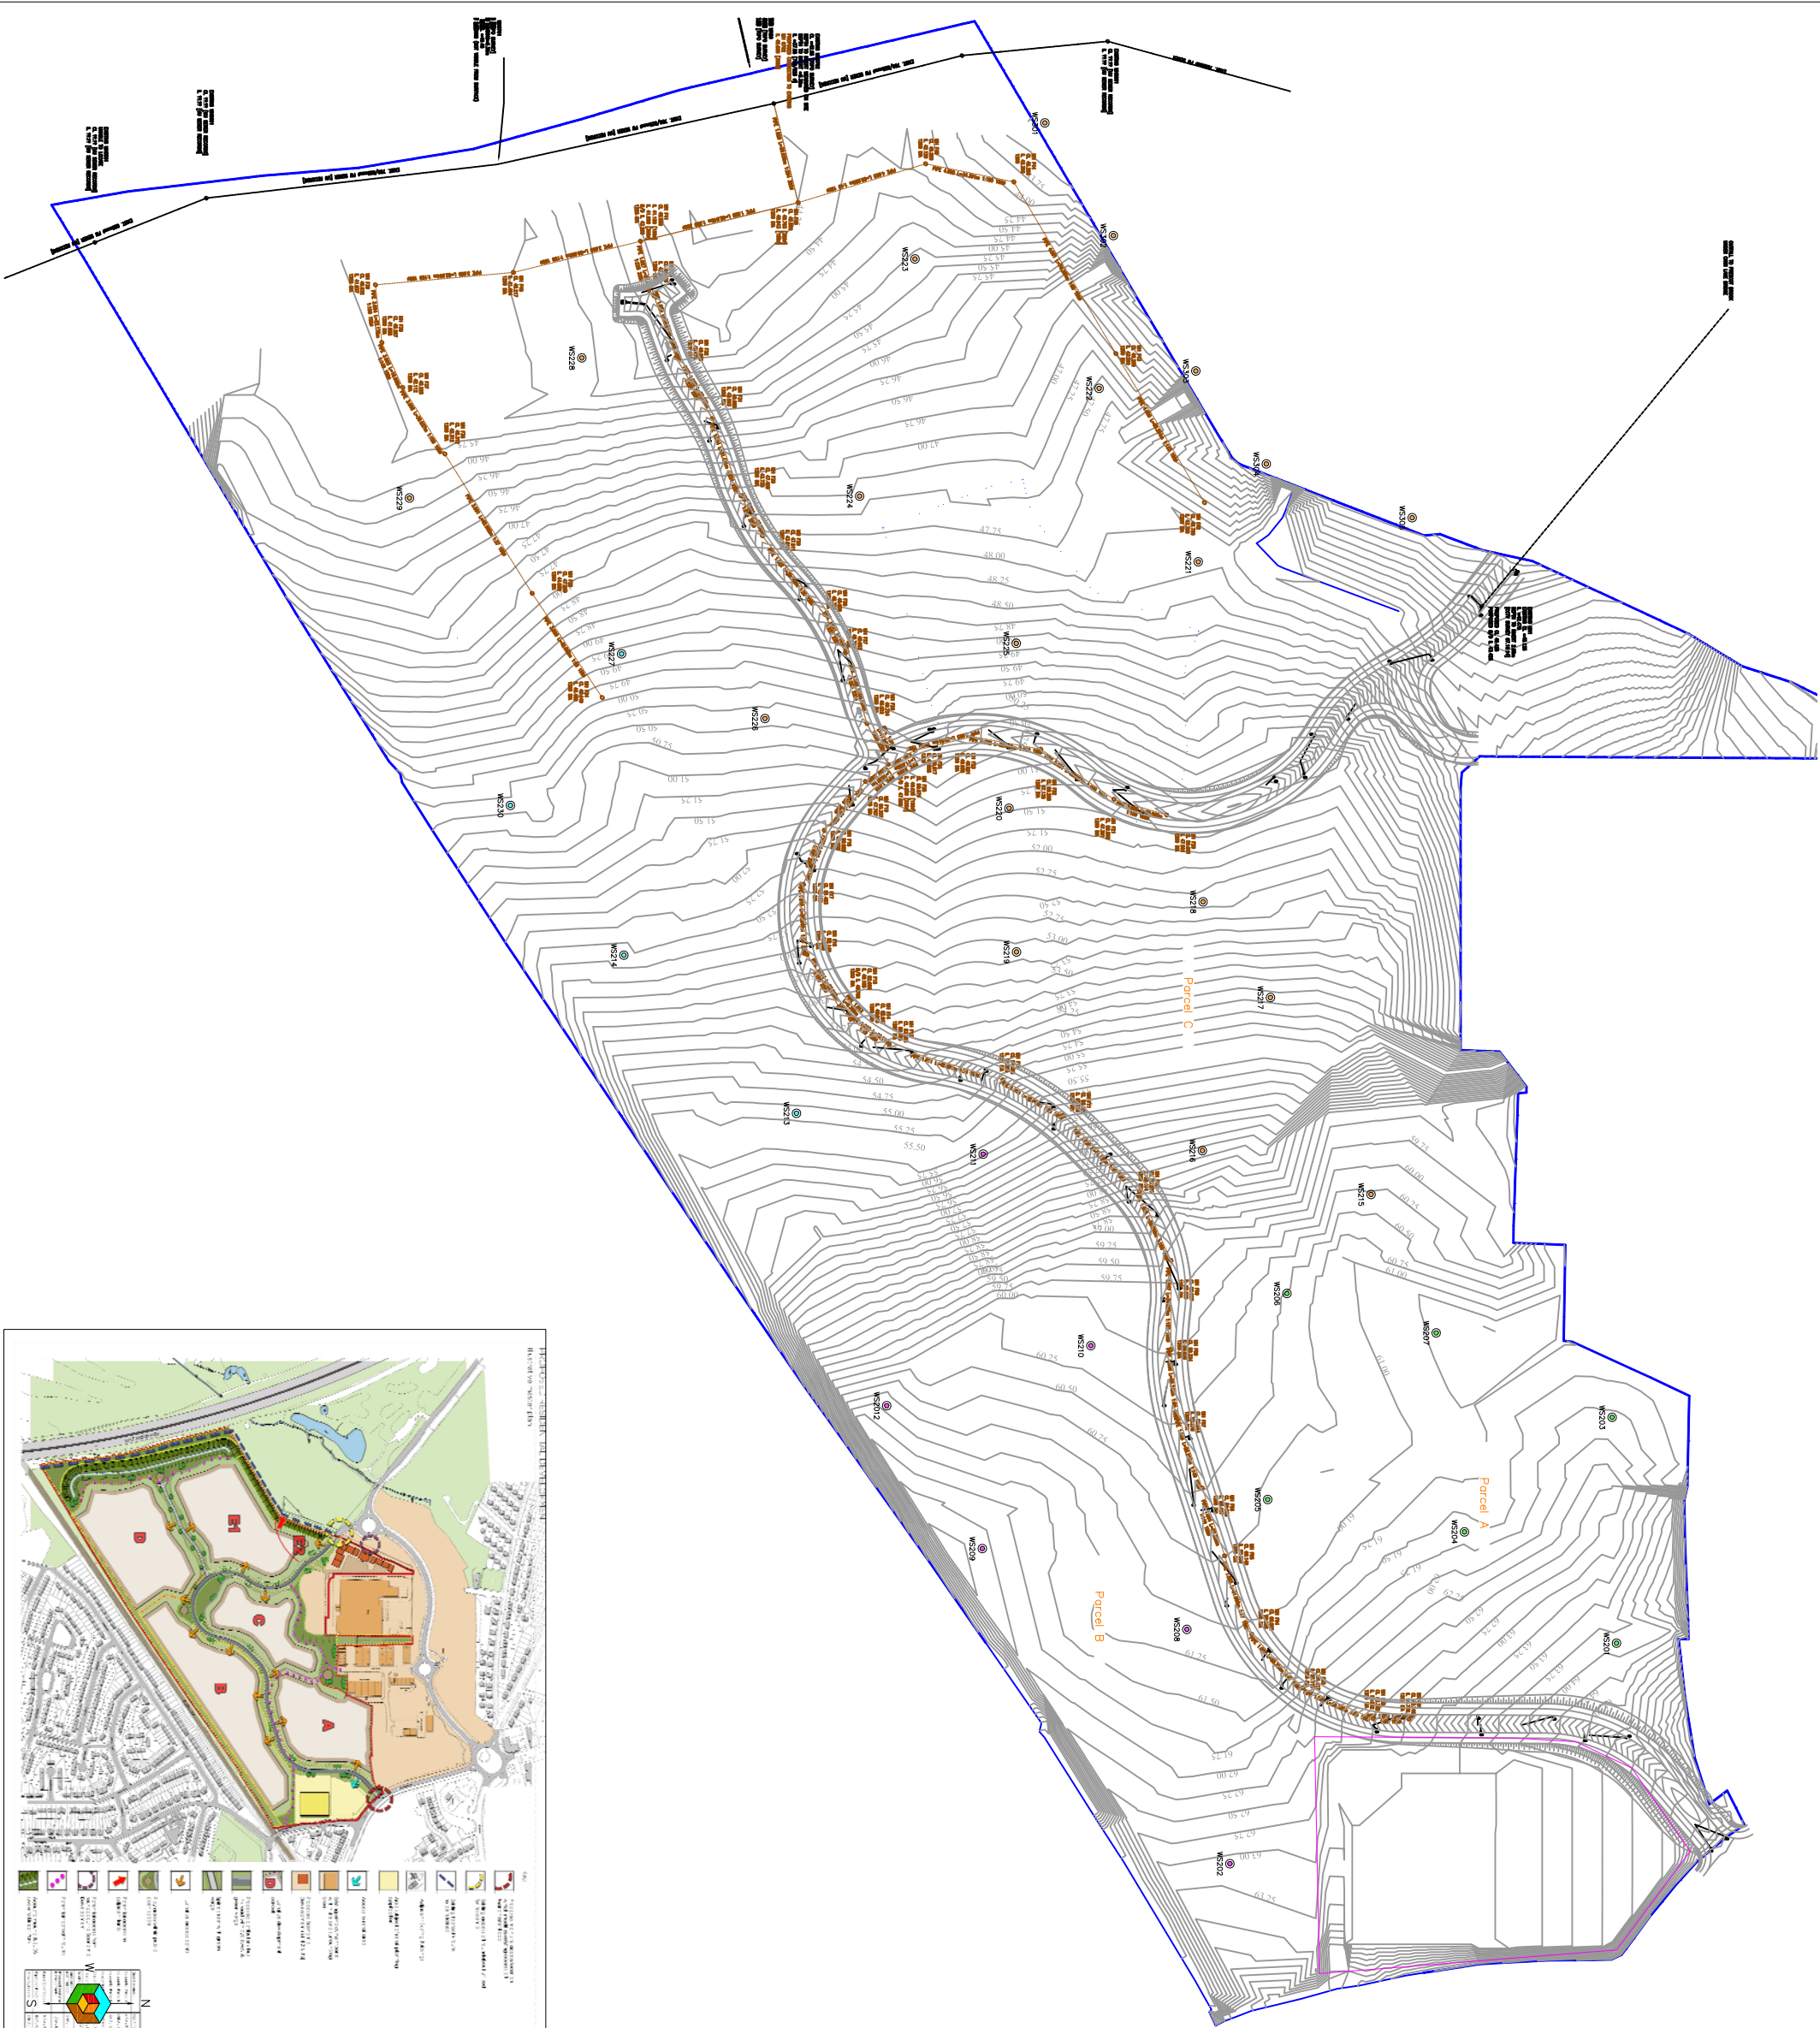
- WS201 Approximate Window Sample Probehole Location
- WS301 Approximate Window Sample Probehole Location (UU Land)
- WS201 Approximate Window Sample Probehole Location (25-01-2016)
- WS201 Approximate Window Sample Probehole Location (26-01-2016)
- WS201 Approximate Window Sample Probehole Location (27-01-2016)

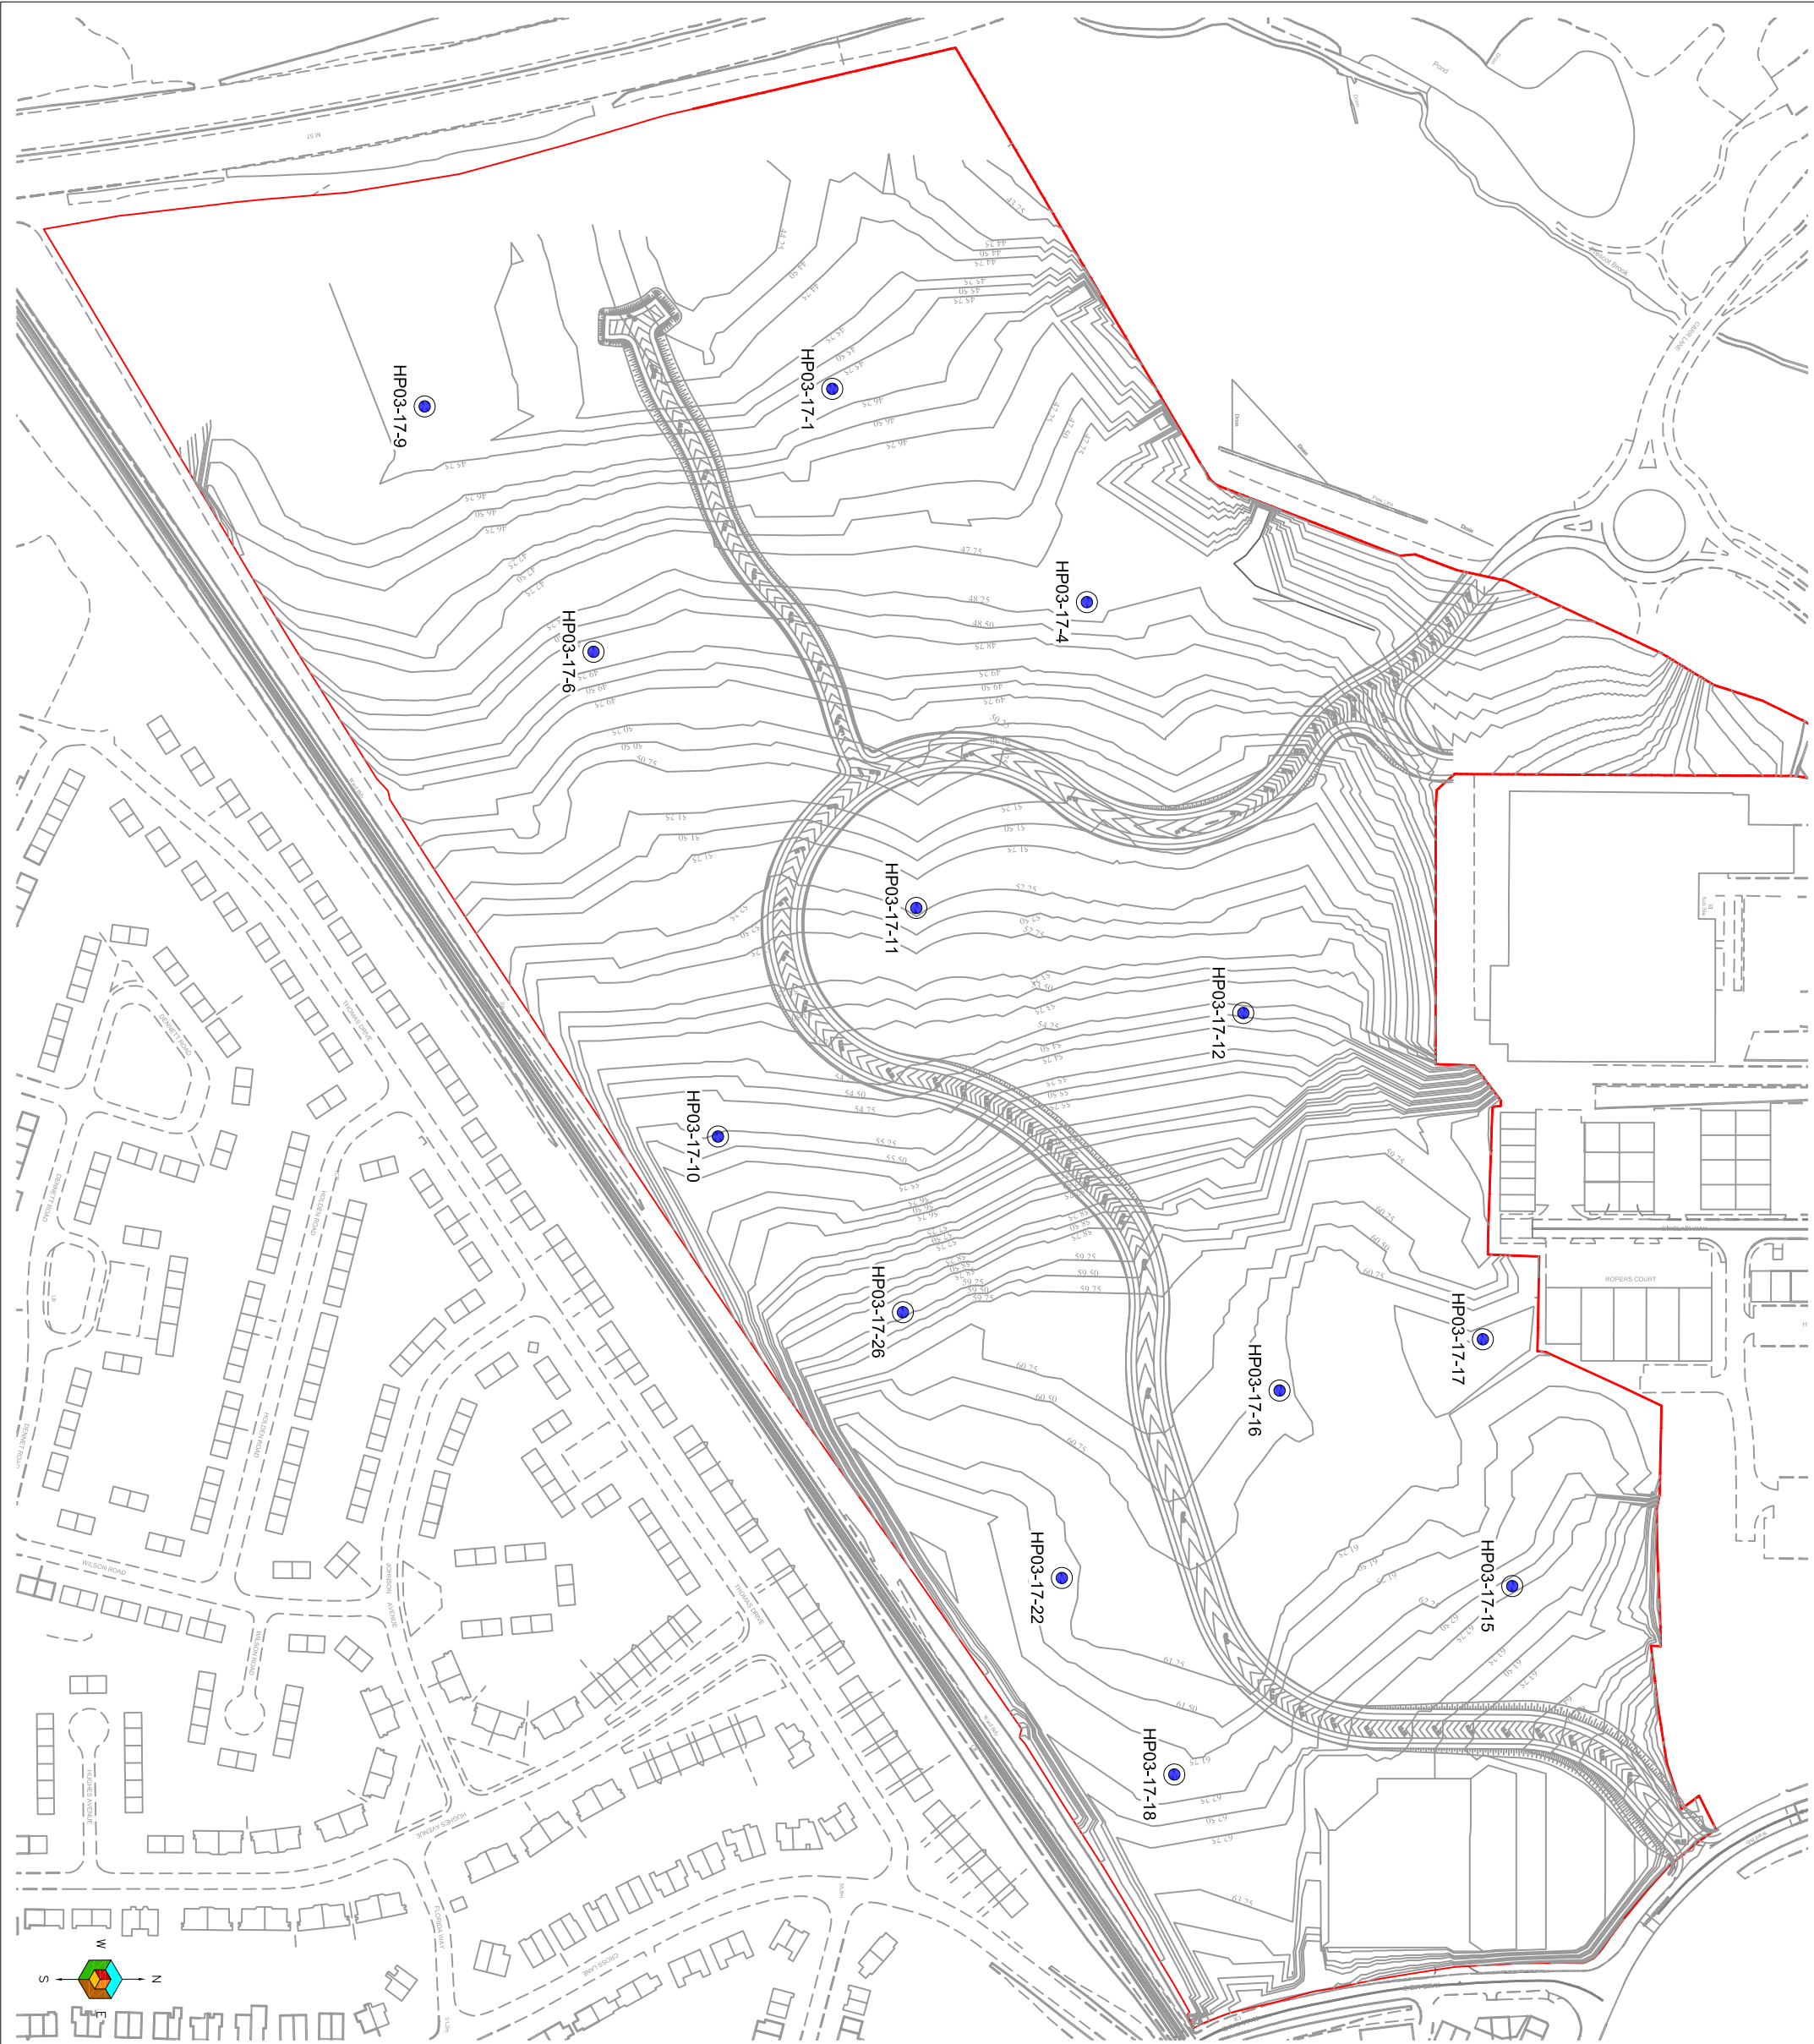
● Hand Pit to 0.00 - 0.40m to Sample Made Ground and Collect Sample for ASB Analysis
