| Report type: | Phase I Site Appraisal (Desk Study) |
| Ref: | GRM/P10738/DS.1 |

## AINTREE UNIVERSITY HOSPITAL

### PHASE I DESK STUDY REPORT FOR VINCI CONSTRUCTION

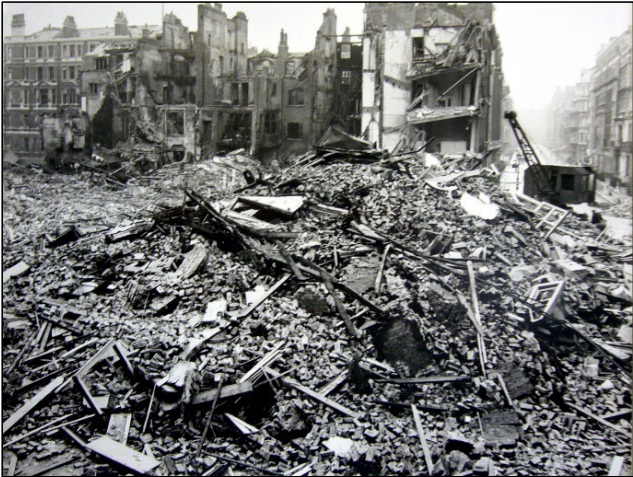
**Top:** J-curve Effect - Due to angle of entry, unexploded bombs would often end their trajectory at a lateral offset from point of entry, often ending up beneath adjacent extant structures/sites.

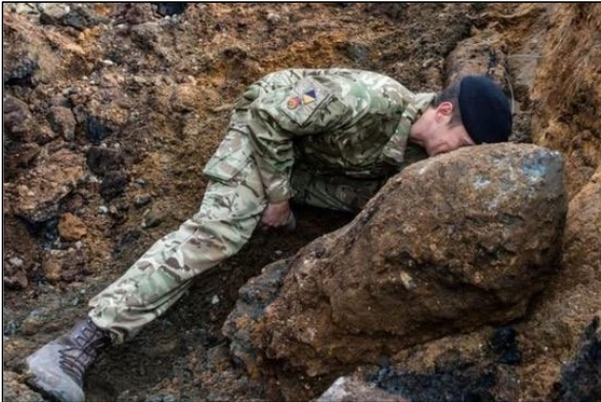
The photograph **above** shows a 250kg unexploded bomb found in Bermondsey in 2015, pointing upwards, demonstrating 'J-curve'.

One of the most common scenarios for UXO going unnoticed was when a UXB fell into a 'bomb site' (such as the area shown **Top Left**), the entry hole of the bomb obscured by any debris and rubble present. Note that the entry hole of a 50kg UXB could be as little as 20cm in diameter (**Left**).

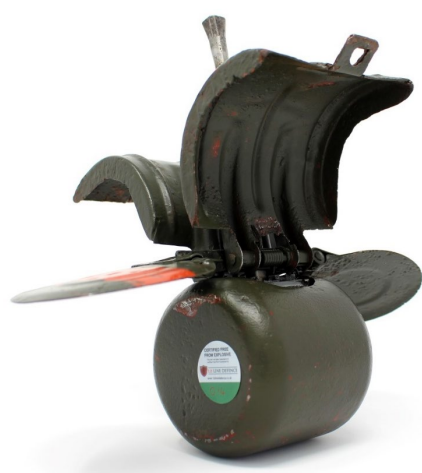
Parachute Mine (Luftmine B / LMB)

| Bomb Weight | Approx. 990kg (2176lb) |
| Fuze Type | Impact/time delay/hydrostatic pressure fuze |
| Use | Against civilian, military and industrial targets. Used as blast bombs and designed to detonate above ground level to maximise damage to a wider area. |
| Remarks | Deployed a parachute when dropped in order to control its descent. Had the potential to cause extensive damage within a 100m radius. |

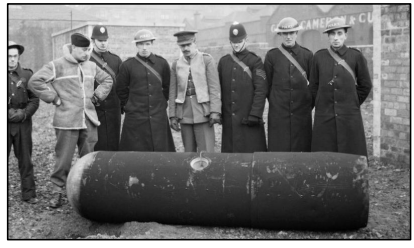
SC 1000kg High Explosive Bomb

| Bomb Weight | Approx. 993-1027kg (2,189-2,264lb) |
| Use | SC-type bombs were General Purpose Bombs used primarily for general demolition work. Constructed of parallel walls with comparatively heavy noses, they are usually of three-piece welded construction. |

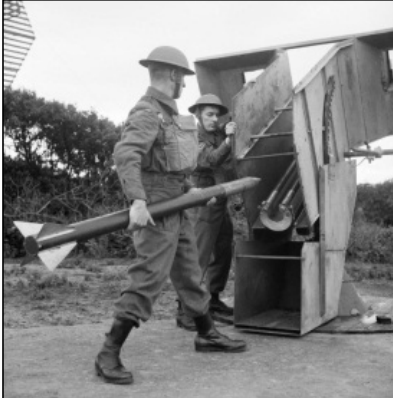
| 3in Unrotated Projectile (UP) Anti-Aircraft Rocket ("Z" Battery) | | | |
|---|---|---|---|
| HE Projectile Weight | 3.4kg (7.6lb) | | |
| Explosive Weight | 0.96kg (2.13lb) | | |
