## AINTREE UNIVERSITY HOSPITAL

### PHASE II SITE APPRAISAL REPORT FOR VINCI

**Project Ref:**  
P10738

**Date:**  
January 2025

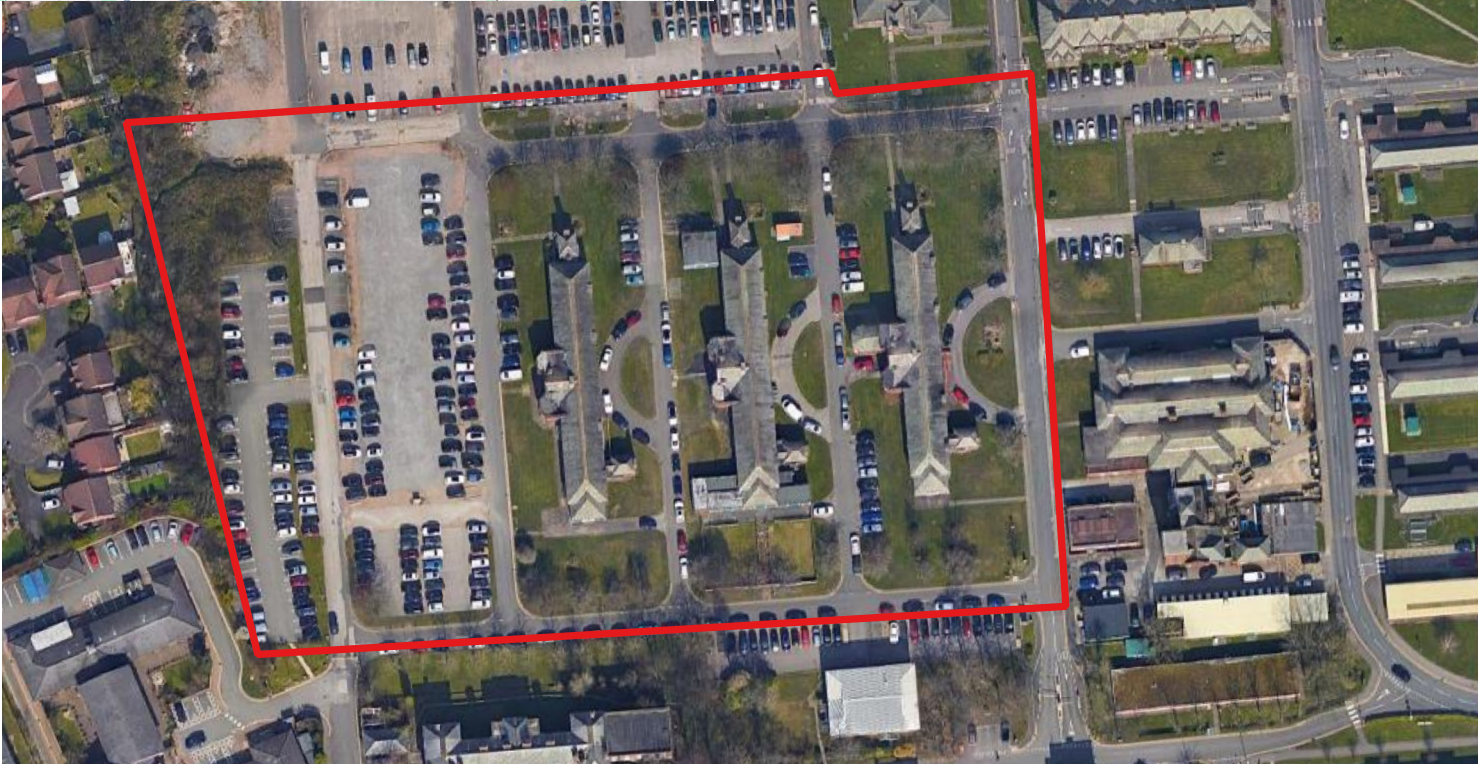
- Site Boundary
- Trees
- Hoarding Line
- Hospital equipment storage
- Ground Hazards - former building footprints

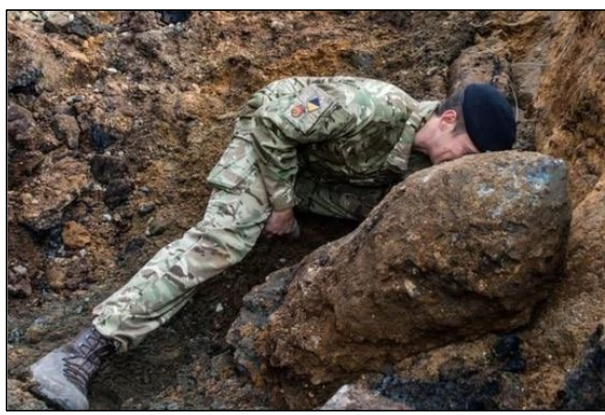
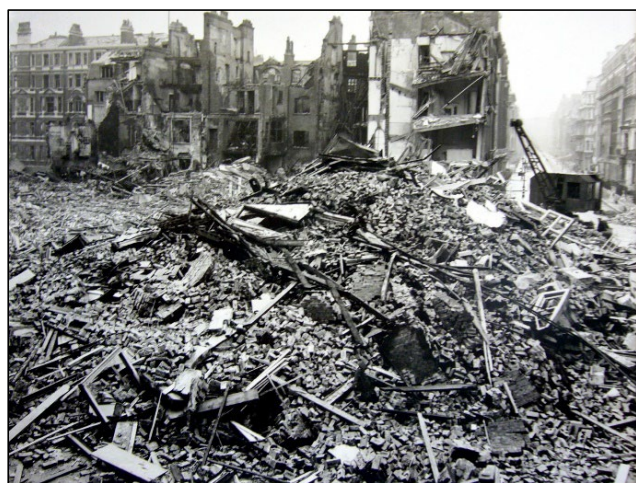
**Top:** J-curve Effect - Due to angle of entry, unexploded bombs would often end their trajectory at a lateral offset from point of entry, often ending up beneath adjacent extant structures/sites.

The photograph **above** shows a 250kg unexploded bomb found in Bermondsey in 2015, pointing upwards, demonstrating 'J-curve'.

One of the most common scenarios for UXO going unnoticed was when a UXB fell into a 'bomb site' (such as the area shown **Top Left**), the entry hole of the bomb obscured by any debris and rubble present. Note that the entry hole of a 50kg UXB could be as little as 20cm in diameter (**Left**).

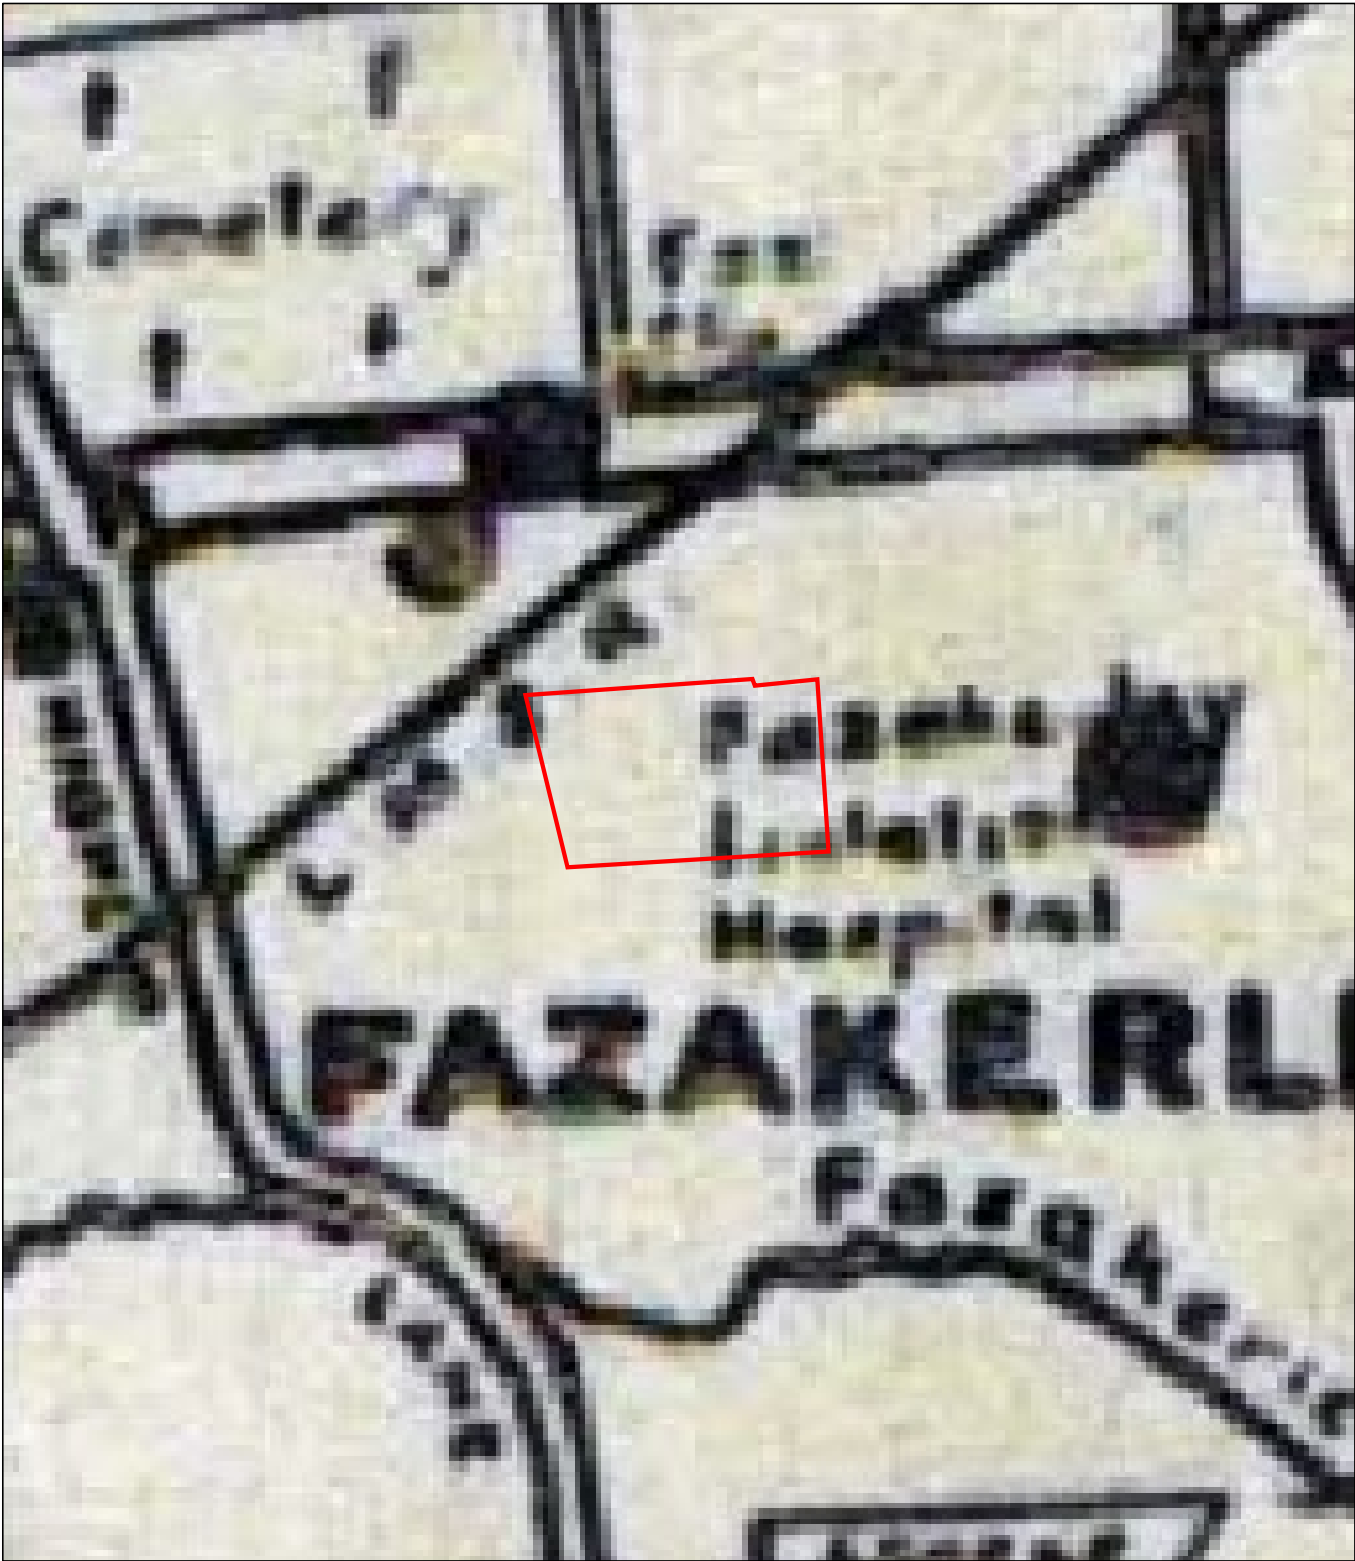
● HE Bomb Strike

| 18/19 Sept.<br>R. 19.41<br>W. 01.04 | Heavy damage through whole of Liverpool. Walton Prison hit by H.E., trapping several people. Railway lines damaged Brownlow Street and St. Michaels Station, Southwood Road. A.T.M. Coy., work impeded for few hours by U.X.B. Nurses' Home, Fazakerley, damaged. |

| 17/18 Oct.<br>P. 21.12<br>R. 21.19<br>W. 22.39 | West wing Fazakerley Sanatorium demolished, and one patient killed. H.E. damage to dwelling houses West Derby. U.X.B. yard of Morrison School. |

- Following the bombing incidents mentioned above, both the Nurses' Home and the west wing of Fazakerley Sanatorium are noted as sustaining damage, with the latter of the two being described as 'demolished'. This is visible in 1946 aerial imagery and wartime ground level imagery. However, no damage is recorded to any of the buildings within the site, which all appear intact and undamaged in post-war imagery.

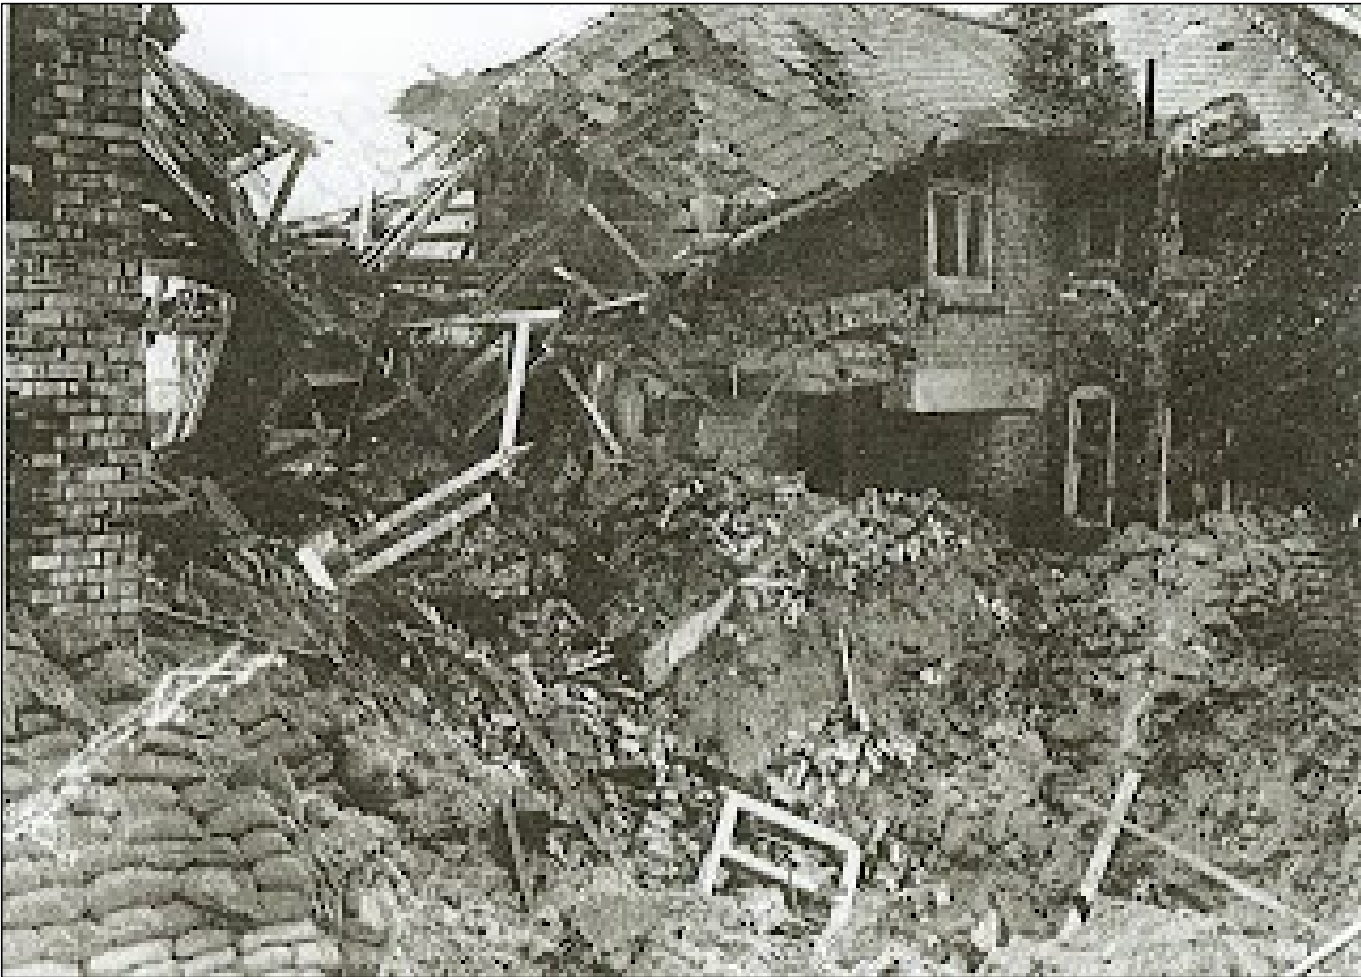
SC 50kg High Explosive Bomb

| Bomb Weight | 40-54kg (88-119lb) |

| Remarks | It could be carried by almost all German bomber aircraft and was used to notable effect by the Junkers Ju-87 Stuka (Sturzkampfflugzeug, or dive-bomber). |

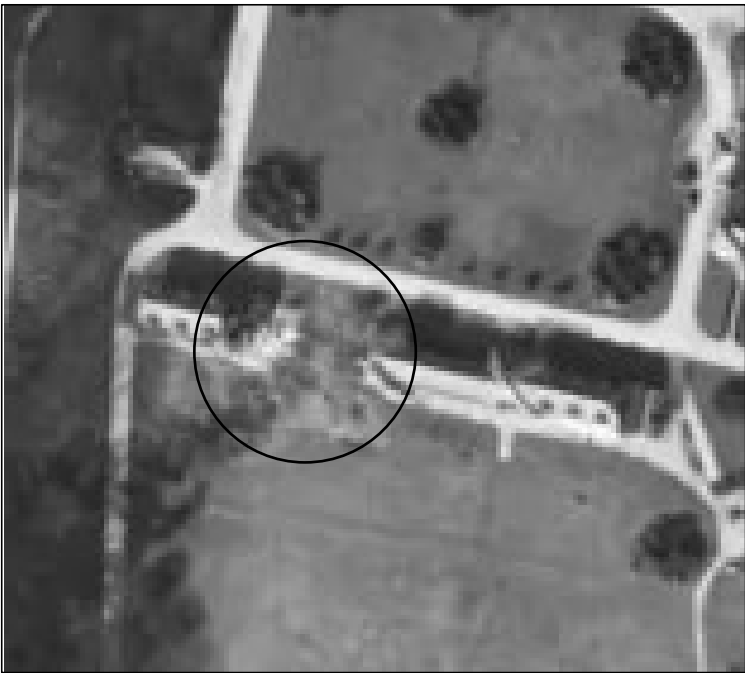
| Remarks | The smallest and most common conventional German bomb. Nearly 70% of bombs dropped on the UK were 50kg. |

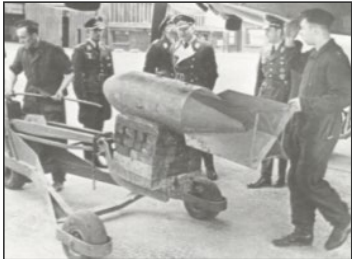
SC 500kg High Explosive Bomb

| Bomb Weight | 480-520kg (1,058-1,146lb) |

| Use | SC-type bombs were General Purpose Bombs used primarily for general demolition work. Constructed of parallel walls with comparatively heavy noses, they are usually of three-piece welded construction. |

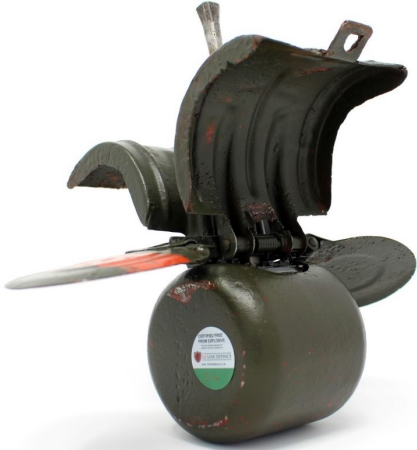
Parachute Mine (Luftmine B / LMB)

| Bomb Weight | Approx. 990kg (2176lb) |
| Remarks | Deployed a parachute when dropped in order to control its descent. Had the potential to cause extensive damage within a 100m radius. |

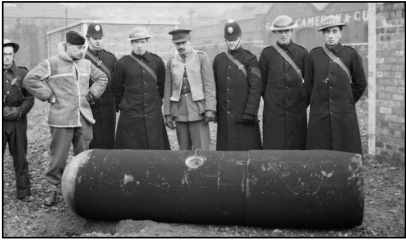
SC 1000kg High Explosive Bomb

| Bomb Weight | Approx. 993-1027kg (2,189-2,264lb) |

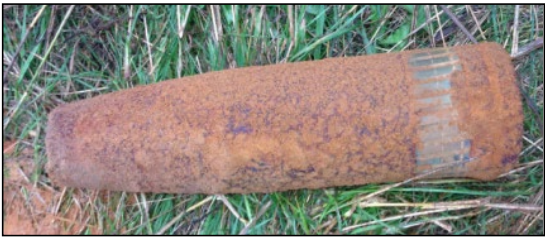
| 3.7 Inch QF Anti-Aircraft Projectile | | | <br> |
| Projectile Weight | 28lb (12.6 kg) | | |
| Explosive Weight | 2.52lbs | | |
| Ceiling | 30,000ft to 59,000ft | | |

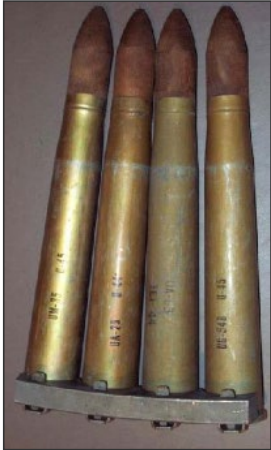
| 40mm Bofors Projectile | | | | |
| Projectile Weight | 1.96lb (0.86kg) | | | |
| Explosive Weight | 300g (0.6lb) | | | |
| Remarks | Light quick fire high explosive anti-aircraft projectile. Each projectile fitted with small tracer element. If no target hit, shell would explode when tracer burnt out. Designed to engage aircraft flying below 2,000ft. | | | |

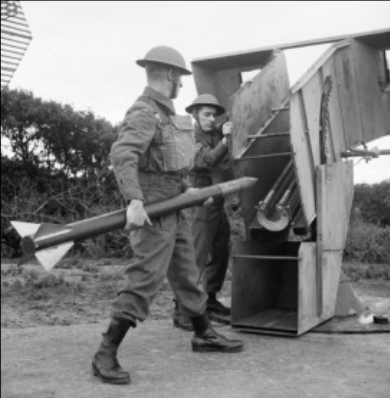
| 3in Unrotated Projectile (UP) Anti-Aircraft Rocket ("Z" Battery) | | | |
| HE Projectile Weight | 3.4kg (7.6lb) | | |
| Explosive Weight | 0.96kg (2.13lb) | | |

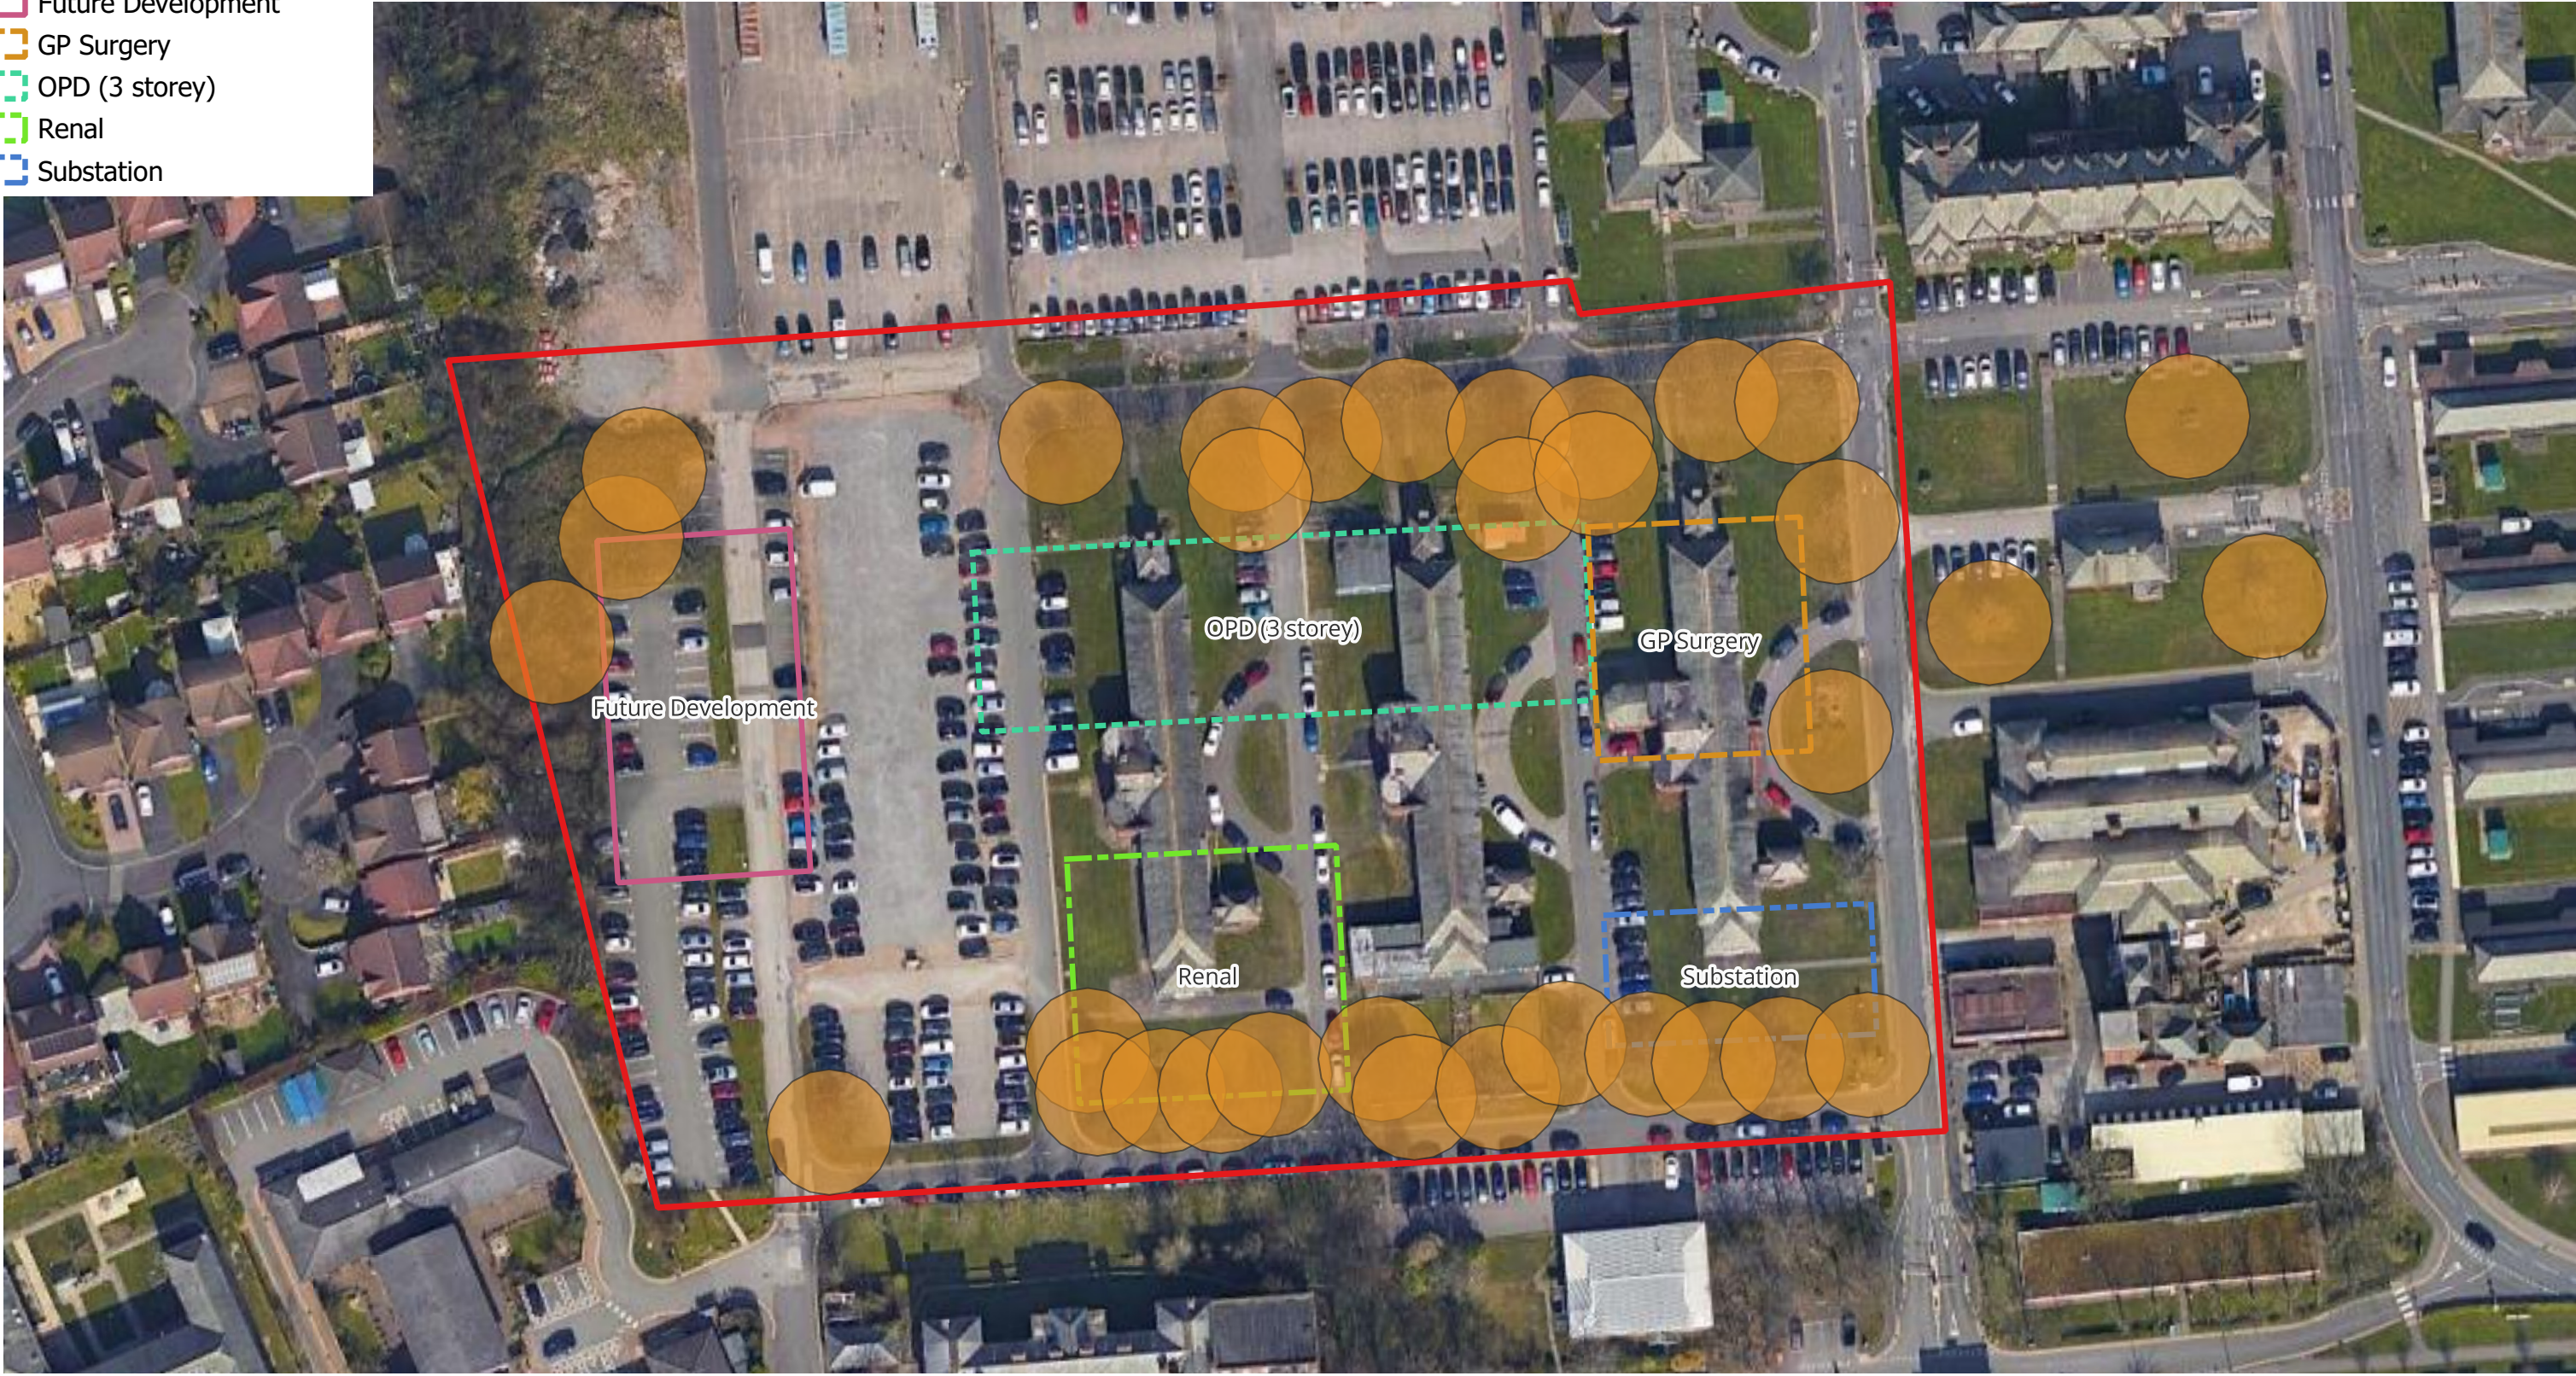
- Tree heave zone 9approx.)
- Site Boundary
- Building Footprints
  - Future Development
  - GP Surgery
  - OPD (3 storey)
  - Renal
  - Substation
