## **STAGE 2 GEO-ENVIRONMENTAL REPORT**

**ST MARY'S CHURCH**

**TAWD VALLEY  
DEVELOPMENTS LTD**

REPORT TYPE: STAGE 2 GEO-ENVIRONMENTAL REPORT

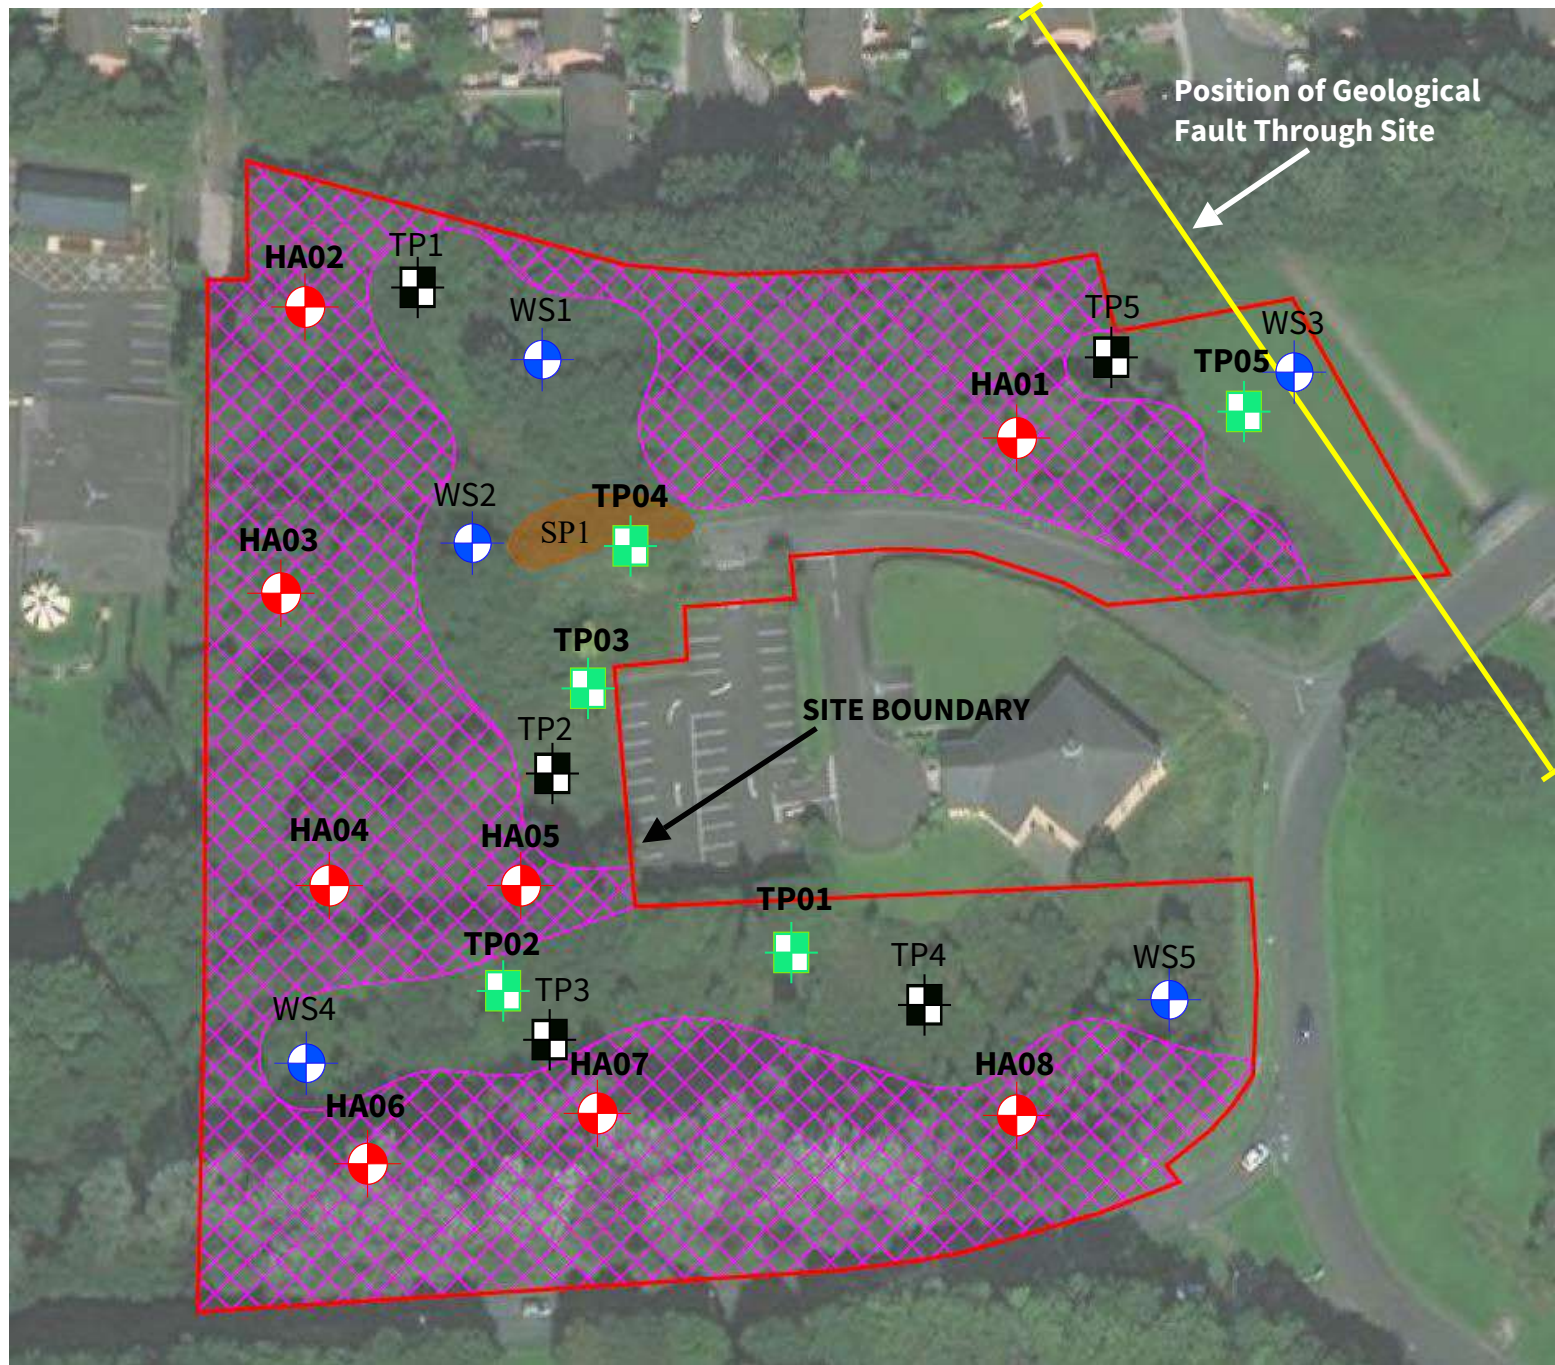
### **BOREHOLE & TRIAL PIT LOCATION PLAN & LOSS**

- 5.8 The ARP trial pit and auger hole location plan (including REFA Trial pit and window sample positions), and logs is included in Appendix B.
- 5.9 Chemical analysis of 10 soil samples, for metals, inorganics, speciated PAH, TPH, phenols, and asbestos, was undertaken by the UKAS was undertaken by the UKAS accredited Eurofins Chemtest Laboratory in Newmarket. The test certificates are included in Appendix C.
