# **ARBORICULTURAL IMPACT ASSESSMENT**

St Luke's RC Primary School

Ref: 21/00093/AIA  
Author: Jonathan Henderson  
Qualifications: B.Sc Hons, TechArborA

## Arboricultural Impact Assessment – St Luke's RC Primary School

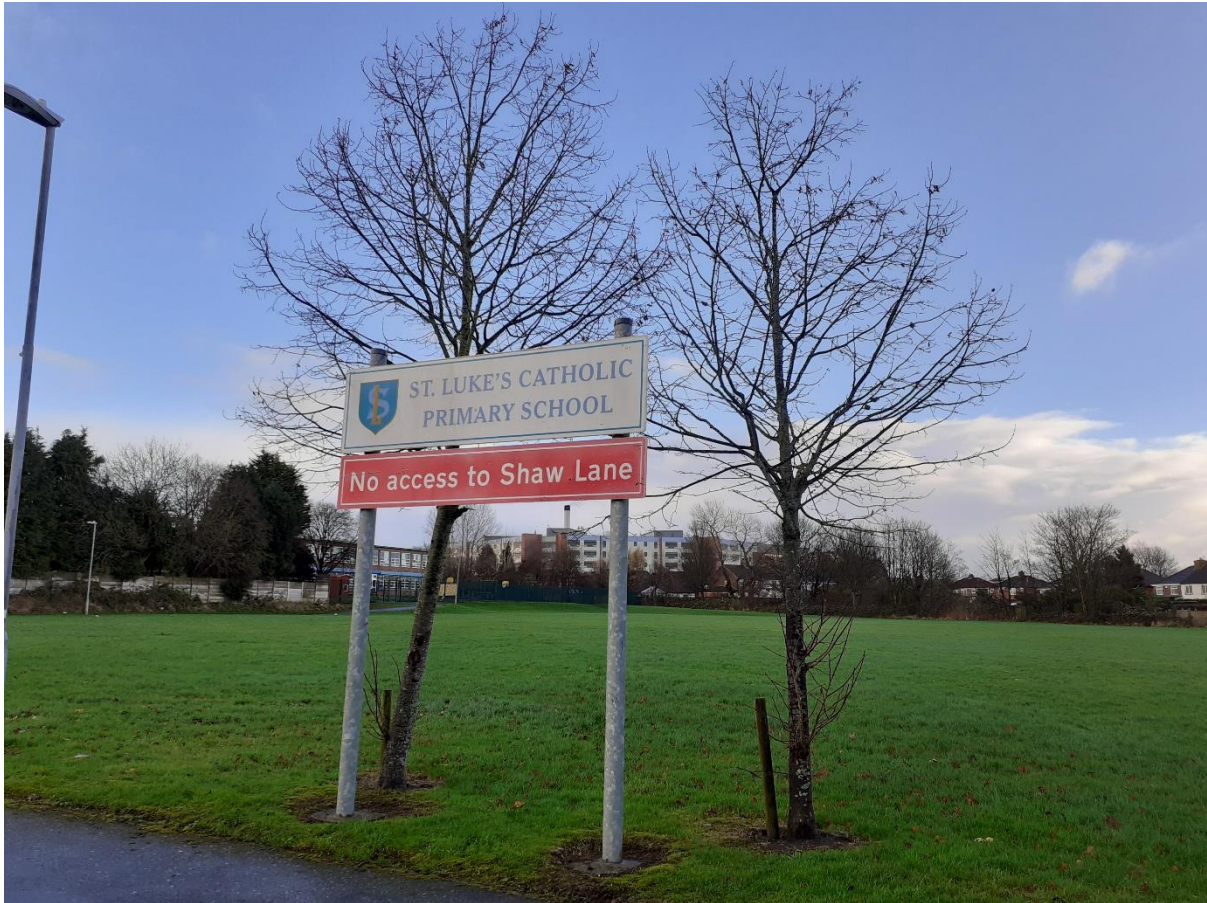
A photograph showing T1 and T2.
