## GEOENVIRONMENTAL DESK STUDY REPORT

### Moorgate Road North Kirkby Liverpool

6673-JPG-XX-XX-RP-G-0601-S2-P03

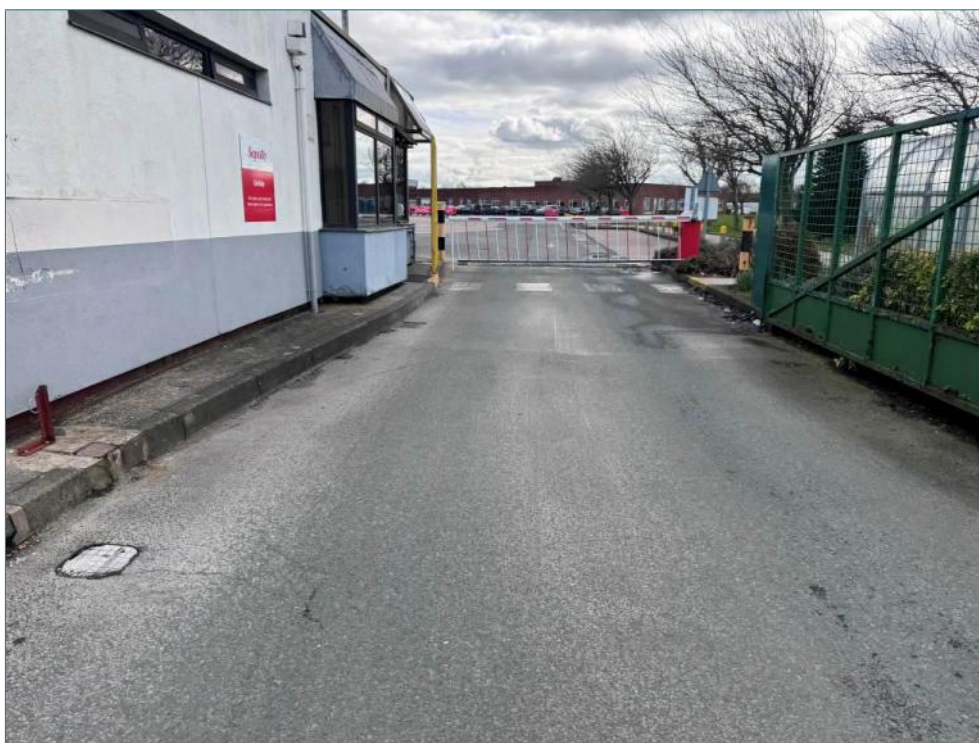
Photograph 1: Looking Southeast at the Egress to the Site.

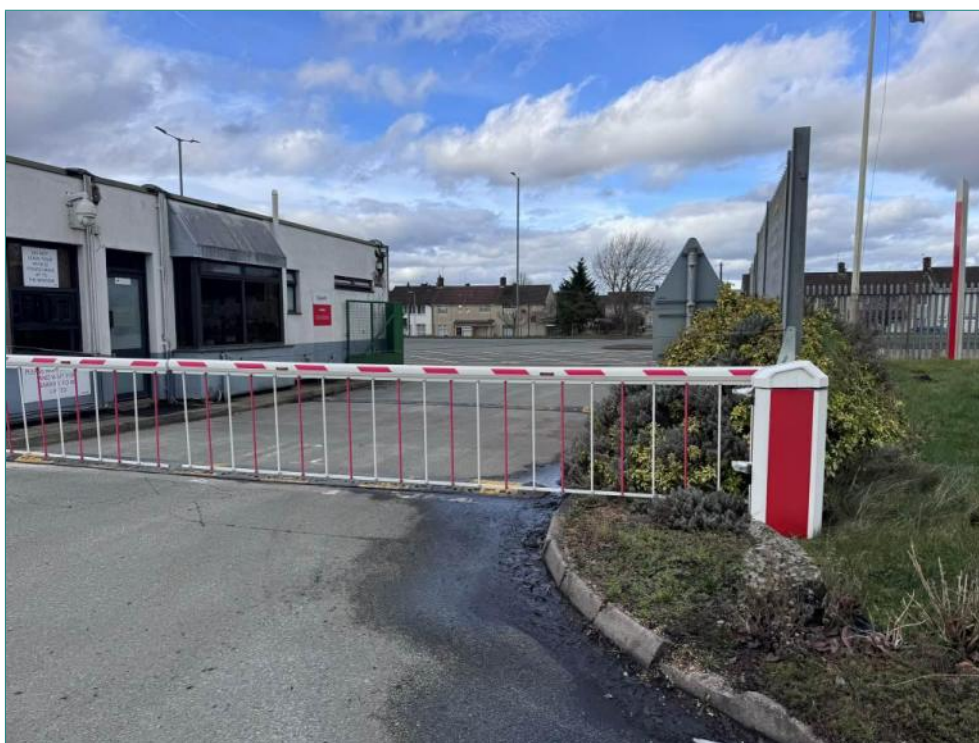
Photograph 2: Looking Northwest at the Entrance to the Site.

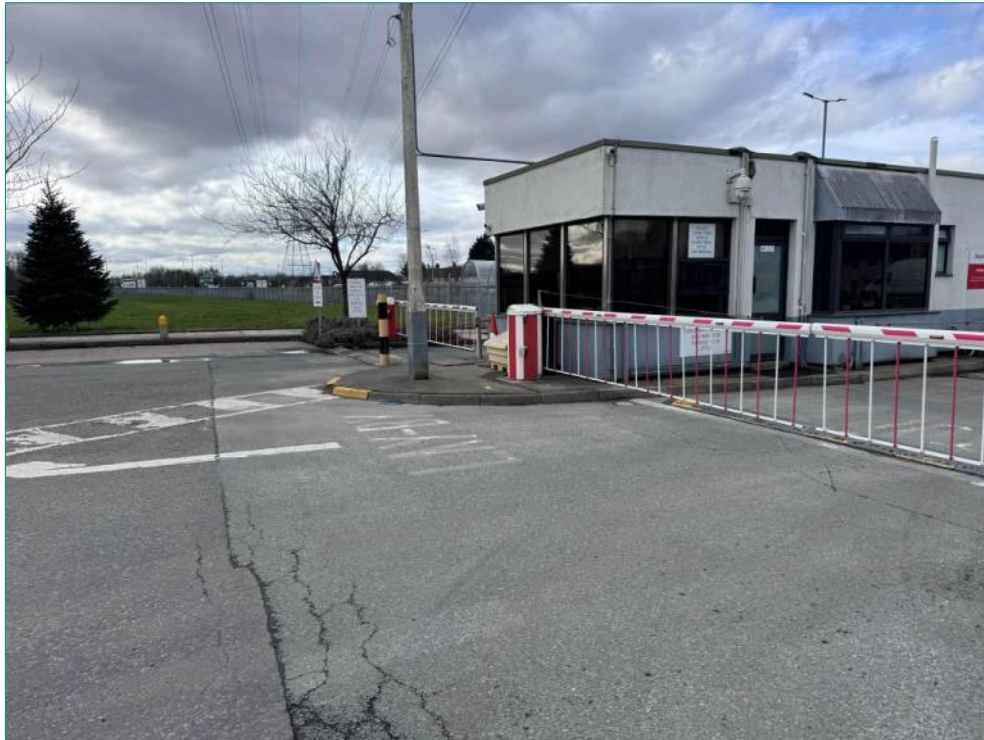
Photograph 3: Looking West Across the Southern End of the Gatehouse.

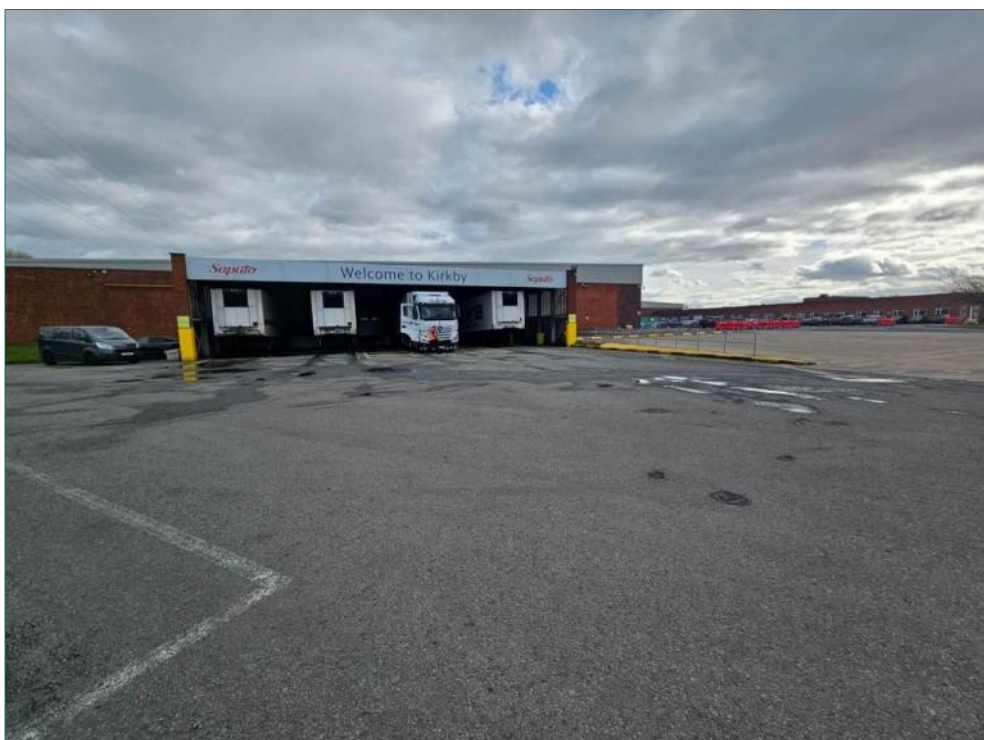
Photograph 4: Looking East Towards the Existing Building.

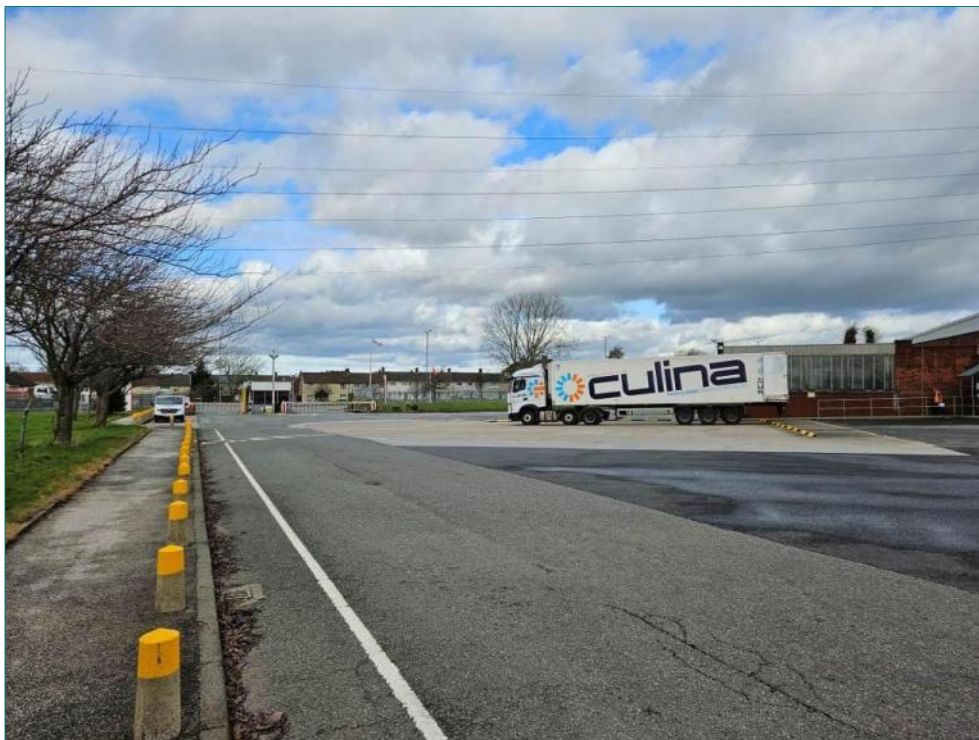
Photograph 5: Looking Northwest Towards the Entrance to the Site.

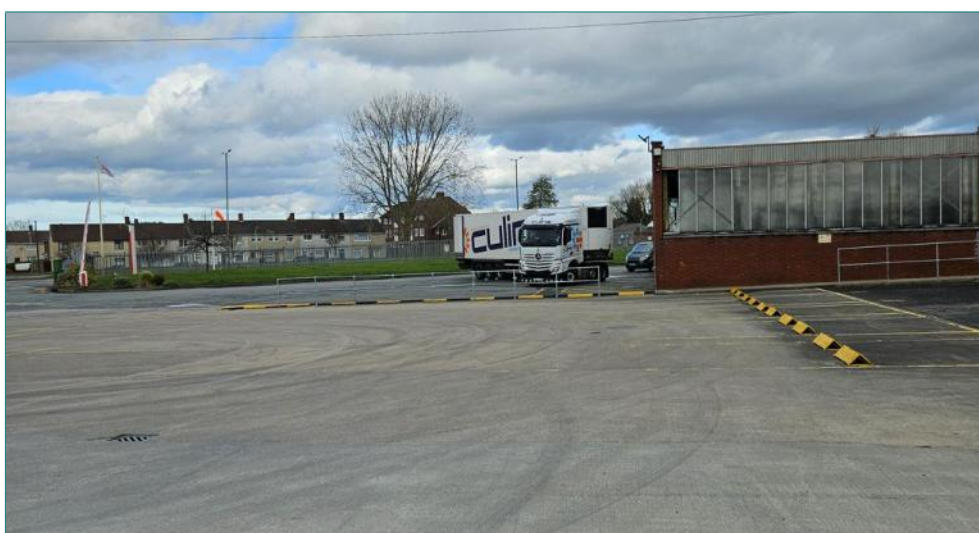
Photograph 6: Looking North Towards the Existing Building.
