HEADBOLT LANE STATION, LIVERPOOL.

# Tree Survey Report

Buckingham Group Contracting

October 2020

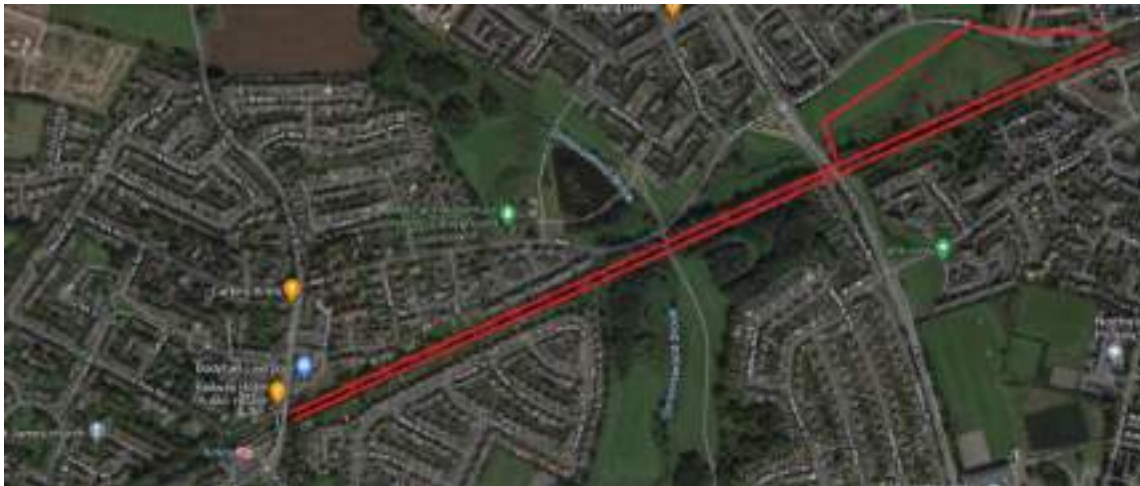
**Figure 1.1:** *Proposed Extent of Works*

This Tree Survey Report has been prepared on behalf of Buckingham Group who are proposing to construct a new running railway line and a new railway station (Headbolt Rail Station) close to the existing Kirkby Station, in Liverpool. The proposed extents of the works are shown as Figure 1.1.

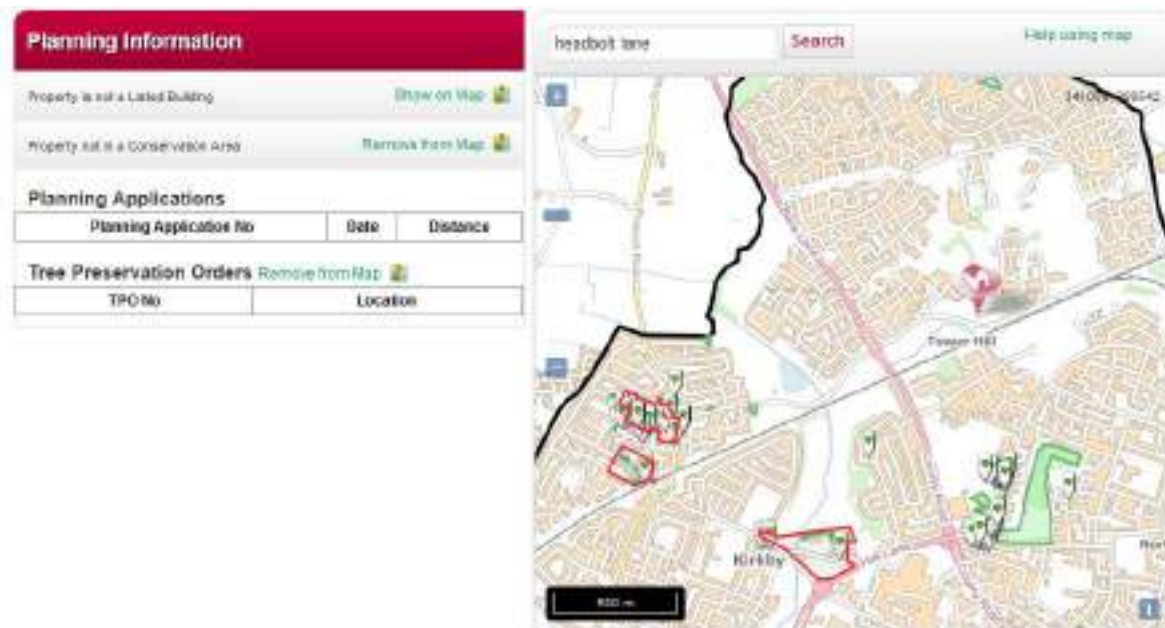
**Figure 2.1:** TPO and Conservation Areas in proximity to the Scheme ([knowsley.gov.uk](http://knowsley.gov.uk) accessed 27/20/2020)

A Conservation Area is present to the north of the existing Kirkby railway station and is not located within the railway line boundary (Figure 2.1). This conservation area will not be impacted upon by the scheme.

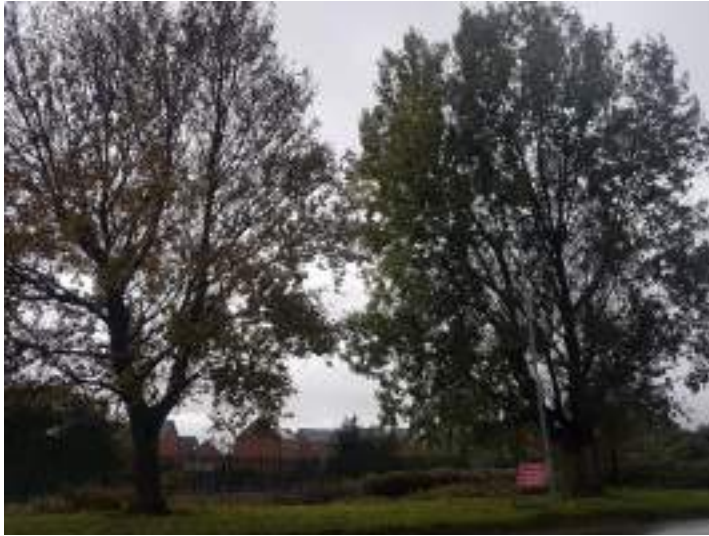
Plate 1: poplar trees within amenity grassland

The location of trees is shown as Figure 1 (Appendix A) with the supporting tree data included as Appendix C. fourteen trees and six tree groups were recorded in the survey area. The majority of individual trees are located within amenity grassland proposed for construction of Headbolt Lane Station. The most notable trees in this area are T1 – T4, which area planted mature poplar species *Populus* sp. All other trees in this area are self-seeded specimens and range from semi-mature to mature.

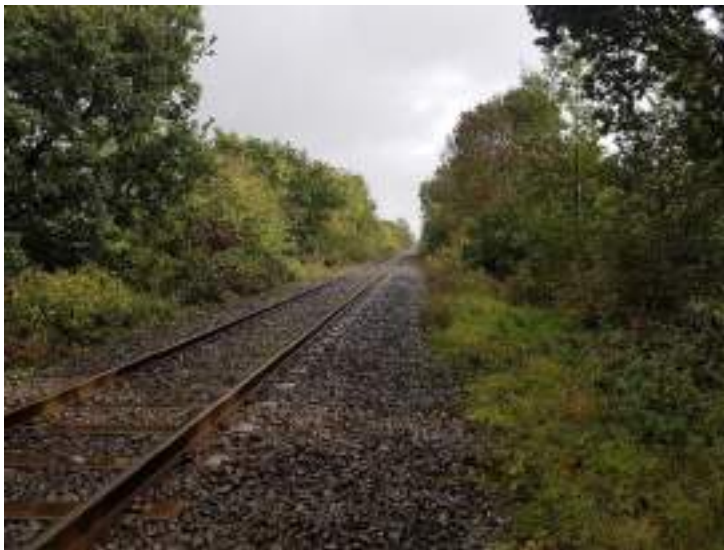
Plate 2: typical example of grouped trees on the railway embankment, although shrub communities largely dominate.

Tree groups are all associated with the embankment of Network Rail owned land. G1 to G4 include mature common ash *Fraxinus excelsior* and pedunculate oak *Quercus robur* as the most notable and mature specimens. Sycamore *Acer pseudoplatanus* is also a frequent species, although is often multi-stemmed to indicate past felling operations along Network Rail land. The tree groups also comprise of dense hawthorn *Crataegus monogyna* scrub communities and young self-seeded trees.
