**Project Name:** 002561, Knowsley Redevelopment Ltd

**Project Description:** WinCan Import in Miraculix WRc4 Standard

**Project Date:** 27/04/2022

**Inspection Standard:** MSCC4 Sewers & Drainage GB (SRM4 Scoring)

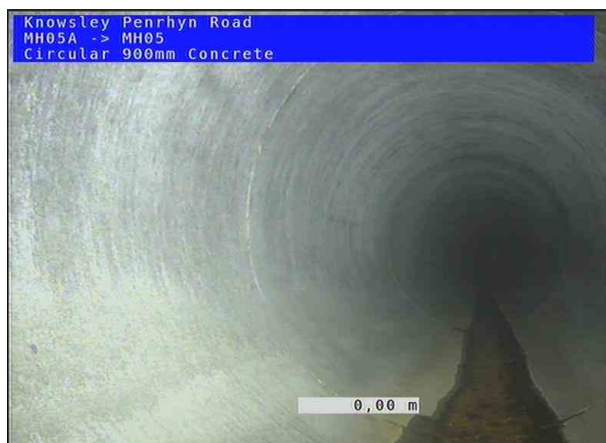
MH05A\_252f41c8-1b5f-44d0-9b73-9d5e78f637a4\_20220427\_143859\_224.jpg, 00:00:11, 0.00 m  
General photograph taken at this point

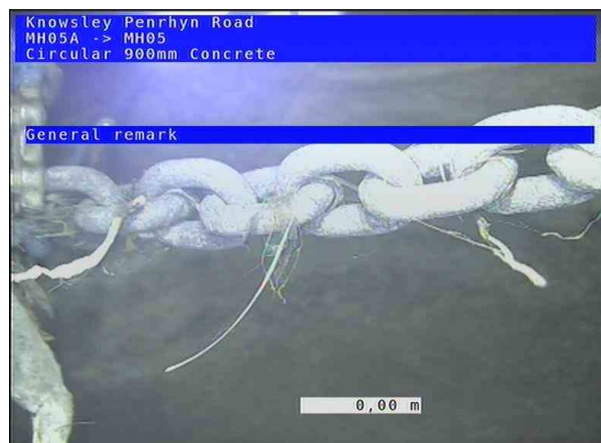
| Scale: | 1:363 | Position [m] | Code | Observation | MPEG | Photo | Grade |
|---|---|---|---|---|---|---|---|
| REM | General remark: CHAIN ACROSS THE OUTGOING PIPE IN MH05A | 00:00:17 | MH05A_b<br>4263f91-a<br>8fb-4f3c-9 | | | | |

MH05A\_b4263f91-a8fb-4f3c-9d3e-a8c5069213ef\_20220427\_143928\_509.jpg, 00:00:17, 0.00 m  
General remark, CHAIN ACROSS THE OUTGOING PIPE IN MH05A

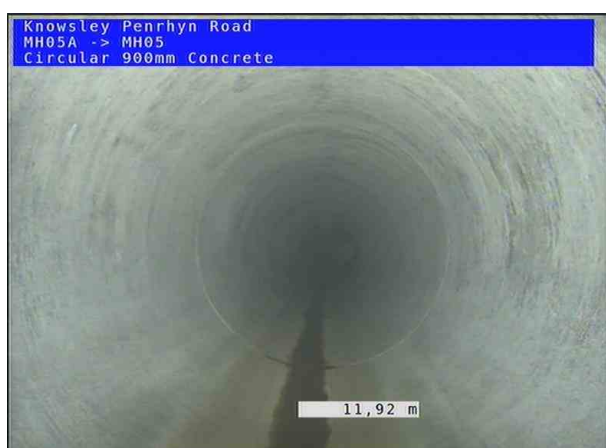
MH05A\_3fd669ff-3047-4c96-9c91-2972cacd3a0b\_20220427\_144214\_706.jpg, 00:01:25, 11.92 m  
General photograph taken at this point

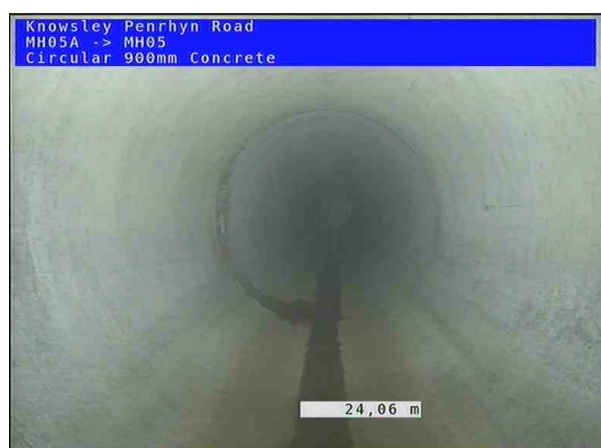
MH05A\_9c5d008f-27e8-414a-9280-e5ffabfe89b0\_20220427\_144309\_525.jpg, 00:02:09, 24.06 m  
General photograph taken at this point

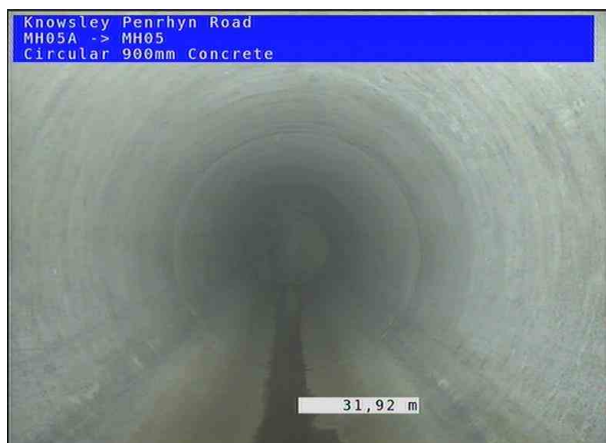
MH05A\_f678e999-6304-49ab-aab9-aac383c1ac44\_20220427  
\_144421\_106.jpg, 00:03:09, 31.92 m  
General photograph taken at this point
