**CCG-C-25-15990**

**GROUND INVESTIGATION REPORT  
FOR SITE AT**

**AVONDALE NURSING HOME  
SANDSTONE DRIVE  
WHISTON  
L35 7LS**

**MARCH 2026**

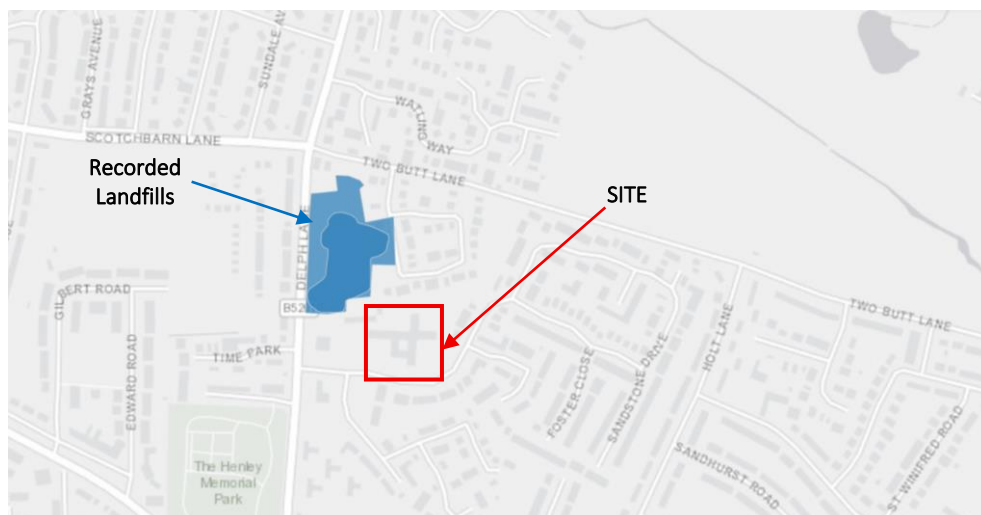
**Fig 1. Recorded Landfill**

It is recorded that 2nr historic landfills are located in close proximity to the site (c.20m northwest) – former Holt Lane Quarry. An extract of the map is presented in Fig 1 hereunder.
