**Mercury 62**

**Proposed Employment Development**

**Environmental Statement Volume 3: Appendices**

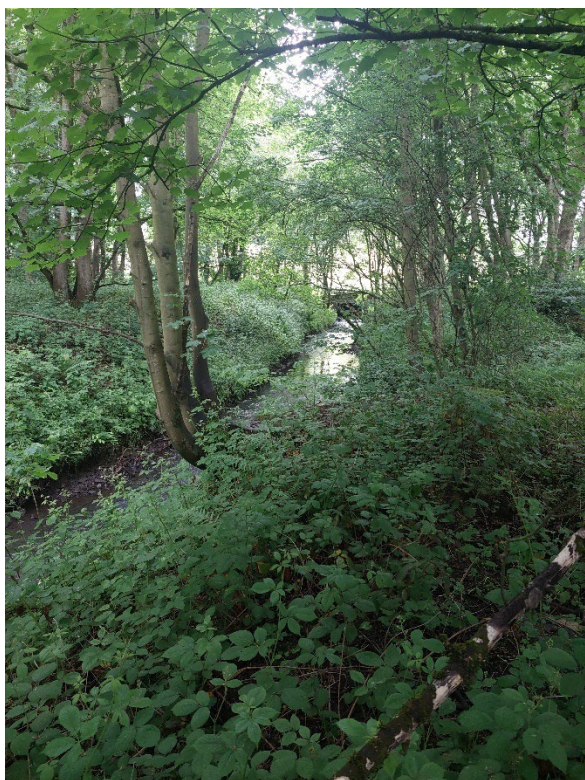
**Photograph 7 – Ochre Brook within the woodland, showing culvert present at western extent of site.**

Ochre Brook flows through the broadleaved woodland present within the western section of the site (TN6). This watercourse was heavily shaded, fast flowing, with minimal aquatic or marginal vegetation present. The watercourse was approximately 2m in width and the water was approximately 50cm deep. The banks were steep to vertical in places throughout the site and reached a maximum height of 3m above the water level. The substrate of the watercourse consisted of large rocks and pebbles which covered in a layer of silt, additionally the water showed evidence of pollution, likely attributed to runoff from the motorway present adjacent to the site.

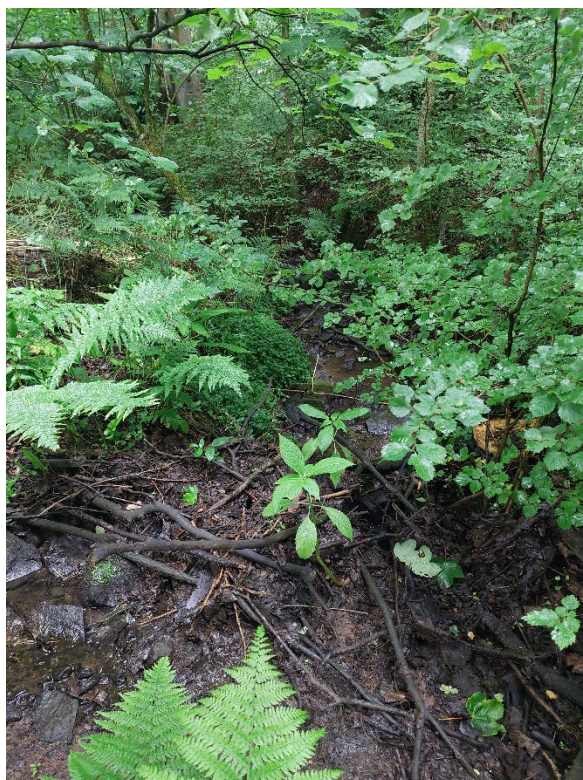
**Photograph 8– Drainage ditch that flows into Ochre Brook within the deep cutting.**

Two ditches are also present on site that flow from a culvert adjacent to the northern boundary into Ochre Brook (TN5 and TN7). This flows through a deep cutting in the northern section of the site which had been subject to extensive earthworks and therefore had minimal vegetation established on the banks. Aquatic vegetation including hard rush (*Juncus inflexus*), field horsetail (*Equisetum arvense*), and hairy willowherb.

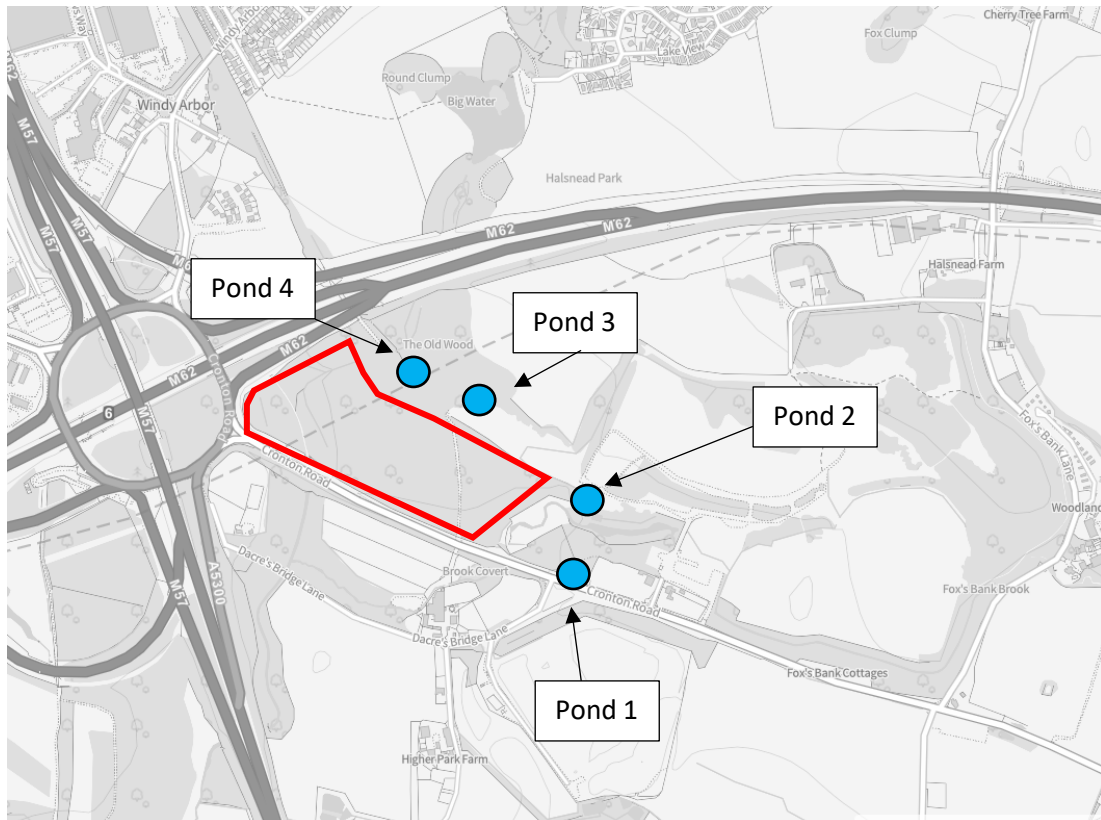
**Figure 2: Locations of ponds within 250m of the Site.**

The location of the ponds identified within 250m of the Site is provided in Figure 2. An HSI assessment of all ponds was conducted in June 2022, and found the following results:

- Pond 1: Average suitability;
- Pond 2 and Pond 3: Below Average suitability;
- Pond 4: Poor suitability.

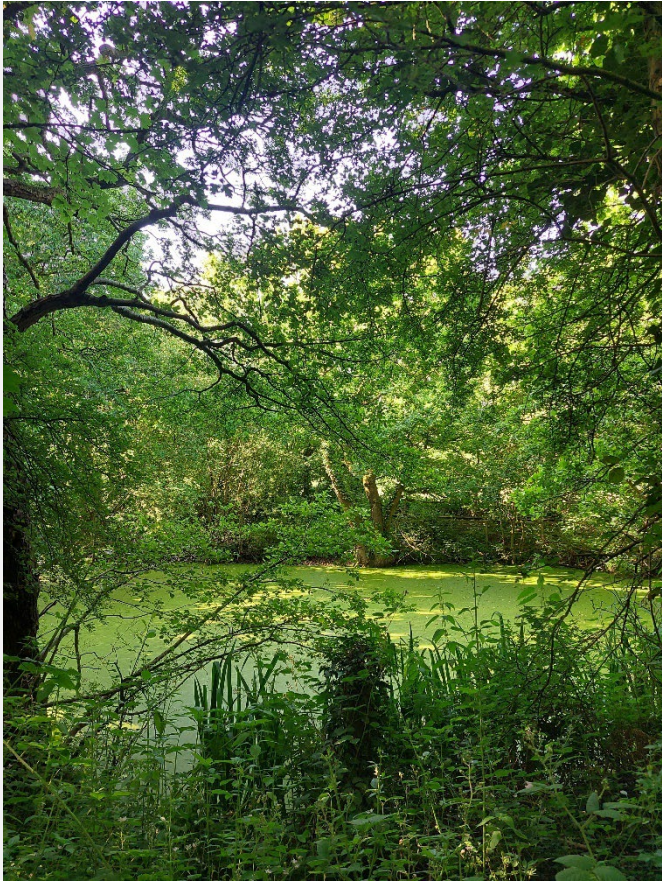
| HSI Score | Standing water (P1) | |
|---|---|---|
| Description | <p>Located approximately 130m east of the Site. A large woodland pond, rounded in shape and covered in a layer of duckweed with no obvious areas of open water visible. The terrestrial habitat surrounding the ponds is of good quality with connectivity for amphibian species, however a major road is present directly south of the Site.</p> | |
| Overall HSI score | 0.63 – Average | |

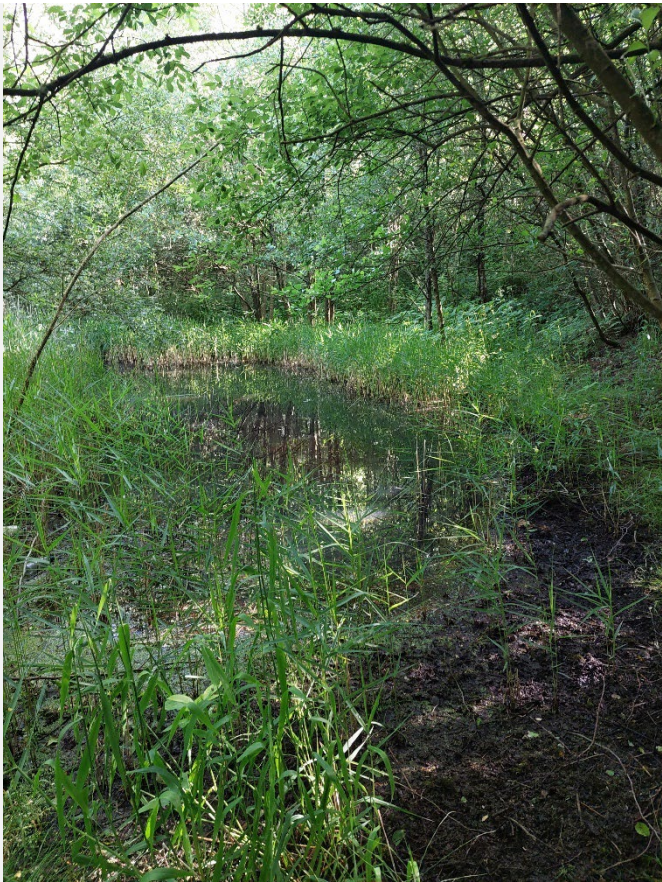
| HSI Score | Standing water (P2) | |
|---|---|---|
| Description | <p>Located approximately 40m east of the site. A woodland pond with low water levels at the time of survey. The pond is highly shaded, with a border of common reed present around the pond. The terrestrial habitat surrounding the ponds is of good quality with connectivity for amphibian species, however a major road is present directly south of the Site.</p> | |
| Overall HSI score | 0.56 – Below Average | |

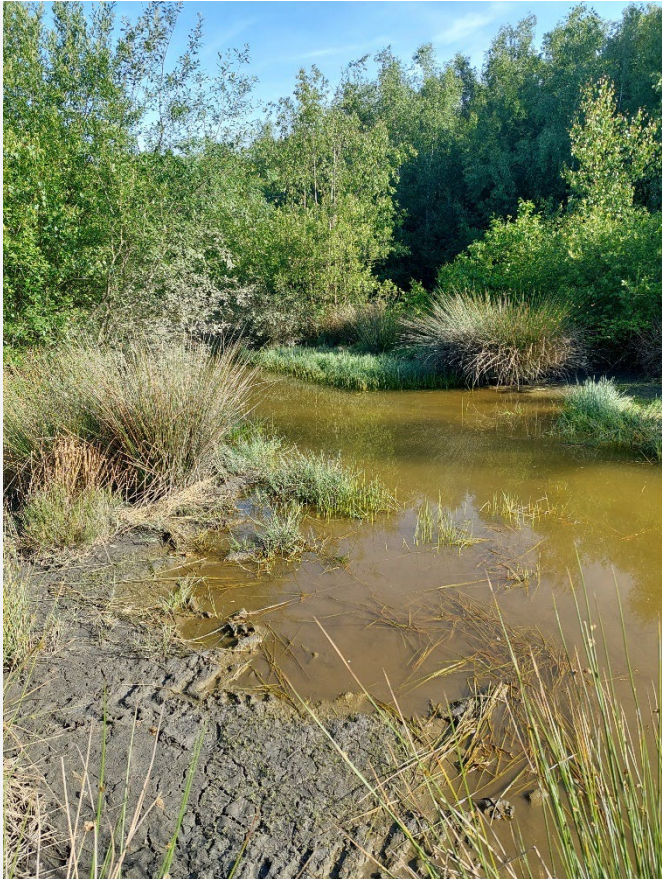
| HSI Score | Standing water (P3) | |
|---|---|---|
| Description | <p>Located approximately 45m north of the site. Shallow pond present within an open area adjacent to woodland. Pond had very shallow water at the time of survey and had clearly shrunk from a previous much larger size. The terrestrial habitat surrounding the ponds is of good quality with connectivity for amphibian species, however a major road is present directly north west of the pond.</p> | |
| Overall HSI score | 0.51 – Below Average | |

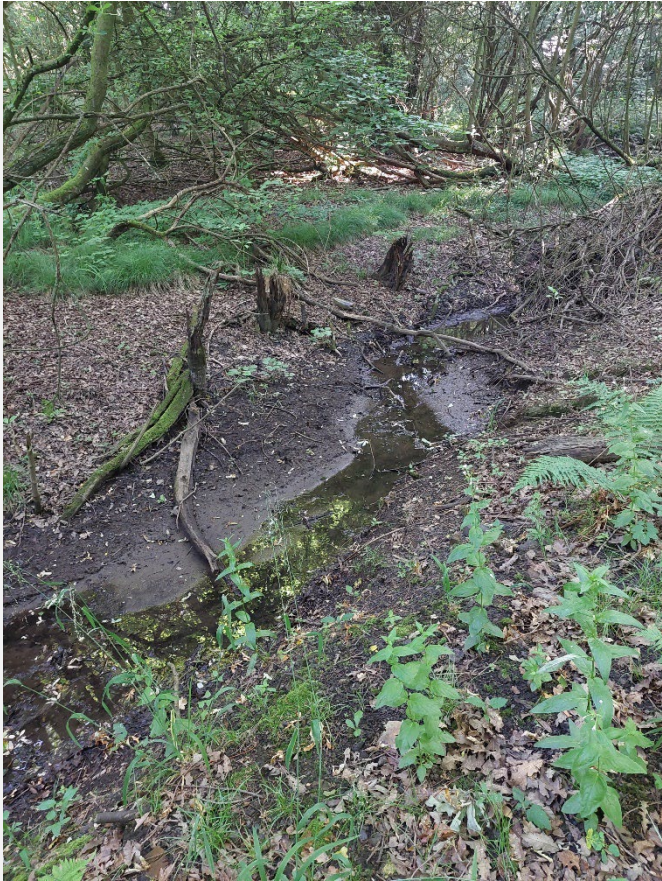
| HSI Score | Standing water (P4) | |
|---|---|---|
| Description | <p>Located approximately 60m north of the Site. A small woodland pond with little water remaining at the time of survey. The pond had a substrate of leaf litter with no bankside or emergent vegetation present. The terrestrial habitat surrounding the ponds is of good quality with connectivity for amphibian species, however a major road is present directly north west of the pond.</p> | |

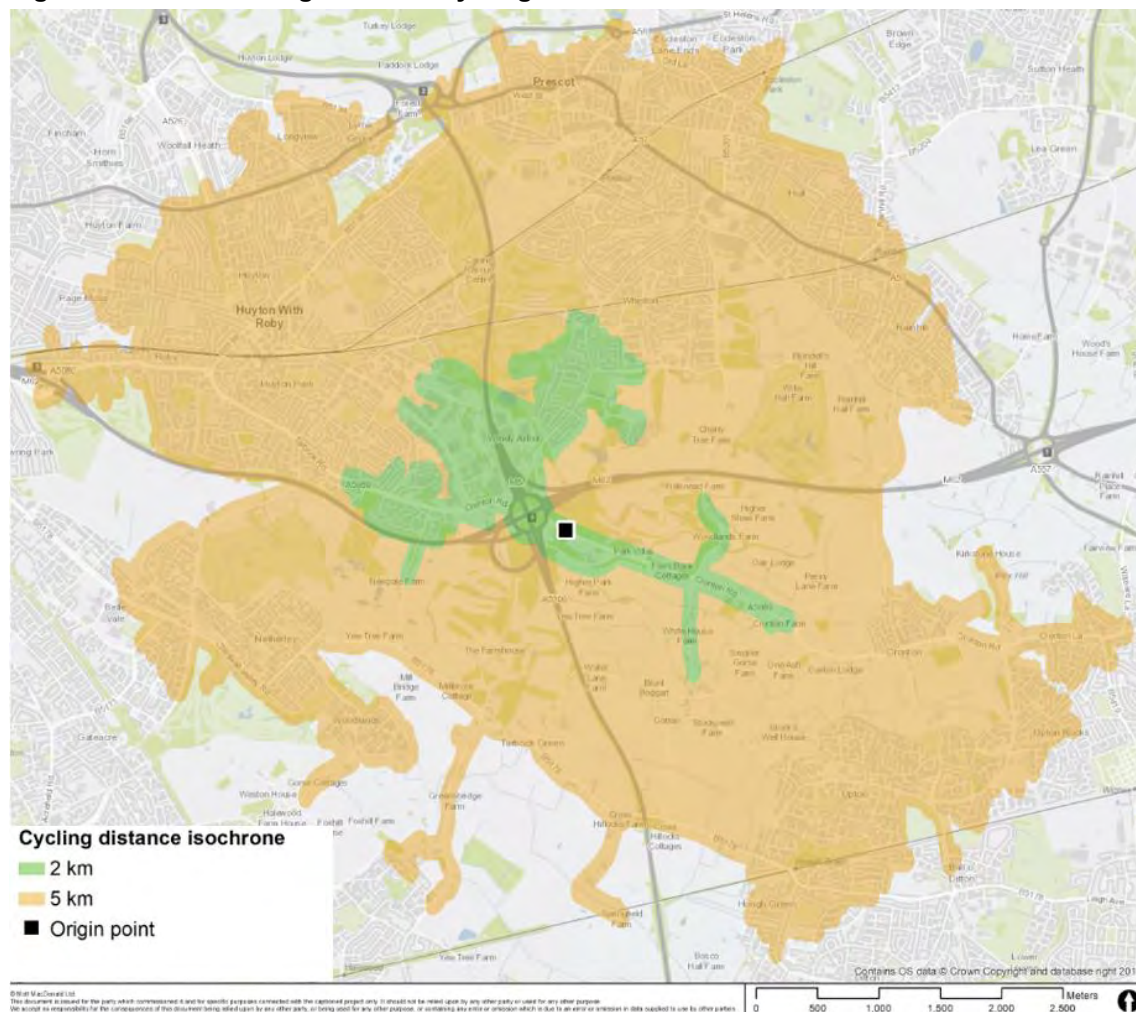
**Figure 3.4: 2km Walking and 5km Cycling Isochrone Plan**

The plan shows that some residential areas of Tarbock are within the 2km isochrone and also some parts of Whiston Cross. However, on account of the 'out of town' location of the site the coverage in terms of proximity to areas of residential dwellings is limited. For the 5km cycling isochrone however the coverage of residential areas is far greater with Huyton, Prescott, Whiston and Hough Green included. We consider that this mode has greater potential for commuting for future employees at the site – especially once the wider Halsnead Masterplan footway and cycleway infrastructure is provided.

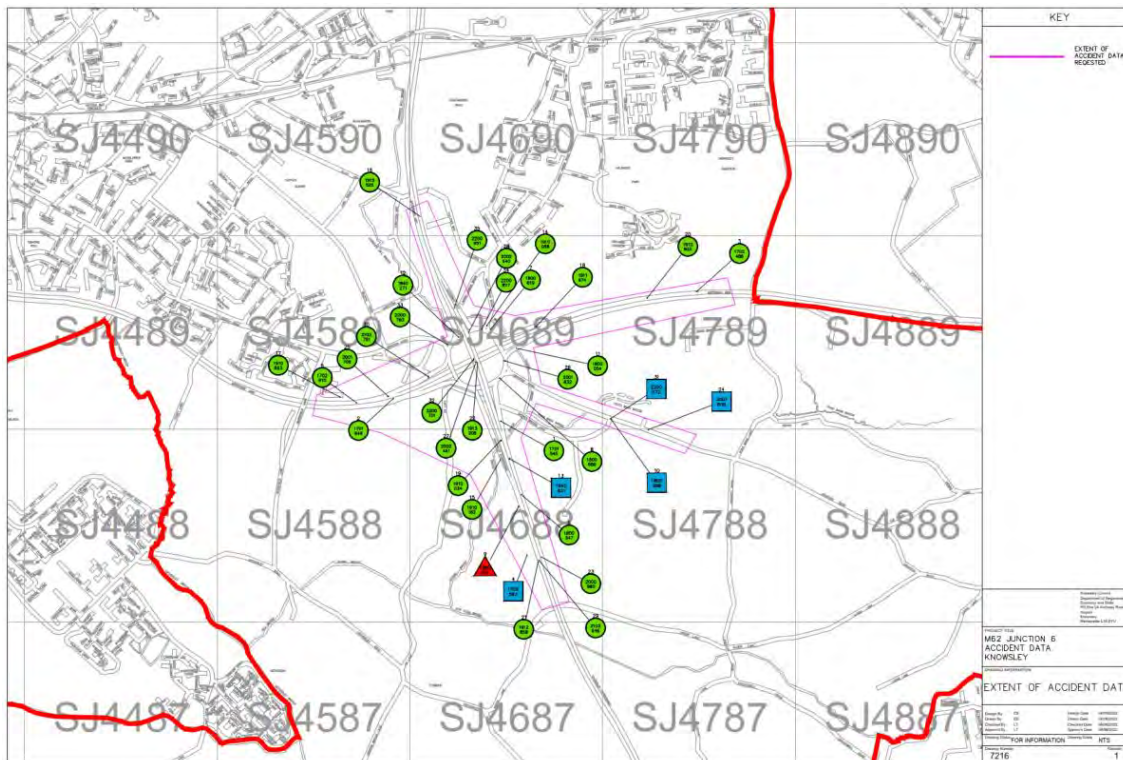
**Figure 4.1: Injury Collision Location**

There have been a total of 35 injury collisions over the five-year period. A summary of the accident data is shown in Table 4.1 below. Of all the collisions only 3 occurred on Cronton Road with the remaining 32 at Tarbock Island, its slips roads or the motorway mainlines.
