Stoford Developments Ltd  
Cranton Road  
Huyton

Phase 2 Geo-Environmental Assessment

September 2021

| <b>Document Number:</b> | HG62-BWB-ZZ-XX-RP-YE-0001_Ph2 |

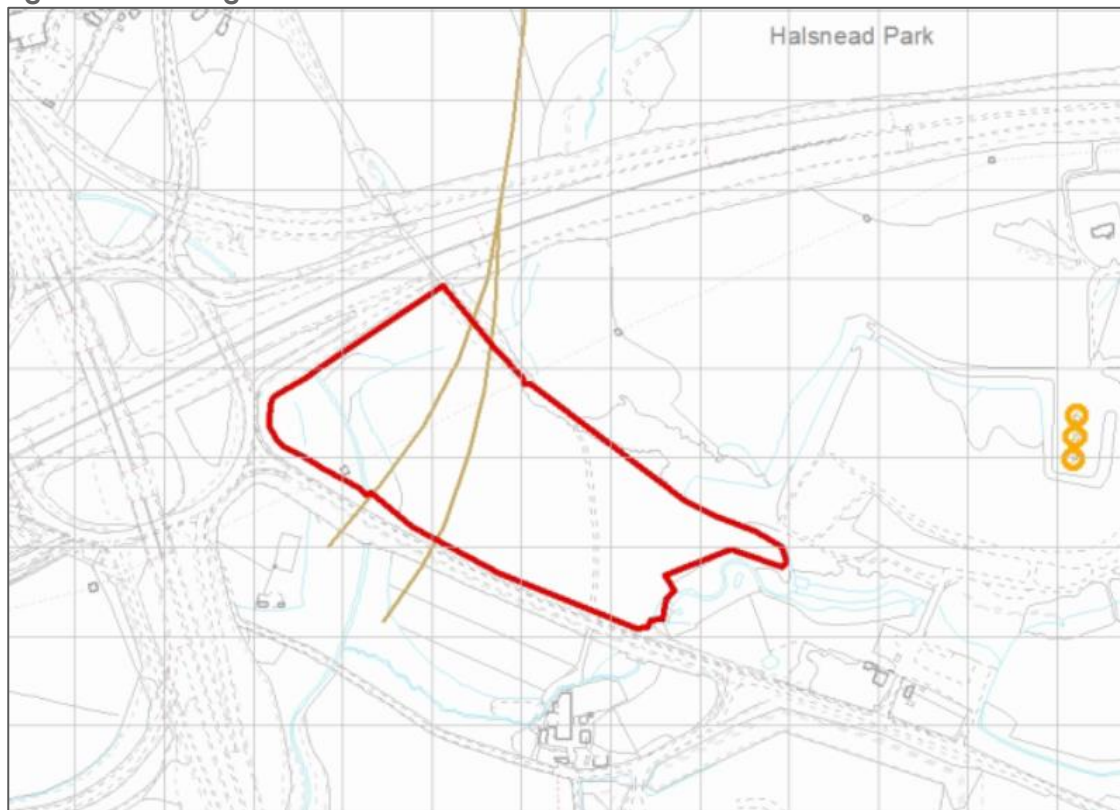
**Figure 3:1: Geological Fault Location Plan**

- 3.1 British Geological Survey (BGS) mapping for the site indicates that the site is underlain by superficial deposits comprising Devensian Till. A thin strip of Alluvium is mapped in the north west of the site along Chapel Brook.
- 3.2 The underlying bedrock is indicated to comprise the Pennine Middle Coal Measures Formation (mudstone, siltstone and sandstone), with the Etruria Formation (mudstone, siltstone and conglomerate) sub cropping along the south western site boundary.
- 3.3 Two faults are mapped within the west of the site, orientated in a broadly north to south direction. The location of the faults is presented within the Coal Authority Report (**Appendix 2**) and reproduced below in **Figure 3:1**.
