6673 Moorgate Road Kirkby  
S278 Works

Road Safety Audit  
Stage 1  
Designer's Response

Moorgate Road  
Kirkby  
S278

Road Safety Audit  
Stage 1 Report

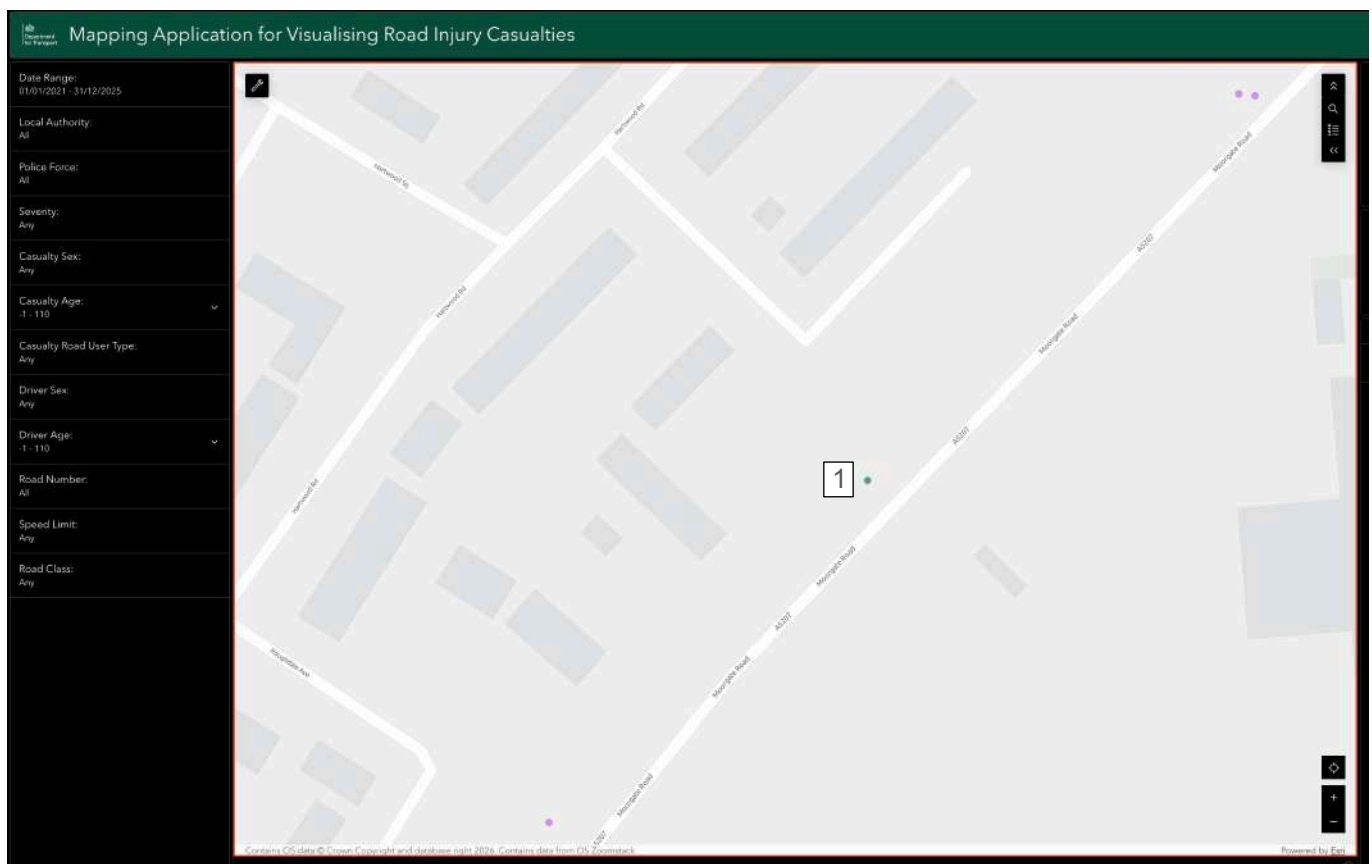
### Collision plot

The data indicates there has been 1 recorded injury collision resulting in 1 casualty at the junction of Moorgate Road and the proposed works access improvements.

| No. | Date | Time | Lighting | Road Surface | Description | Casualties |
|---|---|---|---|---|---|---|
| 1 | 25/01/2023 | 18:27 | Darkness | Wet or damp | Cyclist changing lane to the right is struck by a car heading north on Moorgate Road. | 1 (serious) cyclist age 12 – |
