Moorgate Road  
Kirkby  
S278

Road Safety Audit  
Stage 1 Report

The proposed works comprise S278 amendments to the existing access arrangement serving the Saputo Factory, located to the east of Moorgate Road, Kirkby. The proposals include relocation of the existing gatehouse and entrance, creation of a car-only entry/exit for Saputo, and a short section of link road that could be extended in future to serve further development.

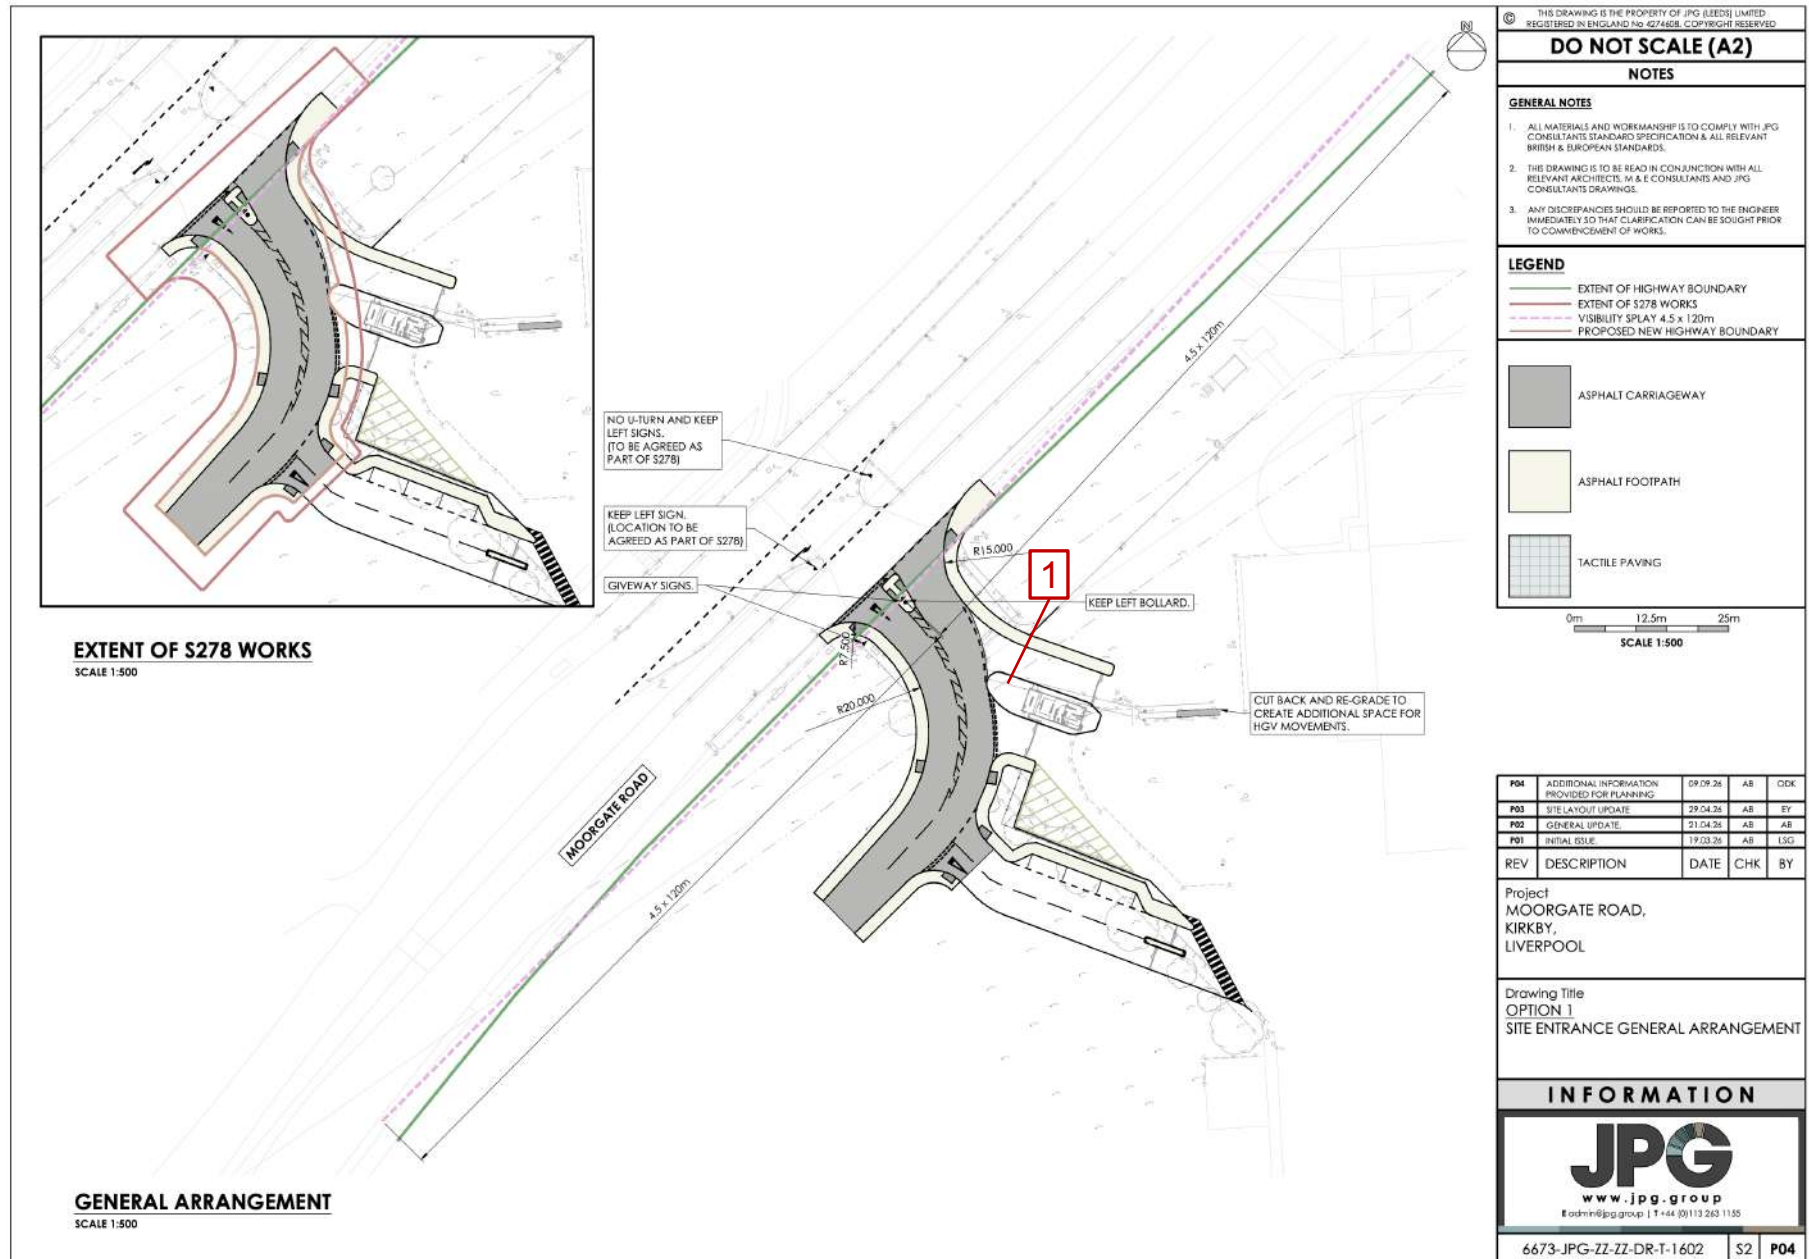
## 8.0 Problem location plan

**Location:** HGV access

**Summary:** Lack of pedestrian crossing point

Although the proposals indicate dropped crossing points across the access road parallel to Moorgate Road, across the car-only access, and across the link road, no corresponding crossing point has been provided across the HGV access. The proposed footway continues along both sides of the link road, indicating a desire line for pedestrians that could require them to cross the HGV access without a defined facility. This may result in pedestrians crossing without the benefit of dropped kerbs, increasing the risk of trip hazards and reducing awareness to drivers of a potential pedestrian crossing movement.

It is recommended that a crossing point be included across the HGV access.
