## **BIODIVERSITY NET GAIN - BIODIVERSITY STATEMENT**

**Huyton Cricket Club**

Huyton Lane  
Huyton  
Liverpool  
L36 7XD

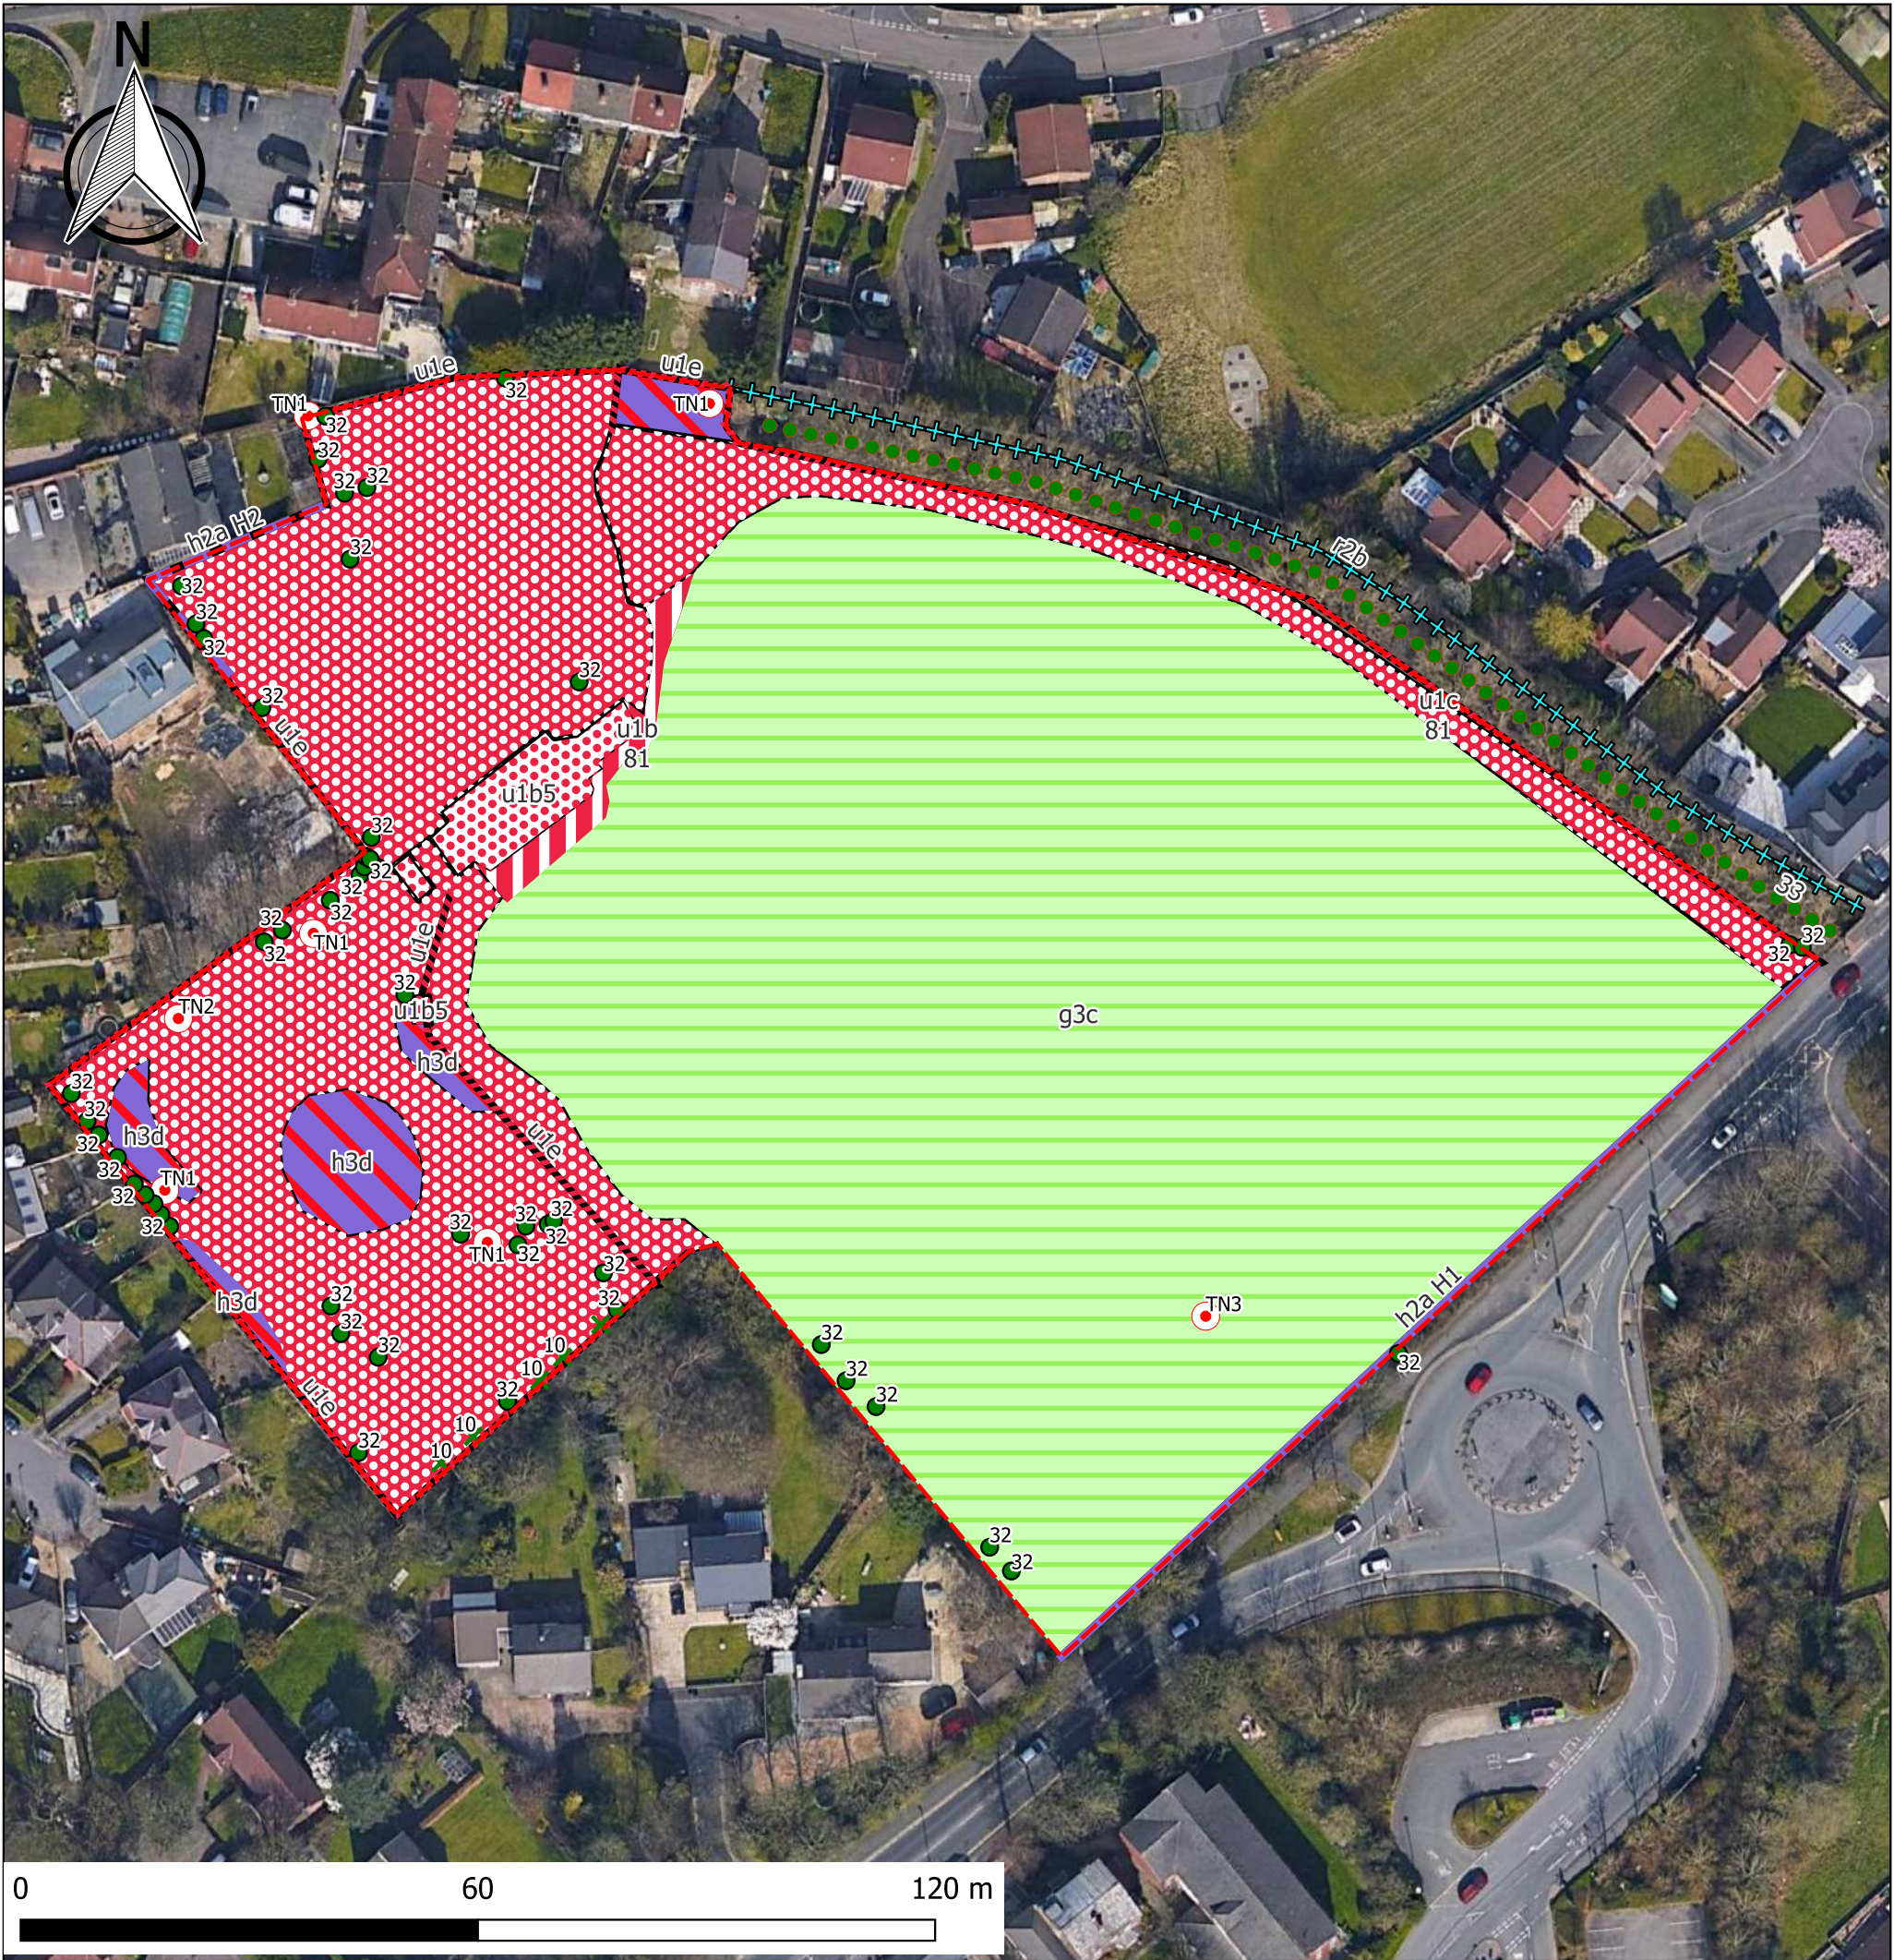
### **Appendix 1 – UKHab plan**

UK Habitat Classification Plan

**Site: Huyton Cricket Club,  
Huyton**  
**NGR: SJ 44456 91306**  
**Author: Bethany Dineley**  
**Date: 14/03/2025**

Habitats recorded within the proposed development site were mapped on a UK habitat classification plan provided at Appendix 1. Full details of each habitat recorded onsite are provided within the PEA report, which has been submitted as part of this planning application (reference UES04790/01).

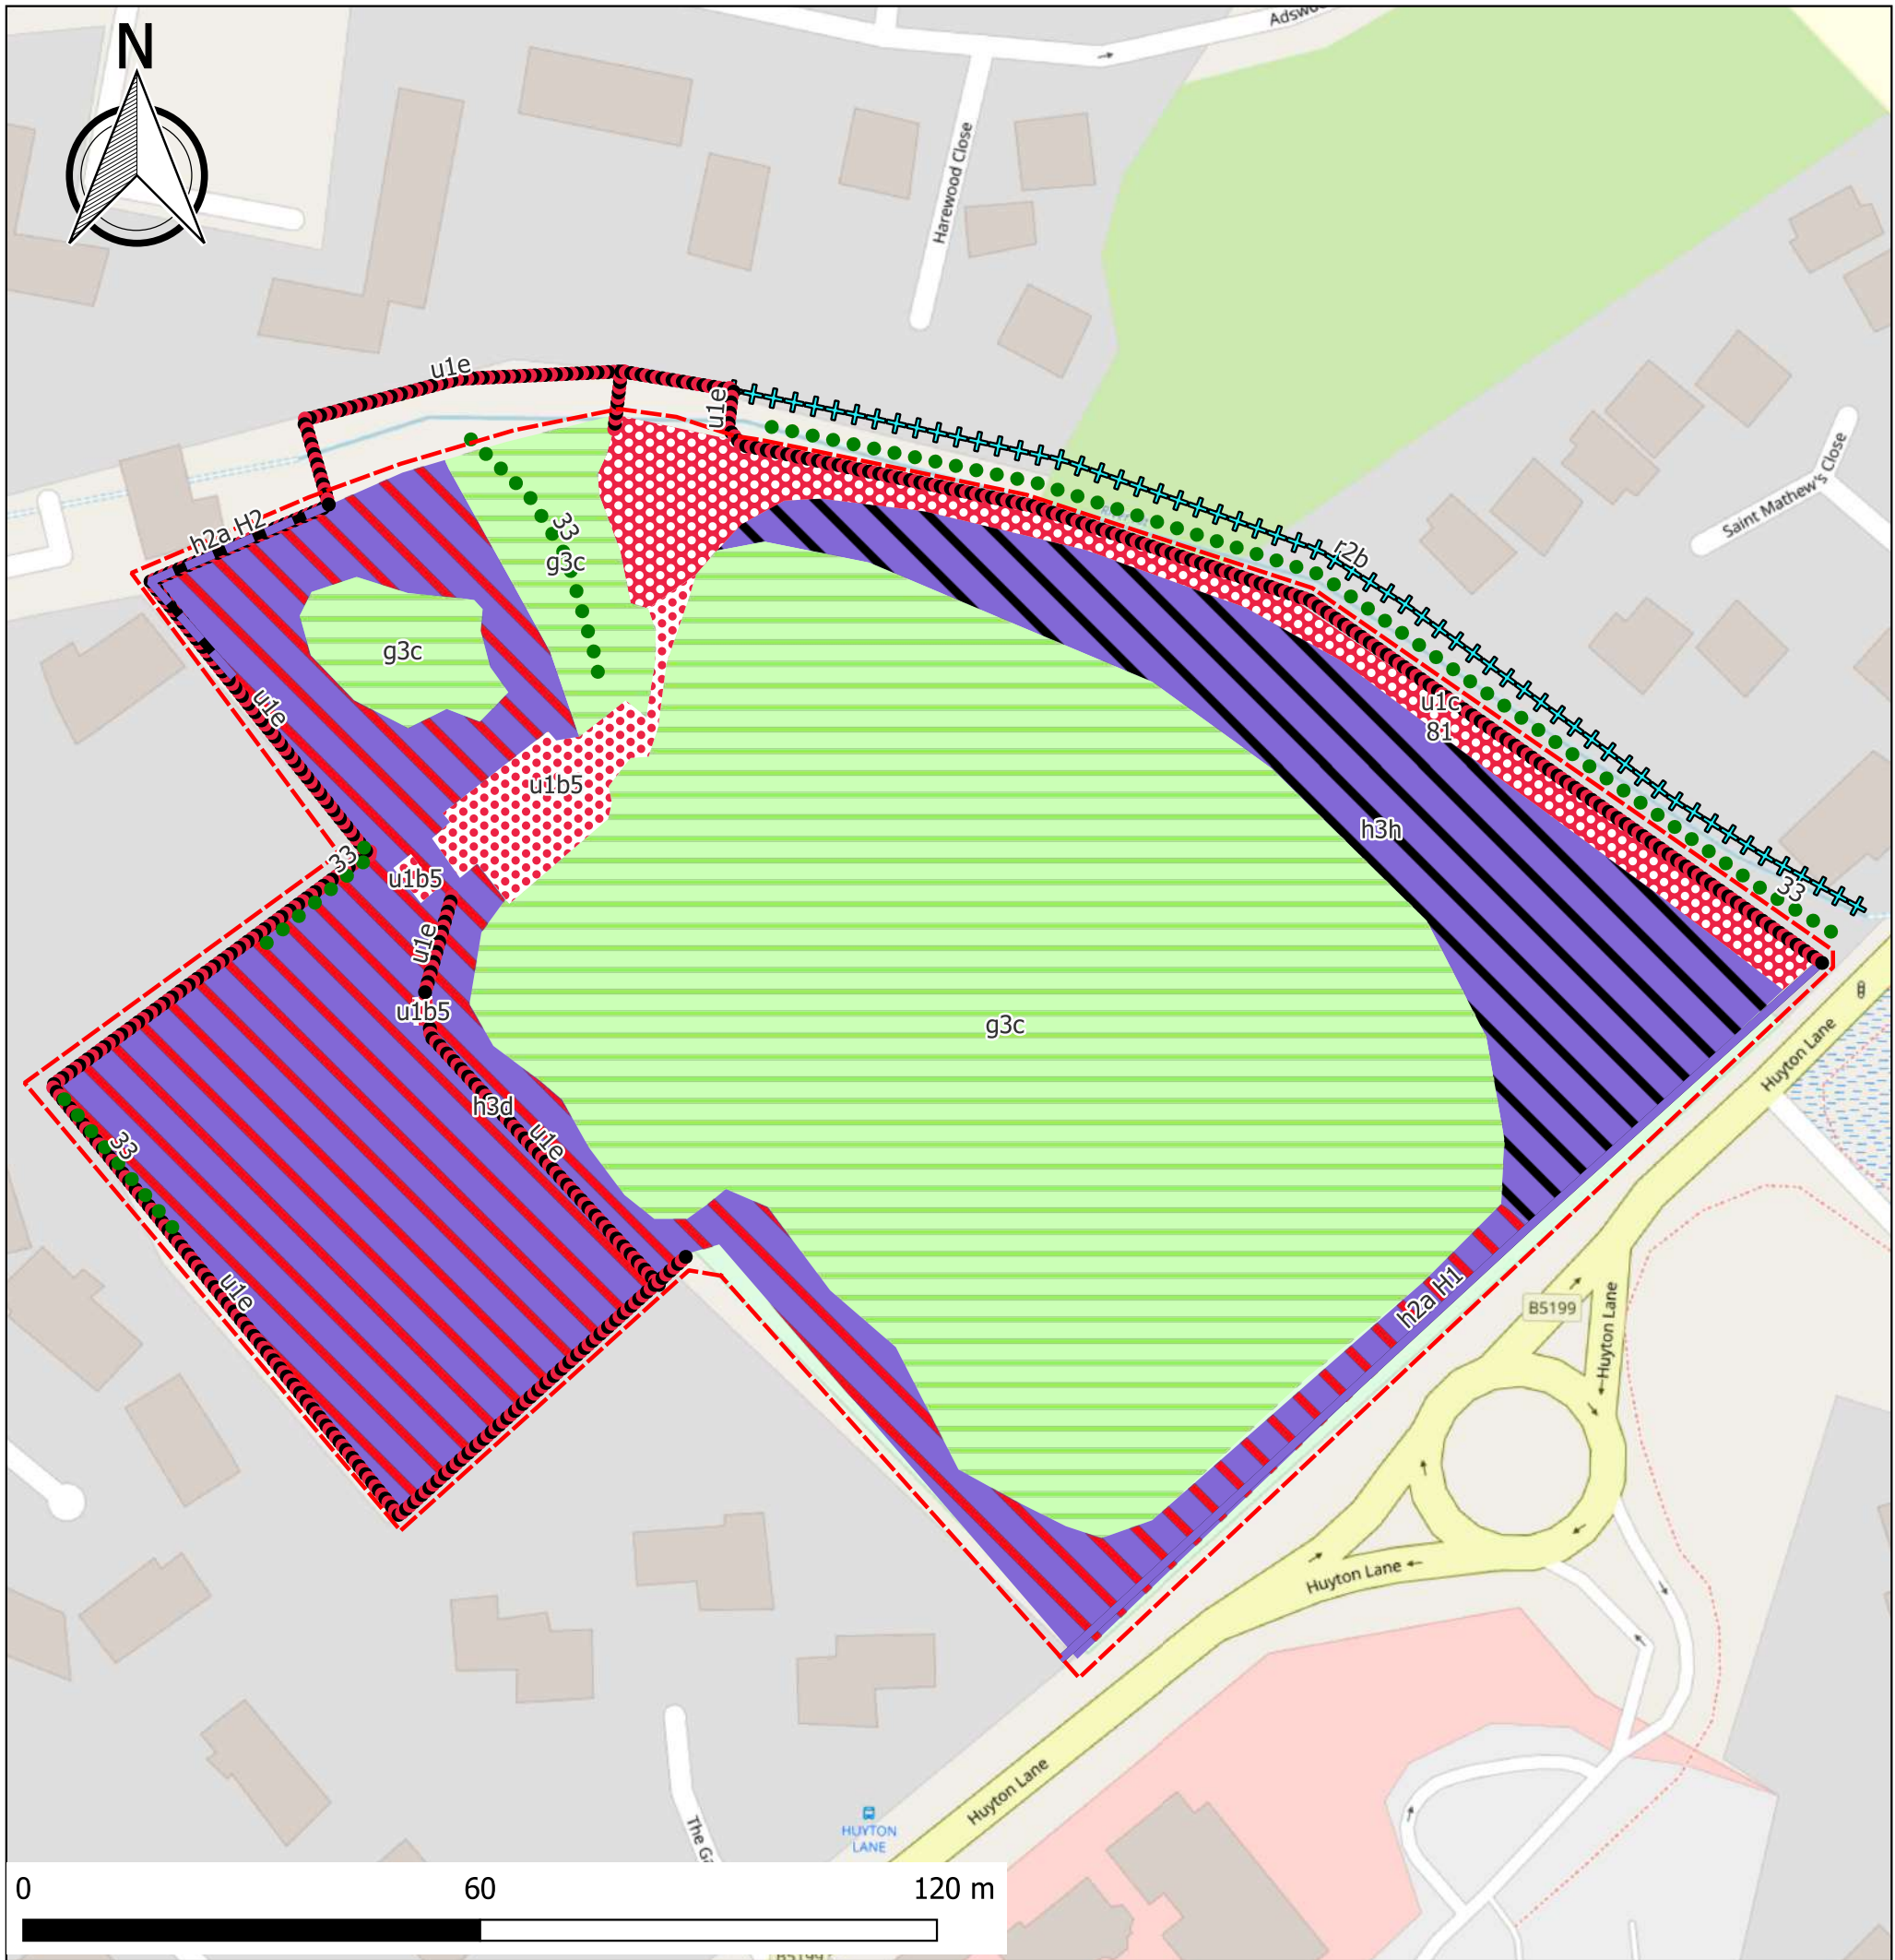
## **Appendix 2 – Pre-degradation habitat plan**

Biodiversity Net Gain - Baseline Habitats

Site: Huyton Cricket Club,  
Huyton  
NGR: SJ 44456 91306  
Author: Mark Halliwell  
Date: 28/07/2025

Habitats which are suspected to have been present within the proposed development area prior to clearance have been mapped on a habitat plan provided at Appendix 2.
