# EXTENDED PHASE 1 HABITAT SURVEY & DAYTIME BAT SURVEY

## SOVEREIGN BUSSINESS PARK, HUYTON, LIVERPOOL

JULY 2021 AND FEBRUARY 2022

**RACHEL  
HACKING  
ECOLOGY**

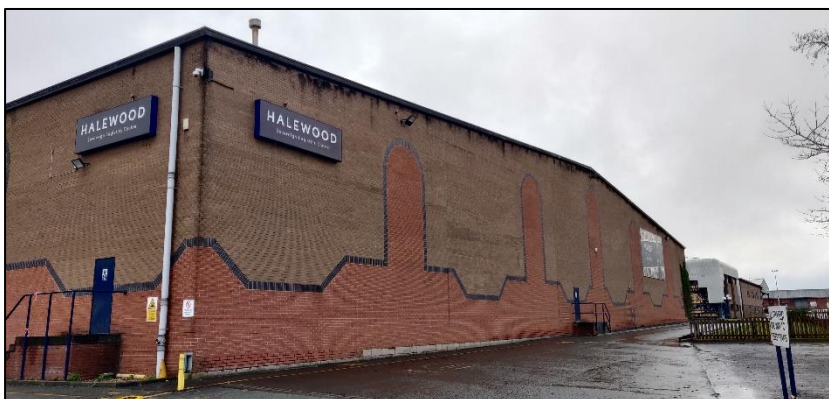
- 3.16 Two warehouses are present on the site, both were the subject of a daytime bat survey, and were otherwise fully accessible. Two smaller buildings are present on the site, there was no internal access to these buildings.
- 3.17 The largest of the two warehouses is comprised of three units and an infill section. The exterior walls are constructed from brick which is all in good condition (see Photograph 12) with all the bricks and mortar complete and no areas of damage or reassessing mortar. The upper sections of some of the walls and the whole of other walls are clad with corrugated metal panels in places (see Photographs 13 and 14). All the cladding is complete with all the panels lying flush to each other. Windows are present within some of the brick sections these are all in good condition and lie flush with the brickwork.

Photograph 12 showing the exterior brickwork

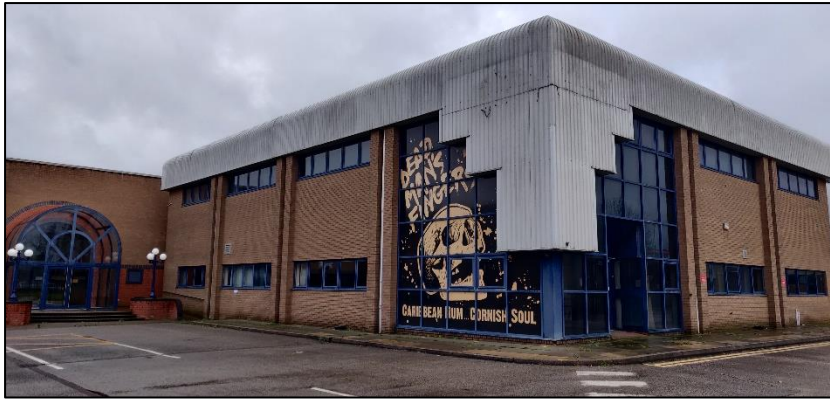
*Photograph 13 showing the corrugated metal panel on the upper walls*

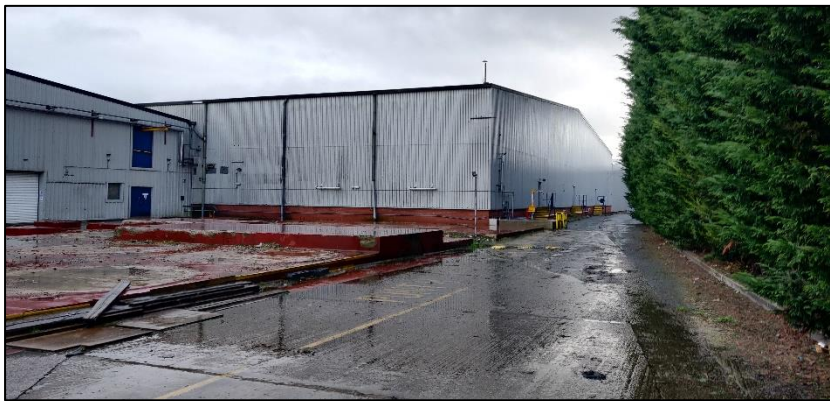
*Photograph 14 showing the corrugated metal panels covering the entire rear walls*

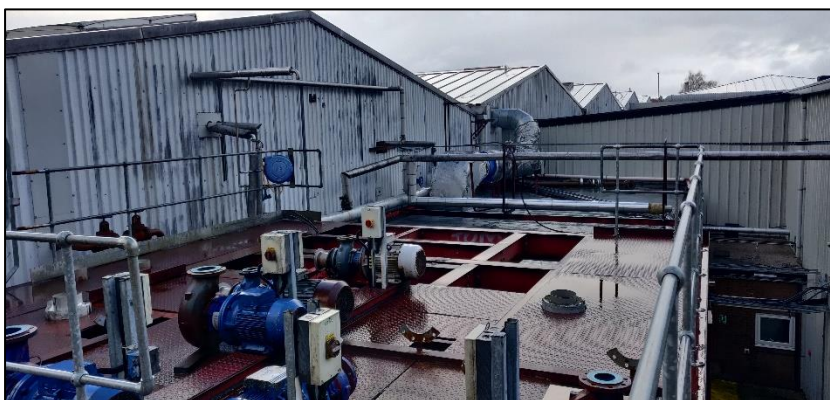
- 3.18 There are different roof types on each section of the warehouse, they are either pitched or flat and are constructed from corrugated metal panels with skylights throughout, all appear to be well maintained although due to the shallow pitch of some roofs it was not possible to view them in their entirety (see Photograph 15). A small section of the roof above the offices is hipped this too is in good condition.

*Photograph 15 showing some sections of the roof at the rear of the building*

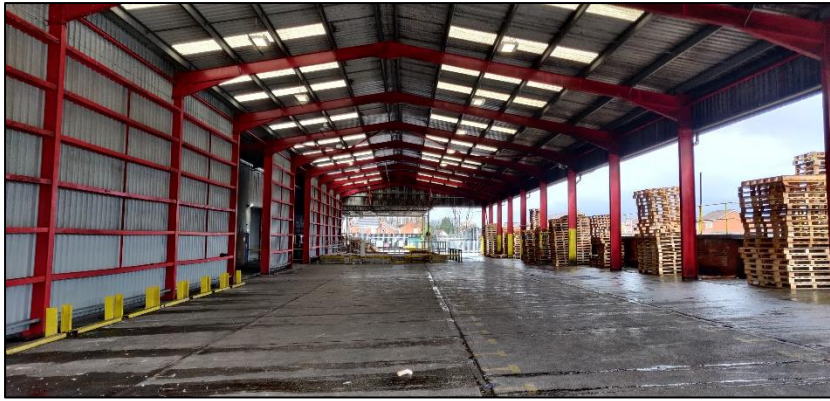
- 3.19 A large canopy area constructed from corrugated metal panels is also associated with this warehouse (see Photograph 16). This is attached to the northern elevation of the building, it is all complete in good condition and well-sealed with the adjoining building.

*Photograph 16 showing the large canopy on the northern elevation*

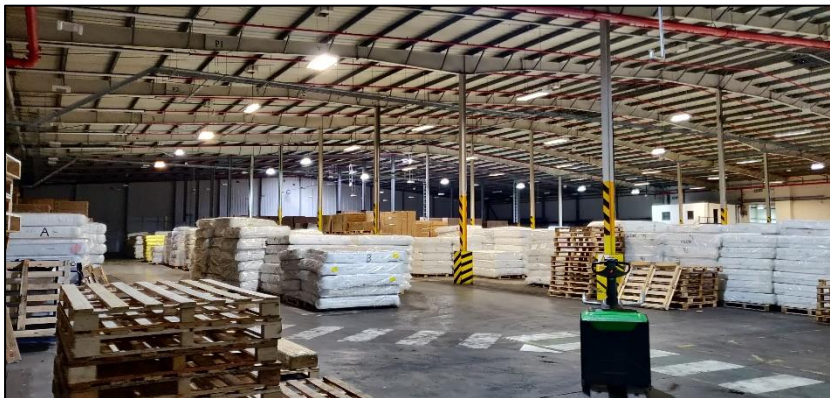
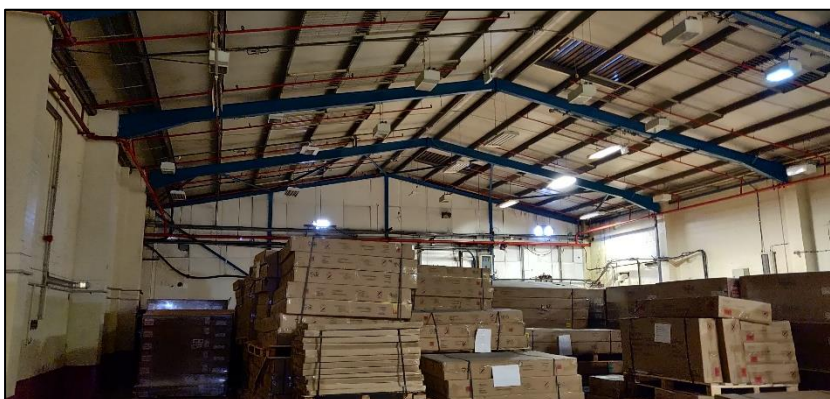
- 3.20 The internal spaces within the warehouse are large and open to the roof (see Photographs 17 and 18). The roofs are supported by a metal frame which is complete throughout and does not support any features that bat bats could exploit for roosting such as crevices. The office spaces within the warehouse have false ceiling, with the space above used for services such as lighting (see Photographs 19 and 20). No evidence of bat activity such as bat droppings was found within the warehouse.

*Photograph 17 showing one of the large internal spaces*

*Photograph 18 showing another of the large internal spaces*

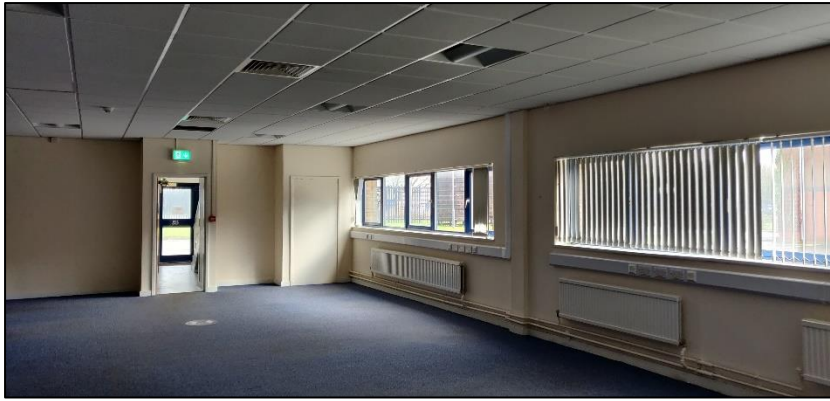
*Photograph 19 showing one of the office spaces*

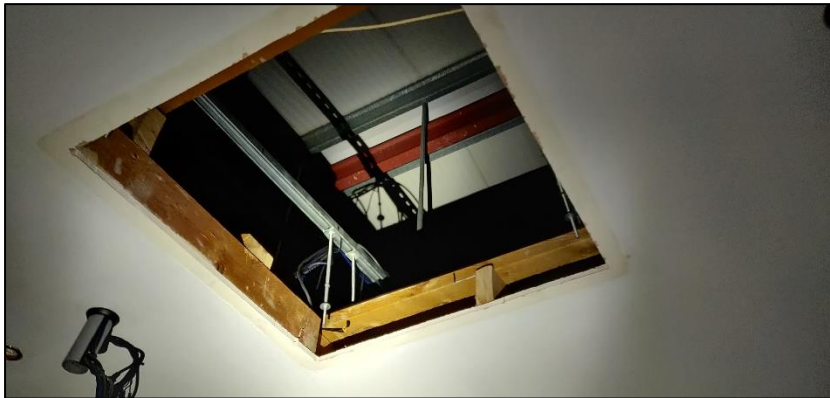
*Photograph 20 showing the space above one of the offices*

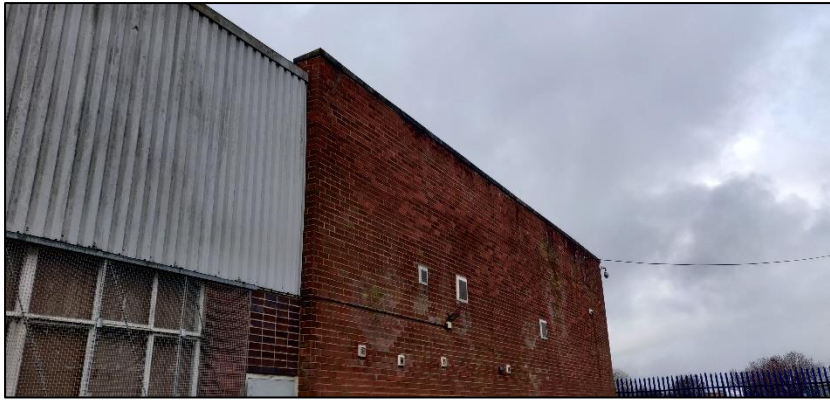
*Photograph 22 showing the section of metal cladding*

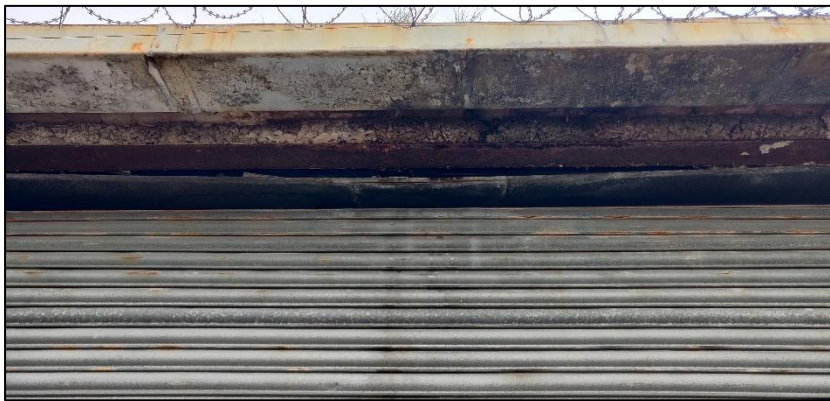
*Photograph 23 showing a gap above one of the metal shutters*

- 4.6 The buildings on site were the subject of a daytime bat survey, all of the buildings were found to be in good material good condition with no suitable access points of bats, other than above one of the metal shutters on the smaller building. The internal spaces of the warehouses are no longer in use and are cold. The rooms are open to the roofs and do not support any roof voids other than the small spaces above the false ceilings in the offices which are uninsulated spaces filled with service wires and pipes. Water ingress is present in the smaller of the two warehouses. No evidence of bat activity was found in any of the buildings on site. All the buildings on site are considered to offer **Negligible** potential to support a bat roost.

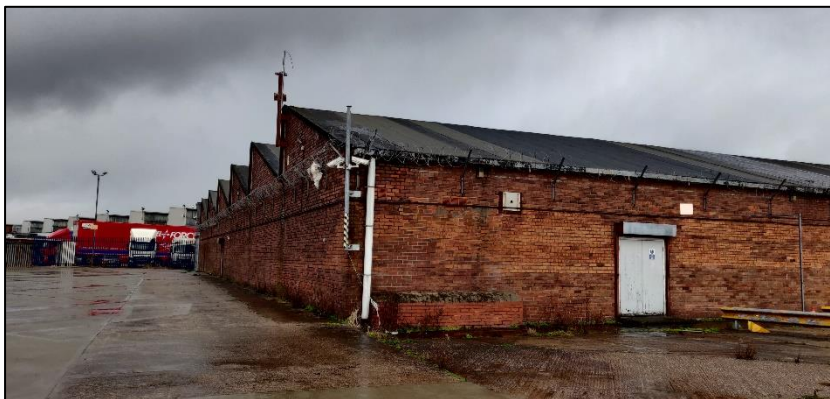
- 3.22 The roof the smaller warehouse is a saw-tooth roof with multiple pitches (see Photograph 24). The roof appears to be in good condition with all the roofing panels flush to each other. The vertical section support skylights which are all in position and do not support any damage.

*Photograph 24 showing the roof of the smaller warehouse*

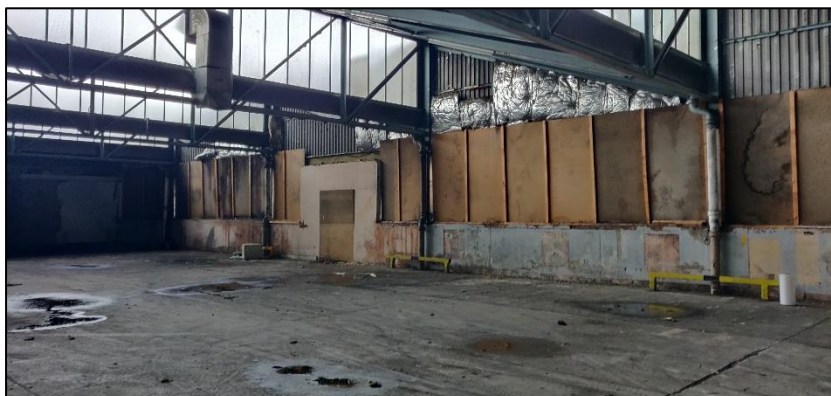
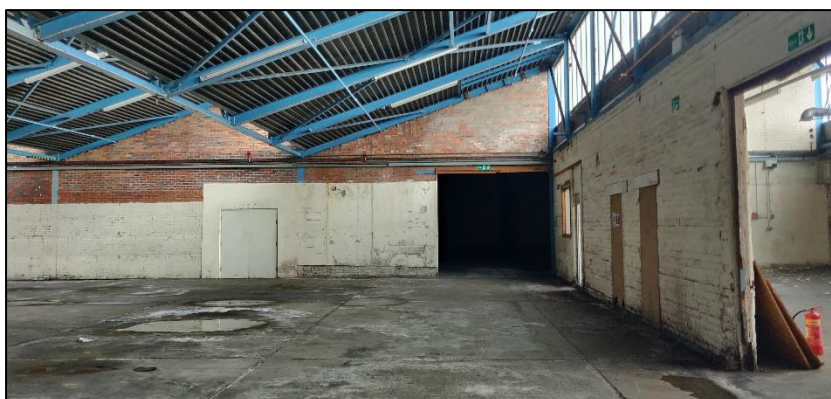
- 3.23 The internal space of the warehouse is comprised of a series of large open rooms, all are open to the roof (see Photographs 25 and 26). The roof is supported by a metal frame which is complete and intact and does not support any suitable roosting opportunities for bats. Signs of water ingress are present throughout suggesting the roof is no longer fully watertight. Offices are also present in this warehouse which have

*Photograph 25 showing the interior space of the smaller warehouse*

*Photograph 26 showing another section of the smaller warehouse internally*

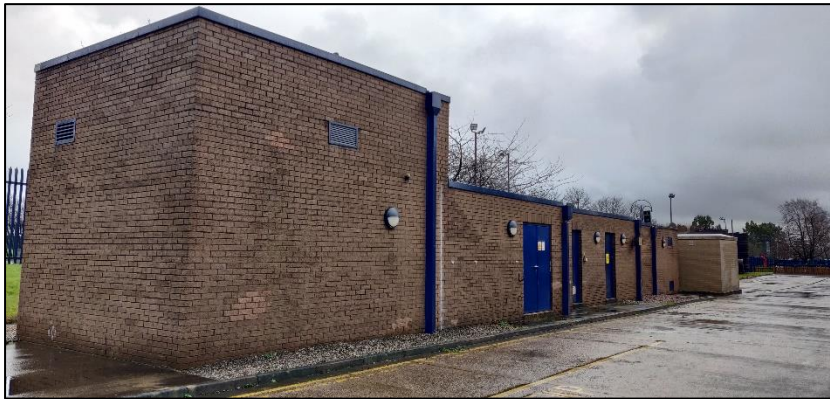
- 3.24 The other buildings and structures on site were not accessed internally but appear to be well-sealed from the exterior inspection. The largest of these additional structures is a single storey brick-built unit with a flat roof (see Photograph 30). It is well maintained with no potential access points for bats. All the roof edges are sealed with capping material which is all complete. Other structures include the gate hut (see Photograph 31) a small single-storey structure with a flat-roof which also appears to be extremely well-sealed.

Photograph 30 showing the single-storey building

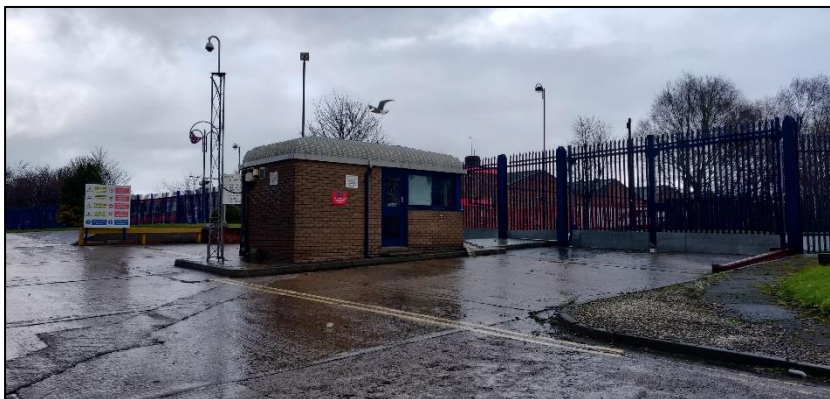
Photograph 31 showing the gate hut

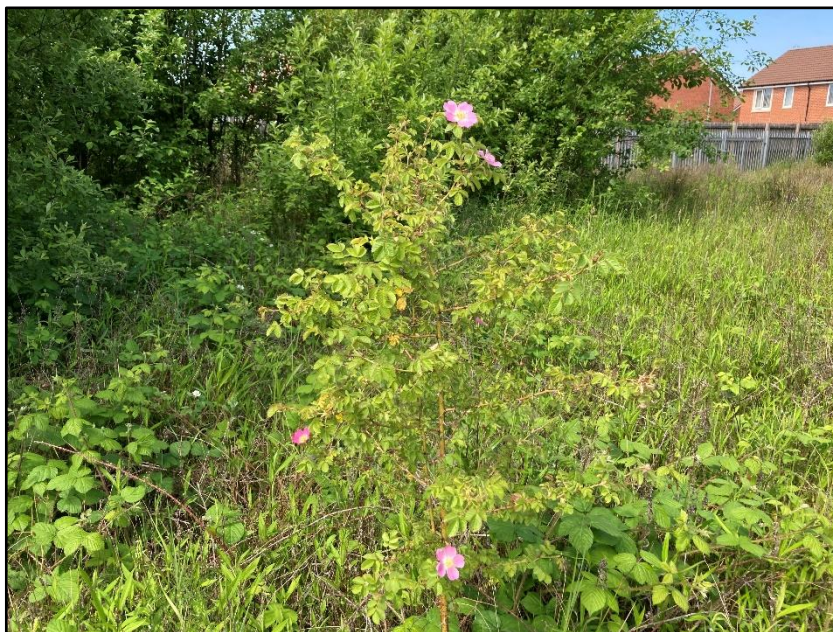
- 3.30 Japanese Rose *Rosa rugosa* occurs on the site (see Photograph 9), this is a non-native, invasive species as listed on Schedule 9 of The Wildlife & Countryside Act 1981 (as amended) which makes it an offence to allow this species to spread in the wild.

Photograph 9 showing some of the Japanese Rose on site

- 5.2 The Japanese Rose should be eradicated from the site as a part of the proposed development.
