### **NLG Ecology Ltd (2021) Bat Survey Report**

## Headbolt Lane, Kirkby

**Title:** **Headbolt Lane**  
Bat Activity Survey Report

**Date:** July 2021

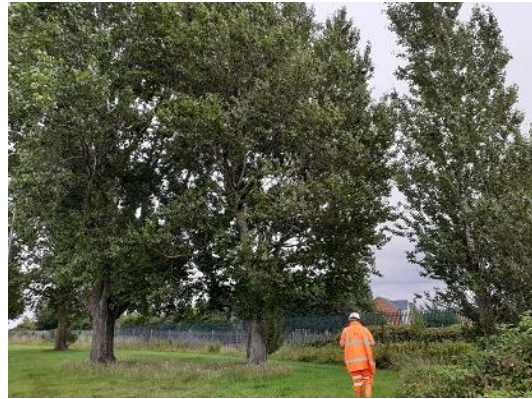
Photograph 1. Mature Lombardy poplar trees; tree with knot hole seen to left hand side.

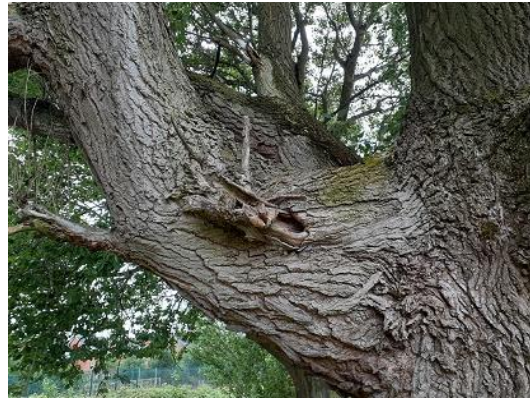
- 3.3.1 A mature Lombardy poplar is present adjacent to Headbolt Lane at SJ 41536 99849. The tree has a knot hole approximately 2.5m high, facing east. The extent of the knot hole could not be fully observed during the preliminary ground-level roost appraisal. Due to the potential of the features to support roosting bats and the suitable surrounding habitat, the tree has been assessed to hold a **moderate** bat roosting potential.

| Structure | Emergence/re-entry | |
|---|---|---|
| Mature Lombardy<br>poplar tree | No re-entries. | Feature with bat roosting potential inspected with endoscope and no bats found. The original feature is a knot hole with a branch tear out identified in 2020. The feature has significantly rotted since the initial inspection. No cavity was found behind the rotted limb within the knot hole, and the small hole had a slug present. This tree can be downgraded to having negligible potential roosting suitability for bats. |

Photograph 2. Knot hole in Lombardy poplar with moderate bat roosting potential. After inspection with an endoscope, this has been downgraded to **negligible** bat potential.

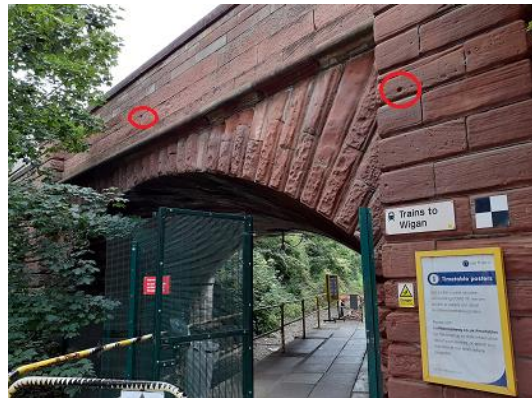
| <p>Glovers Brow Bridge UB<br/>WKL2 57</p> | <p>Glovers Brow Bridge is of solid concrete and sandstone construction, with a section of metal plating underneath the arch. Gaps are present between the concrete arch and metal plating that may provide suitable roosting opportunities for bats, although cobwebs present suggest that these spaces have not been used recently. Some small pockmarks and cracks were present in the eastern sandstone elevation. No evidence of bat use, in the form of droppings, prey remains, staining on crevices by fur oils or urine, or bats themselves were identified across the bridge.</p> | <p><b>Low</b></p> |

Photograph 3. Glovers Brow Bridge (eastern elevation) with crack to left and pockmark to right highlighted (red circles).

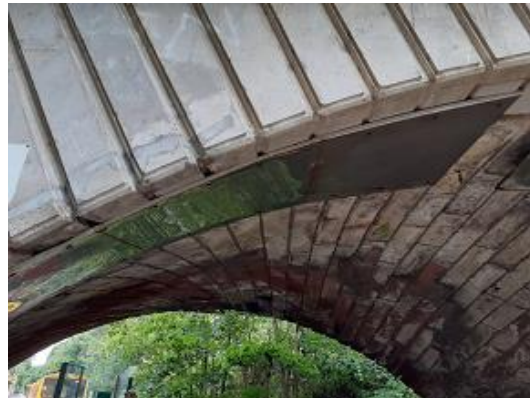
Photograph 4. Metal plate underneath Glovers Brow Bridge with **low** bat potential.

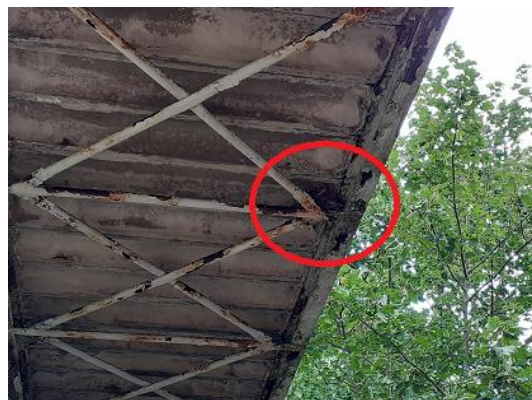
- 4.2.1 Opportunities for nesting birds are present in and around the structures and mature Lombardy poplar. Old bird's nests identified as being from prior to the 2020 nesting season were observed underneath the steel crossbeams of a metal footbridge adjacent to Glovers Brow Bridge.

Photograph 5. Old bird nest present underneath Glovers Brow footbridge.

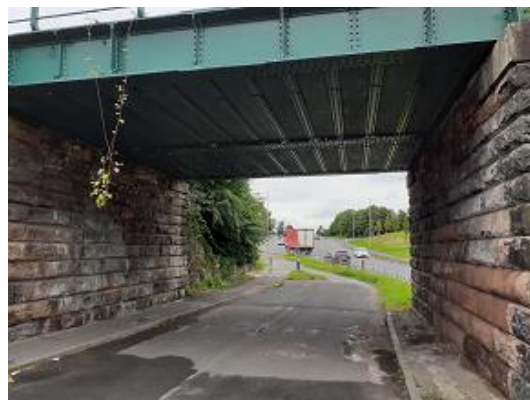
| Building | Description | Bat Roosting Potential |
|---|---|---|
| County Road Bridge A502 UB WKL2 55 | <p>County Road Bridge is a reinforced steel and stone structure, with no signs of weathering or colonisation by plant species. There are no gaps or cracks present that could provide potential spaces for roosting bats. No evidence of bat use, in the form of droppings, prey remains, staining on crevices by fur oils or urine, or bats themselves were identified across the bridge.</p> <p>No further surveys are required due to a lack of evidence of bat use and the absence of any suitable roosting features.</p> | <b>Negligible</b> |

Photograph 6. County Road Bridge with **negligible** bat potential.

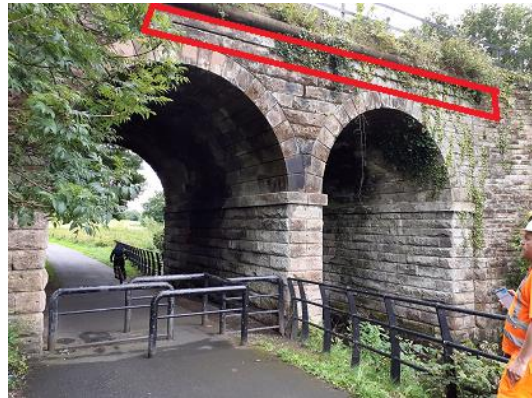
| Structure | Emergence/re-entry | |
|---|---|---|
| Millbrook Bridge<br>UB WKL2 56 | Low levels of bat activity in the local area. No re-entry of bats to the structure observed. | No emergences observed. Pipistrelle bats commuting along tree lines to wards bridge with constant foraging in local area along watercourse and adjacent tree lines. |

Photograph 7. Millbrook Bridge with gap present above arch ring. Wing walls have ivy present which may obscure further crevices within the stone work. Considered **moderate** bat roosting potential.

- 4.1.1 Millbrook Bridge UB WKL2 56 was assessed to have '**moderate**' potential for roosting bats. This structure was subject to further survey efforts in the form of two emergence/ re-entry surveys for bats in May and June 2021 with no roosts confirmed. As the immediate habitats surrounding Millbrook Bridge provide optimal foraging habitats for bats, as a precautionary measure, Millbrook Bridge will be inspected from a Mobile Elevating Work Platform (MEWP) by a licensed bat ecologist in advance of any construction activities. If any evidence of opportunistically roosting bats is found then to avoid any compromise of the legal protection afforded the species, works will be completed under a European Protected Species Licence.

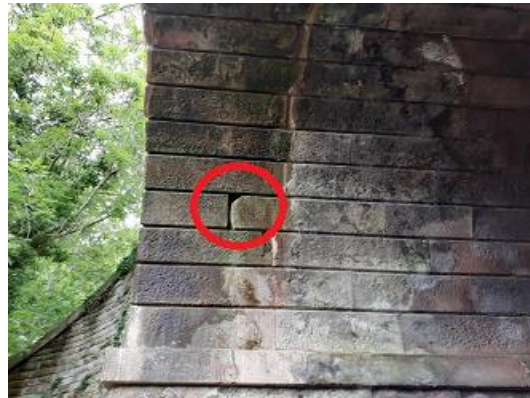
Photograph 8. Gap in arch of Millbrook Bridge near northern elevation, above footpath.

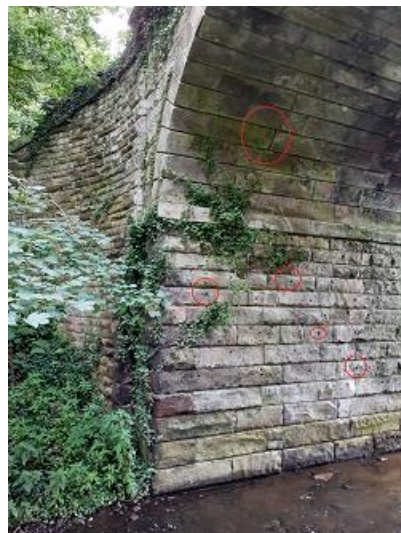
Photograph 9. Cracks and pockmarks in Millbrook Bridge over stream.
