# GeoShield Verification Report 1

GEO106129

27 Newhall Road,  
Prescot  
L34 1AQ

Conservatory - Full Line Out

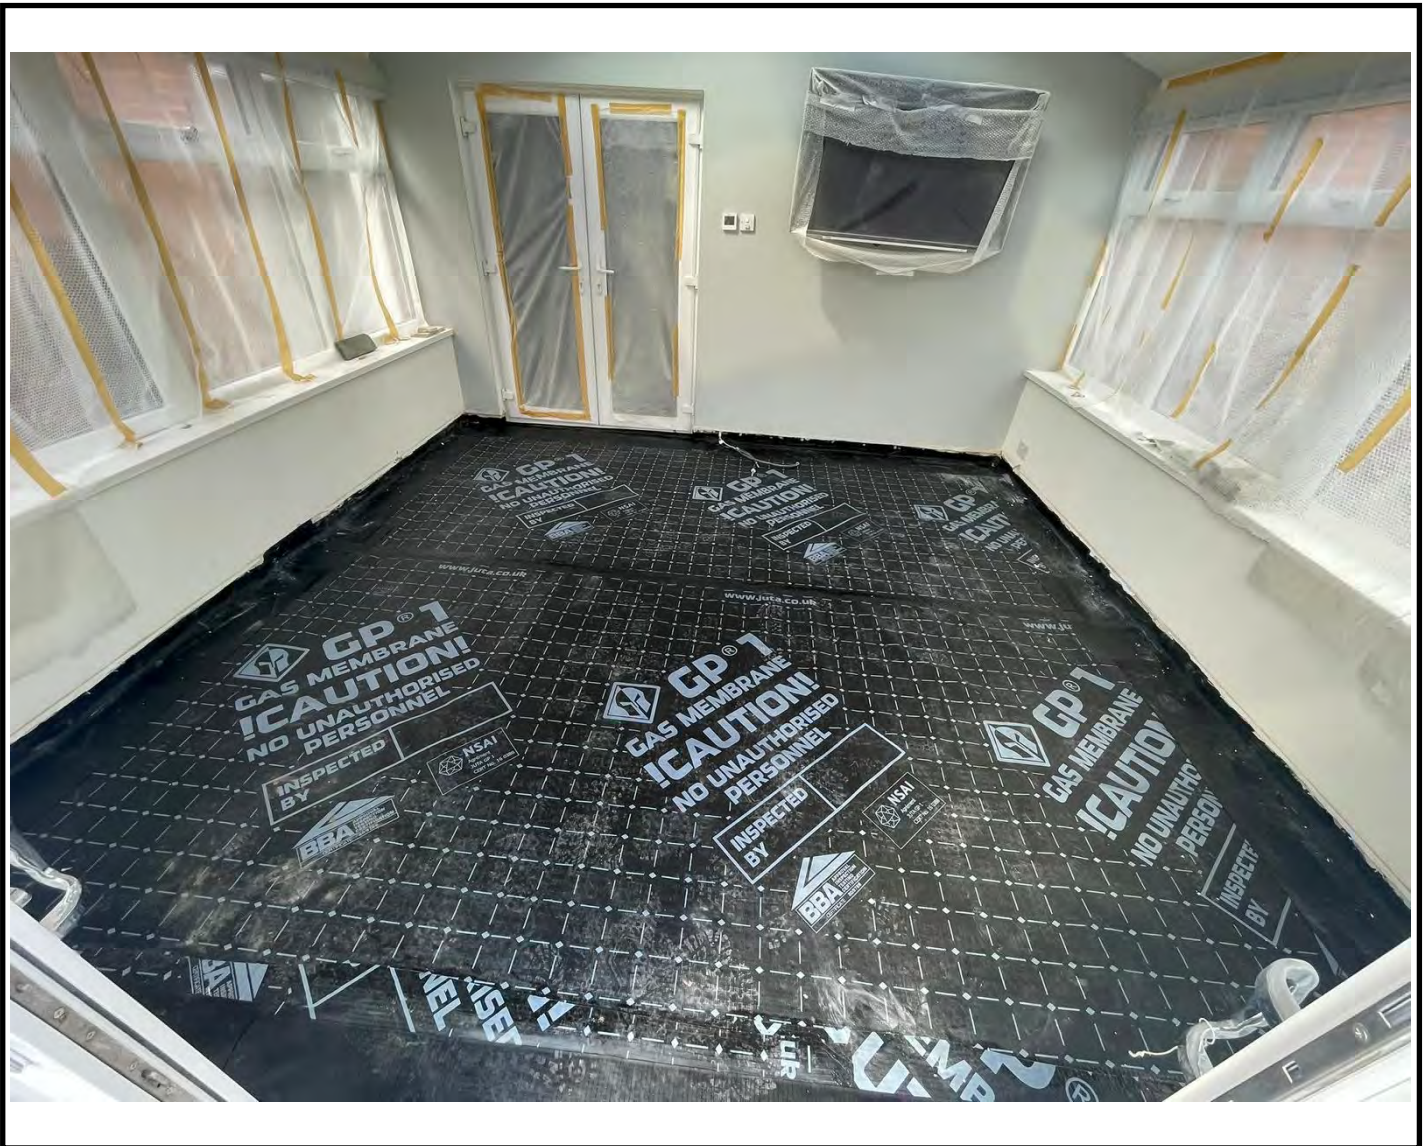
The above image shows the Conservatory where the verification inspection of the JUTA GP1 Gas Barrier complete line out installation took place today.

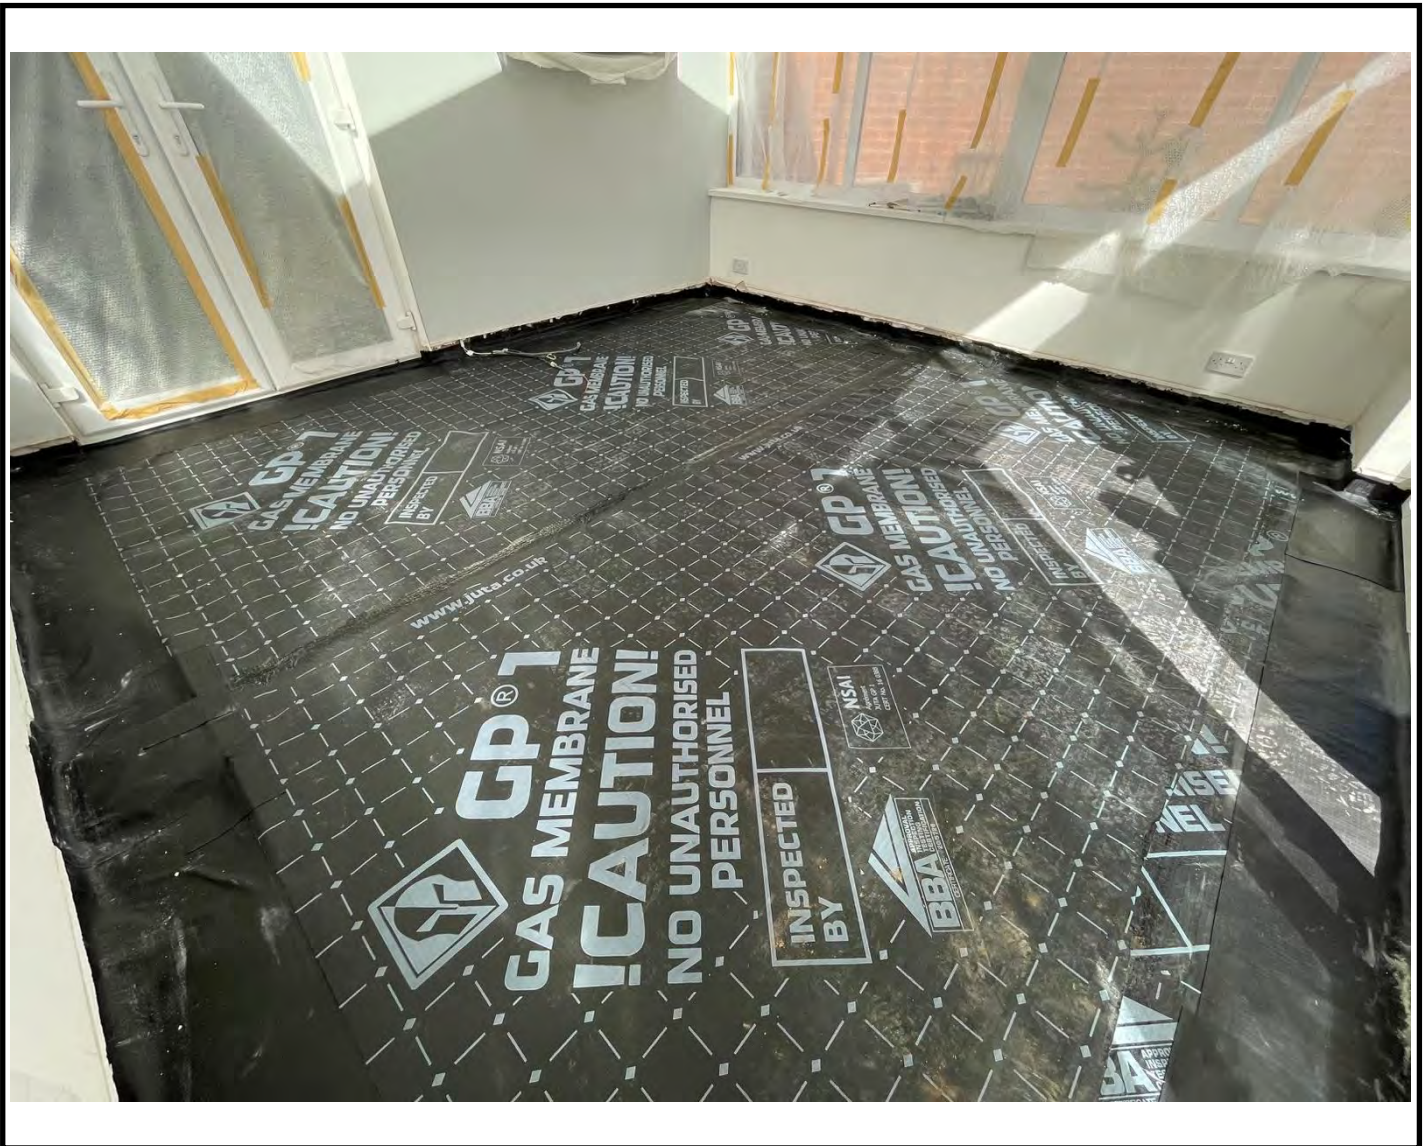
The above image shows the Conservatory where the verification inspection of the JUTA GP1 Gas Barrier complete line out installation took place today.

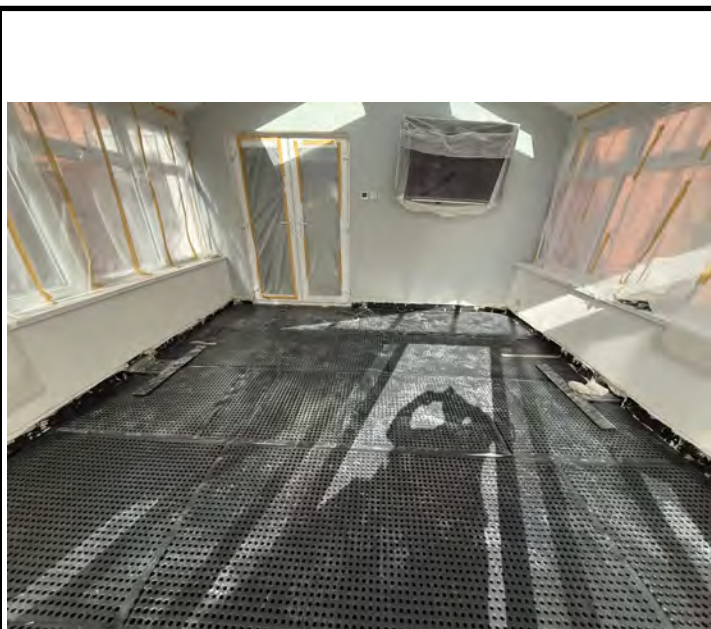
A pressure relief system, in the form of vent matting has been installed on a solid concrete slab within the Conservatory of 27 Newhall Road. The Vent Mat has been lined out across the slab and has been terminated at two side elevations, where the vent mat has been connected onto two T-junctions.

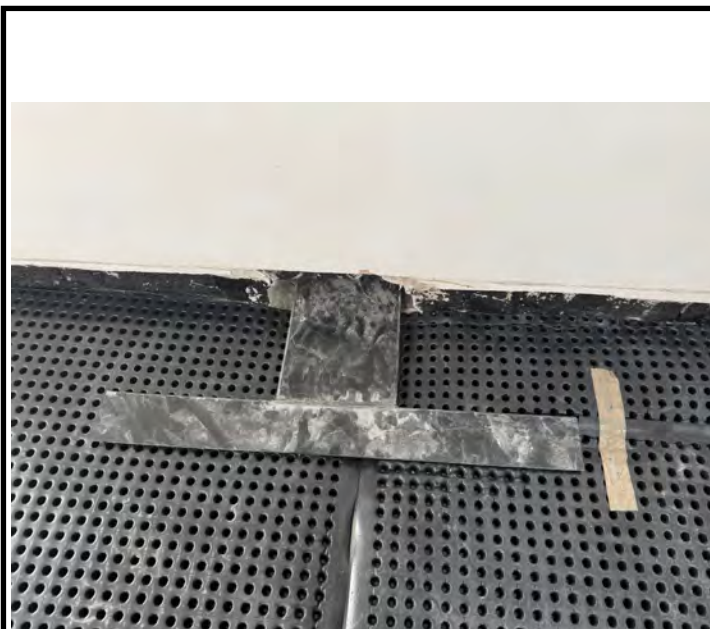
The T-junctions were then connected onto the periscope vents which run through the cavity to the external face of the brickwork.

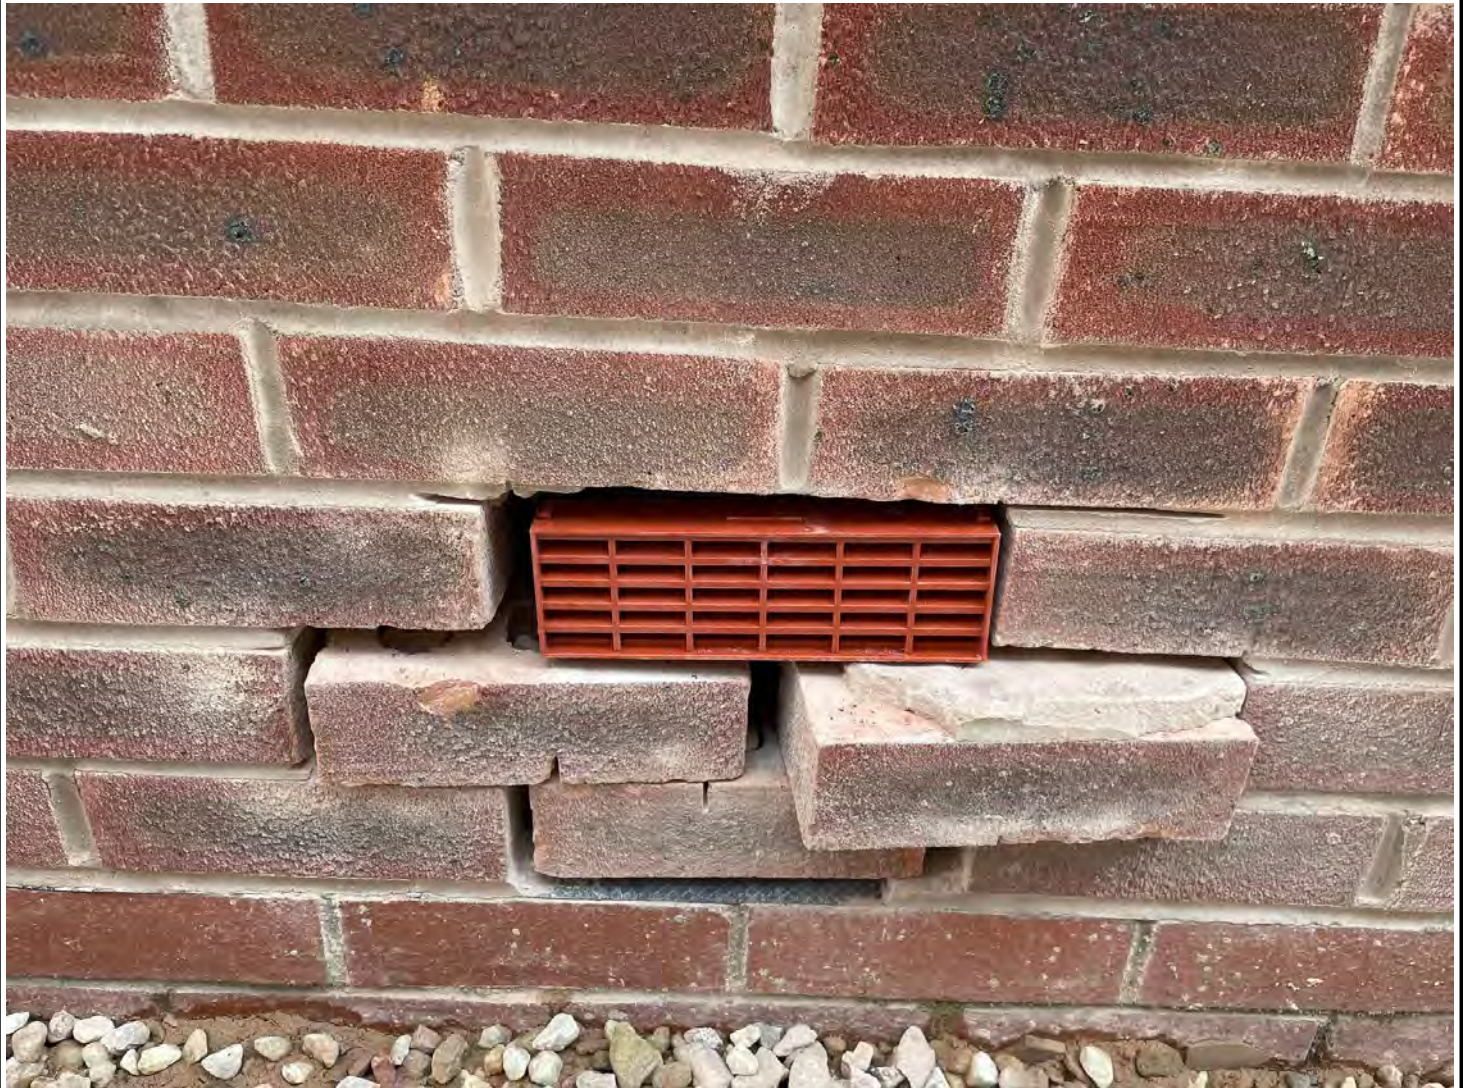
The periscope vents are connected to the external face of the brickwork with an air brick. This completes the pressure relief system.

Thorough visual inspections revealed no issues throughout.  
Tested and verified in accordance with CIRIA 735.

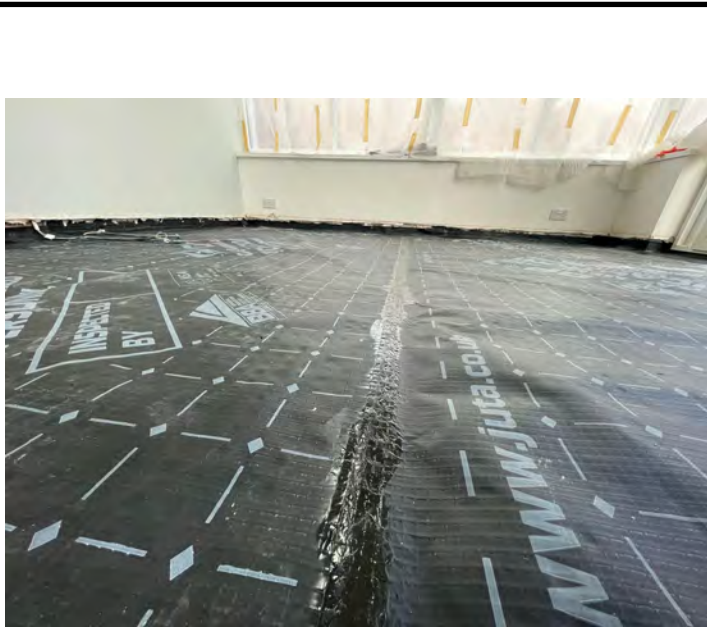
A complete line out of the JUTA GP1 Gas Barrier has been installed across the footprint of the Conservatory, upon a suitable substrate. The JUTA GP1 Gas Barrier has been lined out on top of the pressure relief system vent matting. The JUTA GP1 Gas Barrier has been installed tightly to all four perimeter walls and

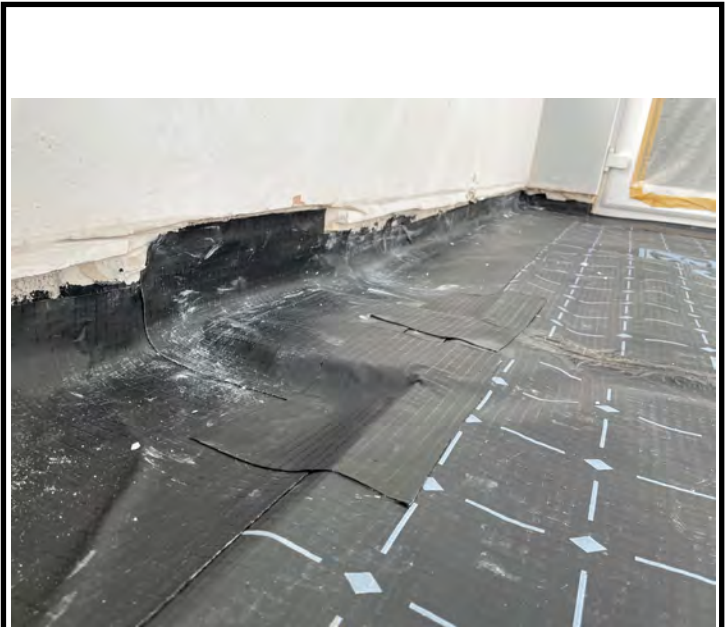
sealed in a retrofit detail. Prior to the implementation of the retrofit detail, the perimeter walls were primed using JUTA GP Primer and once cured, JUTA GP1 SAM was applied upon the primed surfaces, returning onto the newly installed JUTA GP1 Gas Barrier. All lap joints between the adjacent sheets of JUTA GP1

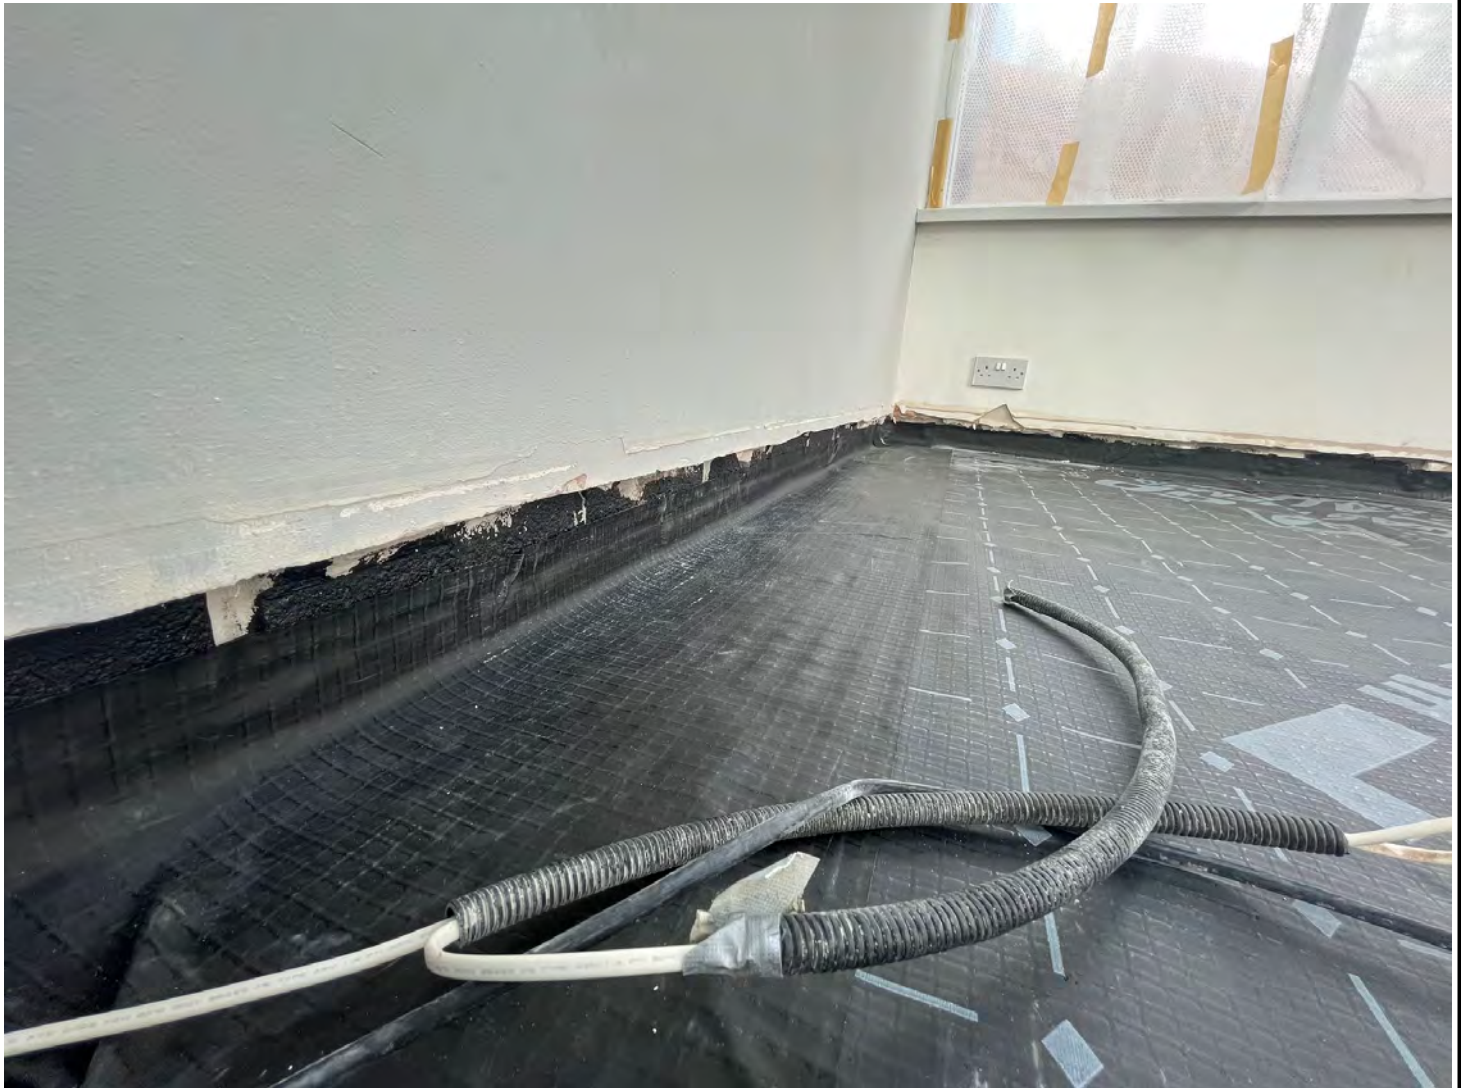
Gas Barrier have been overlapped a minimum of 100mm, conforming to manufacturer's specifications, and heat welded using a hot air tool and a silicone roller with adequate pressure applied to ensure a continuous gas resistant seal is achieved. All lap joints were subjected to thorough visual inspections and mechanical point stress testing.

No faults or defects were identified at the time of the inspection.

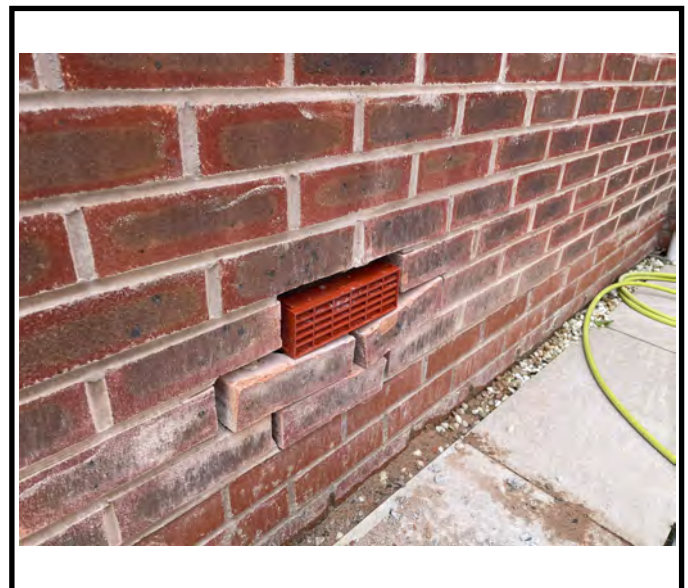
An air brick installed around the external perimeter of the Conservatory.

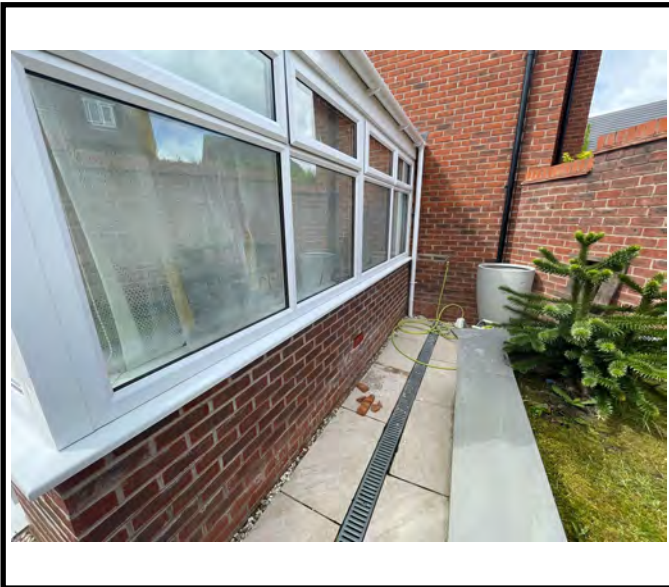
Air bricks installed around the external perimeter of the Conservatory.
