orchard dry stone wall

Tuesday, 28 November 2023

6 Issues Identified

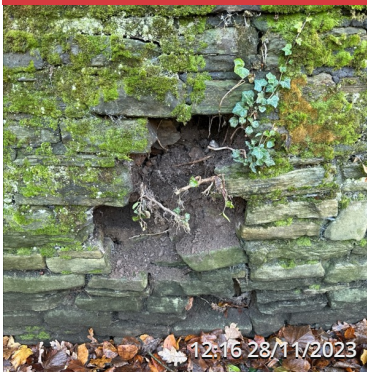
### **ISSUE 1**

Assigned To The Orchard Entrance Road

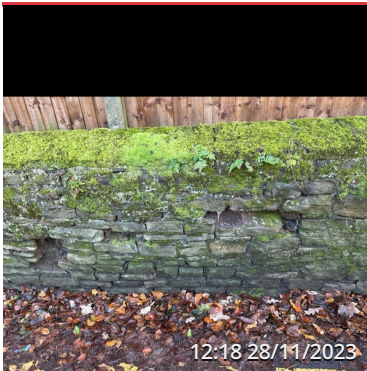
### **ISSUE 2**

Assigned To Dry Stone Wall Orchard Area Of The Complaint.

Looks as though roots are growing through the block and pushing the stone out.

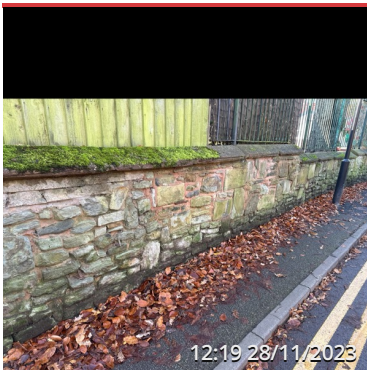
### **ISSUE 3**

Assigned To Orchard Dry Stone Wall

Other areas with the same problem.

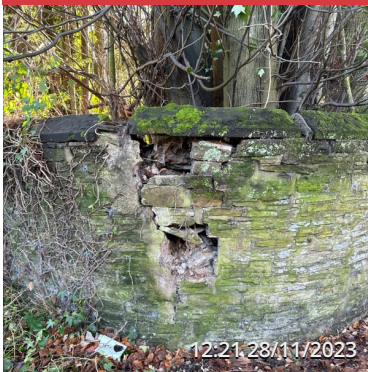
## **ISSUE 5**

Assigned To Photographs 5&6

These areas have not had complaints to my knowledge. The wall as a whole is in very poor condition prior to any work onsite.
