Our ref: 6064/BM/HS

January 2022

## **HERITAGE STATEMENT**

**MAGAZINE BUNKER  
9/10 DRAW WELL ROAD  
KNOWSLEY BUSINESS PARK  
KIRKBY  
L33 7BJ**

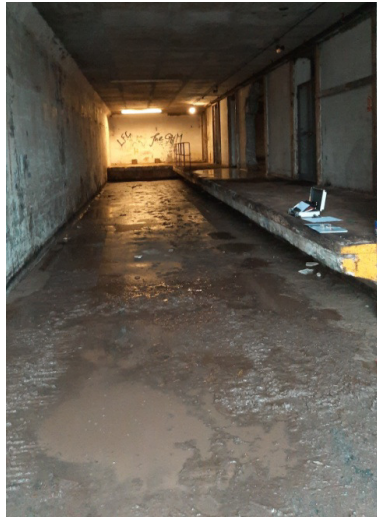
Inside, the bunker is a large empty square room with bare reinforced concrete walls and a bitumen covered reinforced concrete floor. The loading platform for the historic railway is still in-tact, however all railway tracks have been removed. The main floor area consists of 5 rows of 6 square reinforced concrete columns which support the thick concrete roof.

Loading Platform

facilities (WC's, Kitchen) will be provided within the bunker by constructing blockwork walls. Safety guard railing will be introduced around the platform edge to prevent falling.

Internally, the building will be mainly unaltered. Small blockwork walls will be constructed inside to facilitate the necessary addition of staff welfare facilities and covered fire escape routes. Guard railing will be installed around the edge of the loading bay platform for safety of the staff.

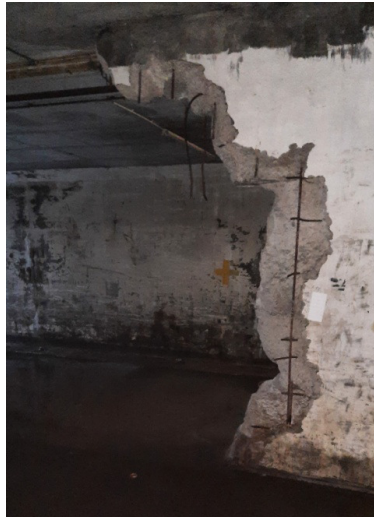
Damaged Walls

The physical layout has not changed since it was constructed in 1940, however – the building is severely damaged. 1 part of the reinforced concrete wall has been partially removed and needs reconstructing, other walls have been extensively vandalised and covered in graffiti, the bunker floor is also flooded with rain water – suggesting the roof may be leaking (allowing water ingress) and the floor level drains are blocked (preventing water egress). At the time of writing, there is no working electricity supply into the bunker, therefore there is no lighting available.

The proposal intends to conduct all necessary remedial works to return the building to a safe, usable facility.

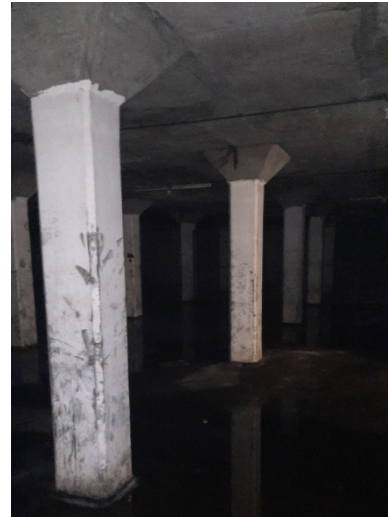
Flooded Interior and Columns

Internally, the majority of the building will remain structurally unaltered. Lighting, drainage and water facilities will all be repaired and be reinstated. An enclosed internal fire escape corridor will be constructed along one side of the facility, to provide a safe egress route. Staff
