**KINGS BUSINESS PARK, KINGS DRIVE,  
PRESCOT, L34 1PJ**

## **PHASE 1 & 2 SITE INVESTIGATION REPORT**

**Report No: 2173R01 Issue 1**

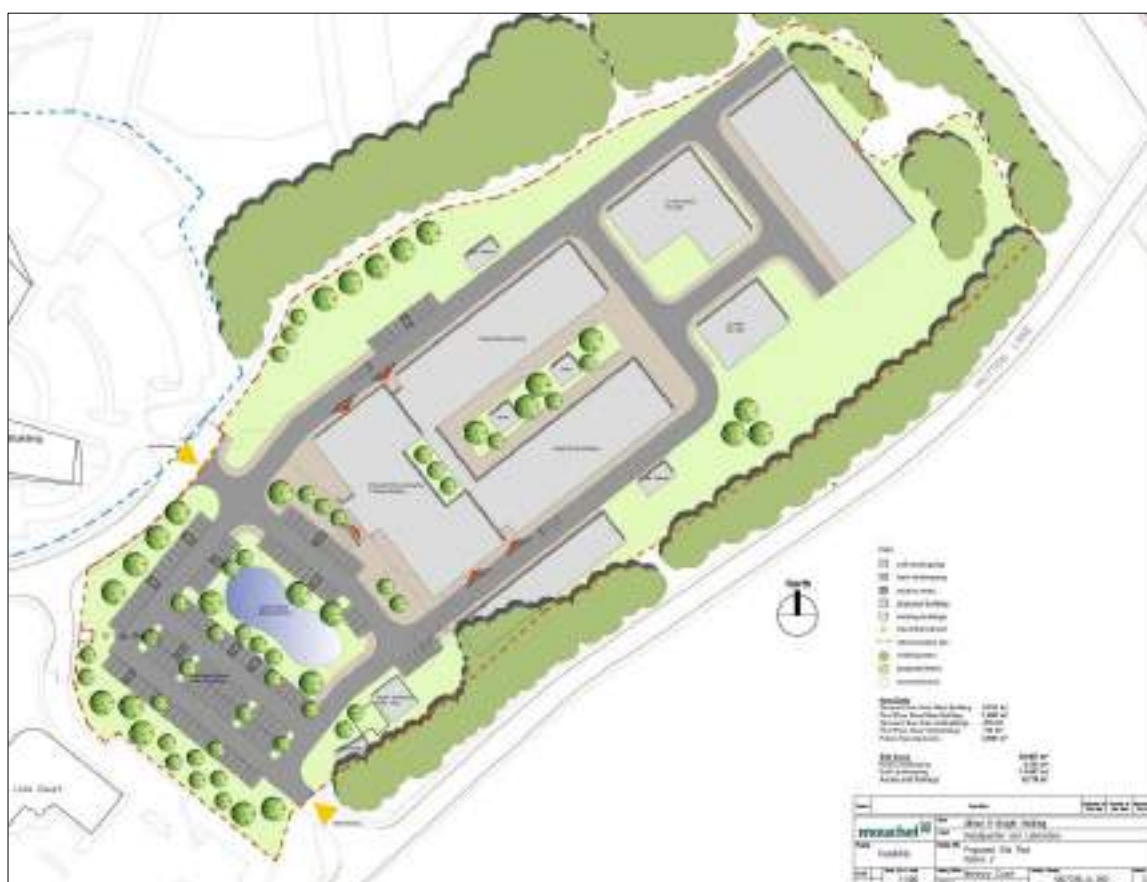
Figure 1a: Development Plan (taken from Mouchel Drawing 1057338\_A\_060 – Option 2)

1.2.2 The initial development proposal provided to TerraConsult was the Client's Option 2 (see Figure 1a below) and this option was similar to Option 1 (see Figure 1b) but includes three additional buildings within the north-eastern part of the site. The investigation and fieldwork was designed on the basis of the Option 2 proposed building layout. The development proposal has changed during the investigation and it is understood that the current development proposal is for Option 1 on the following page. However, the three additional buildings remain an option for future development.

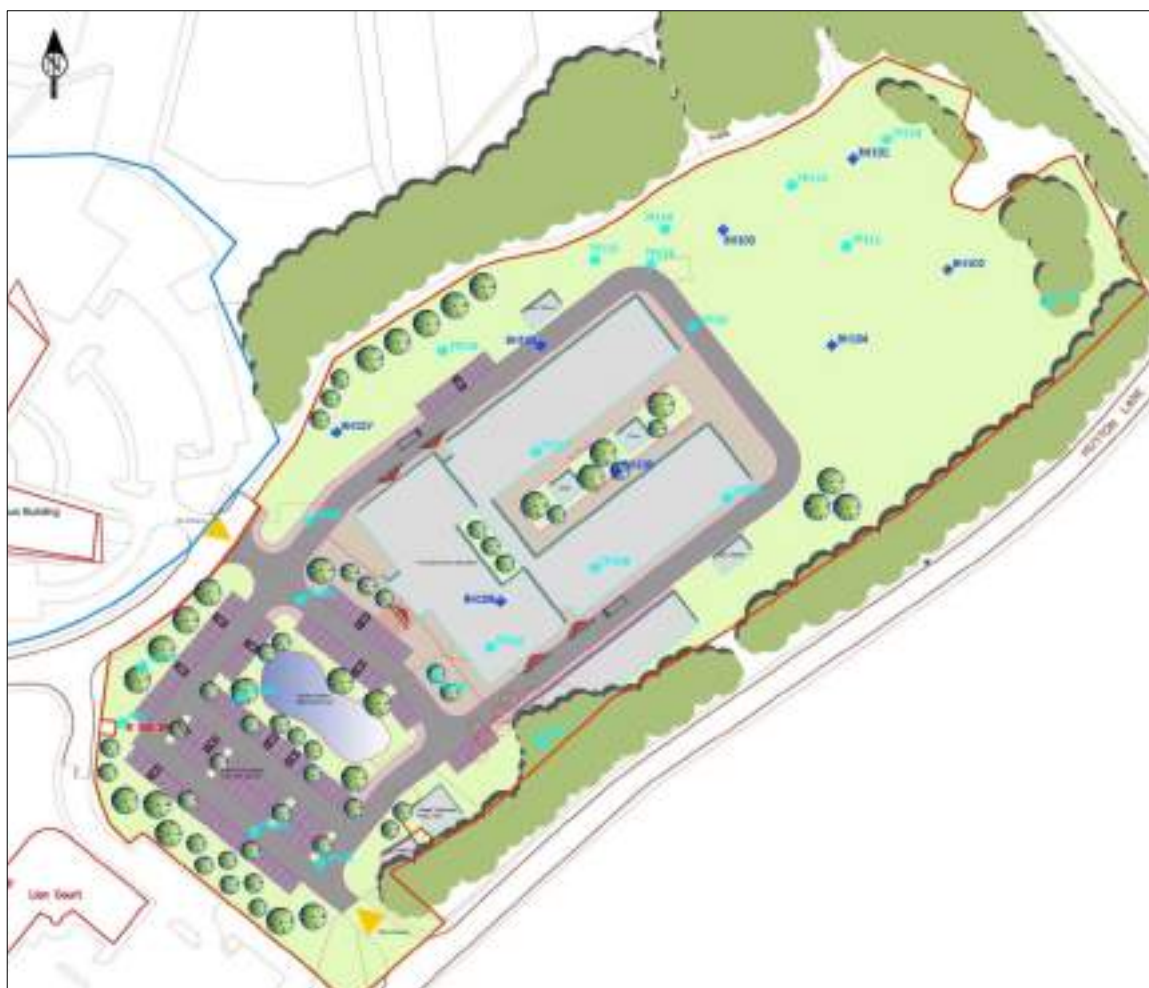
**Figure 1b: Development Plan (taken from Mouchel Drawing 1057338\_A\_060 – Option1)**

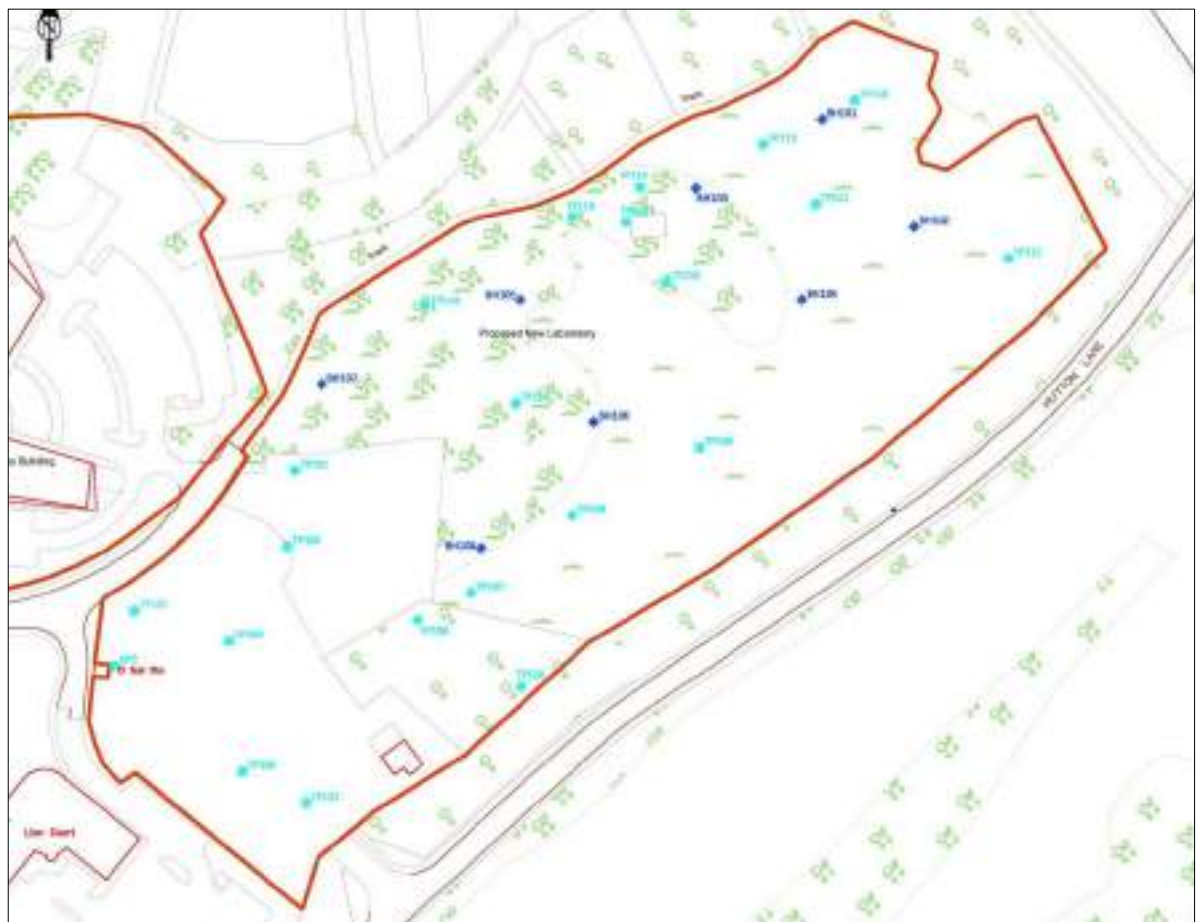
**Figure 5: Exploratory Location Plan**

- 6.1.3 The exploratory locations are shown on Figure 5 below.

- No 21 Machine dug trial pits
  - o to assess the conditions for proposed cut-fill earthworks
  - o enable CBR testing to be carried out in regions of proposed driveways,
  - o for permeability testing and for determining site conditions; and
  - o undertake sampling across the entire site.
- No 8 Rotary boreholes – for enable rock core to be recovered for assessment and sub-samples taken for laboratory analysis as well as to enable the installation of gas and groundwater monitoring wells.
- No 1 Hand dug trial pit – for determining site conditions adjacent to an electrical substation and undertake sampling for chemical laboratory testing with analysis suite to include PCBs because the sub-station could represent a point contaminant source of PCBs if there has been a historical spillage.

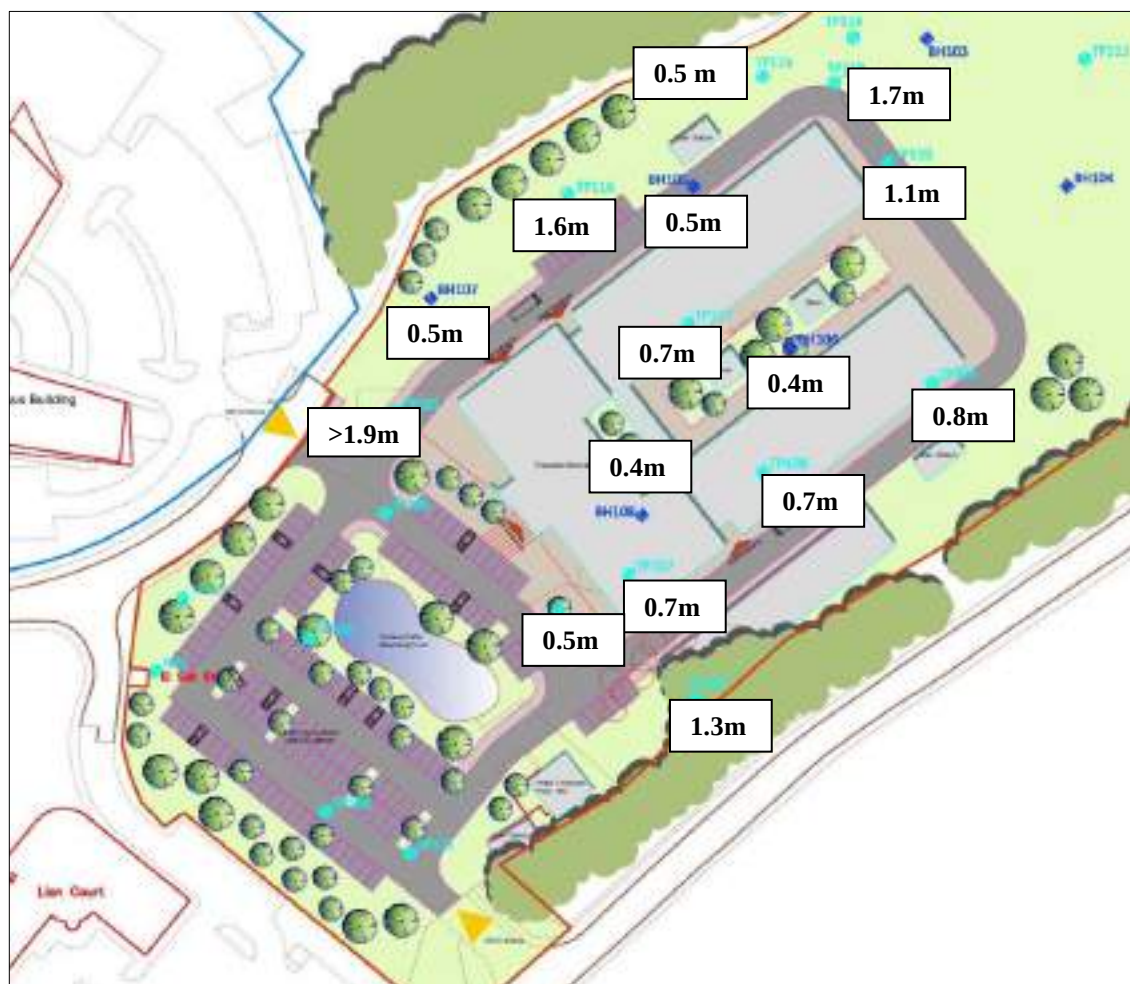
**Figure 10: Depth to Rockhead in Vicinity of Buildings**

12.2.1 In the vicinity of the proposed buildings the depth to rockhead is generally in the region of 0.4 to 0.8m. However the depth is locally higher in the north east (TP119) and in the west (TP101). This is indicated in Figure 10 below.

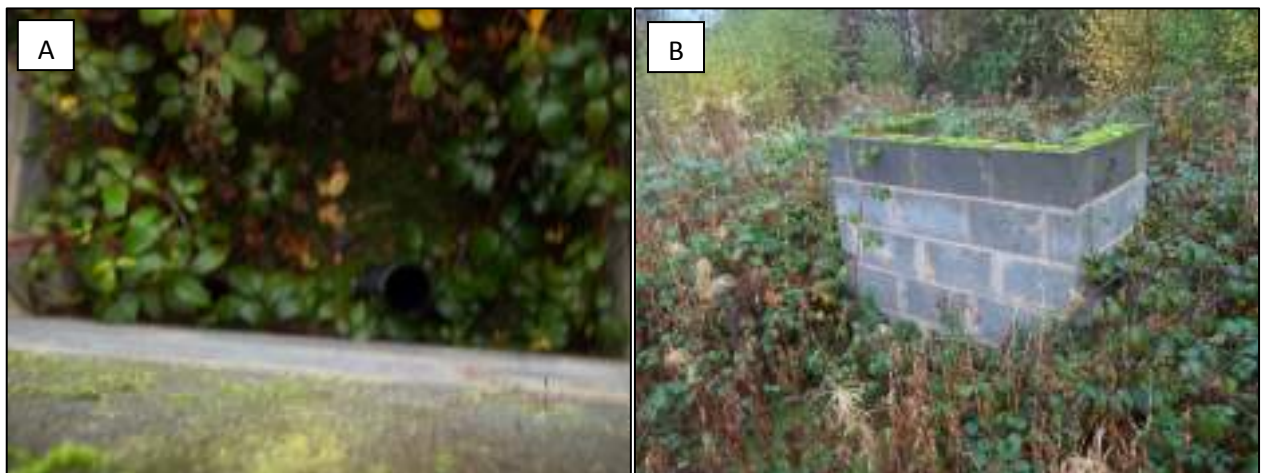
**Photograph 11: View of brick structure surrounding a pipe adjacent to the north western site boundary in the west of the site.**

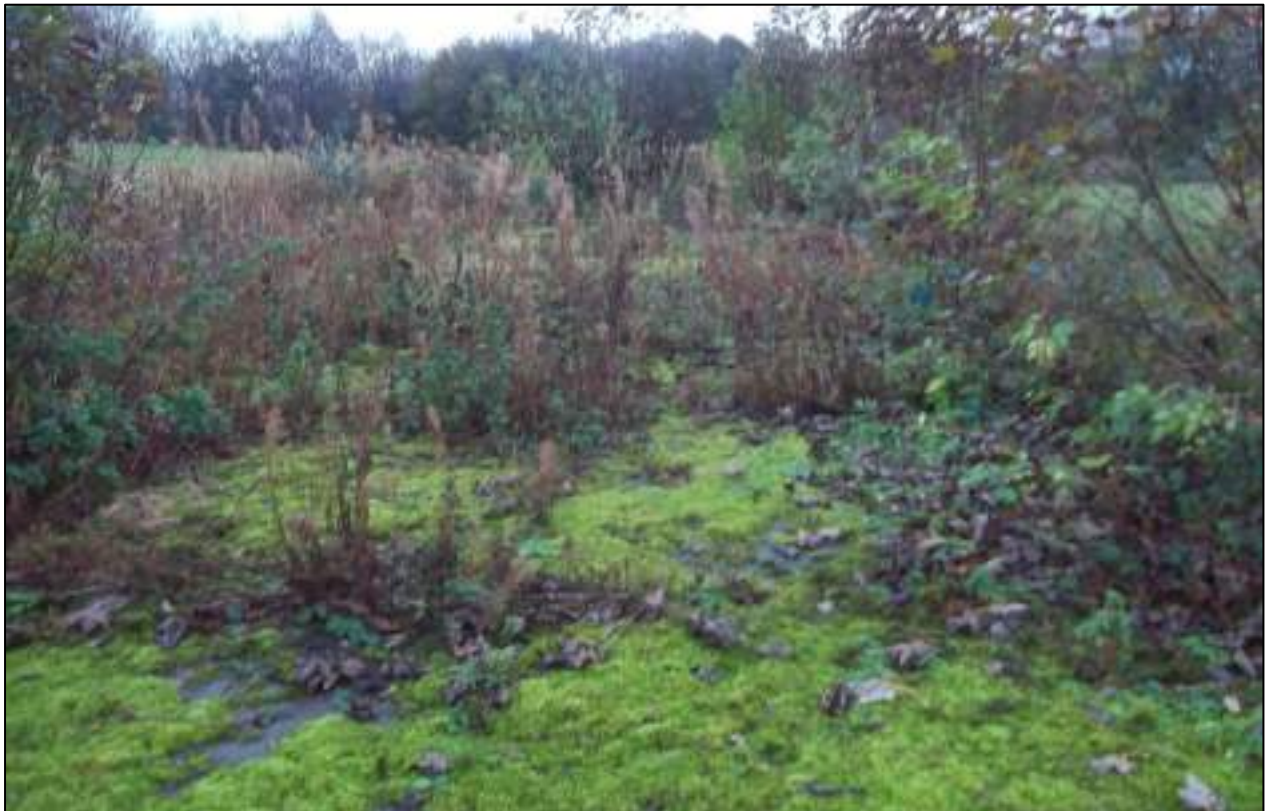
**Photograph 21: View of a concrete floor foundation from a former building in the north east of site.**

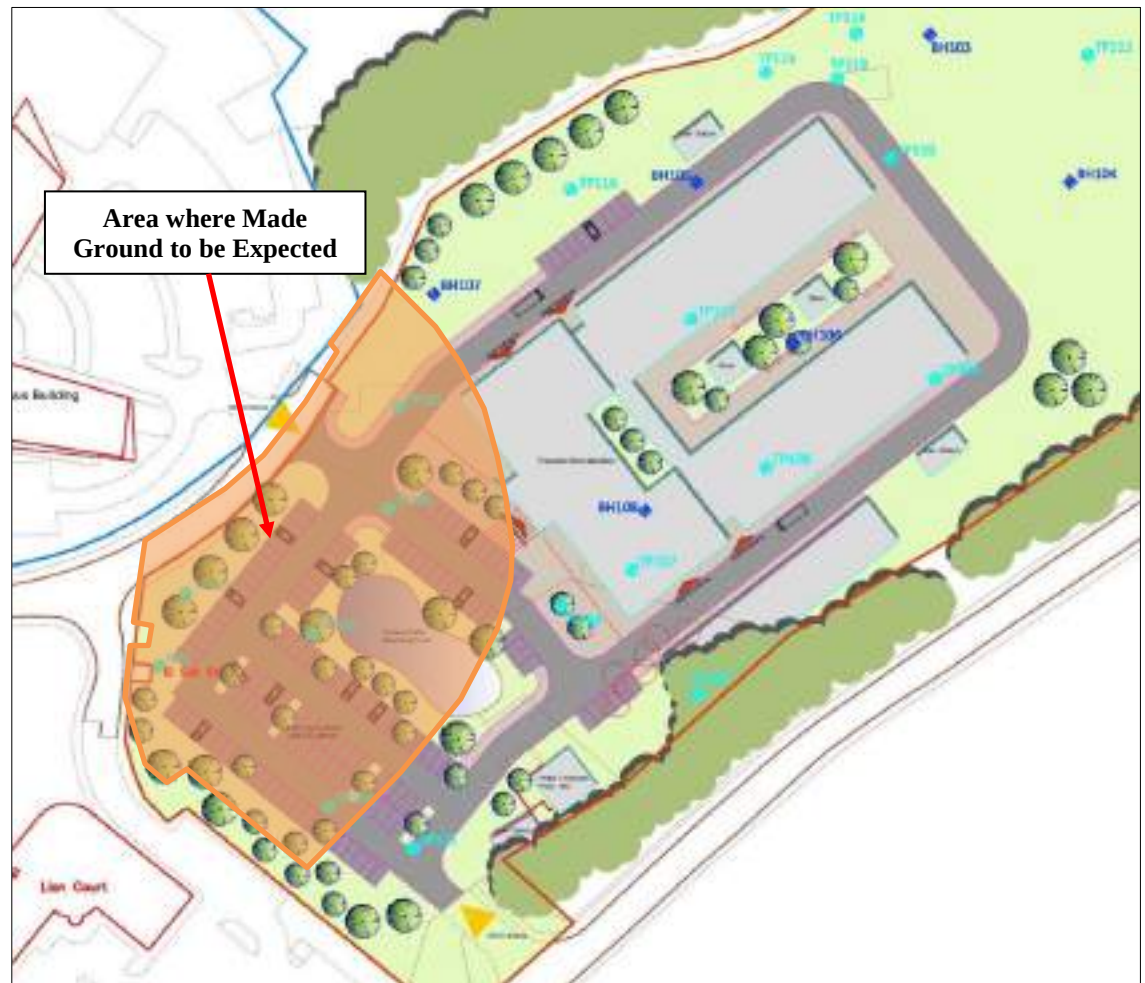
**Figure 7: Likely Presence of Made Ground and Hence Asbestos**

Finding asbestos at such concentrations is very common in Made Ground. Made Ground was only encountered in TP101 to TP105 (plus TP4, TP5, BH4, BH17 and BH18 by FWS) in the southwest of the site within the car park area with the single positive test for asbestos being in this area in TP101. It should be noted that the Made Ground in TP101 was the only location where demolition material was found. Therefore it can be concluded that there is only a risk from asbestos where there is demolition material in the Made Ground. This demolition material could be located locally anywhere within the Made Ground which is likely to be found in the area indicated in Figure 7 below.

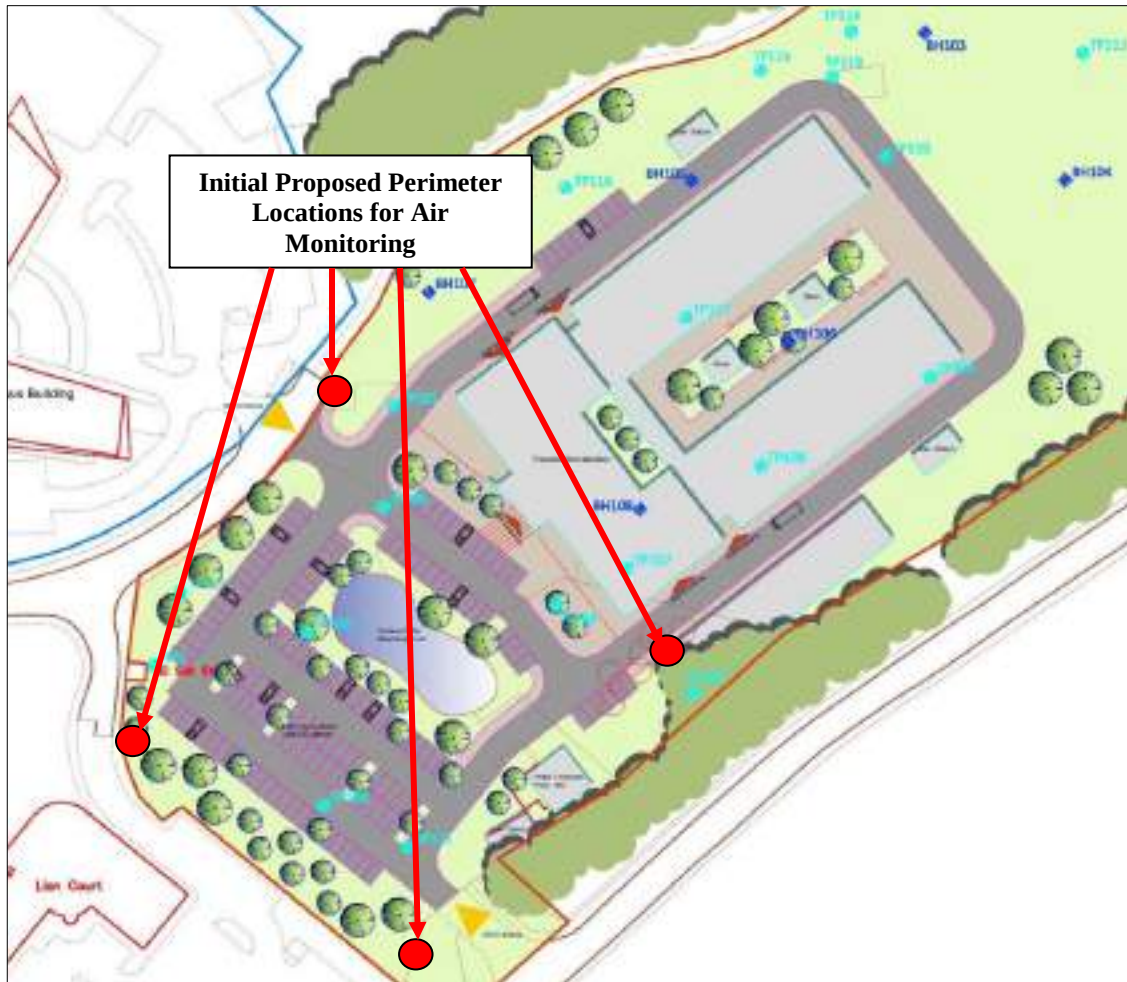
**Initial Proposed Perimeter Locations for Air Monitoring**

The initial proposed perimeter locations for air monitoring based on the usual prevailing wind conditions is shown on the following figure:
