**COMPLETION REPORT**  
**for**  
**REMEDIATION & SITE PREPARATORY WORKS**  
**at land off**  
**ST KEVIN'S DRIVE, KIRKBY**

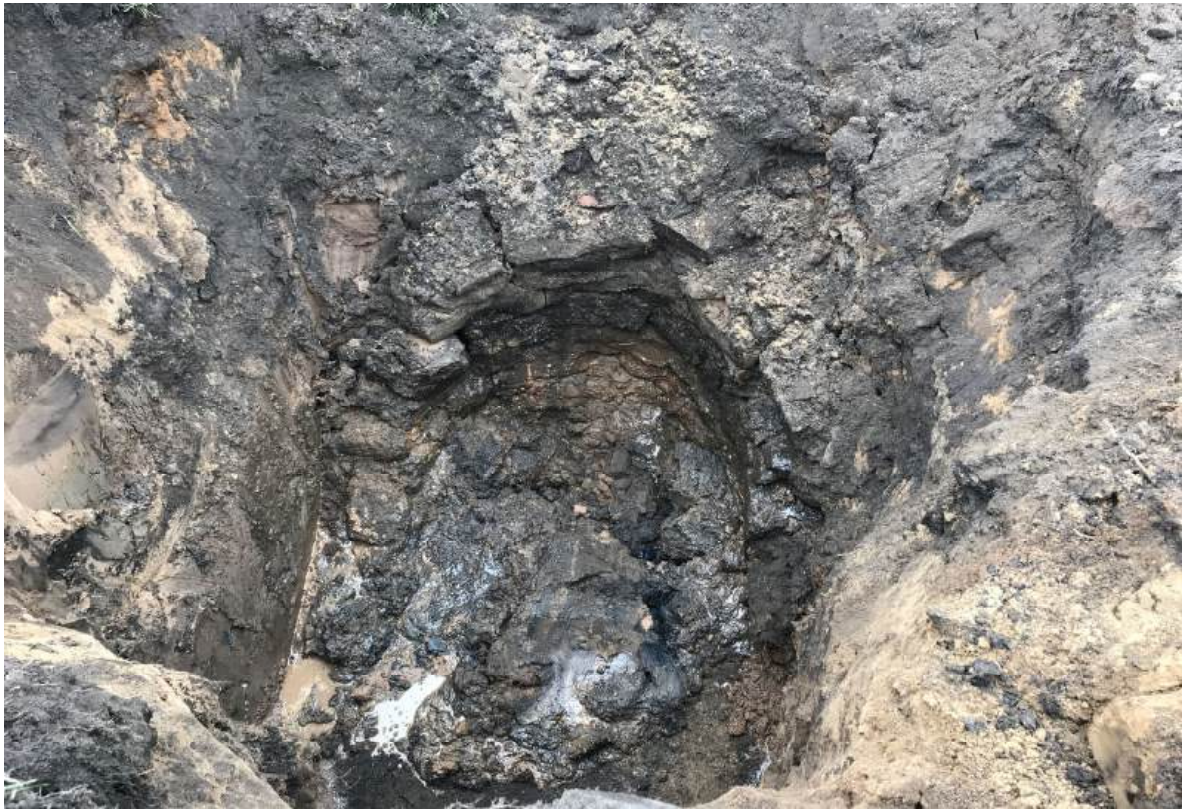
PLATE 7: Well feature showing curved stonework of the former well.

- 3.2.5 Ground conditions comprised approximately 300mm of topsoil overlying fine to medium sand, with occasional cobble of brick suggesting these strata were made ground. At a depth of approximately 1.2m large sandstone cobbles were included in arisings from the excavation, which upon more careful excavation were revealed to be part of a circular feature approximately 1.0m diameter (PLATE 7 in Appendix B).

- 3.2.6 Continued excavation recorded the absence of the structure below a depth of approximately 2.2m and groundwater seepage into the excavation at this depth. Soils at the base of the well were noted to be slightly organic, however, no visual or olfactory evidence of contamination was recorded.

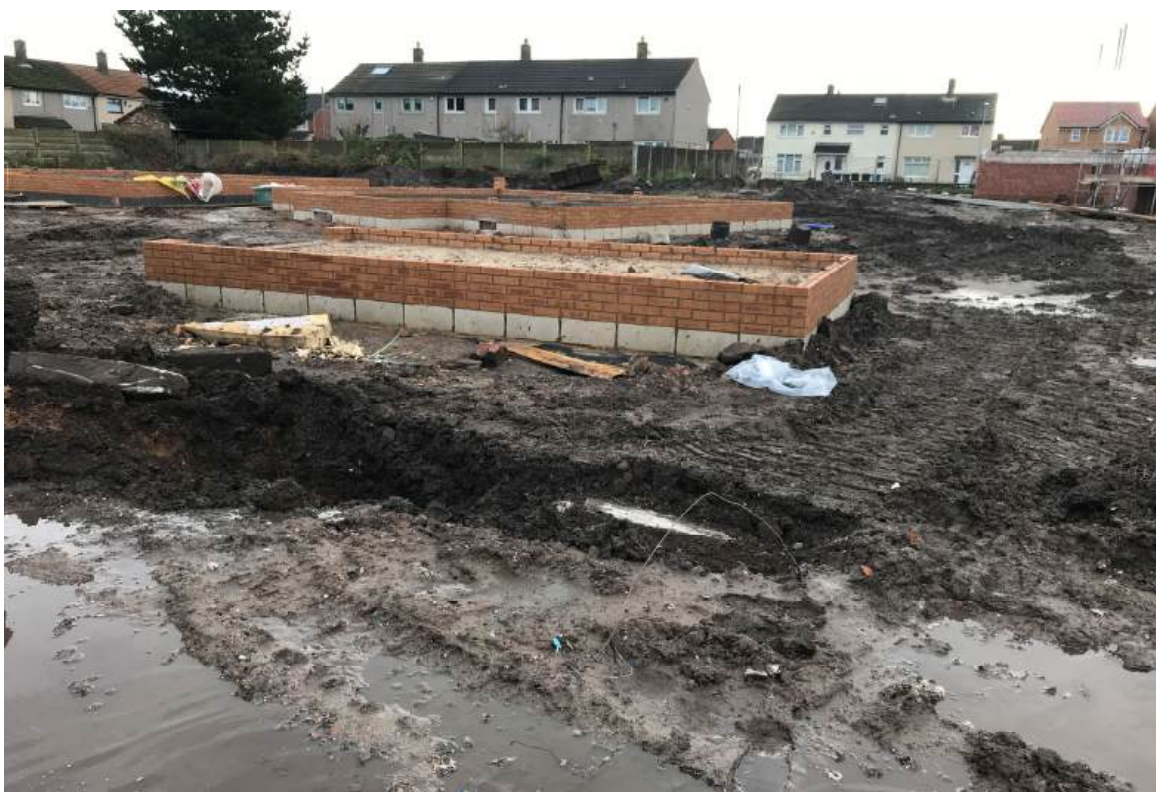
PLATE 12: Exposed surface at location of former Electricity Sub Station (near Plot 83).

- 3.3.1 The former electricity sub station covered an area of approximately 5m x 3m (15m<sup>2</sup>) at the southeast corner of the former Northfield School, as shown on Drawing No.30158-2 in Appendix A.
- 3.3.2 Translation of the position of the former sub-station onto the 'Proposed Site Layout' (MCK Associates Ltd Drawing No.16-075-0003\_Rev\_M, see Appendix A) places the sub-station immediately to the west of a garage structure to the northwest of Plot No.83.
- 3.3.3 The sub station building was demolished to slab level by mid-2020. The concrete floor slab was broken up and excavated shortly after.
