**Combined Stage 1-2 Road Safety Audit**

**Knowsley Business Park**

**Proposed S278 Highway Works**

**Date:** 15/05/2025

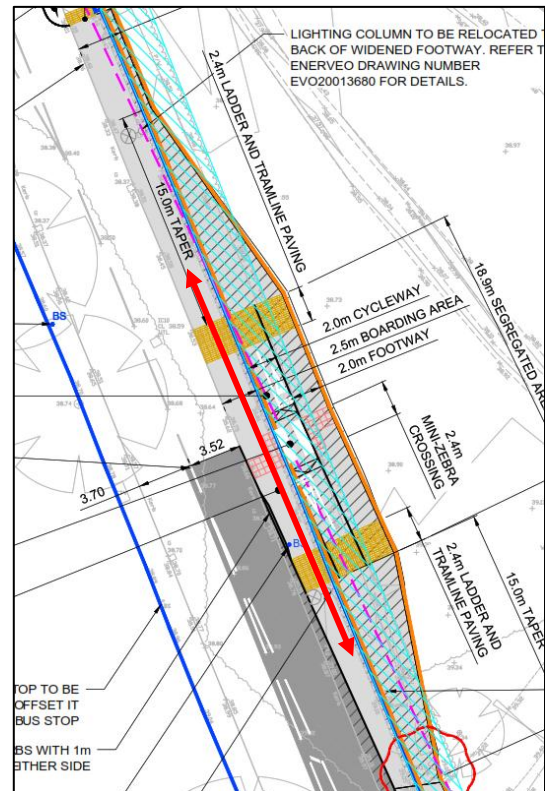
Location: Southbound bus stop

Summary: Potential conflicts between cyclists and users at the bus stop

At the bus boarder by-pass, due to the route either side of the bus boarder being shared and there being no difference in surfacing colour for the cycle section, cyclists are likely to take the direct route following the kerb edge instead of using the short section of segregated route behind the waiting area, particularly if the bus stop is not well used.

It is recommended that if a bus boarder bypass is required, the cycle lane section should be of a contrasting colour to the footway and waiting area, and cycle symbols added to guide cyclists to follow the route behind the bus stop.

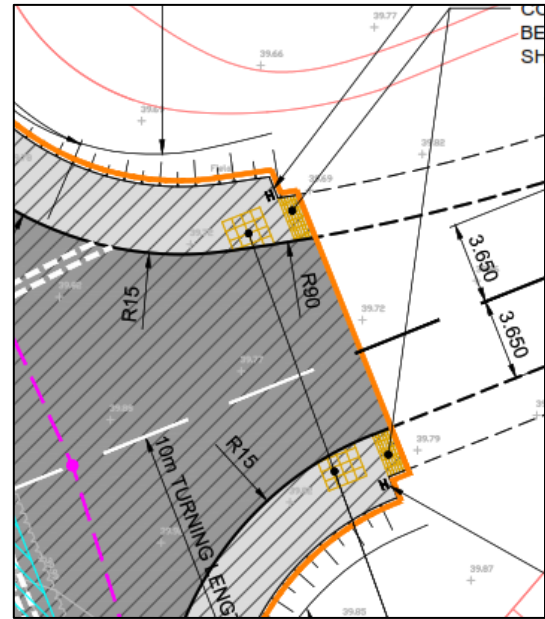
Location: Uncontrolled crossing across site access

Summary: Narrow crossing point potential conflicts between users leading to injury

The proposed width of 1.6m for the shared use crossing facilities at the access is narrower than the recommended latest design advice. Insufficient width to allow users to pass one another at the crossing may lead to pedestrian to cyclist or cyclists to cyclists collisions.

It is recommended that the width of the crossing point is increased to 3m.

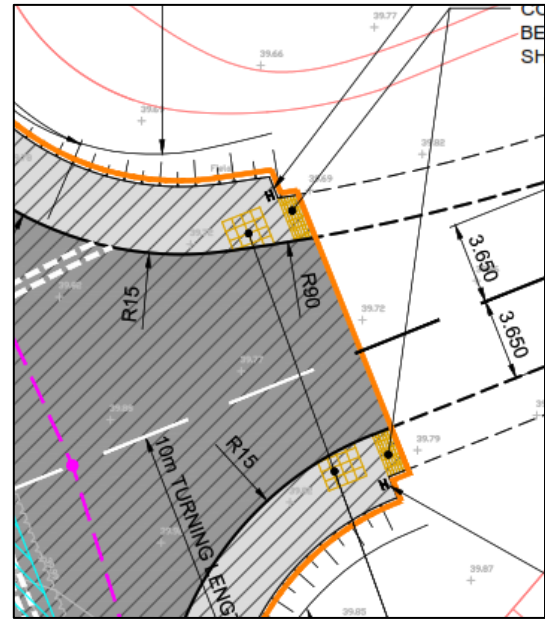
Location: Site access

Summary: Risk of cyclists being hit and injured by vehicles.

The shared footway/cycleway does not extend into the development with the facility starting/terminating at the junction.

Cyclists who rejoin the carriageway at the crossing point may be vulnerable to being hit by vehicles turning into the junction. In particular, by left turning vehicles whose drivers are likely to be concentrating on looking to the right towards vehicles turning off Ormskirk Road as they need to give way to them.

The start of the shared facility for cyclists travelling along the development access road towards Ormskirk Road may not be easily identifiable and they may end up missing the start of the facility and have to negotiate the junction instead with the potential of being hit and injured by passing vehicles.

It is recommended that the shared route on both sides of the development access road is extended further into the development away from the potential conflict with manoeuvring vehicles at the junction. Appropriately positioned lengths of dropped kerbs should be provided to allow cyclists to rejoin/leave the carriageway. The start/end of the route should be clearly identifiable. This may include the use of cycle markings (cycle logos, give way lines and arrows). The cycle dismount sign should be replaced with 'cyclists rejoin carriageway' as recommended in LTN 1/20.

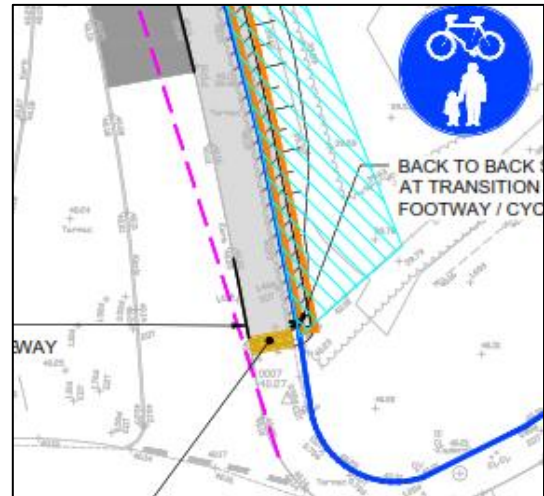
- Location: Southern termination of shared route
- Summary: Risk of cyclists being hit and injured by vehicles.

The width of the approach to the roundabout is a wide single lane and cyclists rejoining the carriageway at this location may be vulnerable to being struck by overtaking vehicles. Cyclists may also find it difficult to position themselves correctly at the roundabout in relation to which exit they are travelling to, particularly during peak periods or when vehicles are queuing back from the junction.

It is recommended that the end of the route is relocated further north to enable cyclists to position themselves in the correct position prior to the junction. It may also be appropriate to highlight to drivers that cyclists are returning to the carriageway by providing a short length of on-carriageway cycle lane markings.

The cycle dismount sign should be replaced with 'cyclists rejoin carriageway' as recommended in LTN 1/20.

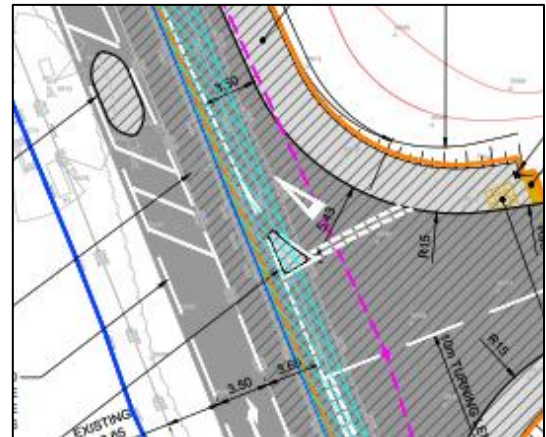
Location: Site Access

Summary: Drivers striking kerb lines of splitter island may lead to loss of control type collisions

The splitter island segregating the through lane and the auxiliary lane is located close to the edge of the running lane and is likely to be at risk of being hit by passing vehicles. This may lead to kerb strikes and tyre damage as a result, which may lead to tyre blow-outs and loss of control type collisions elsewhere on the highway network.

It is recommended that the splitter island should be setback a minimum of 1m from the edge of the running lane.

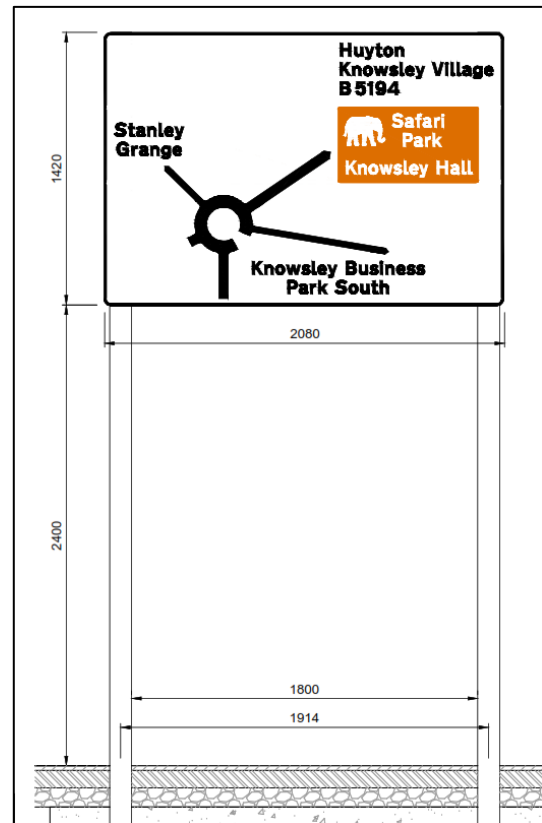
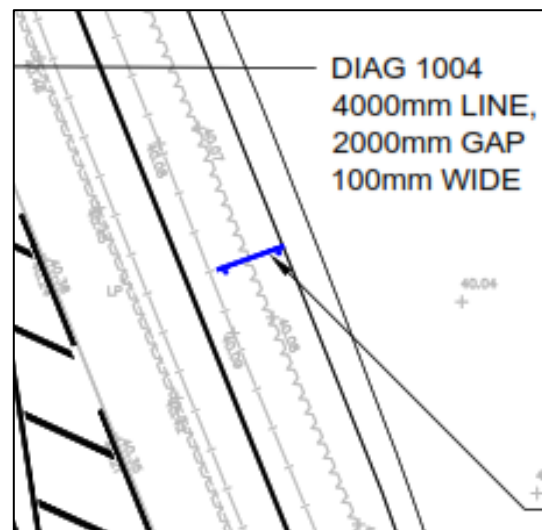
Location: Relocated directional sign

Summary: Sign posts - obstruction and a potential hazard for cyclists and pedestrians.

The spacing between the posts for the relocated directional sign will reduce the effective width of the shared use width and may pose as a hazard for users, particularly during hours of darkness.

It is recommended that the sign assembly is redesigned to prevent the sign posts obstructing the route. It is also recommended that reflective colour contrasting bands are added to the post if they are located within the route.

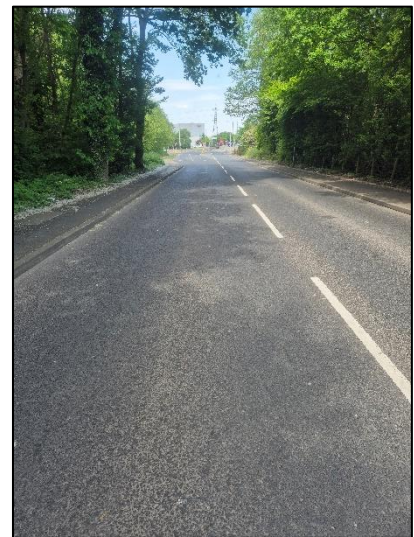
Location: Northbound approach to A580 traffic signal junction

The carriageway markings shown on the drawing for the development of the right turn lane at the traffic signal junction is different to that on site. It is recommended that the road markings on the drawing match those currently on site.

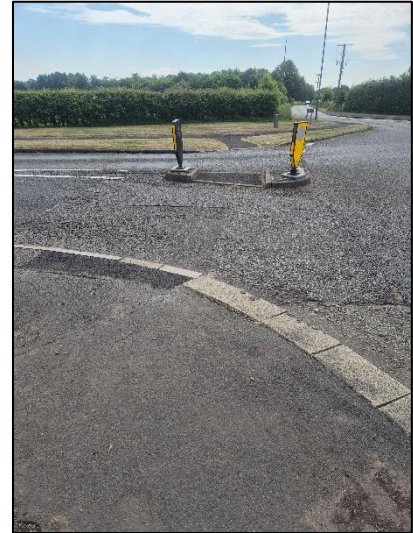
Location: Knowsley Lane/Ormskirk Road  
roundabout, Knowsley Road  
(E)

At the roundabout junction, there are no pedestrian dropped kerb crossing facilities on any of the arms of the roundabout. There is a single dropped kerb on Ormskirk Road (SE) and on Knowsley Lane (E) but there is no receiving dropped kerb. It is recommended that suitable dropped kerb pedestrian crossings are provided at the junction on likely pedestrian desire lines.

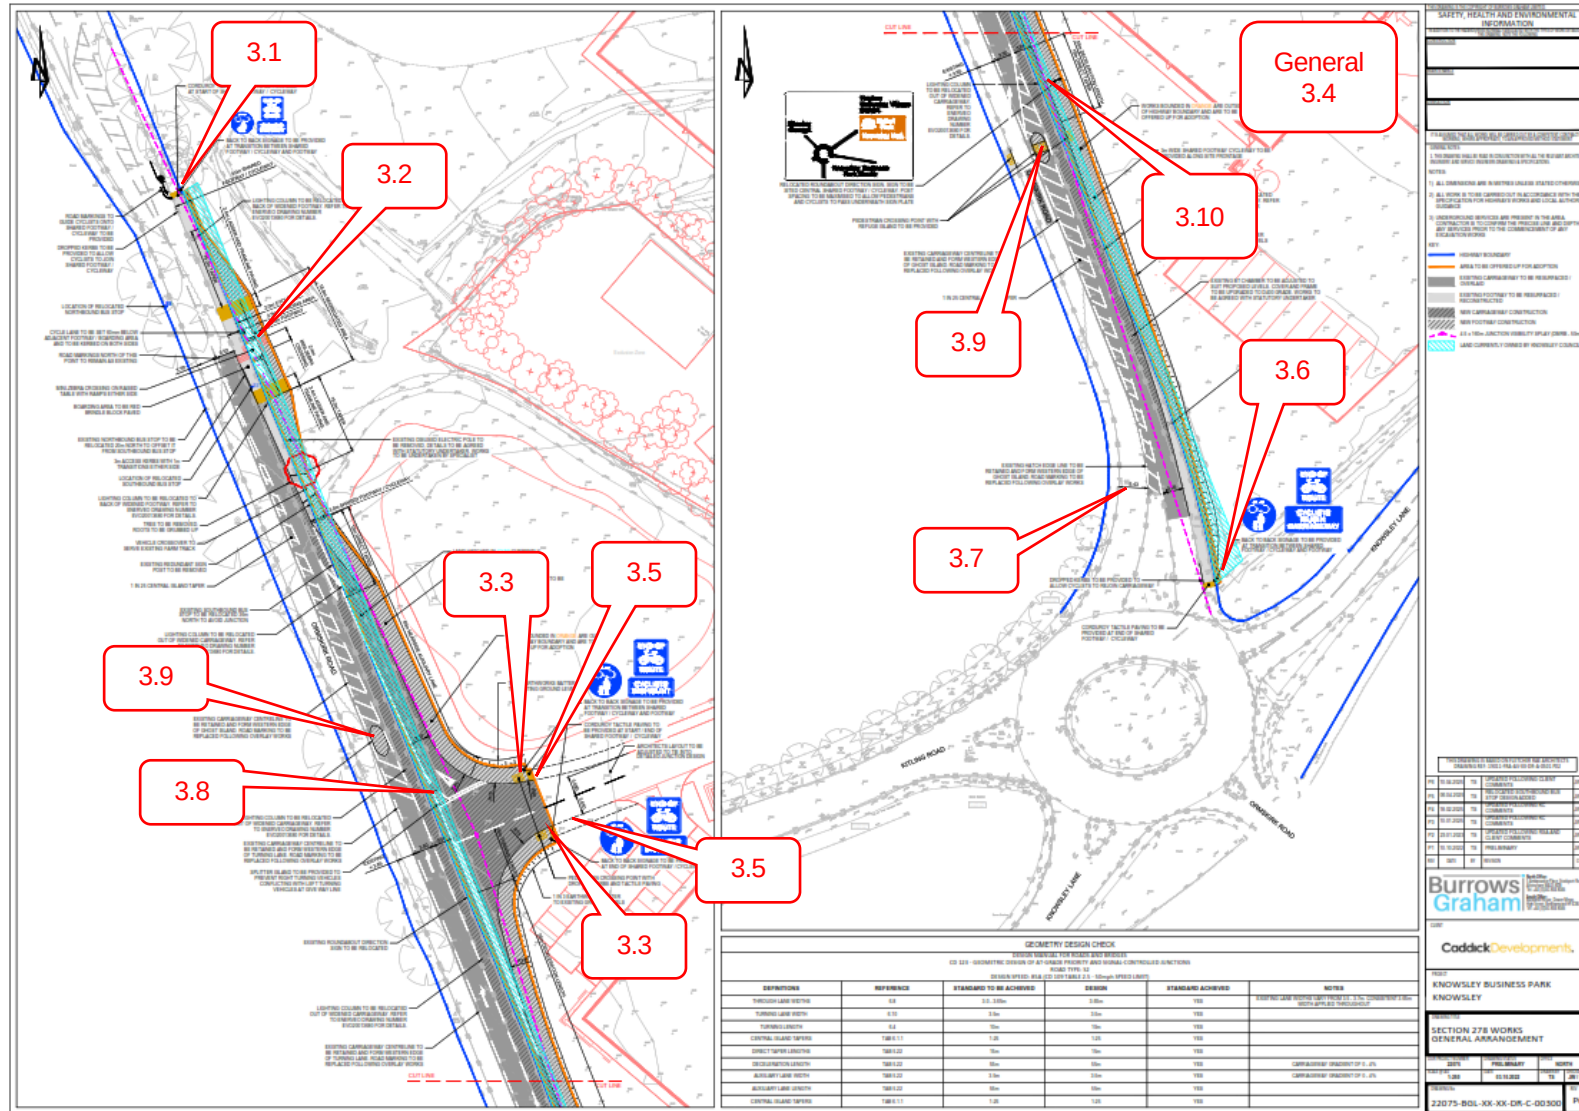
## APPENDIX B: Drawing Showing Proposed Scheme and Problem Locations

- 1.10. All comments and recommendations are referenced to the design drawing and the locations have been indicated on plans in Appendix B.
