# **PROPOSED PLAYING PITCH & ANCILLARY DEVELOPMENTS**

## **NEW HUTTE NEIGHBOURHOOD CENTRE HALEWOOD**

### **SUMMARY DOCUMENT PROPOSED LAYOUT**

**OCTOBER 2025**

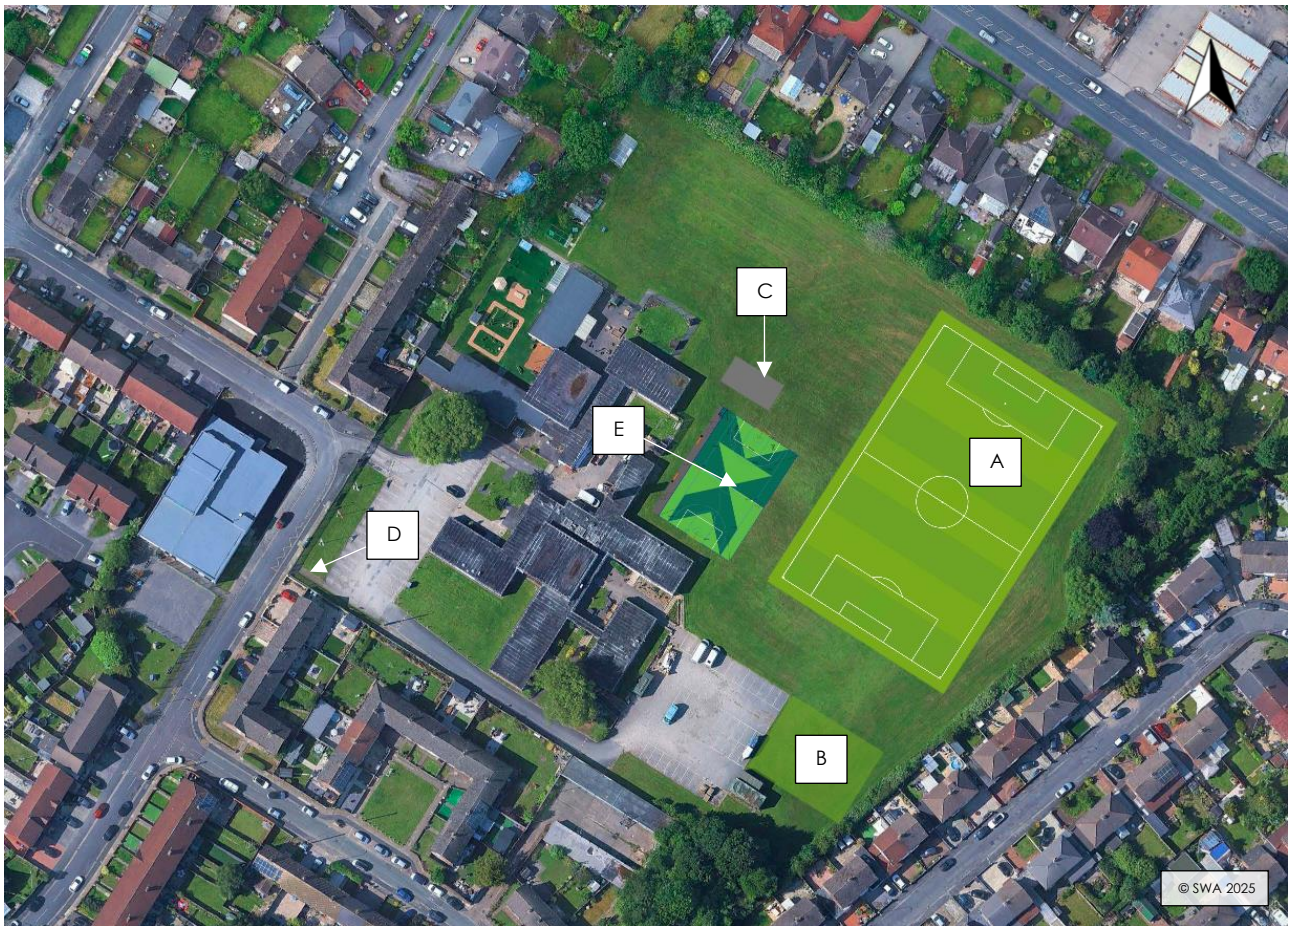
- A Proposed 9v9 grass playing pitch
- B Proposed overflow car park area
- C Proposed modular WC block
- D Proposed new highway access (TBC by others)
- E Proposed Play Zone (by others)

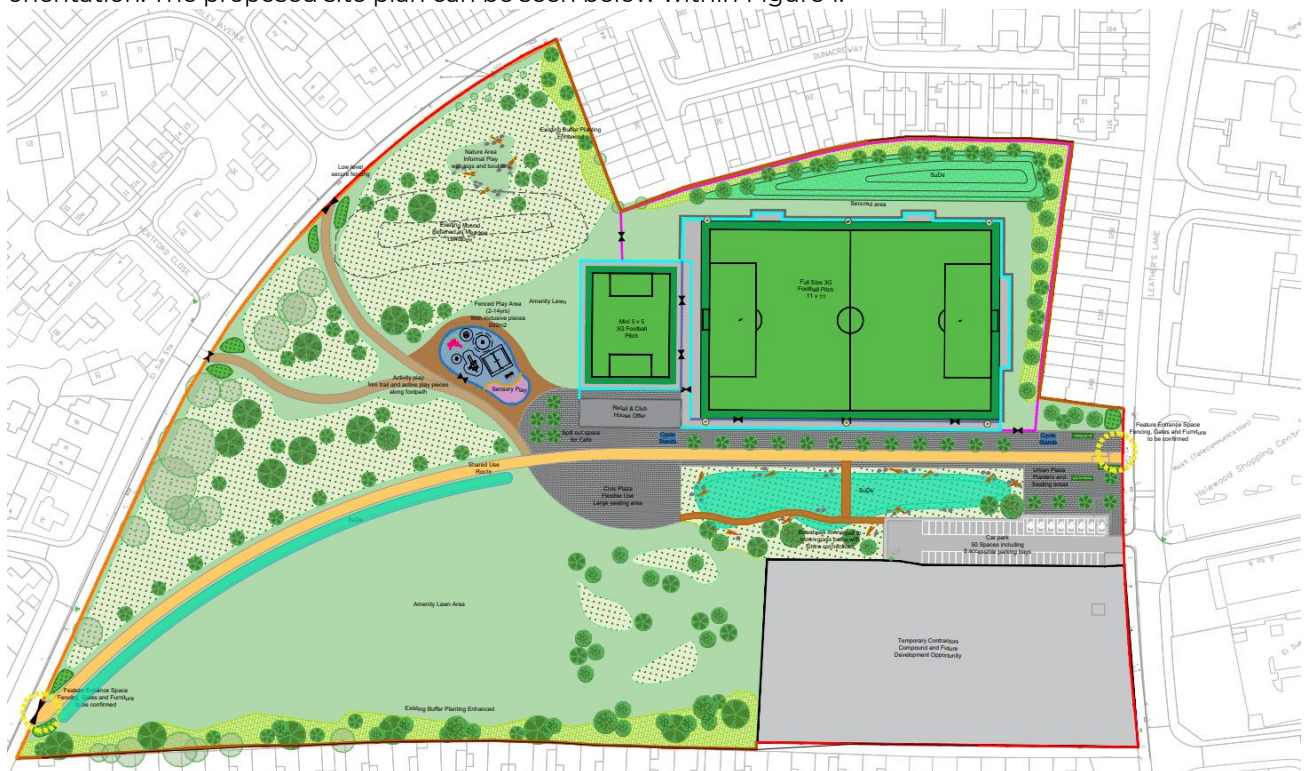
Figure 1 – Proposed site plan

The proposed development would involve the construction of one full size senior 3G artificial pitch and one mini 5v5 3G artificial pitch. Both pitches would be located towards the north of the current site with the senior 3G pitch proposed to be an east-west orientation whereas the smaller 5v5 3G pitch would be a north-south orientation. The proposed site plan can be seen below within Figure 1.

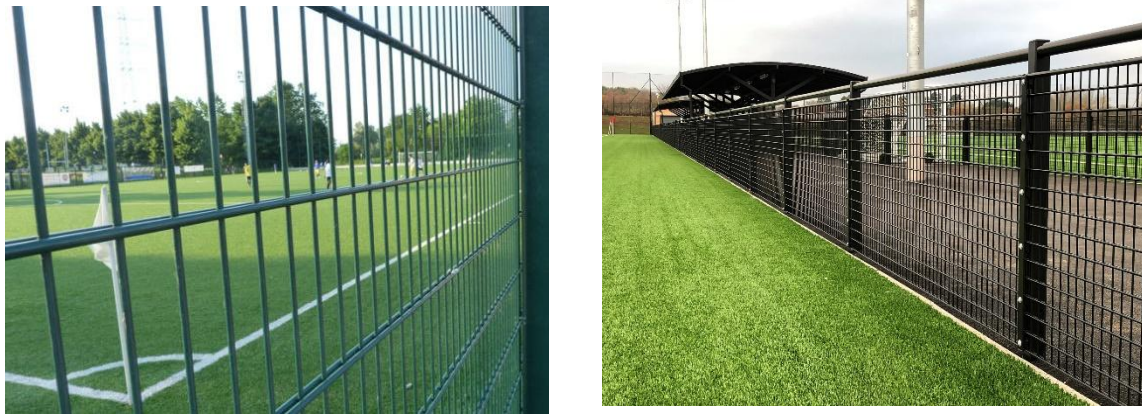
powder coated, typically dark green or black. The mesh used is 50 mm x 200 mm, with the lower 1.2 m consisting of super rebound panels which are 50 mm x 66 mm. Twin horizontal 8 mm thick wires are combined with single 6 mm gauge steel for the vertical wires.

It is common for RMMs to consist of 0.2 m to 0.5 m high barriers at the base of the fence line to prevent infill splash into the wider environment.

**Figures 6 & 7- Left; 50 x 200 mm mesh fence panel in dark green. Right; 1.2 m high spectator handrail fence with super rebound mesh (50 x 66 mm).**

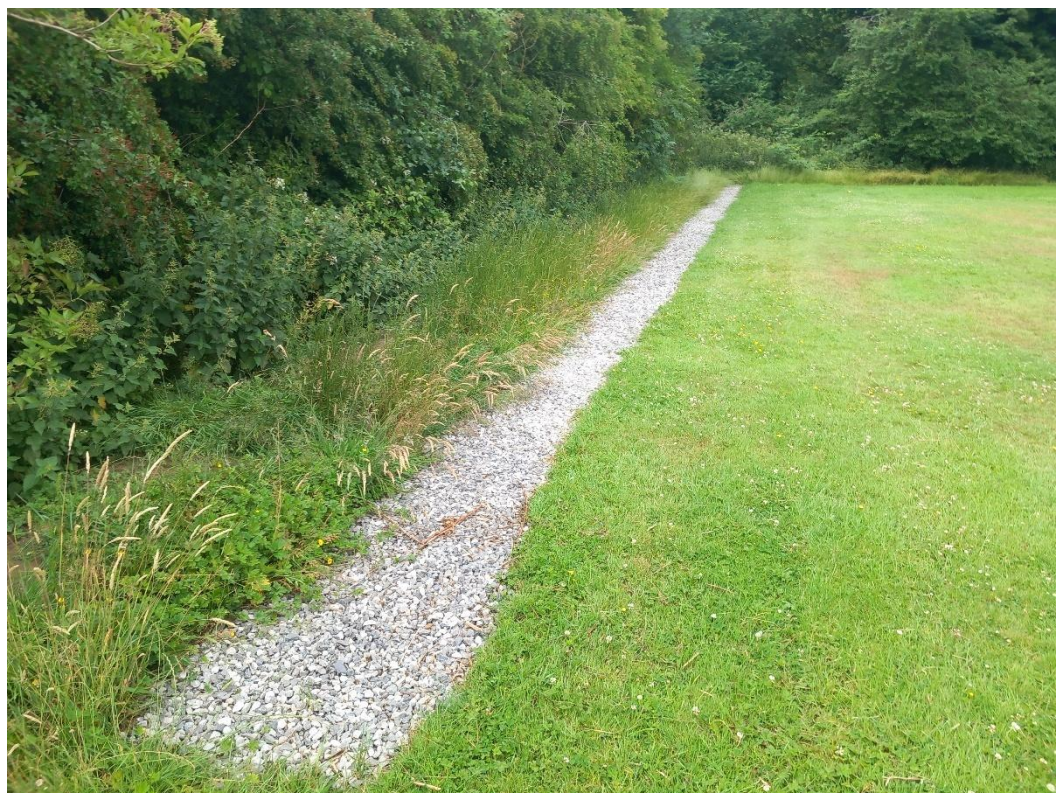
A 'French drain' was observed within the south of the playing field area located in the corner and measured approximately 10 – 15 metres running adjacent to the eastern boundary. This drain appeared to be backfilled with a large MOT aggregate material however it is unknown if any pipe work is underneath the aggregate material.

Photo 2: French drain

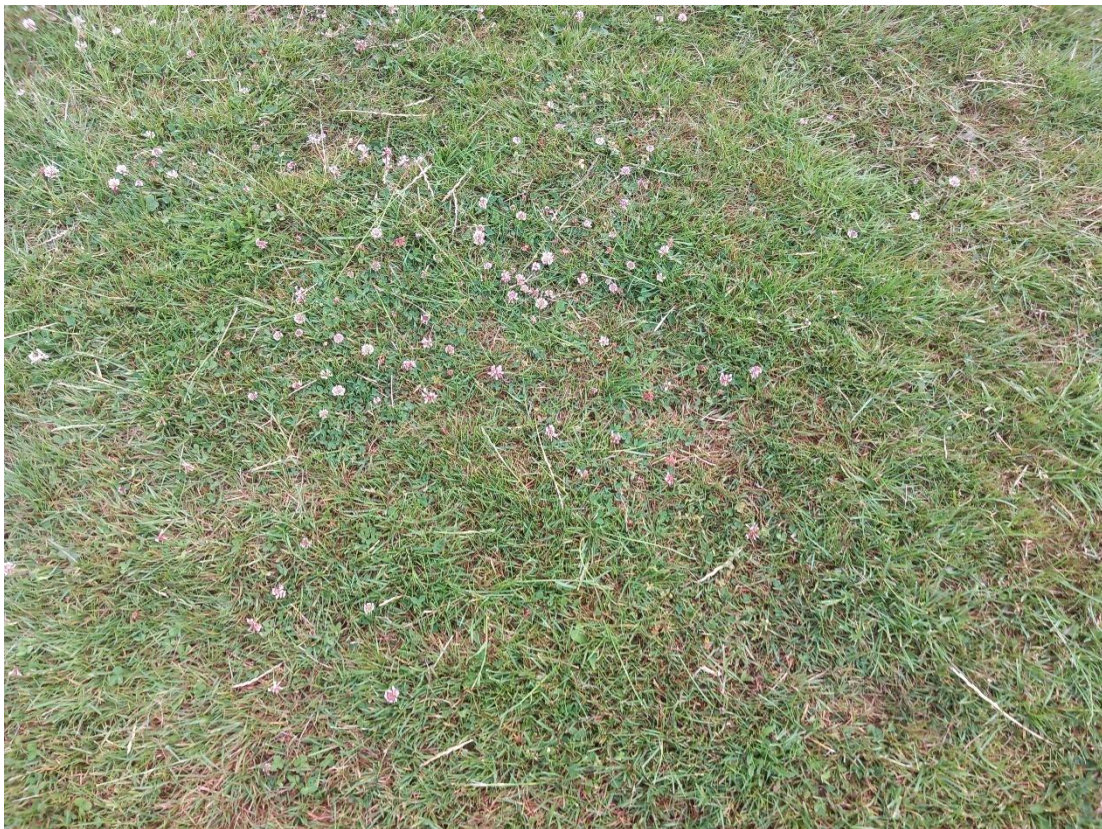
| General: | Existing vegetation was noted to be mown playing field area with a variety of broadleaf weeds observed such as clover ( <i>Trifolium</i> ), Daisy ( <i>Bellis perennis</i> ) and Yorkshire fog ( <i>Holcus lanatus</i> ). Grass height was recorded to be approximately 40 mm and appears that the playing field area is regularly mown with no excess grass clippings observed. |

Photo 4: Broadleaf weed cover

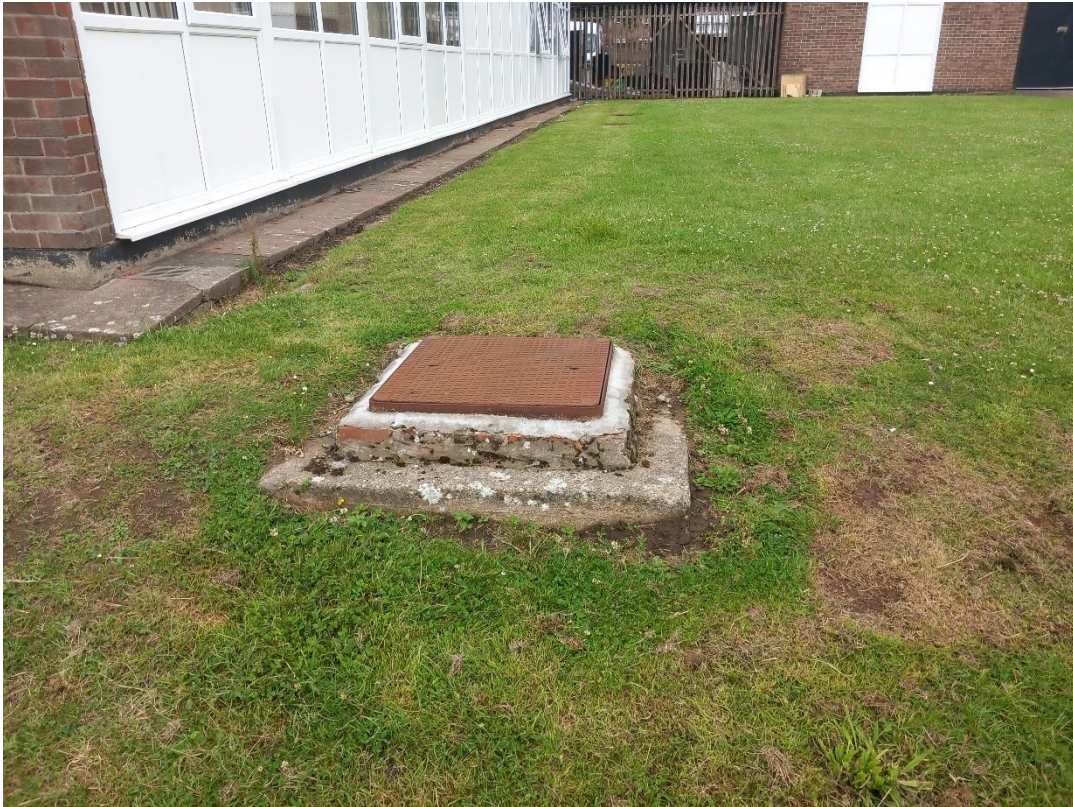
Photo 5: Drainage manhole

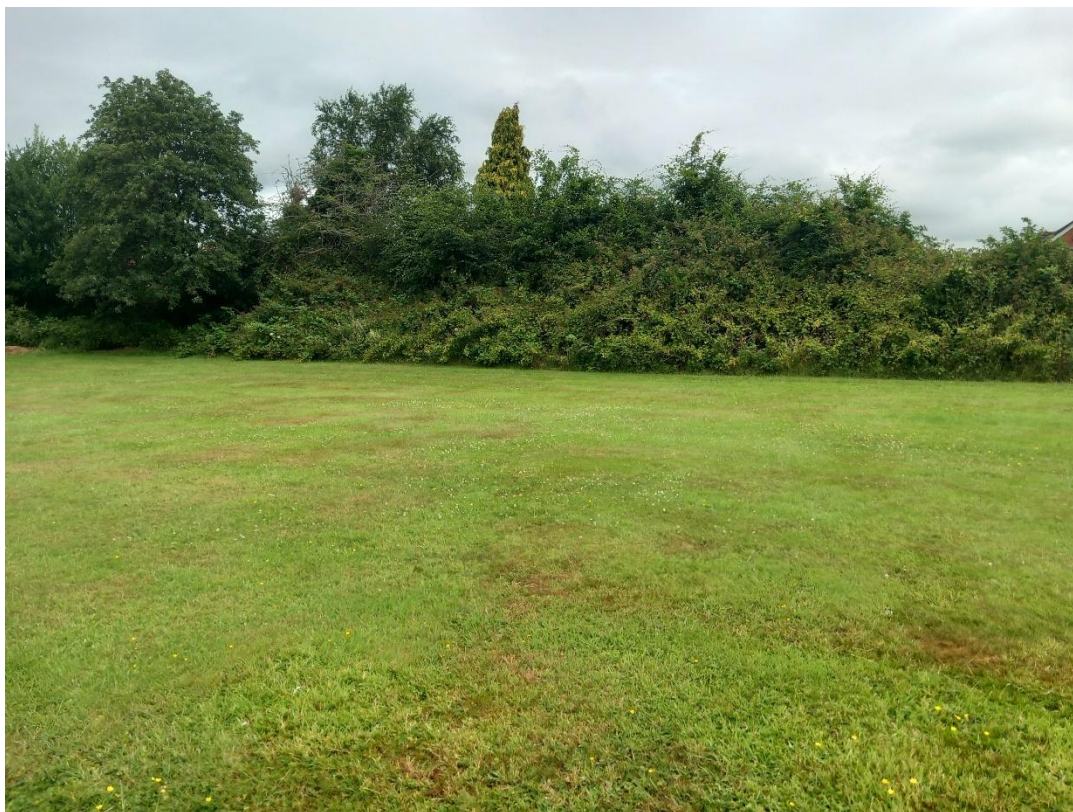
Photo 6: Overgrown vegetation at the lowest part of the site

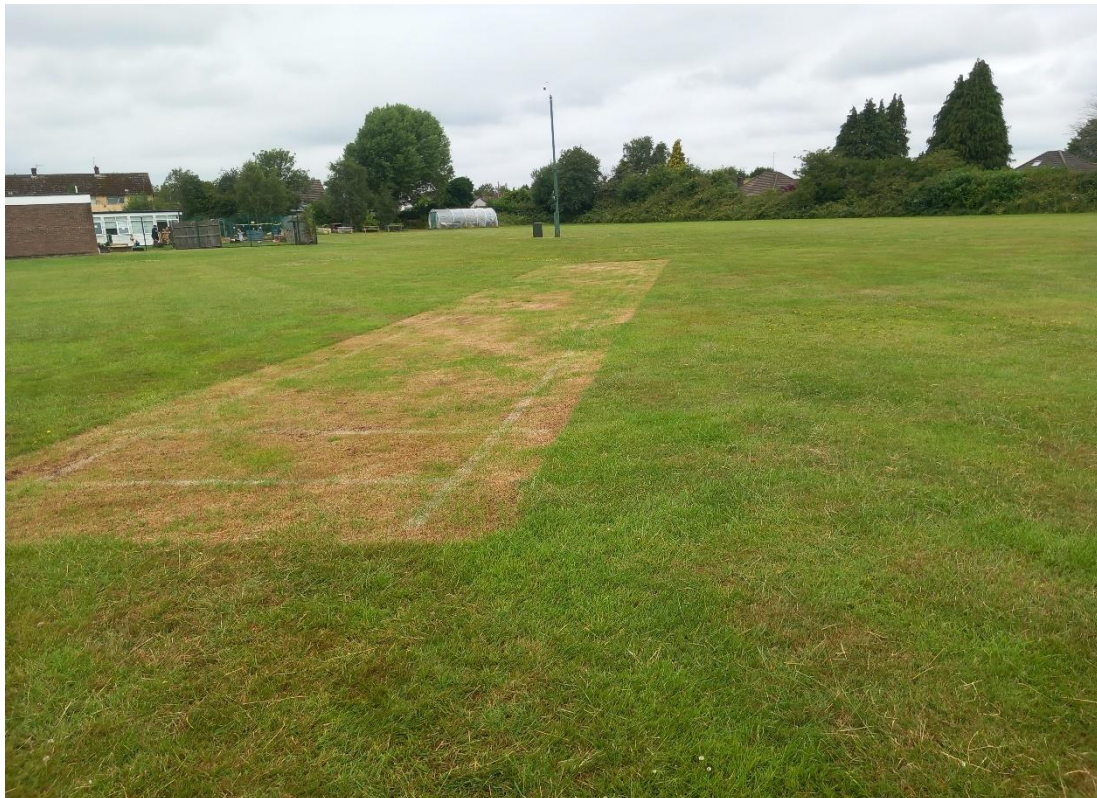
Photo 7: Mown out Cricket wicket
