Phase I and Phase II  
Geoenvironmental Site Assessment

Draw Well Road

Draw well Road  
Knowsley  
Liverpool  
L33 7BJ

**Report Ref: 12-969-r1-1**

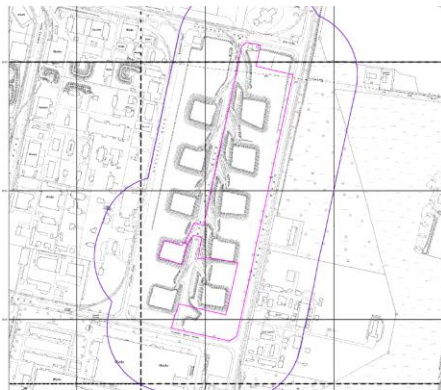
| MAP EDITION | HISTORICAL LAND USE | HISTORICAL MAP EXCERPT |
|---|---|---|
| <b>1960-1962</b><br><b>1:2,500</b> | <p>Site has changed significantly and shows similar structures to present day. Roads are now present around the site area. Ashcroft Road to the north, Acornfield Road to the east, Kirby Bank Road to the south and Draw Well Road have been constructed.</p> <p>Four rectangular bunkers align roughly north-south along Draw Well Road with associated hardstanding.</p> <p>Draw Well Road is a no through Road that can be accessed from Ashcroft Road to the north.</p> <p>Trees can also be seen to border the eastern boundary of the site.</p> | |

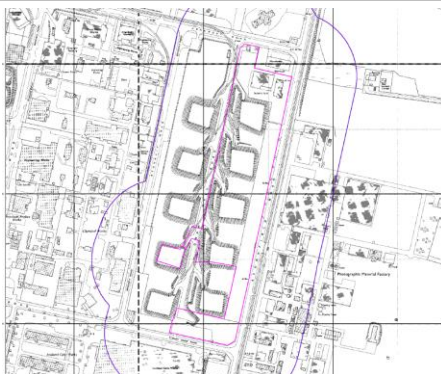
| MAP EDITION | HISTORICAL LAND USE | HISTORICAL MAP EXCERPT |
|---|---|---|
| <b>1972</b><br><b>1:2,500</b> | <p>Two buildings are located in the north east of the site with a 'Builders Yard' located immediately southwest of the two buildings. Two buildings have been constructed in the north east of the site with associated hardstanding.</p> | |

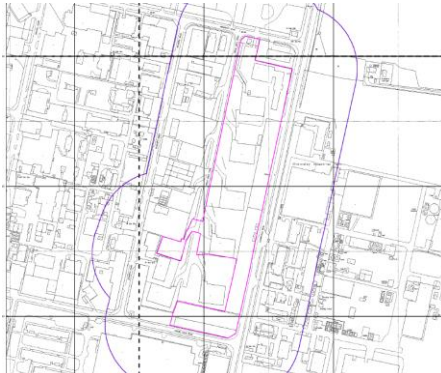
| MAP EDITION | HISTORICAL LAND USE | HISTORICAL MAP EXCERPT |
|---|---|---|
| <b>1993</b><br><b>1:2,500</b> | <p>Hardstanding ground is now present in the south of the site. The two buildings located in the north east of the site and the current office buildings have been constructed.</p> | |

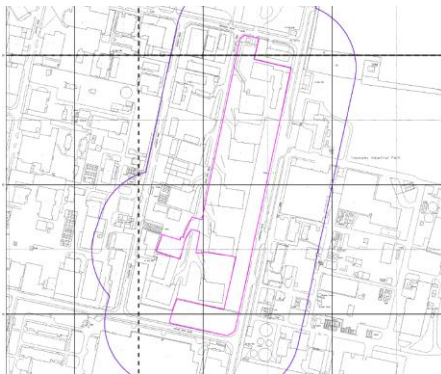
| MAP EDITION | HISTORICAL LAND USE | HISTORICAL MAP EXCERPT |
|---|---|---|
| <b>1994</b><br><b>1:2,500</b> | <p>There are no significant changes to subject site.</p> | |

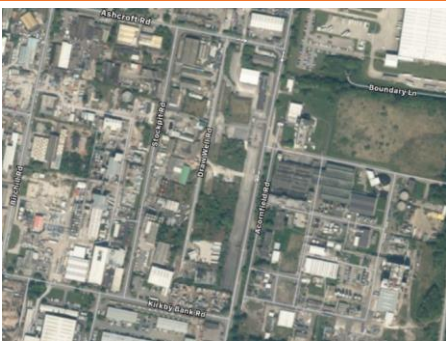
| MAP EDITION | HISTORICAL LAND USE | HISTORICAL MAP EXCERPT |
|---|---|---|
| <b>Google Earth<br/>2019</b> | There are no significant changes to subject site. | |

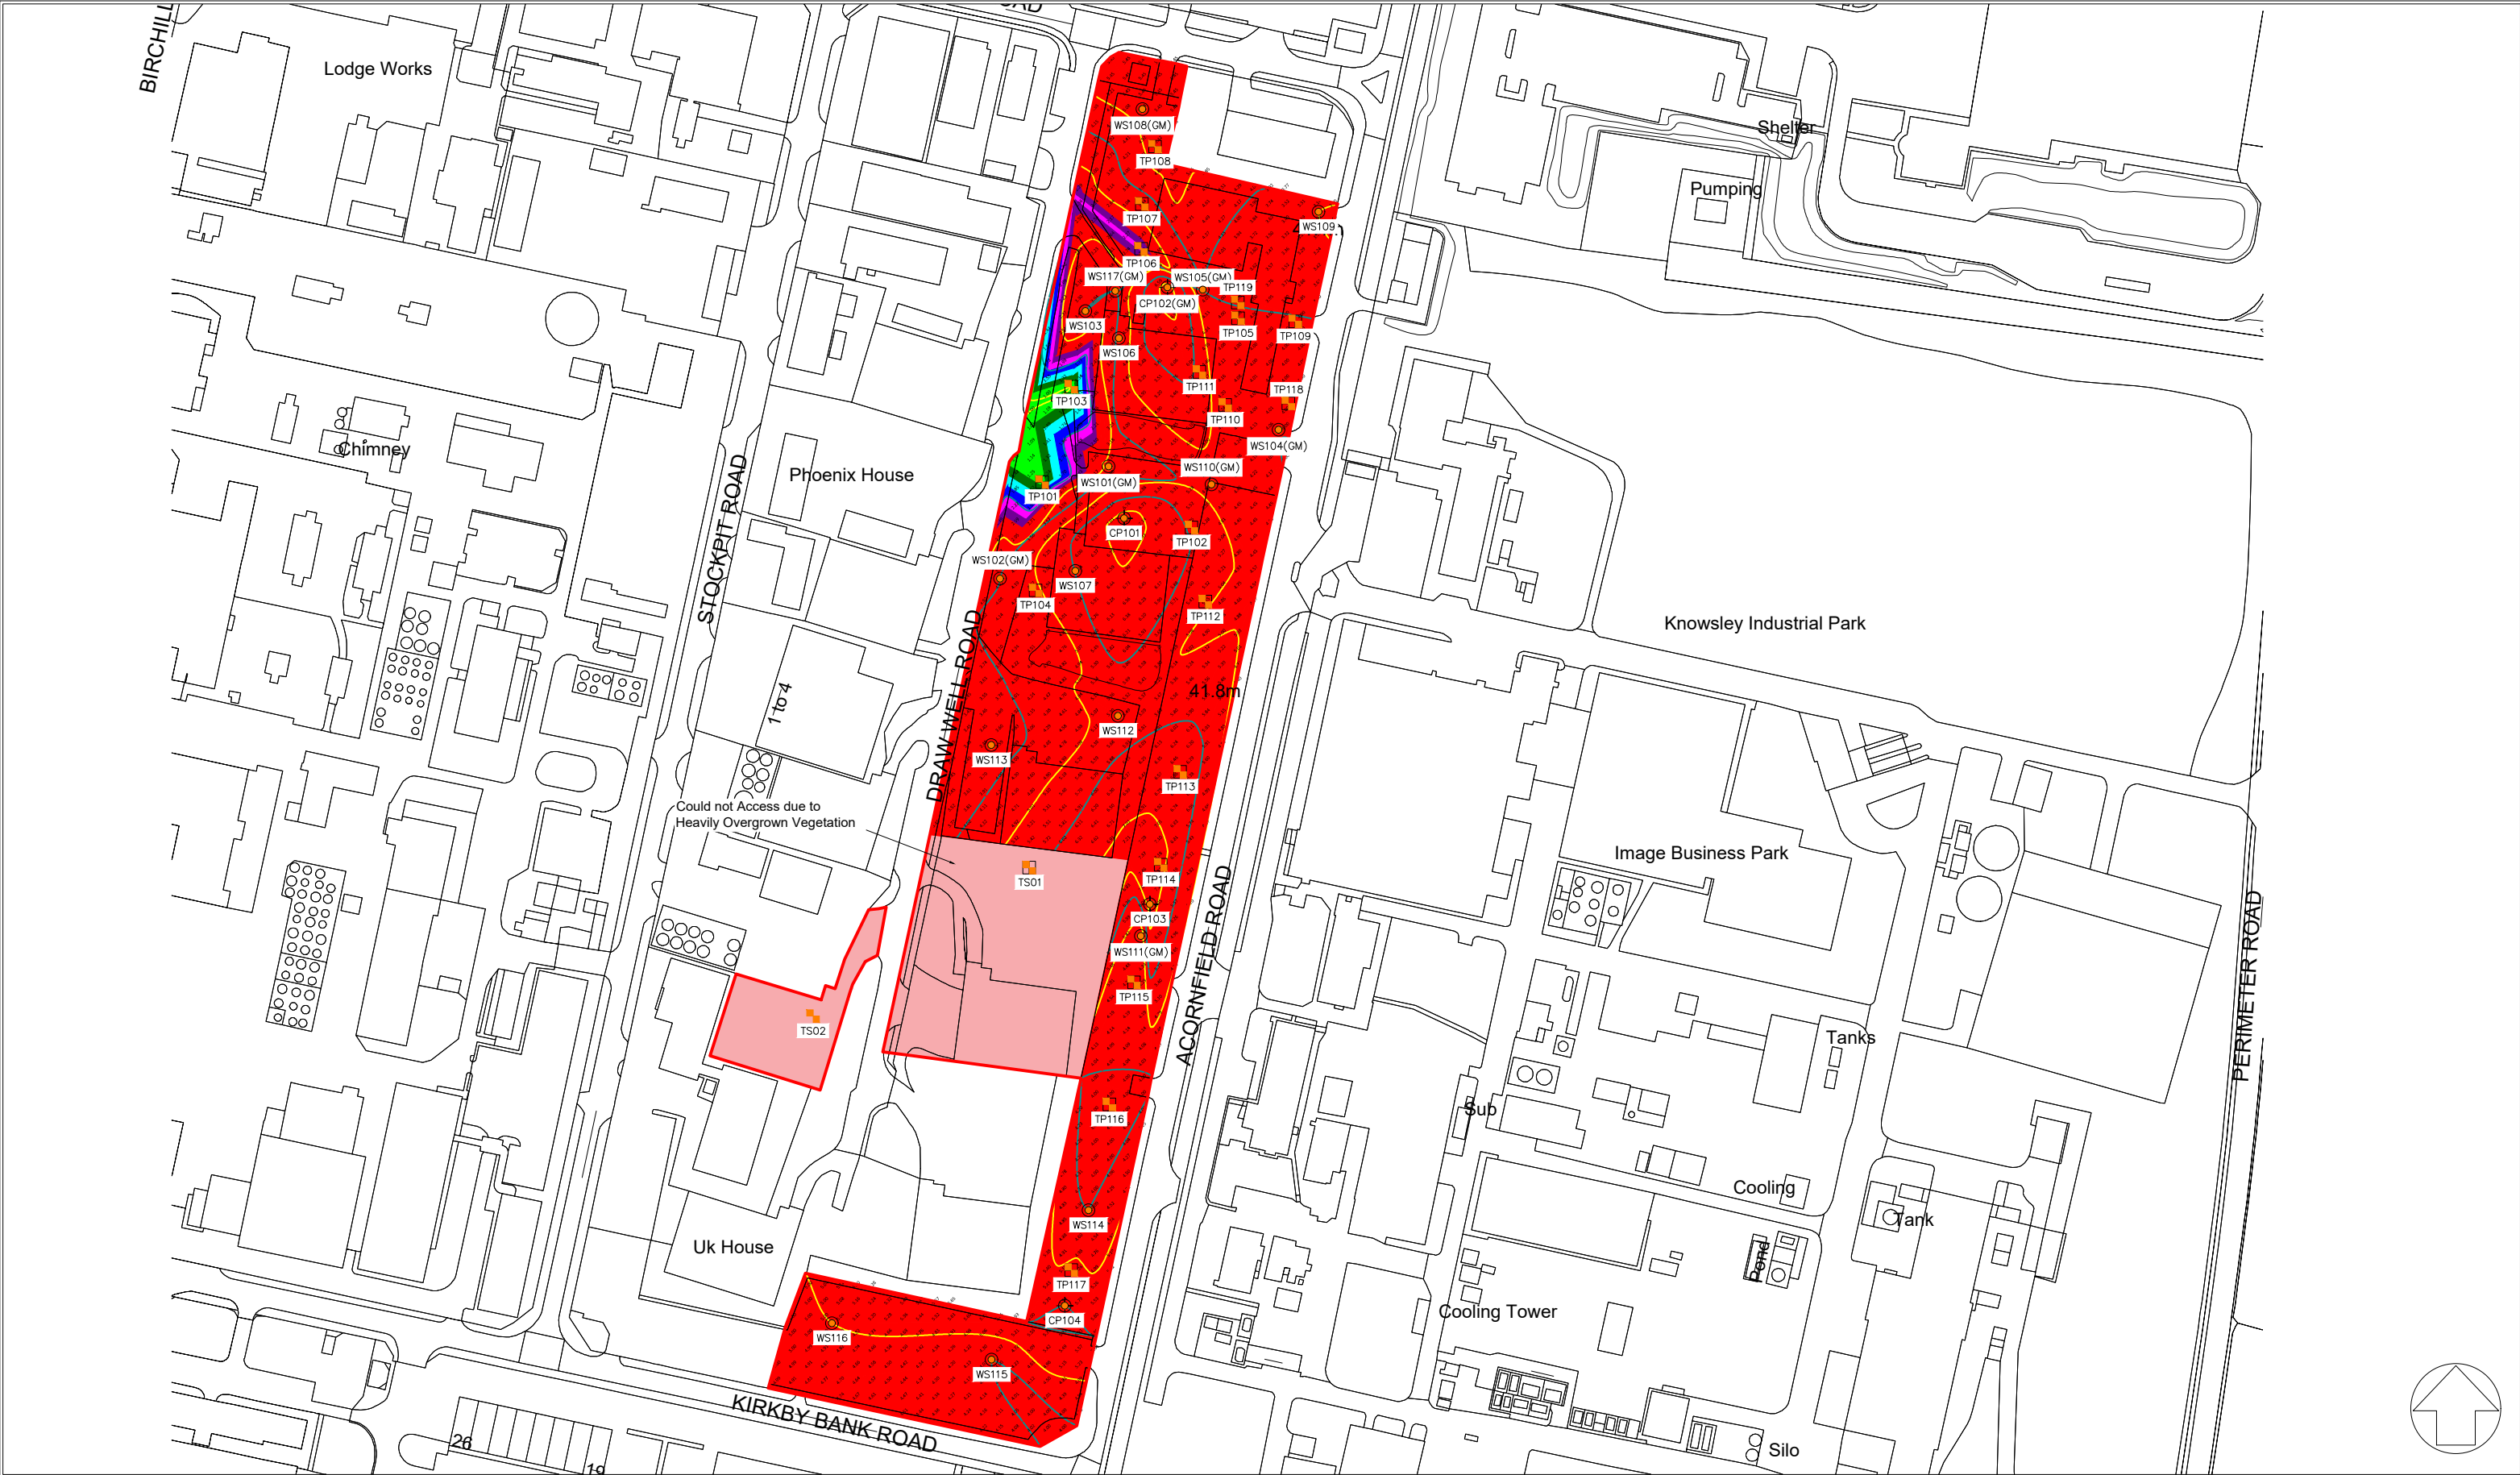
| Location Symbols | | Shallow Spread Footings | |
| | Approximate Window Sample Probehole Location | | Depth to Founding Strata 0.00 - 1.24m |

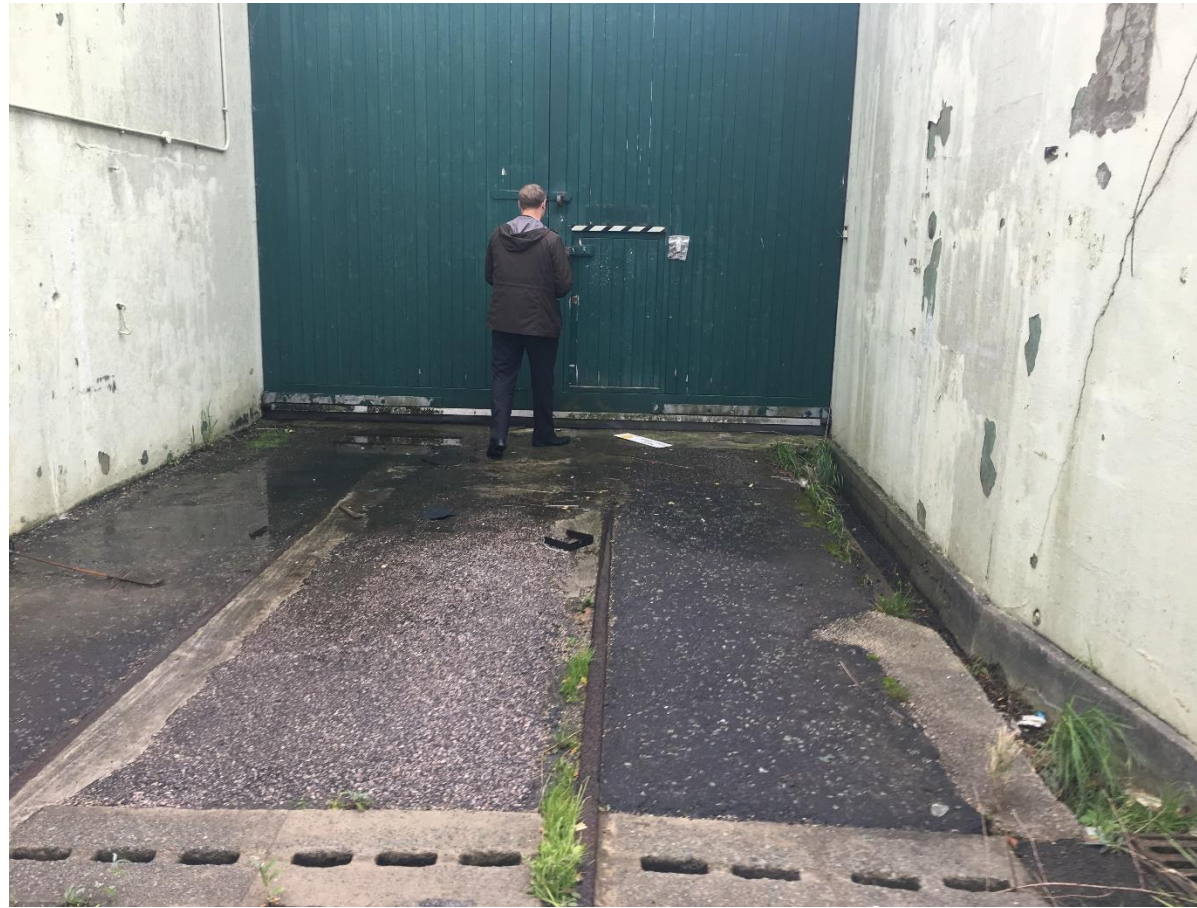
PLATE 6

BUNKER DOORS

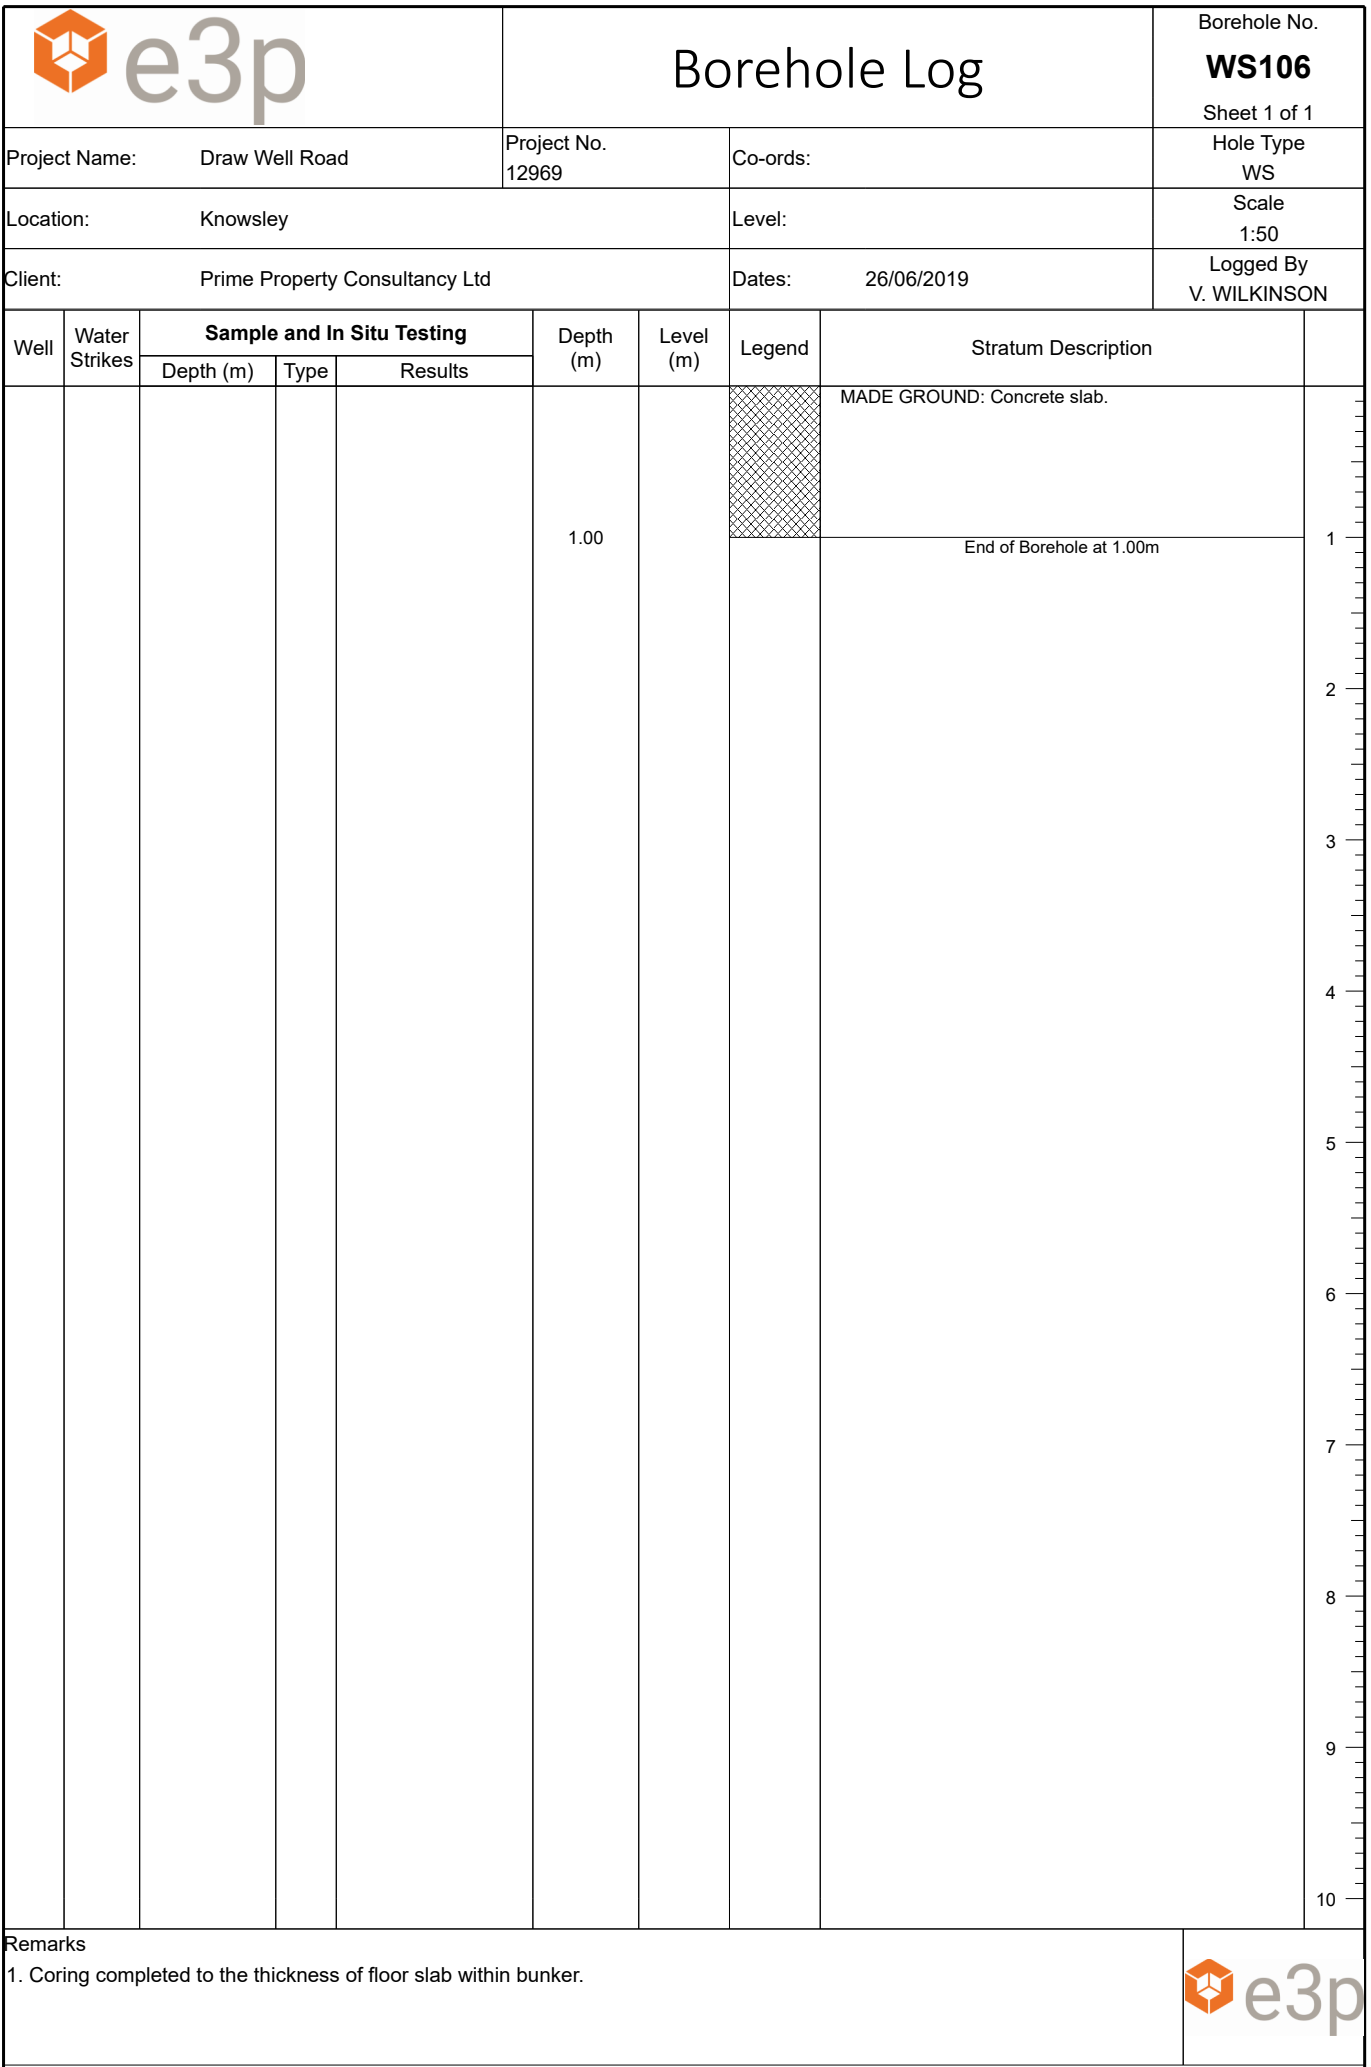
| | | | | | <h1>Borehole Log</h1> | | | Borehole No.<br><b>WS107</b><br>Sheet 1 of 1 | |

1. Complete 2. Monitoring well installed
