**Taylor Wimpey (UK) Ltd**  
**Coal Mining Risk Assessment**  
For  
**Whiston Phase 3, Foxes Bank, Widnes**  
July 2026  
**REPORT NO: 24TAY072/CMRA**

**Contract No:** 24TAY072  
**Client:** Taylor Wimpey  
**Contract:** Whiston Phase 3, Foxes Bank, Widnes  
**Document:** Coal Mining Risk Assessment

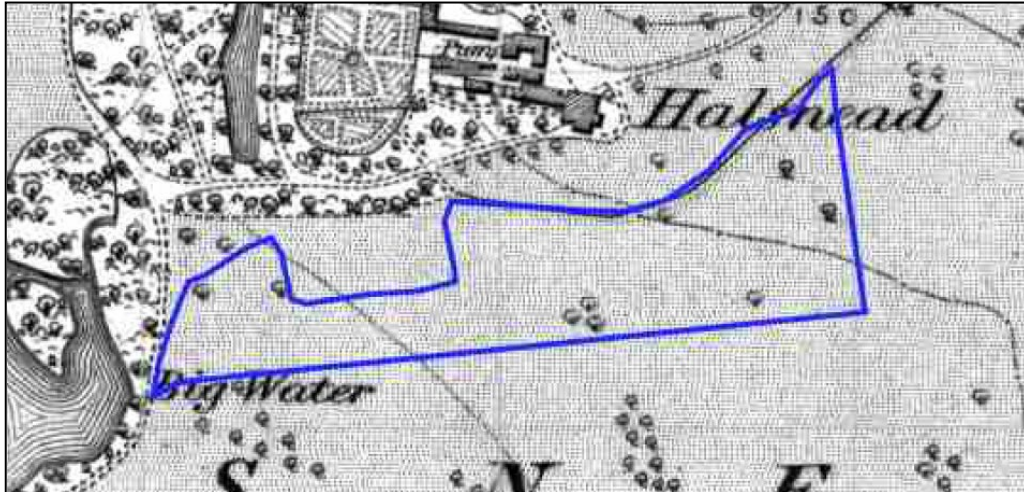
#### 1850 1:10,560 map

The earliest available map of the site is the 1850 1:10,560 map which shows the site as undeveloped. An extract of this map is shown below;

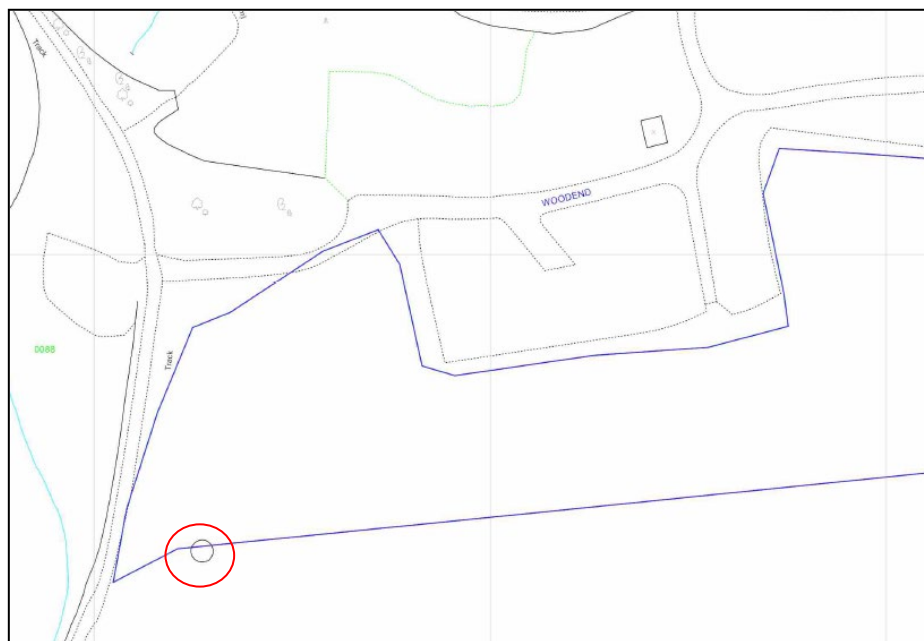
**2003 1:1,250 map**

Circa 1981 – 1986, neither of the tracks previously located on site are now shown. Circa 1989 - 2023, the structure in the south western area of site is still present. This structure is only shown on the larger scale 1:2,500 & 1:1,250 mapping (which ends in 2003) and not the smaller scale 1:10,000 mapping therefore it cannot be determined when this structure disappeared from site. An extract of the 1:1,250 2003 mapping can be seen below;

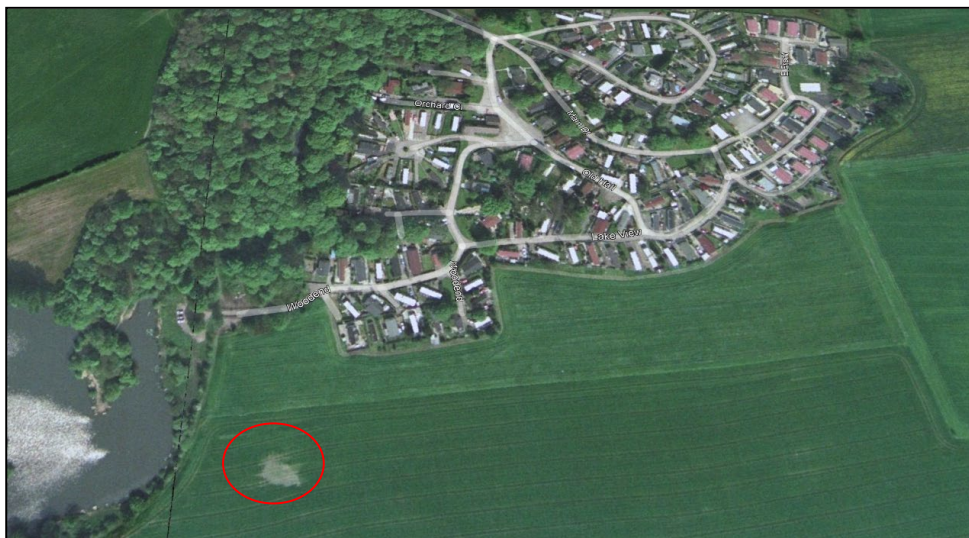
Satellite imagery from 2000 does show a similar feature on site. The Groundsure data set highlights this

feature to be a tank (see Environmental Data section below for further details).
