**TC/L9523/2020/04**

**FLOOD RISK ASSESSMENT & DRAINAGE STRATEGY**

**Lakeside School  
Naylor's Road  
Liverpool  
L27 2YA**

**The Witherslack Group**

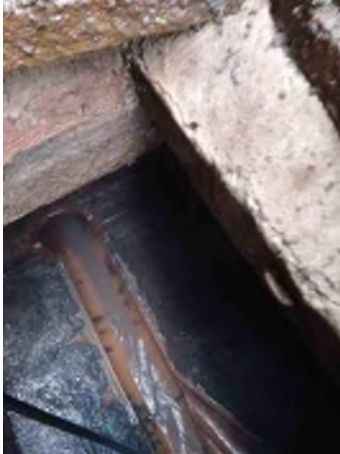
Blockage cleared

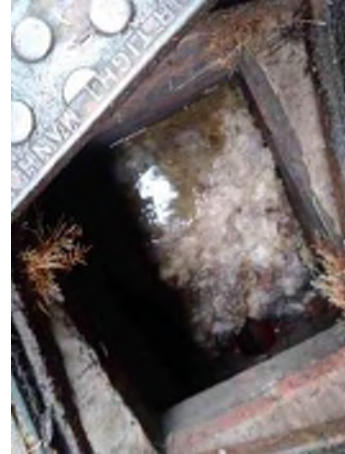
FW MH1 blocked

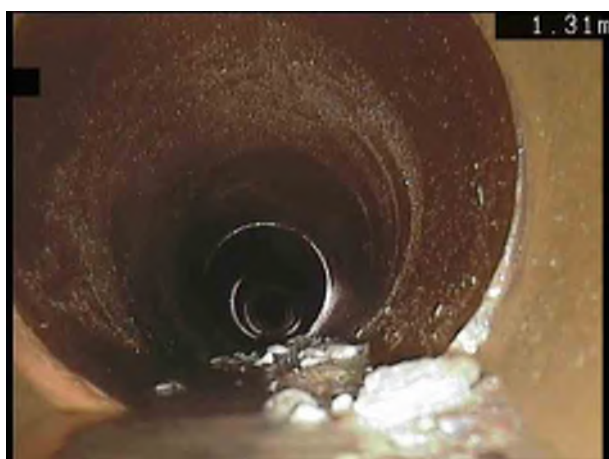
FW MH

1X\_51589a05-3edd-463a-9ca9-0a6cec873bf8\_20210616\_111  
 018\_161.jpg, 00:00:21, 1.31 m  
 Settled deposits, coarse, 10% cross-sectional area loss

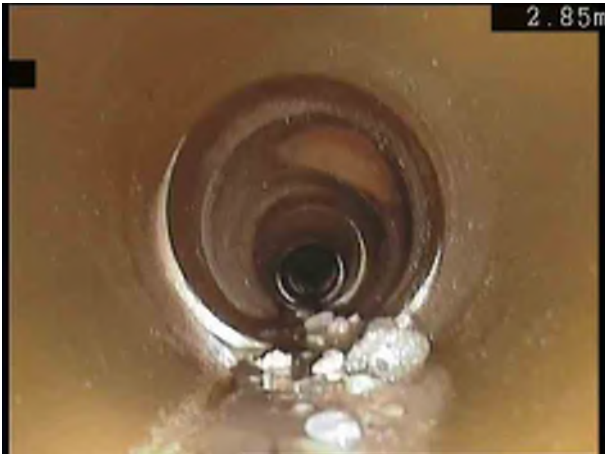
FW MH

1X\_96e6f74d-0085-4924-a400-24aa898ddd7b\_20210616\_134024\_378.jpg, 00:00:29, 2.90 m  
 Settled deposits, coarse, 10% cross-sectional area loss

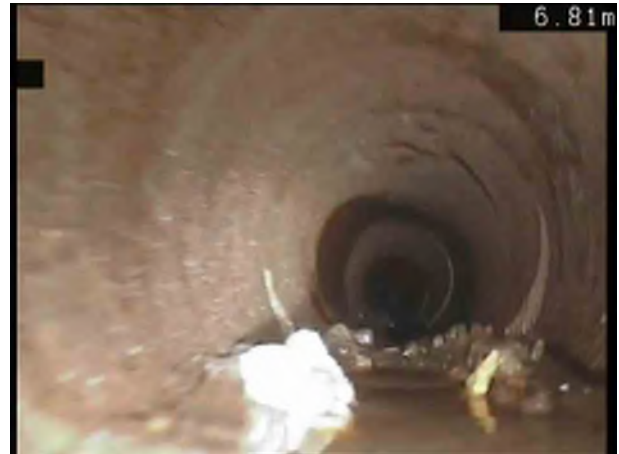
FW MH

1X\_05f0625c-7144-4976-967b-63d0c4468839\_20210616\_134122\_205.jpg, 00:00:50, 6.81 m  
 Settled deposits, fine, 10% cross-sectional area loss, start

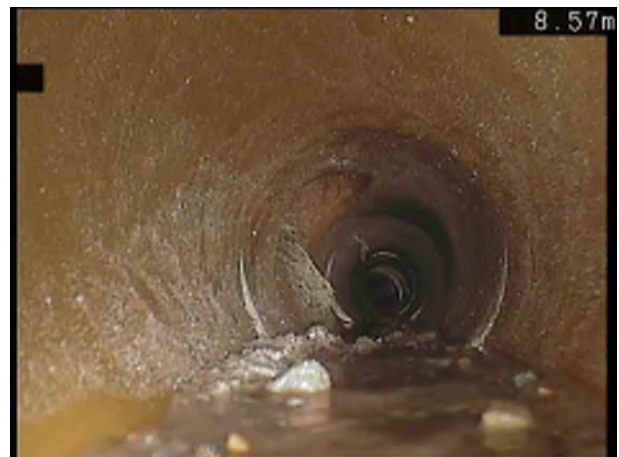
FW MH

1X\_c1dab73b-1d4e-4dc9-84d5-07ebdf0c6080\_20210616\_143013\_775.jpg, 00:00:59, 8.46 m  
 Settled deposits, coarse, 5% cross-sectional area loss

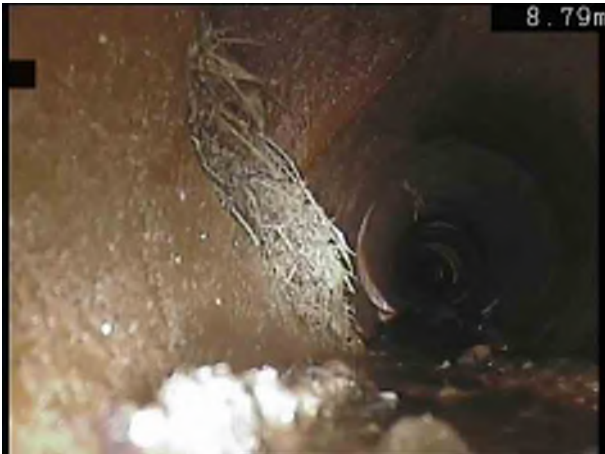
FW MH

1X\_49a23b46-80c6-4896-99b5-2f04e414eb6c\_20210616\_142  
 316\_761.jpg, 00:01:02, 8.80 m  
 Roots, mass, 10% cross-sectional area loss

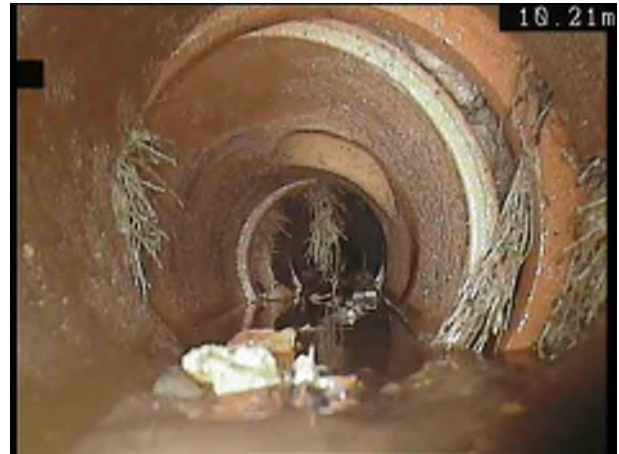
FW MH

1X\_ecc8749b-0b5d-4560-b2c2-f598ac11b332\_20210616\_143  
 135\_329.jpg, 00:01:13, 10.21 m  
 Roots, mass at joint, 10% cross-sectional area loss

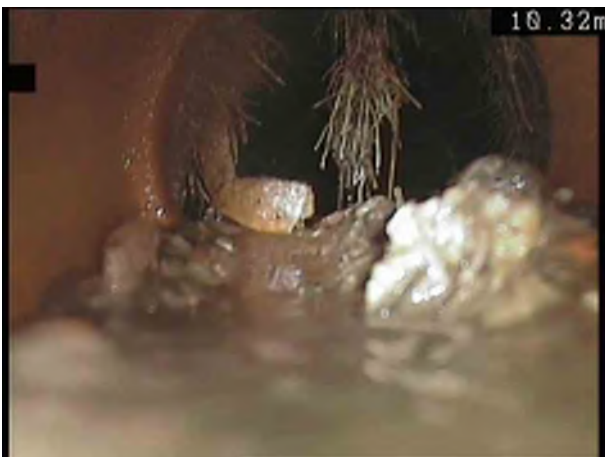
FW MH

1X\_90d911cc-de53-4a2b-b400-0bc737496cd6\_20210616\_14  
 3332\_641.jpg, 00:01:36, 10.50 m  
 Settled deposits, coarse, 30% cross-sectional area loss

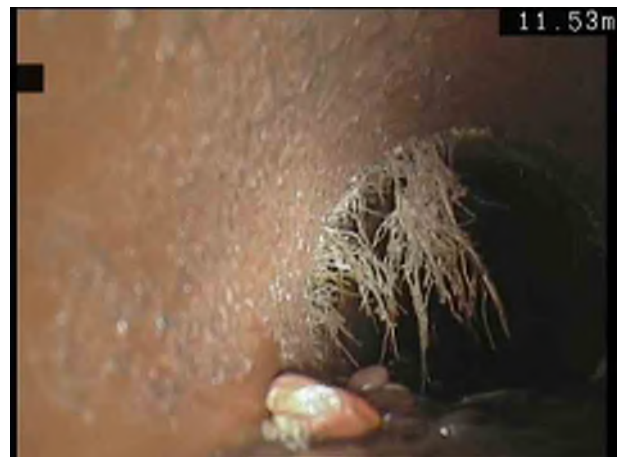
FW MH

1X\_57721712-d903-45e8-8fe1-bb8616590cf0\_20210616\_143  
 531\_459.jpg, 00:01:40, 11.42 m  
 Roots, mass at joint, 15% cross-sectional area loss

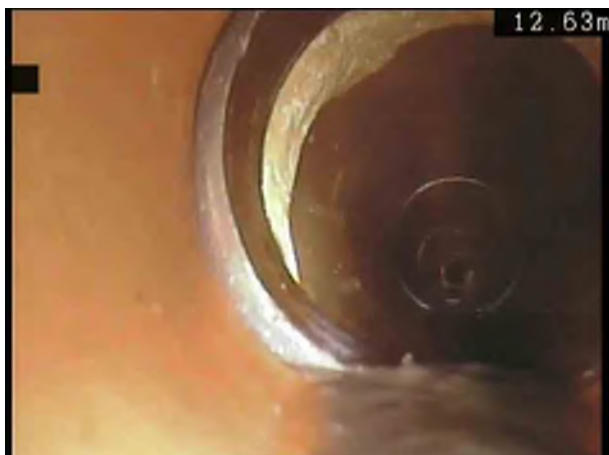
FW MH

1X\_820044ce-260e-4b71-a857-7502a8eb560f\_20210616\_143617\_280.jpg, 00:01:45, 12.63 m  
 Surface damage, spalling from 8 o'clock to 4 o'clock

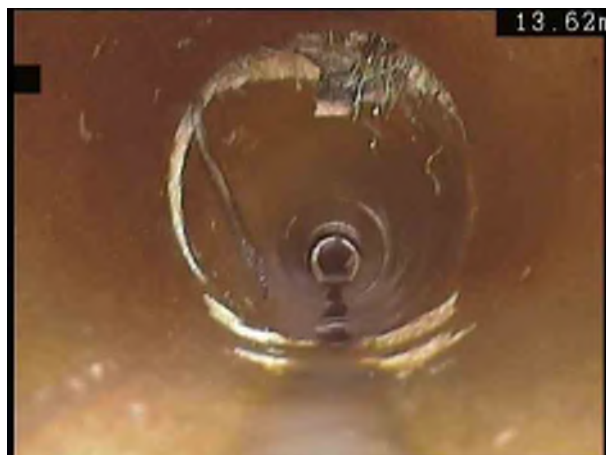
FW MH

1X\_45714bd1-7a53-4d52-a8b1-2c37a8c65142\_20210617\_085101\_313.jpg, 00:01:50, 13.62 m  
 Broken pipe from 11 o'clock to 1 o'clock

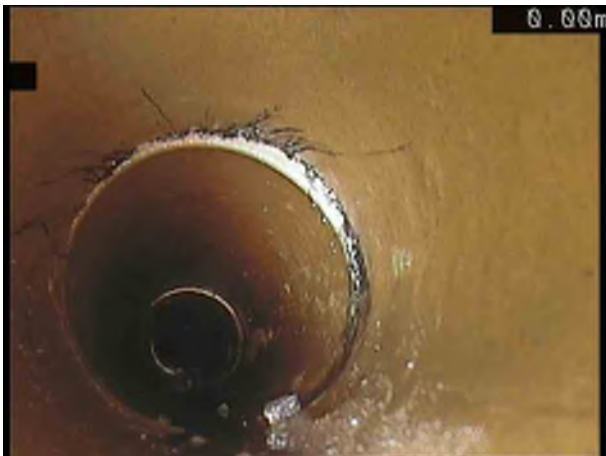
RestbendX\_27f34987-24cf-470e-85e7-e43a7974c5d0\_20210616\_144016\_834.jpg, 00:00:12, 0.01 m  
 Roots, fine at joint

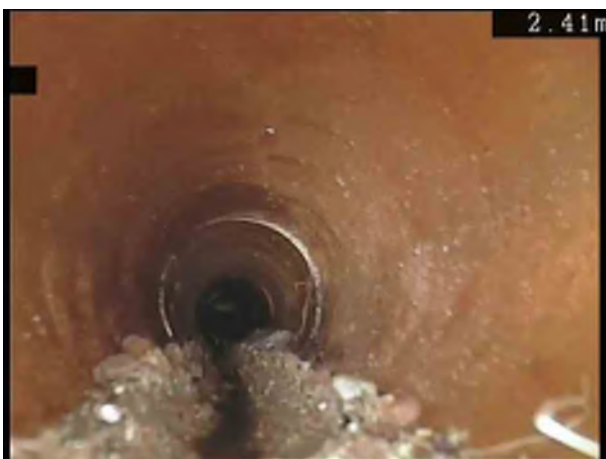
RestbendX\_0f3820d8-099e-425e-9139-fdf29d5a9806\_20210616\_144256\_545.jpg, 00:00:32, 2.41 m  
 Settled deposits, fine, 15% cross-sectional area loss

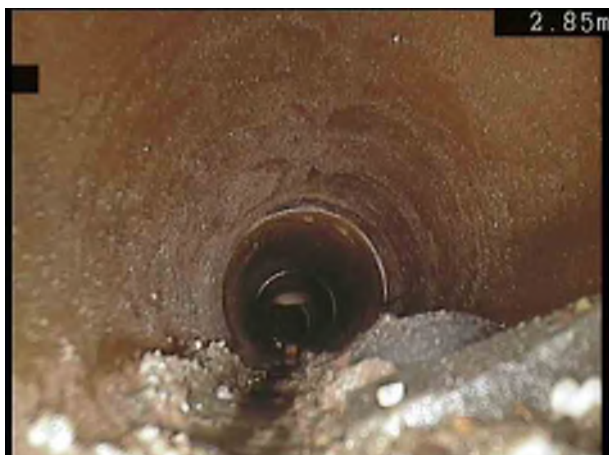
RestbendX\_a1255de8-41b1-417e-bfa2-59b1900ebc1c\_20210616\_144324\_703.jpg, 00:00:38, 2.85 m  
 Settled deposits, coarse, 15% cross-sectional area loss

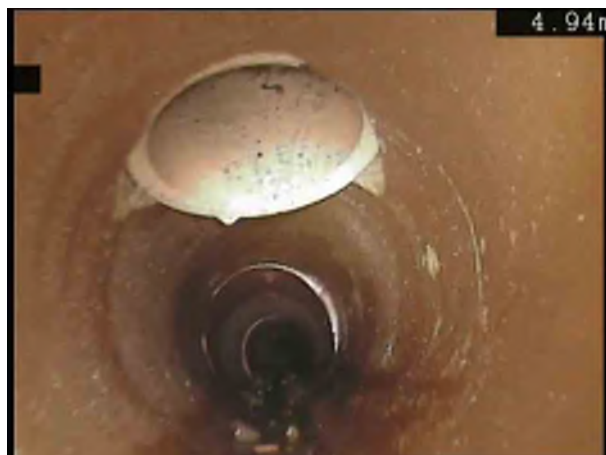
RestbendX\_4feb9845-e82f-488f-ba6b-d6561b4100a5\_20210616\_144353\_230.jpg, 00:00:48, 4.94 m  
 Connection defective, position incorrect at 12 o'clock, diameter: 100mm

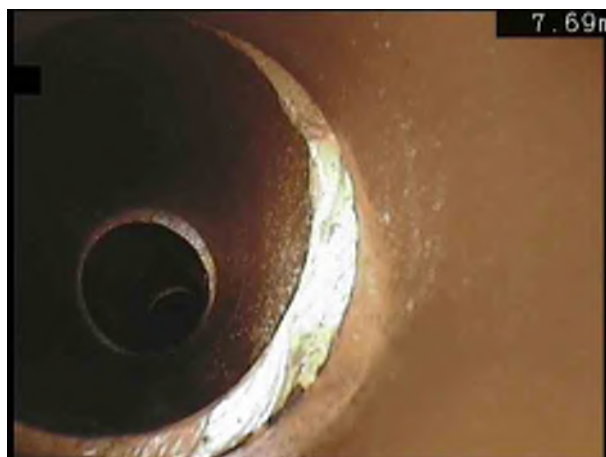
RestbendX\_551fc0bd-cb36-4e11-816e-89f571abec55\_20210616\_144448\_579.jpg, 00:01:01, 7.70 m  
 Joint displaced, large

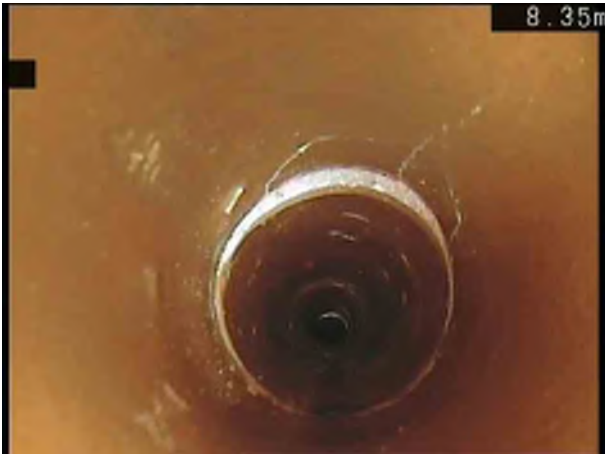
RestbendX\_9fea196c-3957-46a2-a91d-e2bb84135b2c\_20210616\_144522\_065.jpg, 00:01:13, 8.35 m  
 Crack, circumferential from 11 o'clock to 2 o'clock

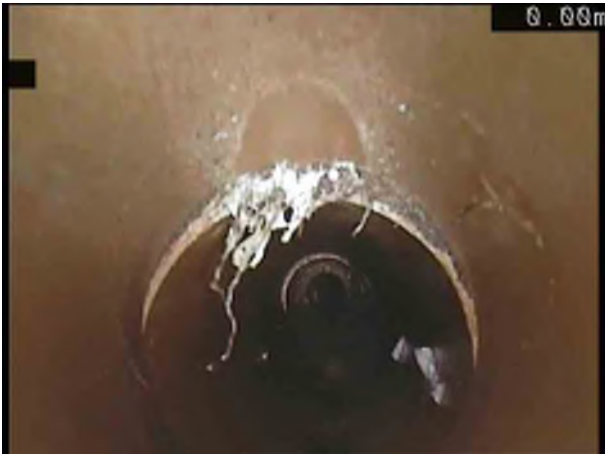
RestbendX\_067135e8-2877-4bd1-905c-283d61ee4e34\_2021  
 0616\_145103\_454.jpg, 00:00:20, 0.01 m  
 Crack, circumferential at joint from 9 o'clock to 4 o'clock

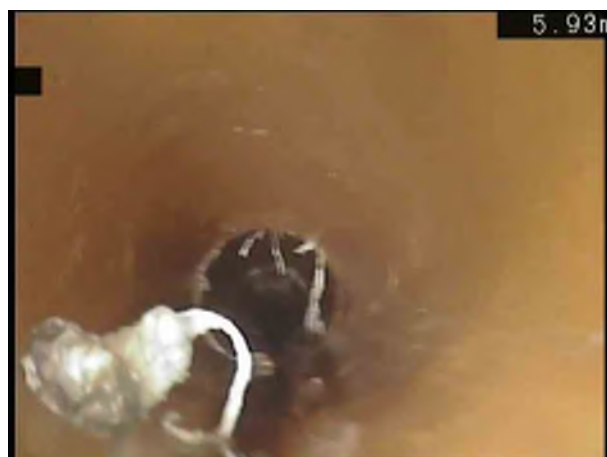
FW MH  
 2X\_97f0604e-9ab9-4ad3-ad8c-4b991e199cdc\_20210616\_145525\_912.jpg, 00:00:30, 5.93 m  
 Settled deposits, other, 10% cross-sectional area loss, Unknown

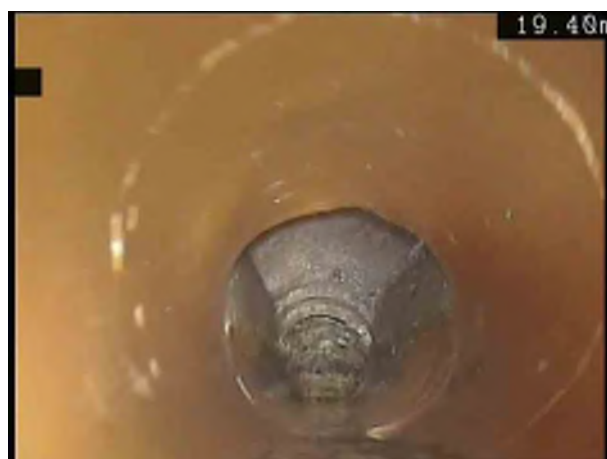
FW MH  
 2X\_dcd94b59-a7b6-49b7-a00d-1049417c1517\_20210616\_145901\_468.jpg, 00:01:15, 19.40 m  
 Crack, circumferential from 9 o'clock to 5 o'clock

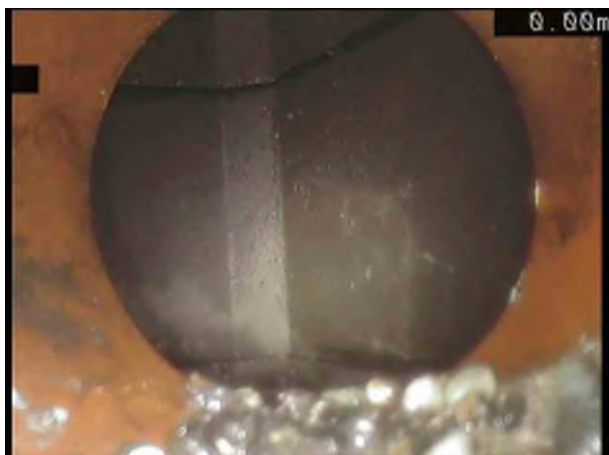
SW MH

Settled deposits, coarse, 5% cross-sectional area loss
