**PHASE I  
GEO-ENVIRONMENTAL SITE ASSESSMENT**

**Land at Ellis Ashton Street,  
Huyton  
Merseyside**

**REC Report: 43938p1r0  
Issued: March 2011**

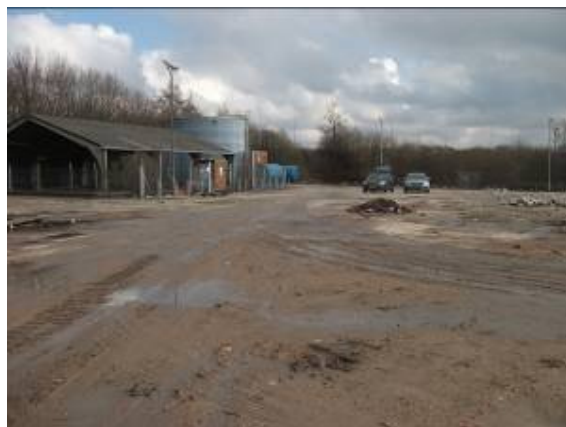
Northeast corner showing fire tank, asbestos roof  
and formerly vertical tanks, waiting for disposal

- The asbestos cement roofed structure does not pose a risk providing it is either left untouched and remains in good condition. Should it be subject to demolition or refurbishment then it should be undertaken according to best practice;

The asbestos roof material on the northern boundary is not regulated. The transformer on-site may contain PCBs and care should be taken if this unit is either changed or the oil replaced.

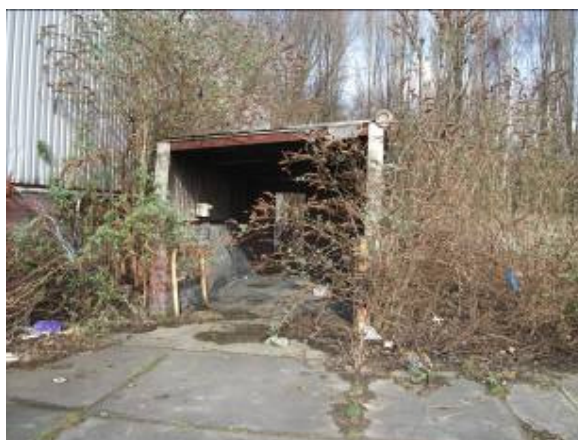
Washdown shed

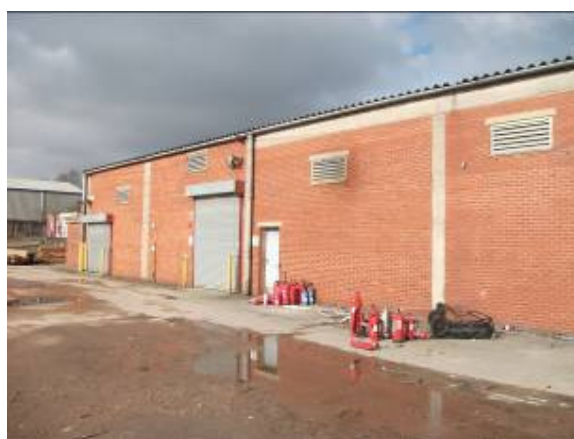
Vehicle maintenance (assumed)

- The vehicle repair buildings may have contained small quantities of oils and solvents for degreasing. The actual use of these buildings has not been confirmed as entry was not possible. It is REC's understanding these buildings are being retained;

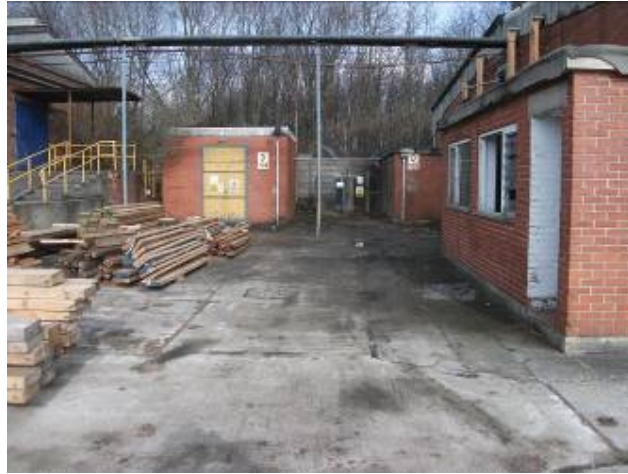
Transformer with Sub-station on left

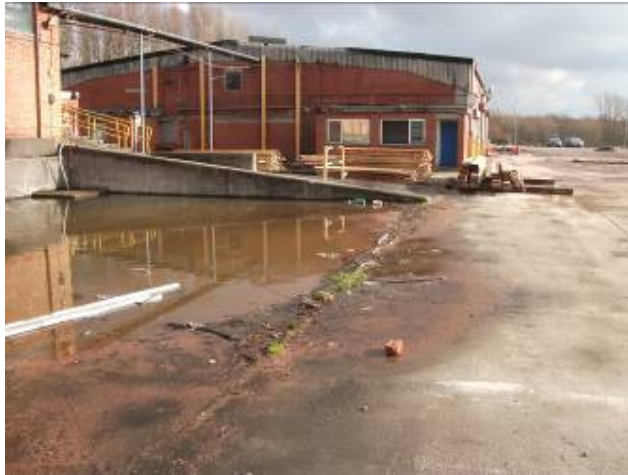
Washdown area with sump in left corner

- Made Ground imported to level the site may contain inorganic compounds or resulted in organic matter being buried that could generate ground gas;
- The wash down area may have mobilised minor quantities of oils or road materials. Although there are no stains in the area in question. The receiving point of the discharge from this area is unknown.

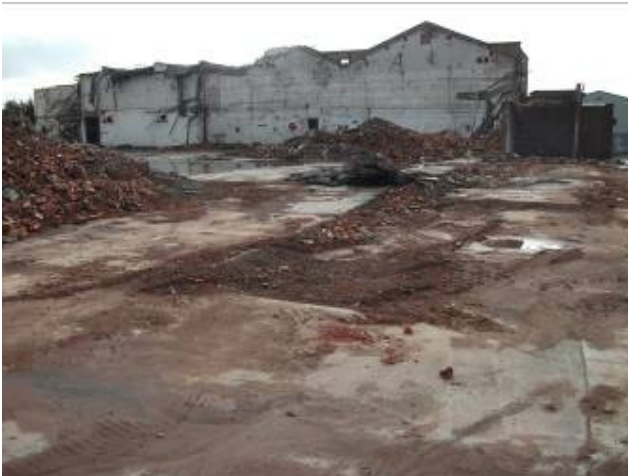
Demolished main building with floor intact
