# LAND AT ACORNFIELD ROAD, KNOWSLEY

GEOENVIRONMENTAL  
APPRAISAL  
(PHASE 2 ASSESSMENT)

S2405/02, MAY 2026  
FINAL, ISSUE 4.0

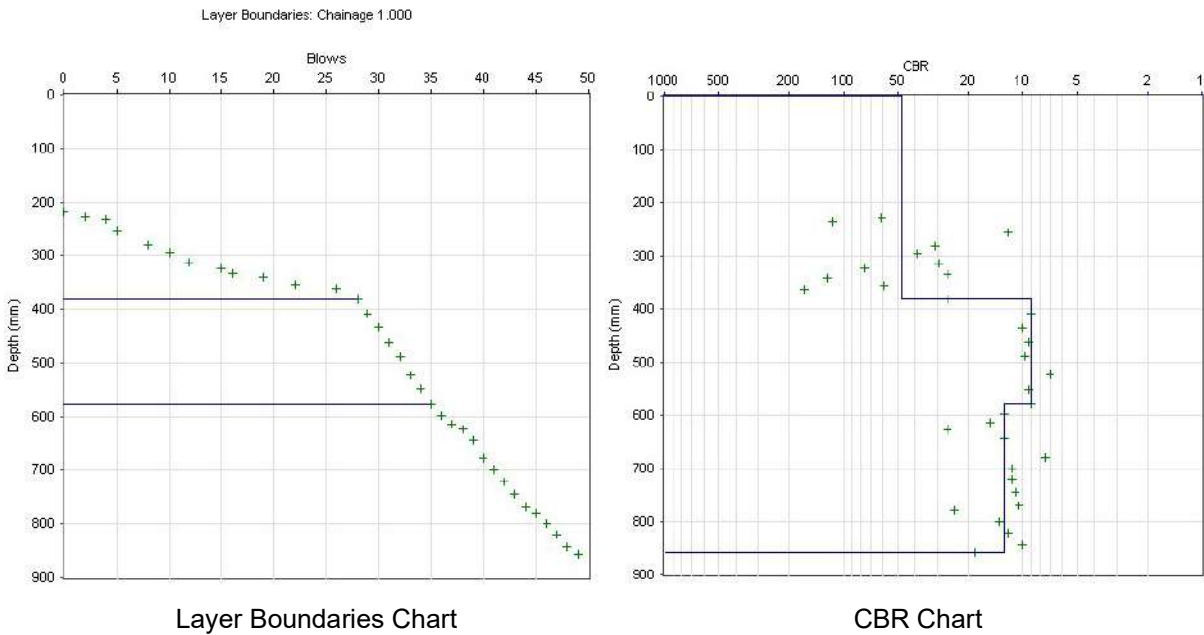
| Zero Error (mm): | 0 | Surface Moisture: | Unknown |
| Test Date: | 03/10/2024 | Moisture adjustment factor: | Not adjusted |

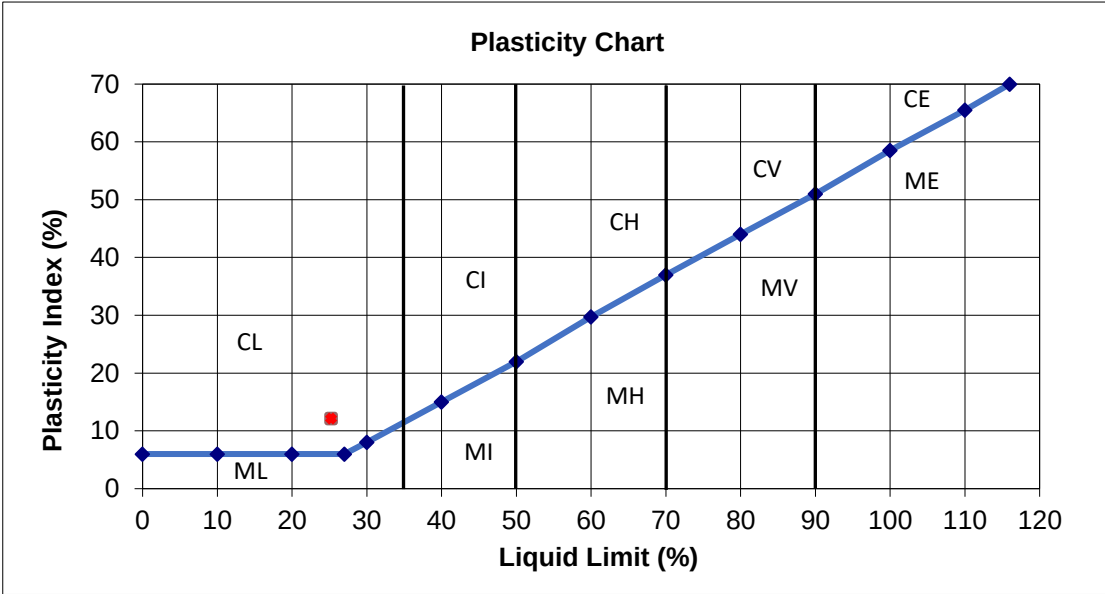
Report/Sample ID No: **S1899-04**

| | Test Results | Specification |
|---|---|---|
| Passing 425mic (%) | 80 | |
| Soil Classification: | CL | |

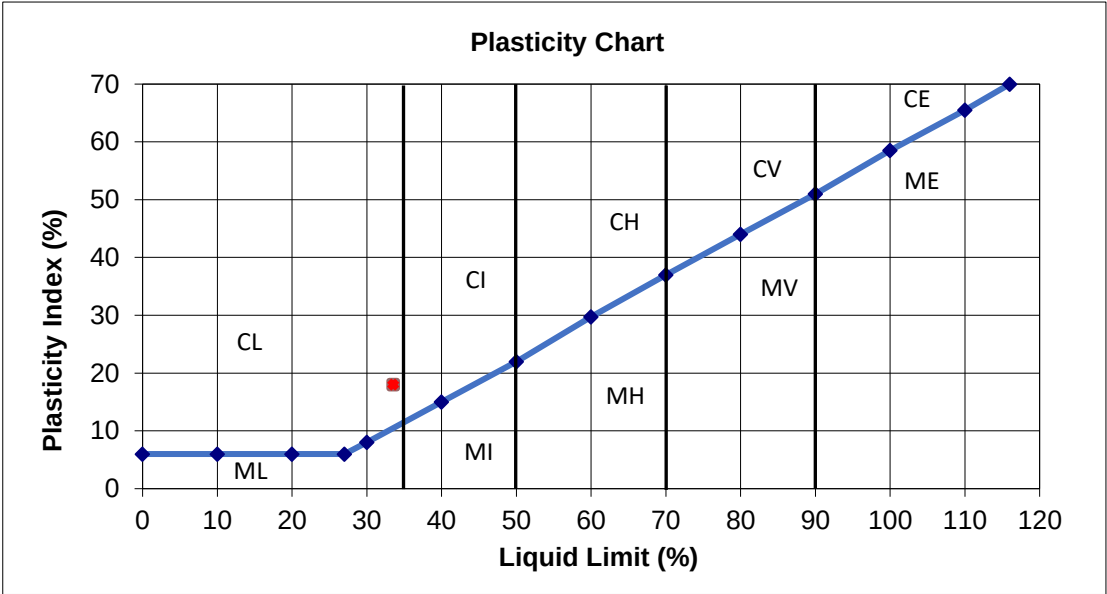
Report/Sample ID No: **S1899-05**

| | Test Results | Specification |
|---|---|---|
| Passing 425mic (%) | 92 | |
| Soil Classification: | CL | |

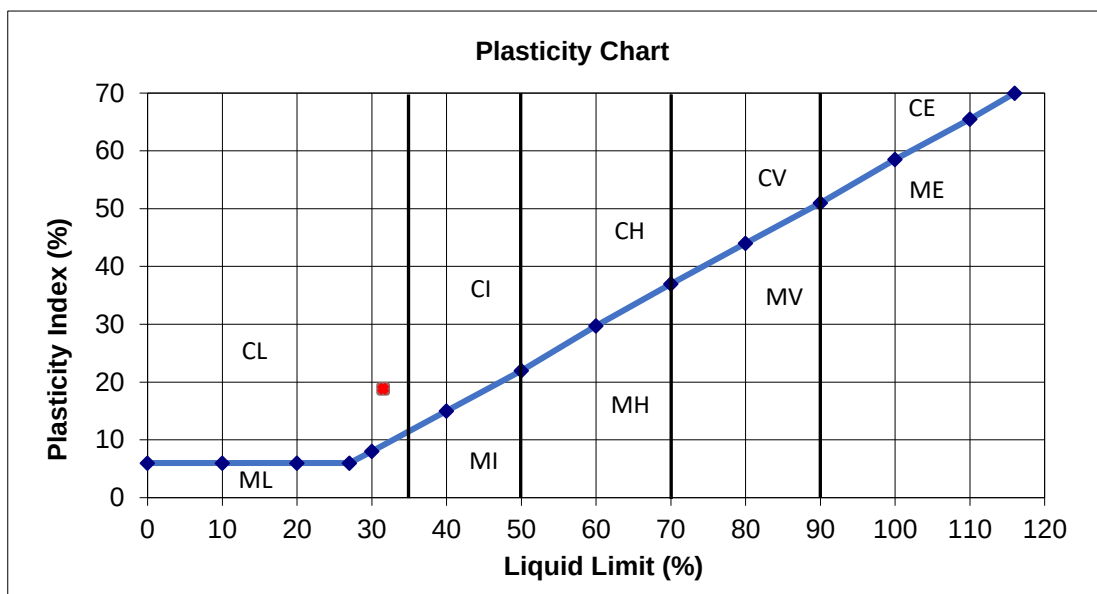
Report/Sample ID No: **S1899-06**

| Passing 425mic (%) | <b>92</b> | |
| Soil Classification: | <b>CL</b> | |

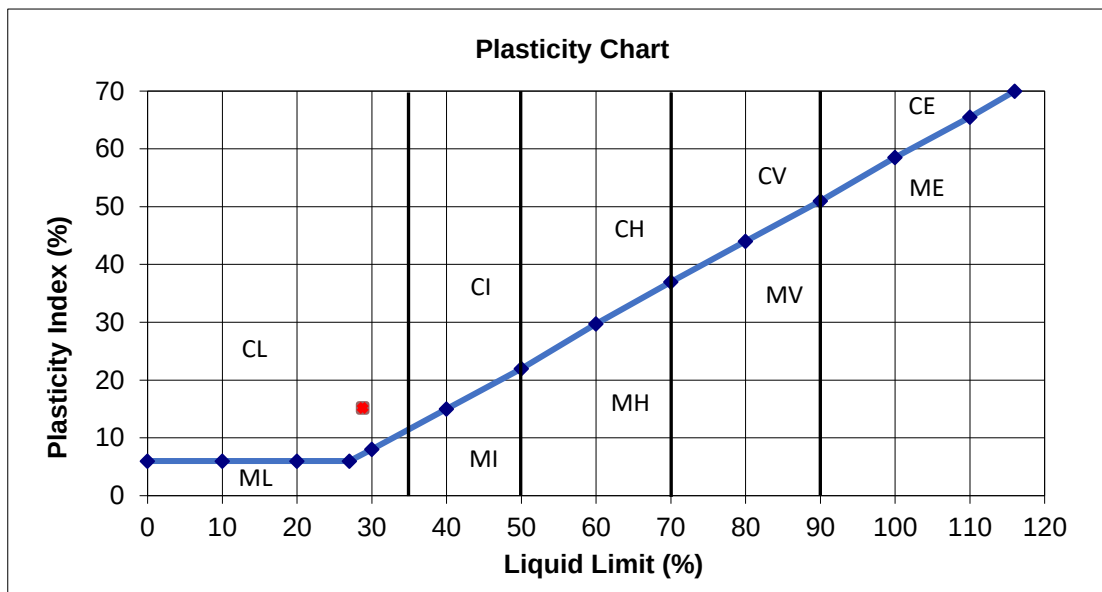
Report/Sample ID No: **S1899-07**

| Passing 425mic (%) | <b>91</b> | |
| Soil Classification: | <b>CL</b> | |

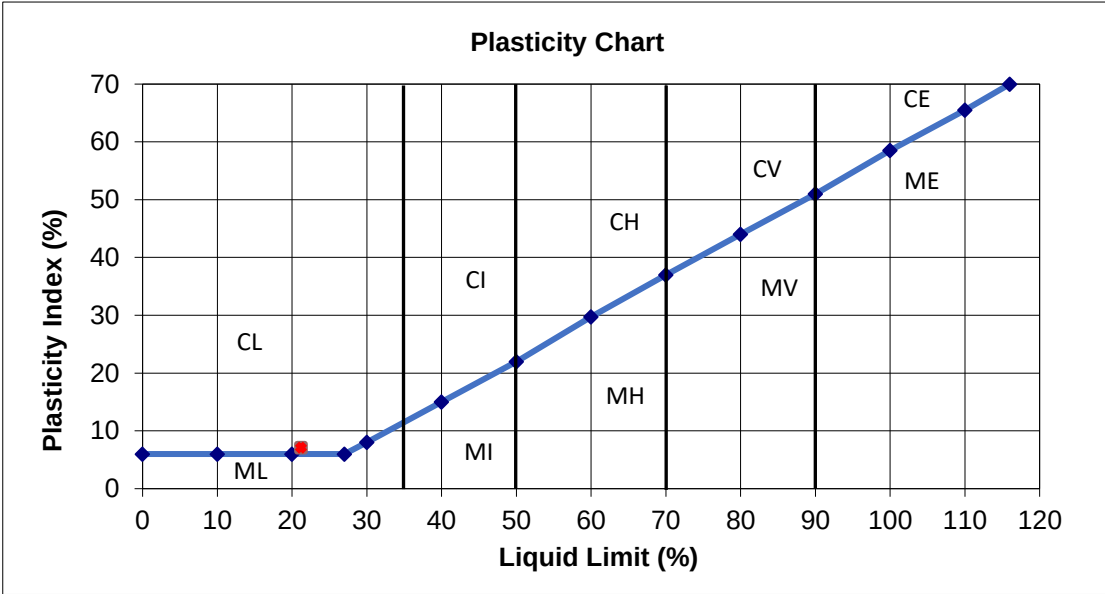
Report/Sample ID No: **S1899-08**

| | Test Results | Specification |
|---|---|---|
| Passing 425mic (%) | 96 | |
| Soil Classification: | CL | |

**Remarks:** Sample had a very strong odour

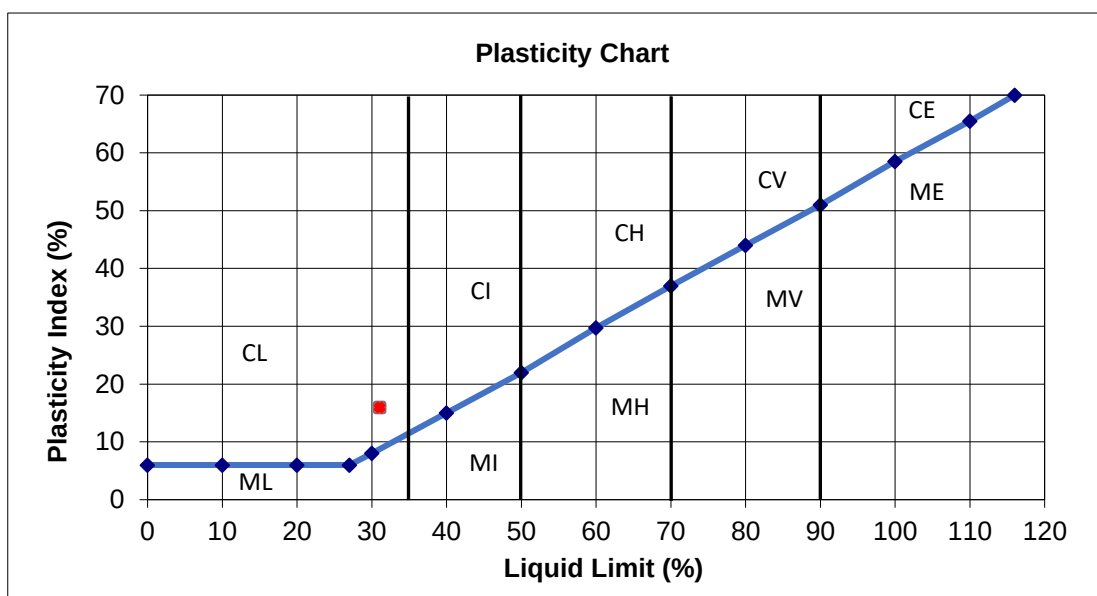
Report/Sample ID No: **S1899-09**

| Passing 425mic (%) | <b>88</b> | |
| Soil Classification: | <b>CL</b> | |

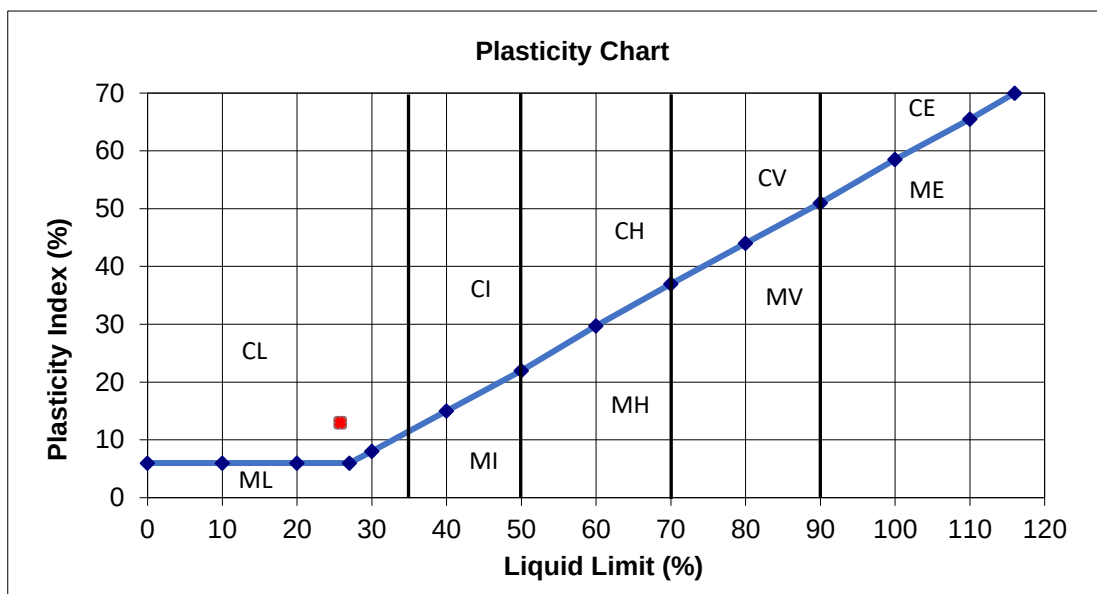
Report/Sample ID No: **S1899-10**

| Passing 425mic (%) | <b>88</b> | |
| Soil Classification: | <b>CL</b> | |

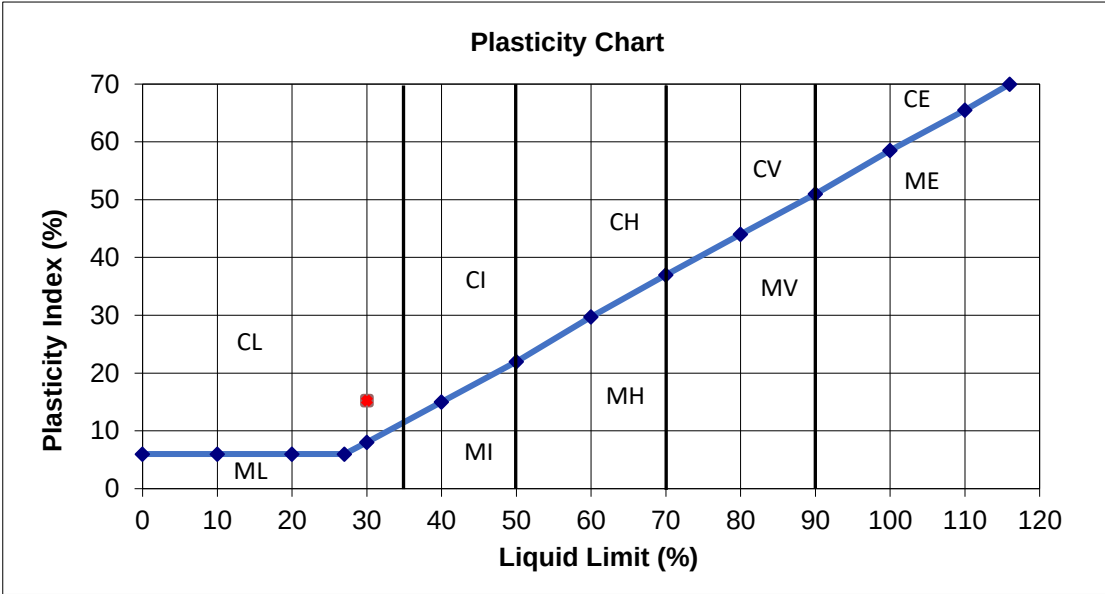
Report/Sample ID No: **S1899-11**

| | Test Results | Specification |
|---|---|---|
| Passing 425mic (%) | 90 | |
| Soil Classification: | CL | |
