# LAND AT ACORNFIELD ROAD, KNOWSLEY

GEOENVIRONMENTAL  
APPRAISAL  
(PHASE 2 ASSESSMENT)

S2405/02, JUNE 2026  
FINAL, ISSUE 5.0

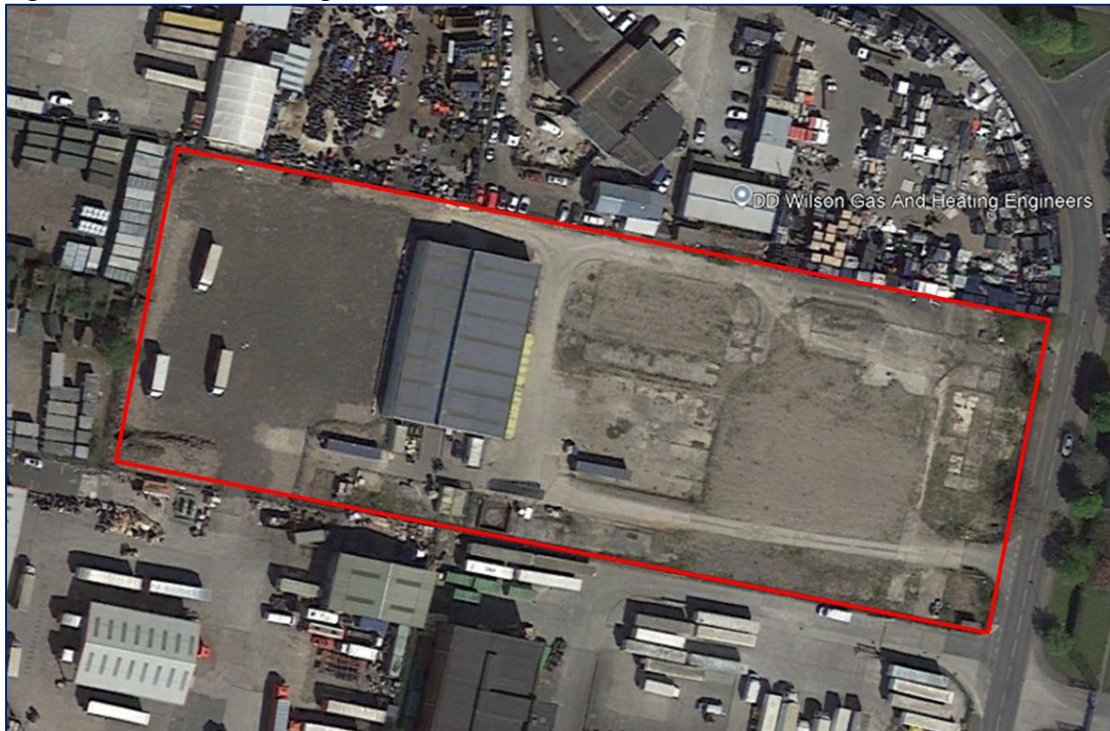
Figure 2: Site Aerial Image

2.1.1 The site measuring approximately 1.45Ha is located at Acornfield Road, Knowsley Industrial Park, Kirkby (Figure 1). The site lies at an approximate Ordnance Survey (OS) National Grid Reference (NGR) of 343647, 399369.

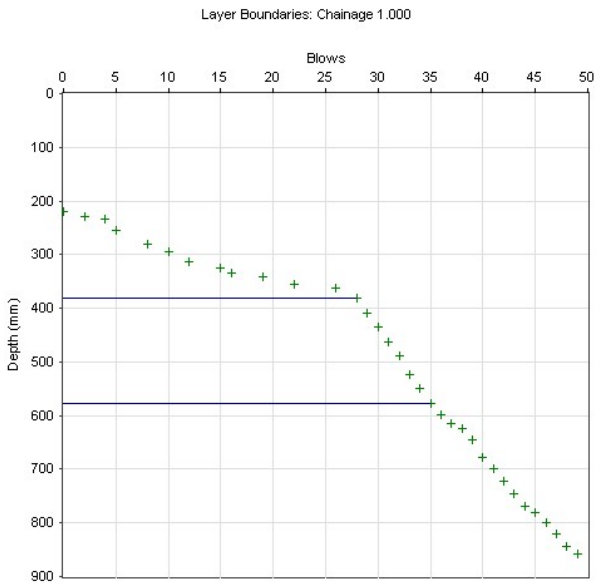
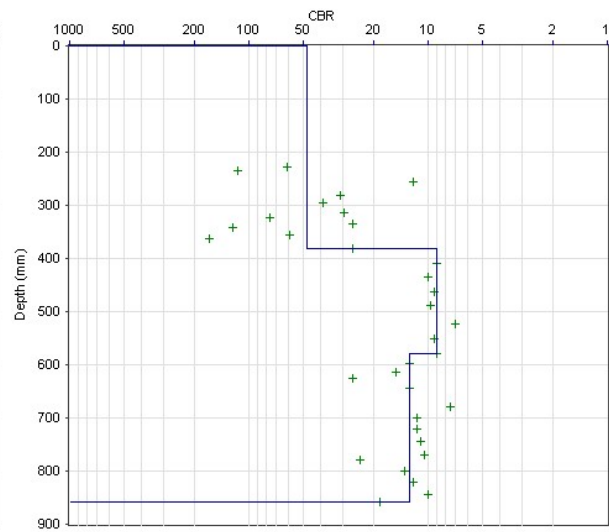
Layer Boundaries Chart

CBR Chart

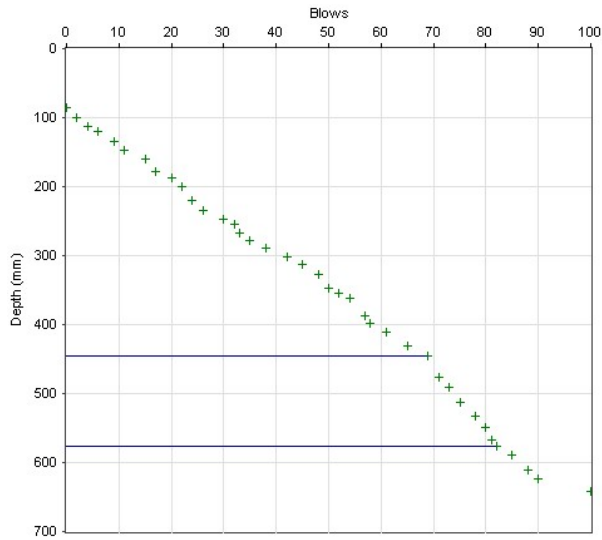
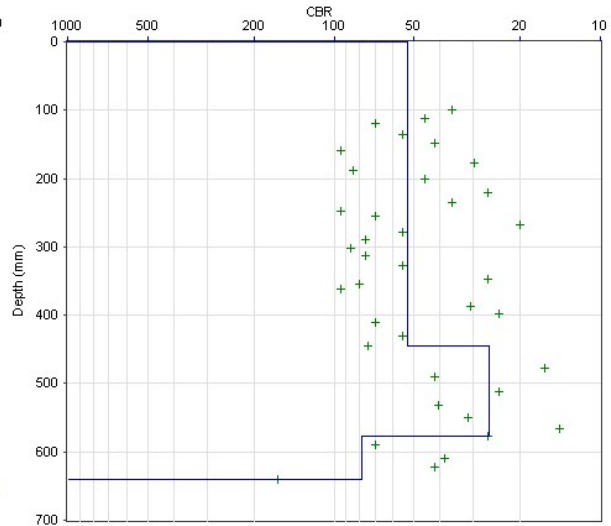
Layer Boundaries: Chainage 2.000

Layer Boundaries Chart

CBR Chart

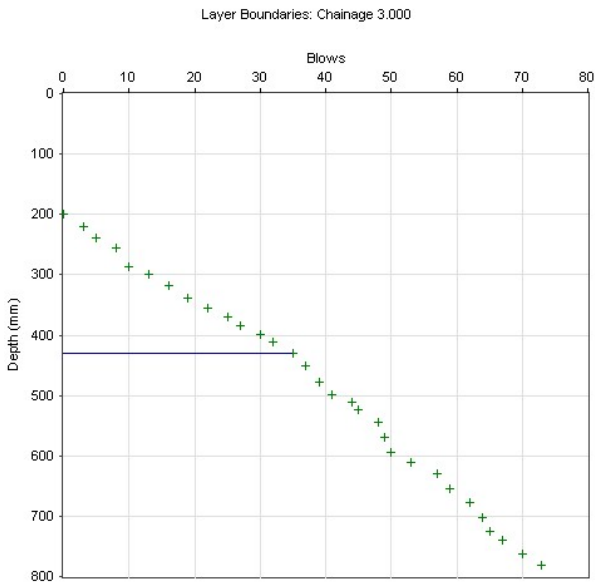
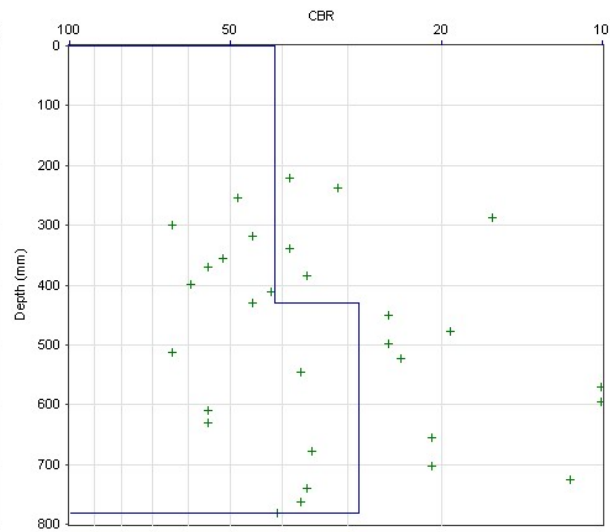
Layer Boundaries Chart

CBR Chart

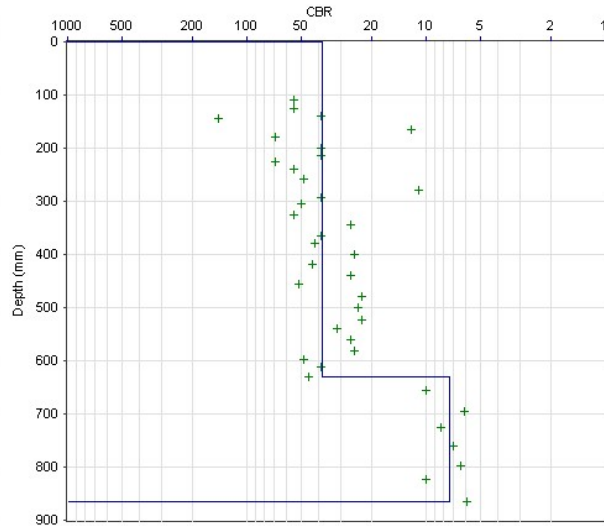
Layer Boundaries: Chainage 4.000

Layer Boundaries Chart

CBR Chart

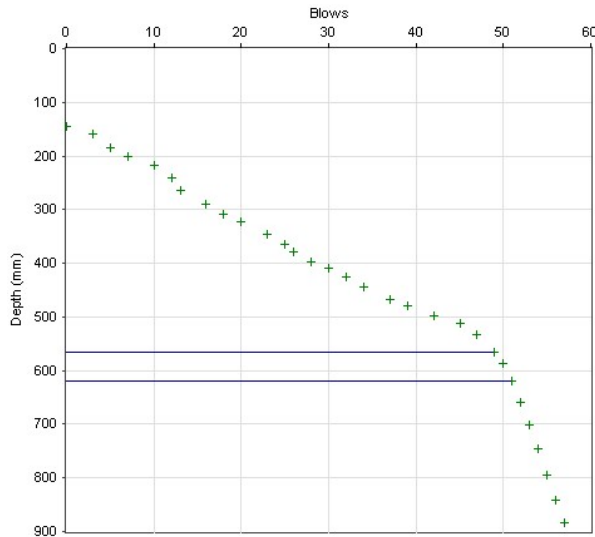
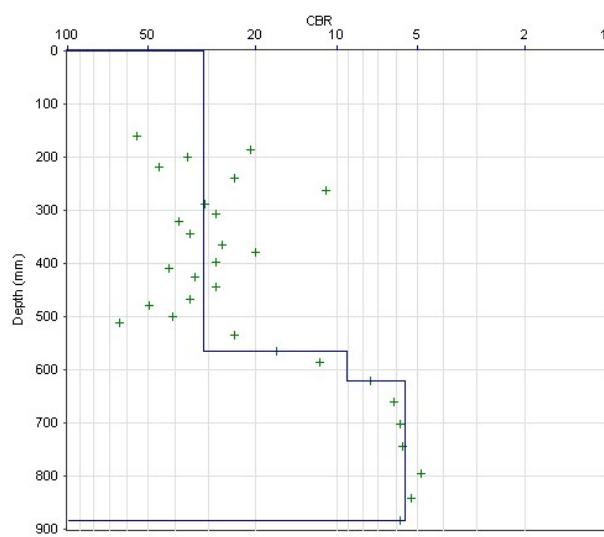
Layer Boundaries: Chainage 5.000

Layer Boundaries Chart

CBR Chart

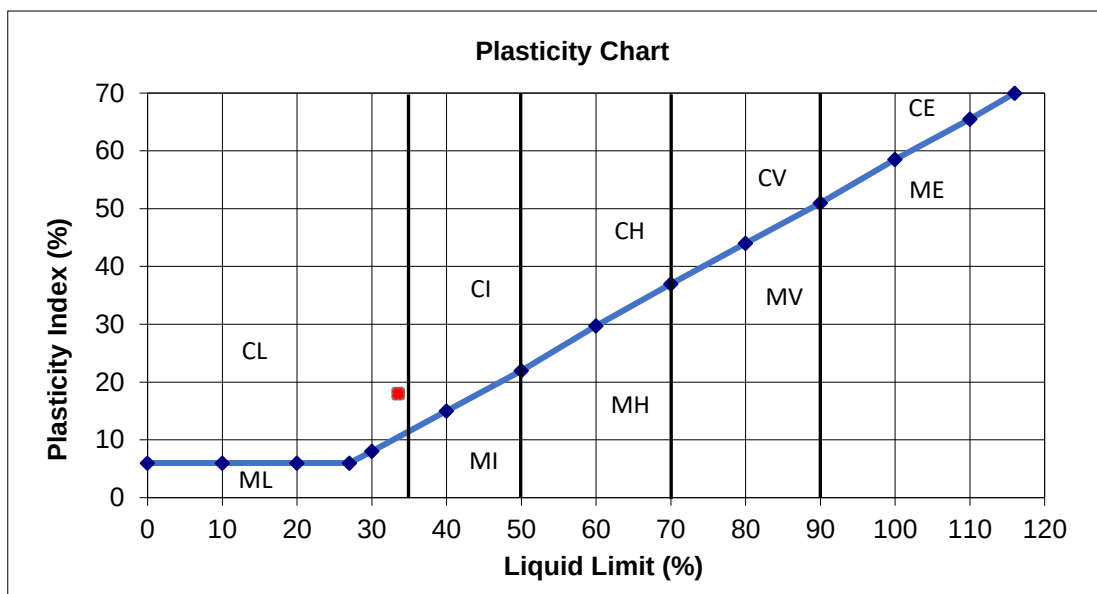
Report/Sample ID No: **S1899-05**

| Soil Classification: | <b>CL</b> | |

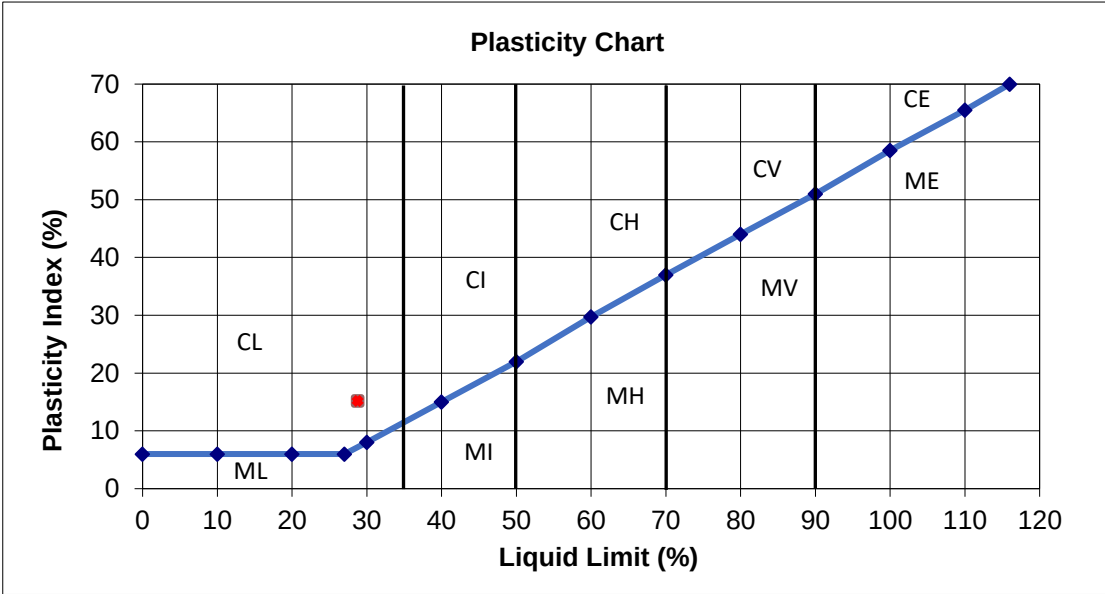
Report/Sample ID No: **S1899-07**

| | Test Results | Specification |
|---|---|---|
| Soil Classification: | CL | |

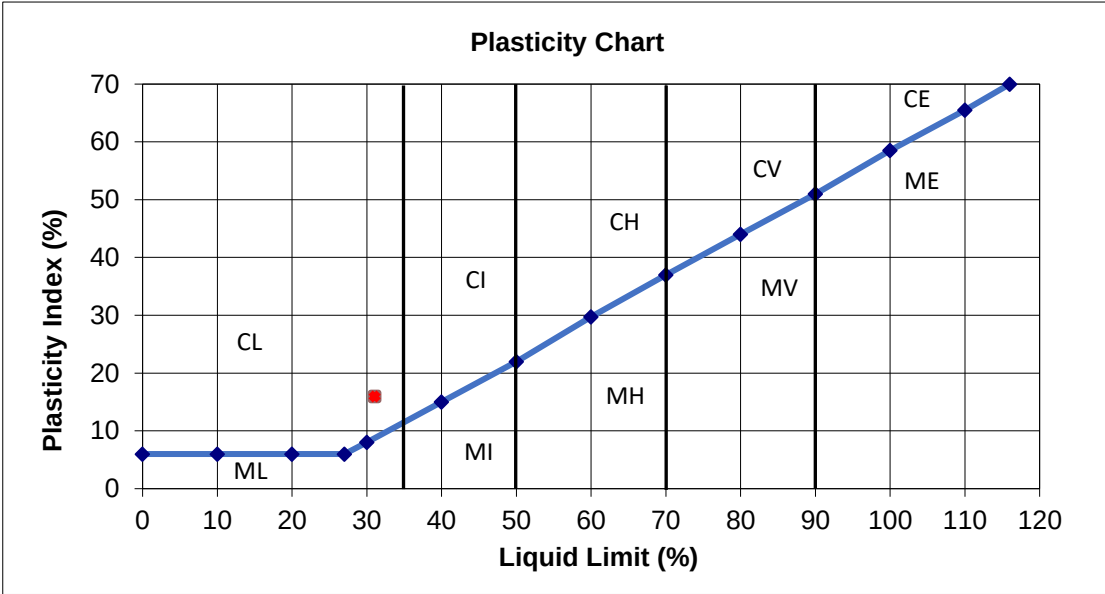
Report/Sample ID No: **S1899-09**

| | Test Results | Specification |
|---|---|---|
| Soil Classification: | CL | |

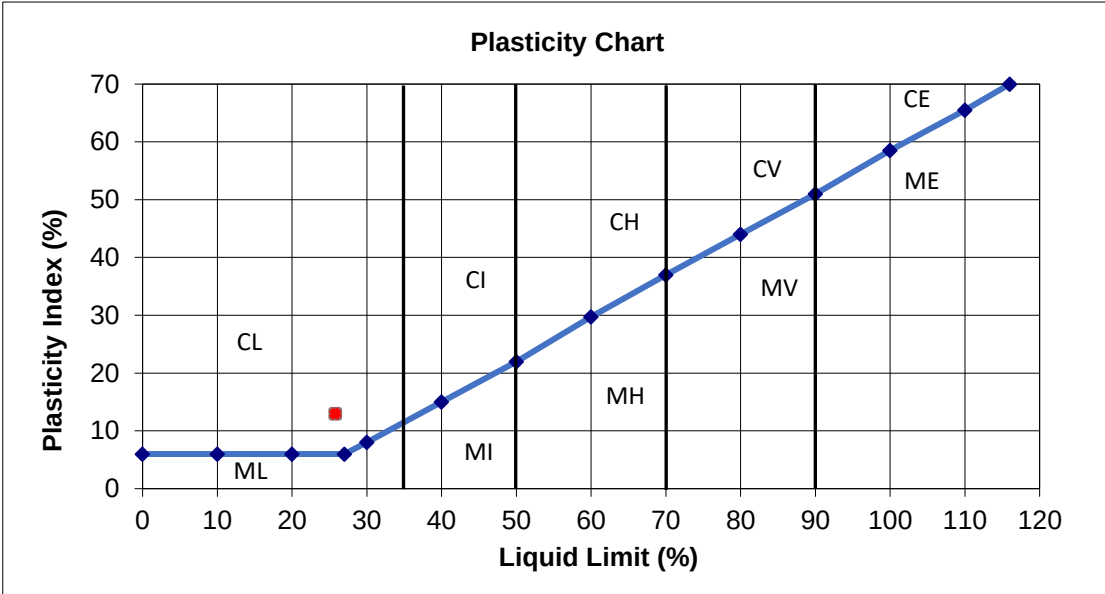
Report/Sample ID No: **S1899-10**

| | Test Results | Specification |
|---|---|---|
| Soil Classification: | CL | |

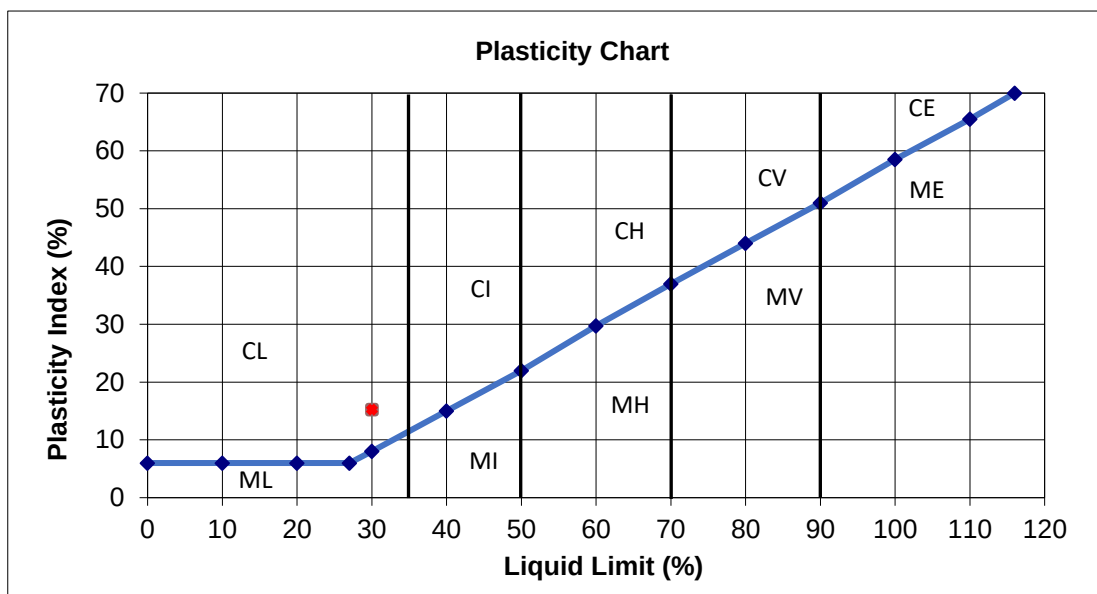
Report/Sample ID No: **S1899-11**

| Soil Classification: | <b>CL</b> | |
