# Phase I and II Geoenvironmental Site Assessment

Site: Glen Dimplex, Prescott

Reference: 17-500-R1-2

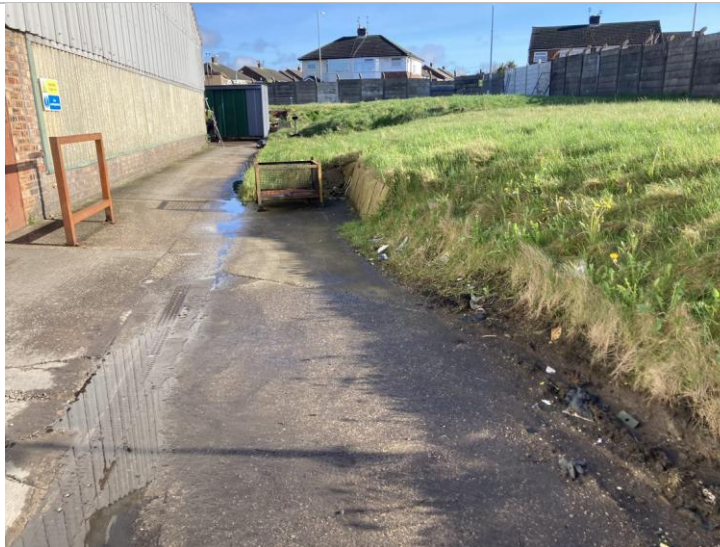
| FEATURE | DESCRIPTION | PHOTOGRAPHIC EVIDENCE |
|---|---|---|
| Retaining Structures | <p>Small retaining structures were noted in the small area of landscaping towards the east of the main factory structure.</p> <p>Further retaining walls were noted along the northern boundary adjacent to Stoney Lane to the north of the structure.</p> | |

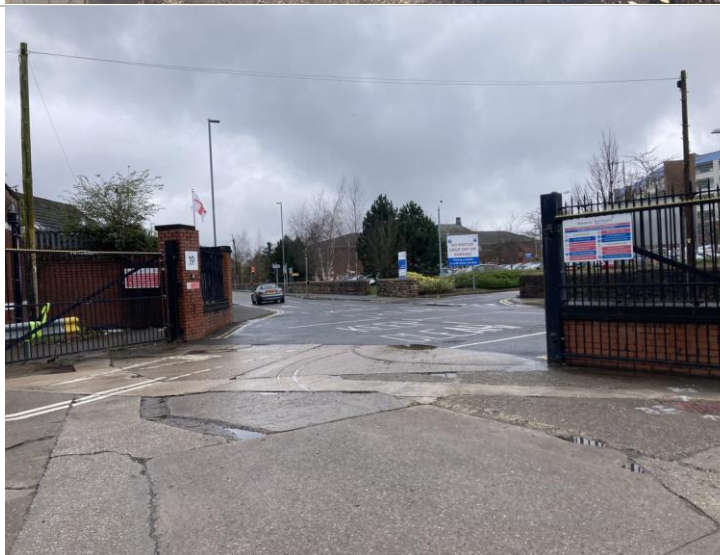
| FEATURE | DESCRIPTION | PHOTOGRAPHIC EVIDENCE |
|---|---|---|
| Access | <p>Surrounding the main factory structure, a service road is present to the south and the west, connecting to Stoney Lane at the north.</p> <p>Access for both pedestrians and vehicles can be gained at the northwest off Stoney Lane in Prescott.</p> <p>The access is restricted with security adjacent at the northwest, which is manned 24 hours.</p> | |

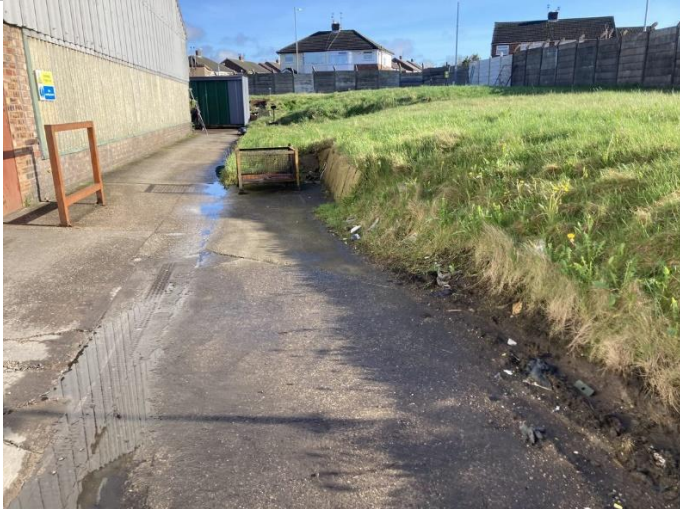
| FEATURE | DESCRIPTION | PHOTOGRAPHIC EVIDENCE |
|---|---|---|
| <b>Slope</b> | <p>Minor slopes were identified particularly at the northern boundary and towards the west at the soft cover adjacent to the structure.</p> <p>A small retaining structure is noted at the southern face adjacent to the building.</p> | |

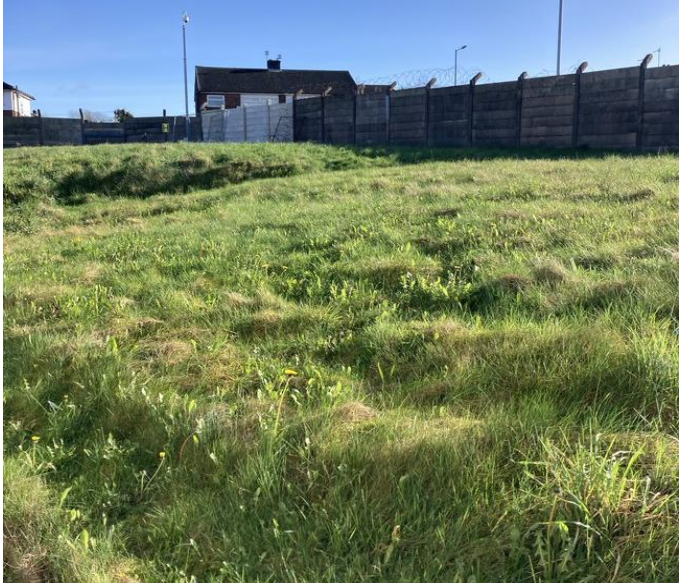
| FEATURE | DESCRIPTION | PHOTOGRAPHIC EVIDENCE |
|---|---|---|
| <b>Vegetation/Ecology</b> | <p>No significant instances of vegetation/ecology were noted with the exception of small areas of soft cover landscaping (managed grasses) are noted at the north and east of the structure, with semi sporadic semi-mature trees towards the northern boundary.</p> | |

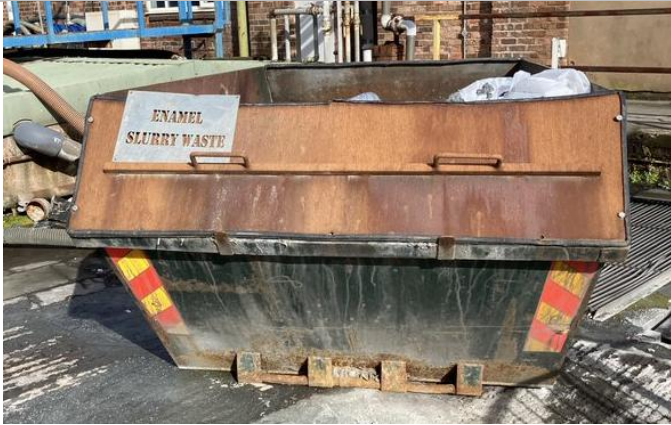
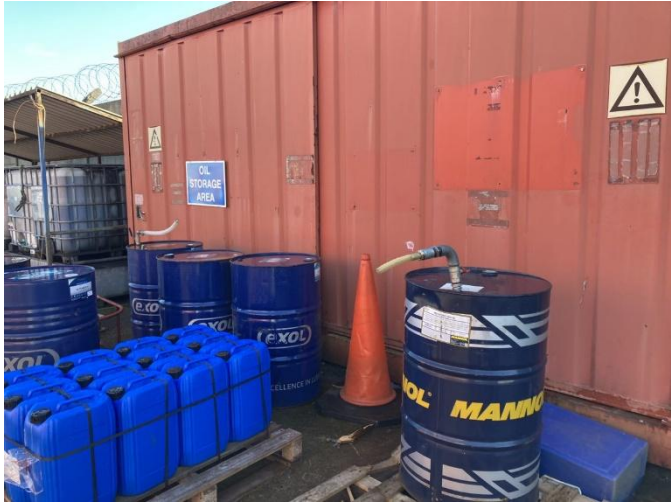
- ✳ Localised areas of elevated Trichloroethene (TCE), Dichloroethene (cis 1,2-Dichloroethene, and Trans 1,2-Dichloroethene), and Vinyl Chloride have been identified within soils in three locations (WS101 to WS103) across the southern boundary of the site, directly to the south of the main factory structure. It is noted that WS102 and WS103 are located within the immediate vicinity of the enamel slurry waste storage area, located to the southeast of the main factory structure. As such, the enamel slurry waste storage area may be the potential source of these exceedances.

| FEATURE | DESCRIPTION | PHOTOGRAPHIC EVIDENCE |
|---|---|---|
| <b>Hazardous Material Storage</b> | <p>An enamel slurry waste storage area was recorded to the southeast of the main factory structure both in an above ground waste skip pictured to the right, and in a below ground storage tank.</p> <p>Two large above ground oil storage containers were noted to the west of the structure, with all containers identified in good condition with no sign of damage.</p> <p>Further instances of hazardous material storage is anticipated within the factory. However, this has not been confirmed at the time of the walkover as a full survey of the factory interior has not been completed.</p> | |

- ✳ Further investigation and subsequent testing is recommended in order to determine the spatial extent of the VOC contamination identified within the soils across the southern boundary of the site and to understand whether leaching had occurred into the underlying natural strata, particularly in WS101 and WS103 where exceedances were only recorded within Made Ground Deposits.

- ✳ If the enamel slurry waste storage area is deemed to be the source, removal of the impacted material is recommended to mitigate any further migration and degradation of TCE into further areas of the site. Subject to the findings of further phases of intrusive ground investigation, further assessment in the form of a Detailed Quantitative Risk Assessment (DQRA) may also be required.

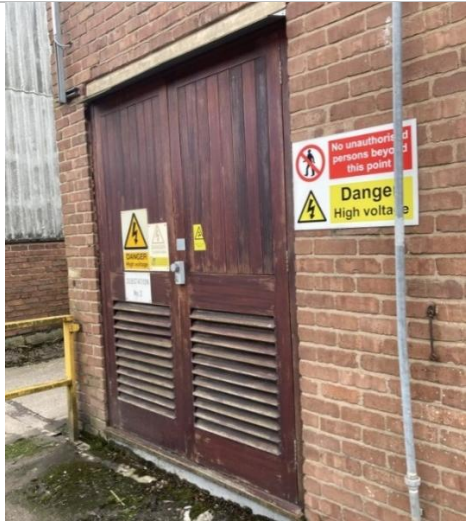
| FEATURE | DESCRIPTION | PHOTOGRAPHIC EVIDENCE |
|---|---|---|
| <b>Polychlorinated Biphenyls (PCBs)</b> | <p>Two electricity substation have been identified on-site towards the northwest and south, both of which were present prior to 1970. Therefore, it is considered likely PCBs are contained within the vicinity of these substations.</p> | |

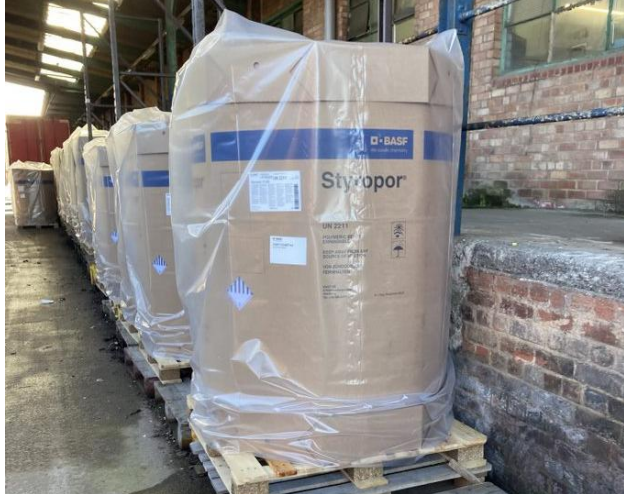
| FEATURE | DESCRIPTION | PHOTOGRAPHIC EVIDENCE |
|---|---|---|
| <b>Volatile Organic Compounds (VOCs)</b> | <p>An active polystyrene manufacturing plant was noted with large imports of polystyrene recorded at the northern boundary adjacent to the structure.</p> <p>This presents a potential source of VOCs within the vicinity of the polystyrene manufacturing plant (northern boundary), however all instances of polystyrene were well stored with all surrounding areas covered in hardstanding.</p> <p>It is understood the polystyrene manufacturing plant was constructed in 2006, and that during the site walkover, no evidence of above or below ground storage tanks of VOCs were identified. However, as access to the plant was restricted due to its active nature, the presence of storage tanks within the plants interior cannot be fully discounted at this time.</p> | |

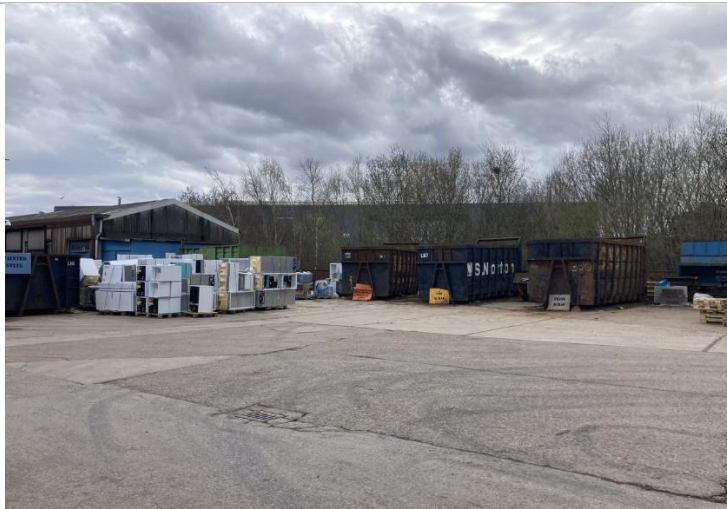
| FEATURE | DESCRIPTION | PHOTOGRAPHIC EVIDENCE |
|---|---|---|
| <b>Waste Storage</b> | <p>Non-hazardous waste storage was present in large containers to the south of the main factory structure adjacent to the two small outbuildings.</p> <p>Some localised areas of fly tipped material was noted across the site however none appeared hazardous.</p> | |

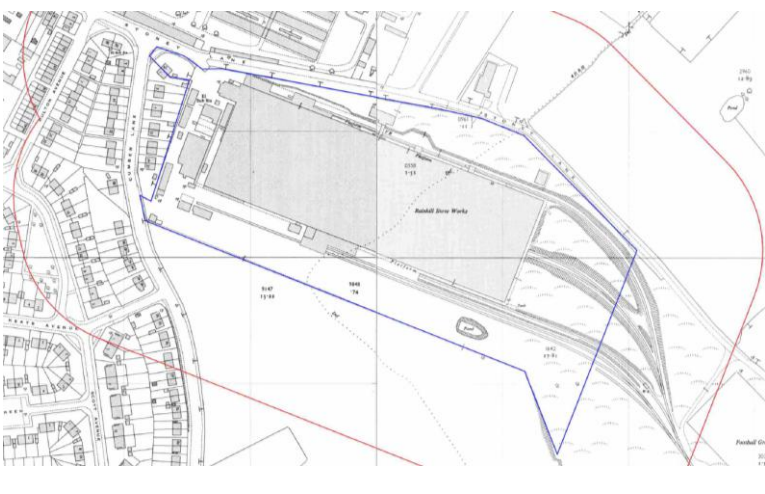
| MAP EDITION | HISTORICAL LAND USE | HISTORICAL MAP EXCERPT |
|---|---|---|
| <p><b>1954-1955</b><br/><b>1:1,250</b></p> | <p>The site now comprises one large structure, with the sidings previously noted segmenting the two structures removed.</p> <p>Additional outbuildings have been constructed towards the northeast of the site with an electricity substation noted to the northwest of the main factory structure.</p> <p>A small pond is noted at the southern boundary adjacent to the sidings towards the east.</p> <p>The tank previously recorded at the southwestern boundary has been removed with a new tank recorded present at the southeastern corner of the main factory structure.</p> <p>Two platforms at the north and south of the main factory structure are noted.</p> | |

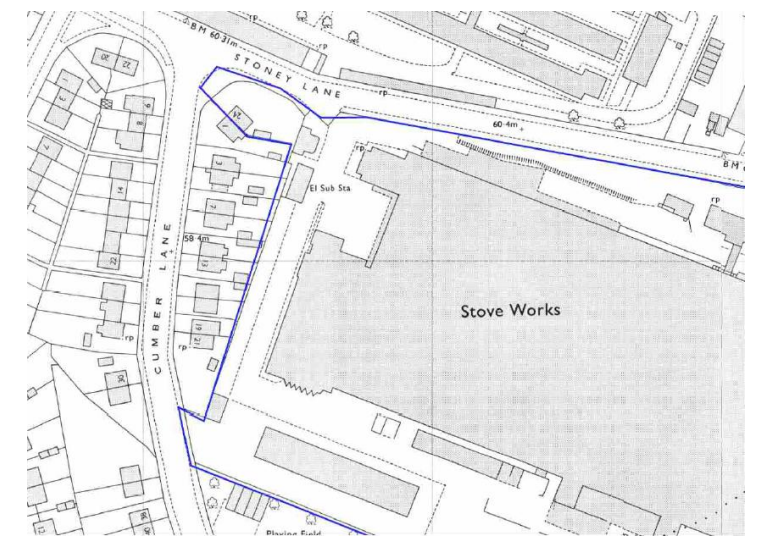
| MAP EDITION | HISTORICAL LAND USE | HISTORICAL MAP EXCERPT |
|---|---|---|
| <p><b>1972-1975</b><br/><b>1:1,250</b></p> | <p>The separated outbuildings previously noted along the western boundary have either been removed or incorporated into the main factory structure.</p> <p>An additional connecting structure is noted at the central northern point of the main factory structure.</p> <p>The structure at the southwestern sector of the site is noted as extended.</p> <p><i>Other sectors of the site are not available within historical mapping.</i></p> | |

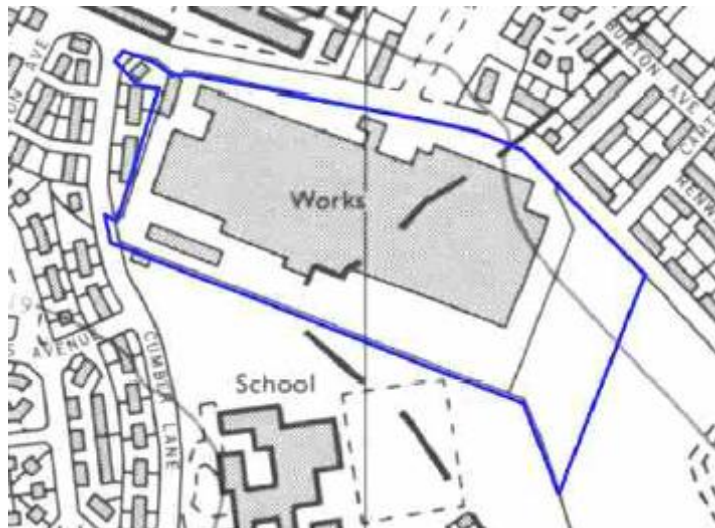
| MAP EDITION | HISTORICAL LAND USE | HISTORICAL MAP EXCERPT |
|---|---|---|
| <p><b>1978</b><br/><b>1:10,000</b></p> | <p>All railway and tramway sidings present in previous mapping have now been removed.</p> <p>A County Parish boundary is noted segmenting the site through the centre of the site.</p> <p>A segmenting boundary is noted at the eastern sector of the site, separating the area from the main works structure. It is assumed this is the construction of the car parking area.</p> | |

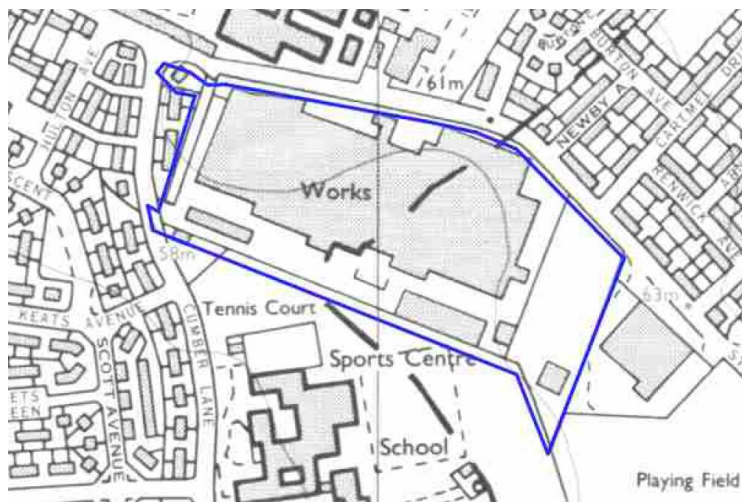
| MAP EDITION | HISTORICAL LAND USE | HISTORICAL MAP EXCERPT |
|---|---|---|
| <p><b>1990</b><br/><b>1:10,000</b></p> | <p>Small compositional changes to the main factory structure have been identified, with expansions noted towards the northern and southeastern sector of the main factory structure.</p> <p>Additional structures are noted at the southeastern and southern sectors of the site.</p> <p>Further boundaries segmenting the western sector of the site are noted.</p> | |

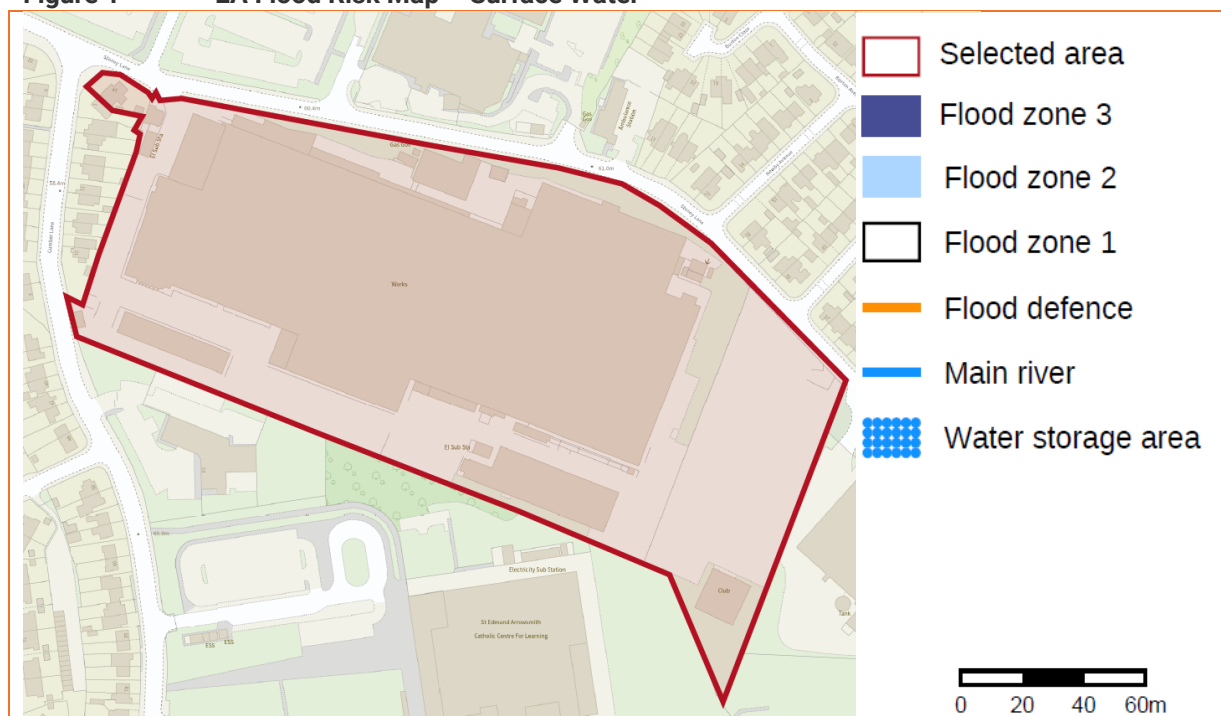
**Figure 1 EA Flood Risk Map – Surface Water**

The site is predominantly located within a currently defined “Flood Risk Zone 1”, defined as land assessed as having less than 1 in 1,000 annual probability of river or sea flooding (< 0.1%) and, as such, is considered to be unaffected by river flooding. In addition, the Groundsure report states there is a limited potential for groundwater flooding at the majority of the site, with discrete areas at the southeast at a moderate risk. The Environment Agency (EA) Flood Risk Maps for the site is presented in Figure 1 and Groundsure Groundwater Flooding Map in Figure 2.

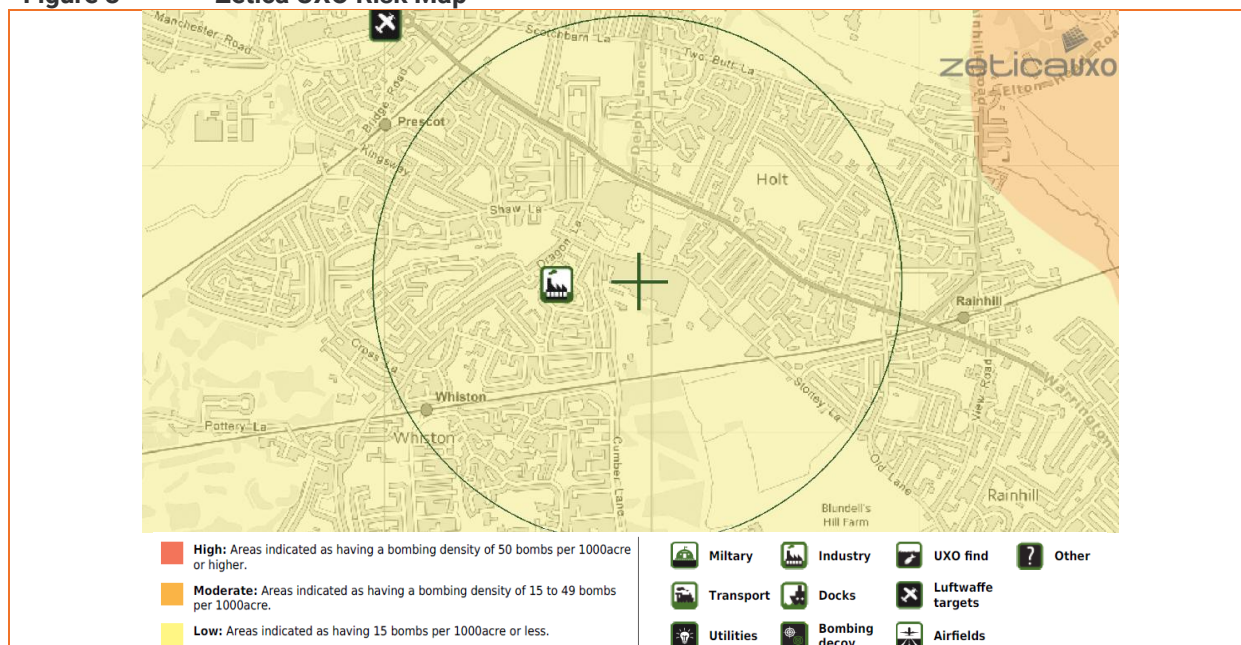
**Figure 3 Zetica UXO Risk Map**

The regional unexploded bomb risk map from Zetica (2014) indicates that the site is in an area at a low risk from possible unexploded ordnance (UXO) resulting from the Second World War. The Zetica UXO Risk Map is presented in Figure 3.

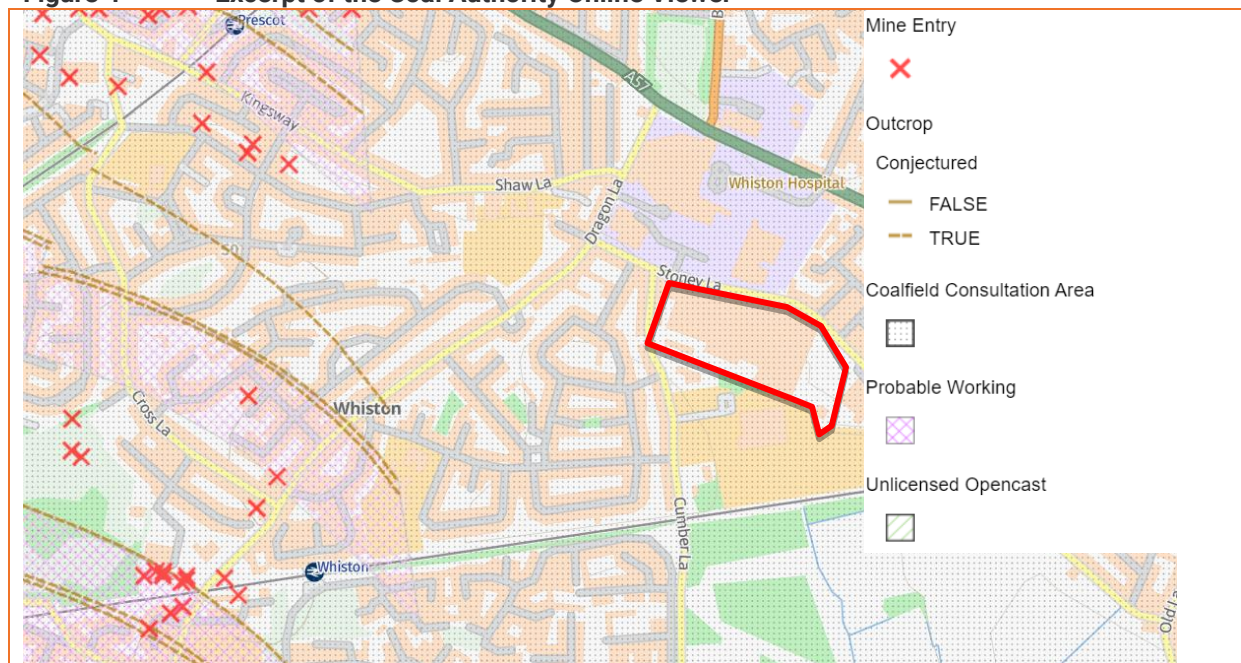
**Figure 4 Excerpt of the Coal Authority Online Viewer**

In the first instance, E3P has reviewed the Coal Authority Online Viewer, and an excerpt of this is presented in Figure 4. This map shows that the site does not lie within a high-risk development area. No recorded coal seams are present on-site; the closest worked coal seam is located approximately 530 m to the west, which dip down away from the site.

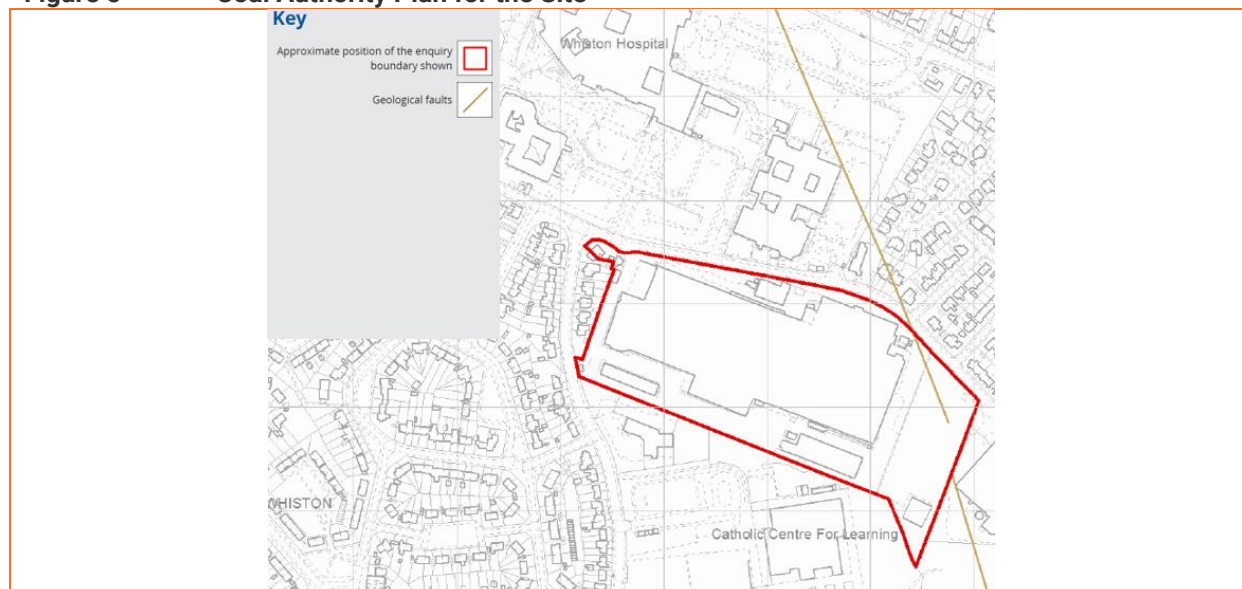
**Figure 5 Coal Authority Plan for the Site**

The Coal Authority plan referenced: MR-LARGE-PLOT-51003408185001-1709132950870 shows there are no hazardous mining associated features within the vicinity of the site as illustrated in Figure 5.

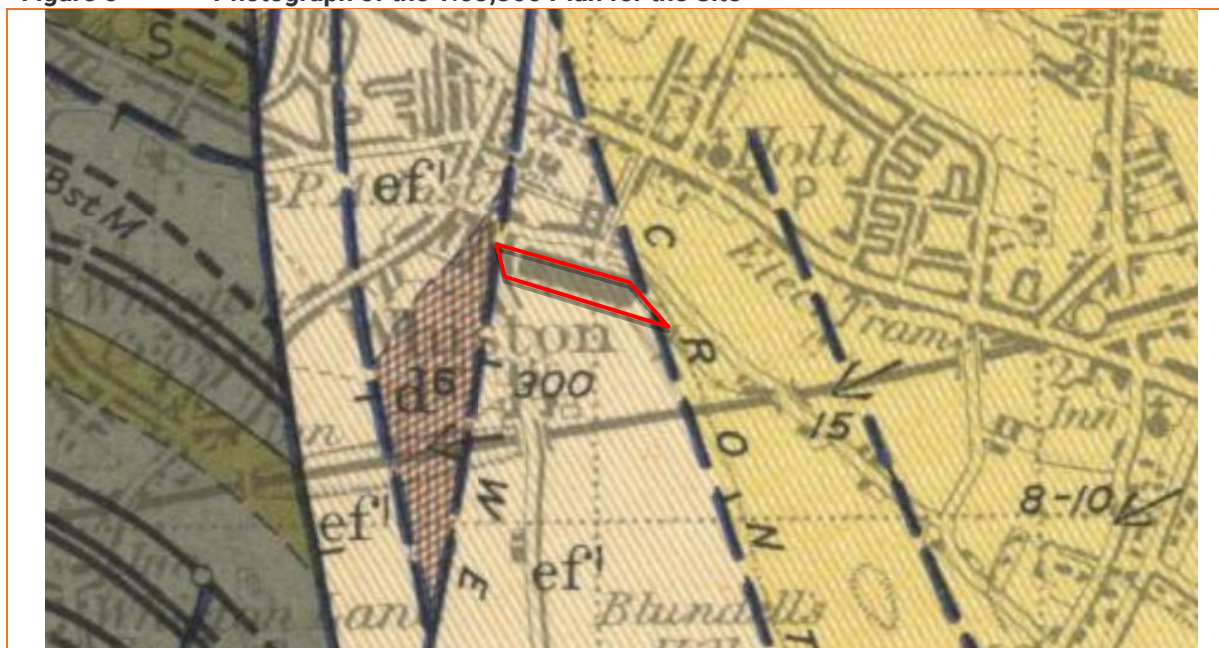
**Figure 6** Photograph of the 1:63,360 Plan for the Site

Figure 6 is a photograph of the 1:63,360 plan for the site, which shows a geological fault (Cronton Fault) traversing northwest to southeast through the eastern sector of the site, with a downthrow to the east.

No coal outcrops are recorded within an influencing distance to the site, with all known worked seams situated > 500 m to the west of the site within the Pennine Middle Coal Measures.

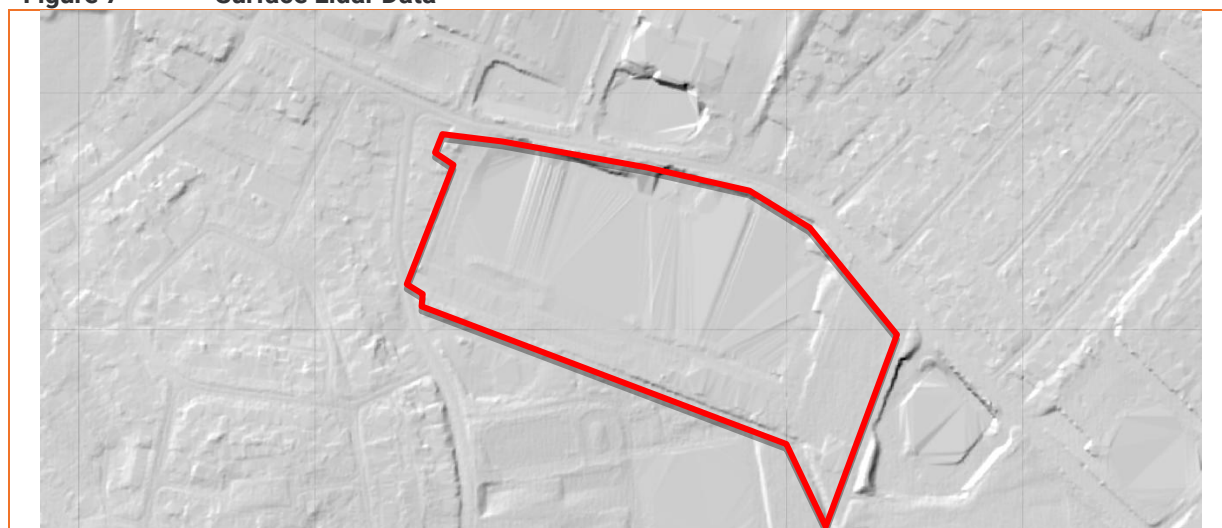
**Figure 7**      **Surface Lidar Data**

It is possible that the historical level raising has resulted in a greater thickness of Made Ground overlying the natural glacial till and glaciofluvial deposits, and potentially underwent earthworks to create a development platform for the factory present.

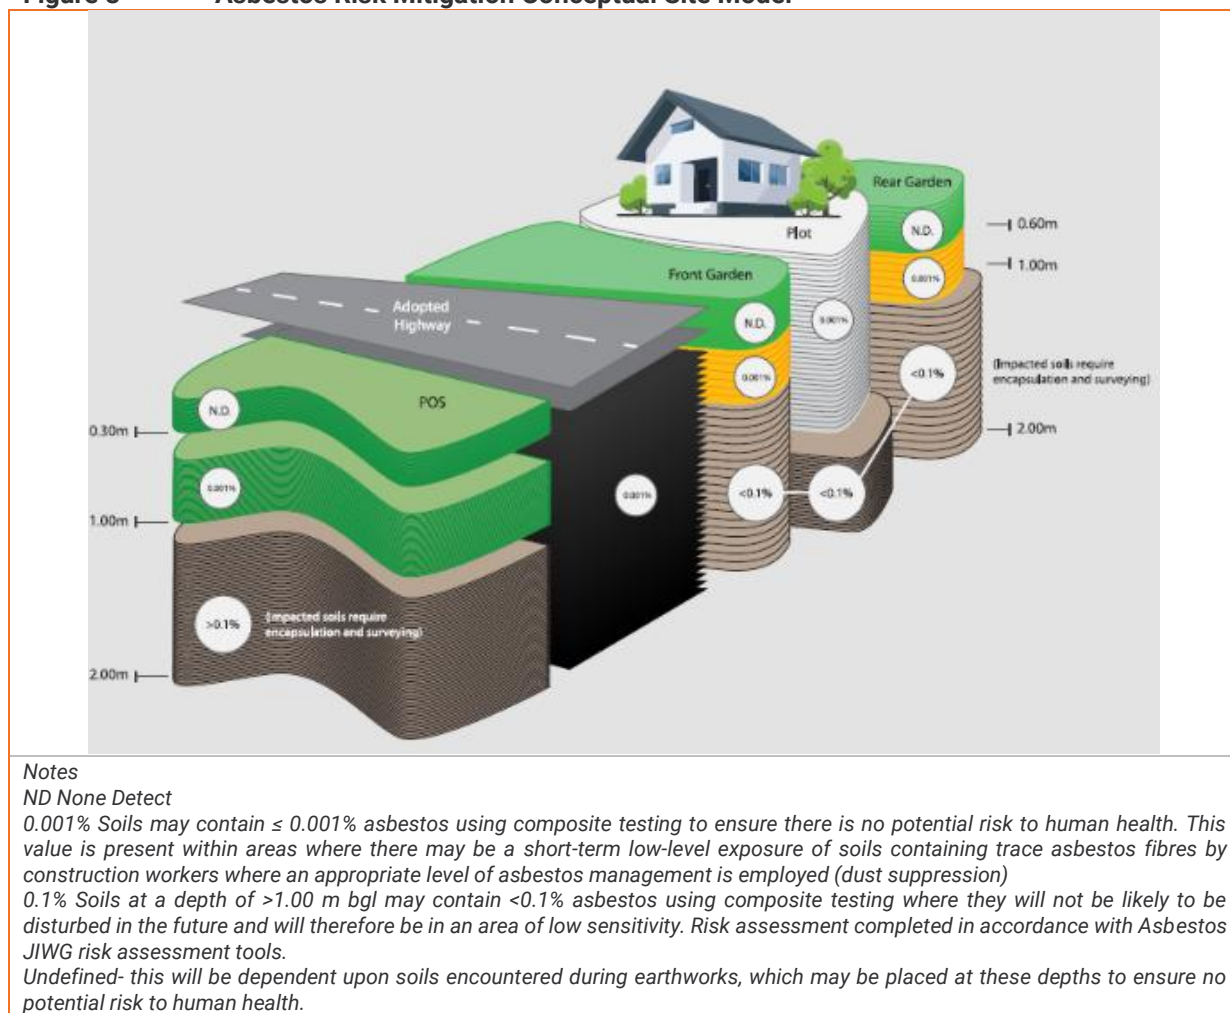
**Figure 8 Asbestos Risk Mitigation Conceptual Site Model**

If Asbestos fibres are encountered, a primary exposure pathway of inhalation of fibres (PL3) would be presented to site personnel and end users. Impacted soils should be managed according to the asbestos risk mitigation conceptual site model shown in Figure 8.

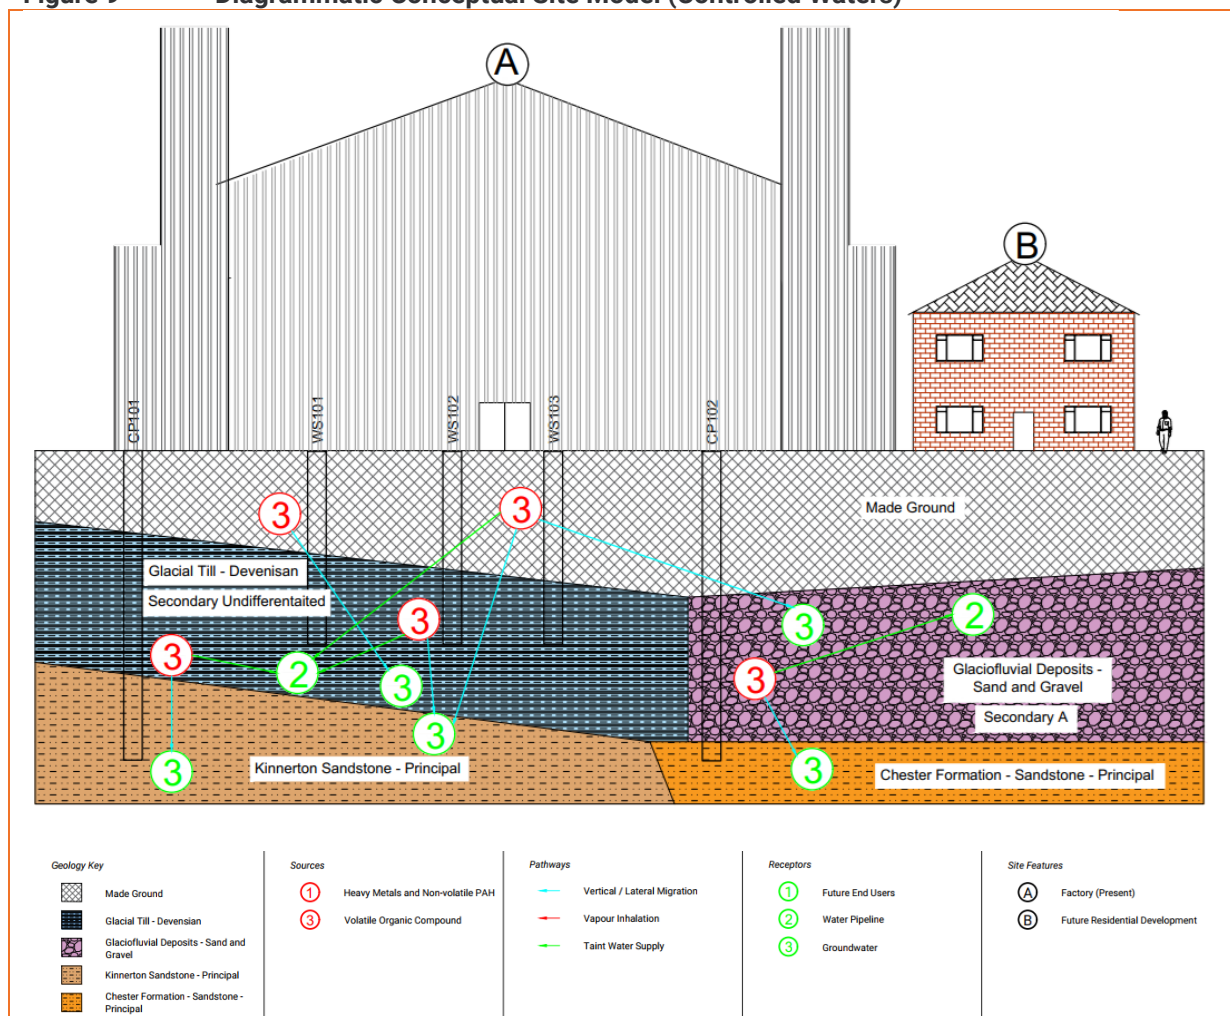
**Figure 9** Diagrammatic Conceptual Site Model (Controlled Waters)

In addition to above, E3P has developed a diagrammatic controlled waters conceptual model which considers the factors in Table 30. This is presented as Drawing 17-500-027 in APPENDIX IV and a snapshot is included in Figure 9.

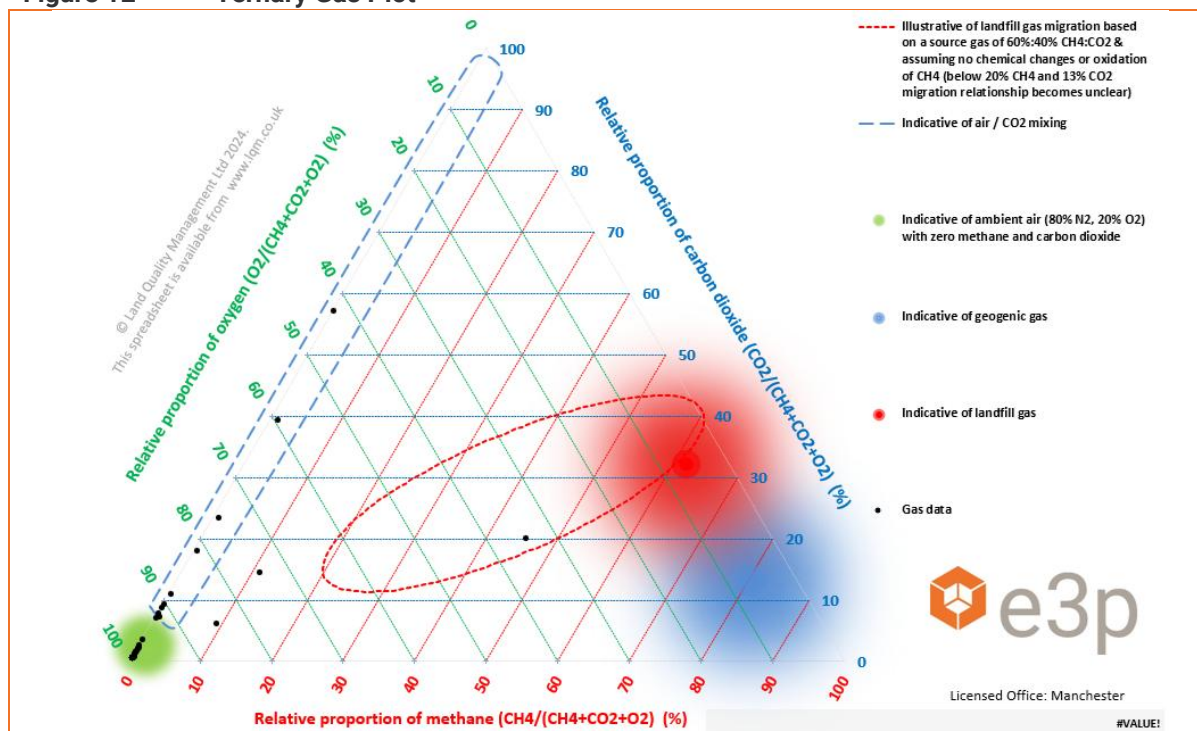
**Figure 12 Ternary Gas Plot**

Figure 12 shows the ternary gas plot for the gas monitoring data.

The ternary gas plot indicates the majority of the ground gas monitoring results have standard oxygen and generally low carbon dioxide concentrations with limited occasions of carbon dioxide concentrations above 5%, and no elevated methane, which is indicative of natural sources (green area on the ternary plot).

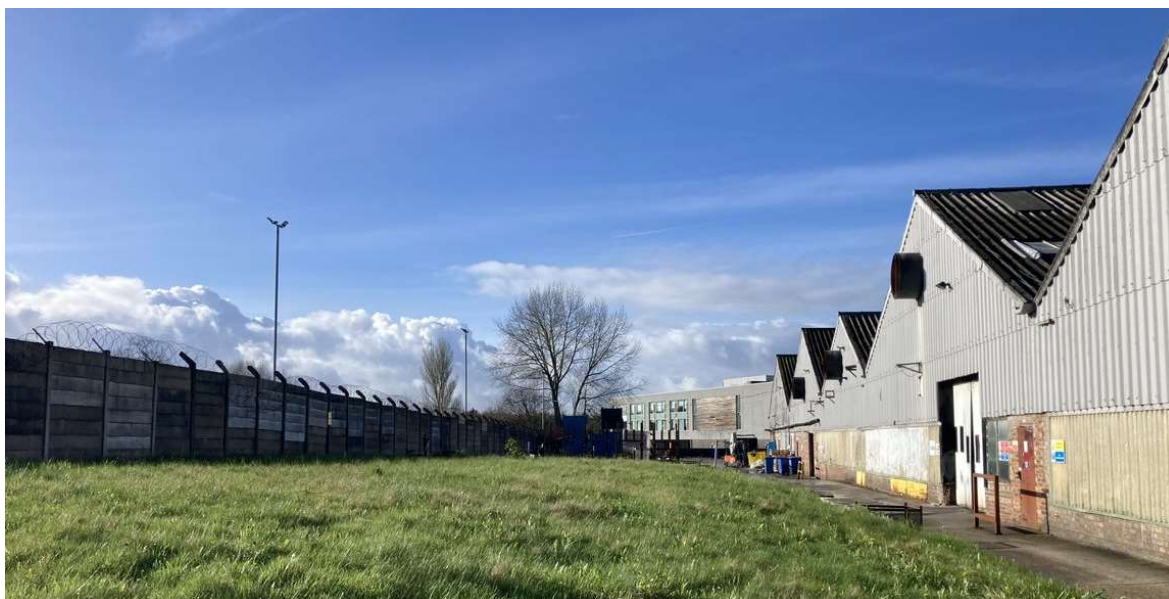
PLATE 1 WESTERN BOUNDARY OF FACTORY BUILDING (FACING SOUTH)

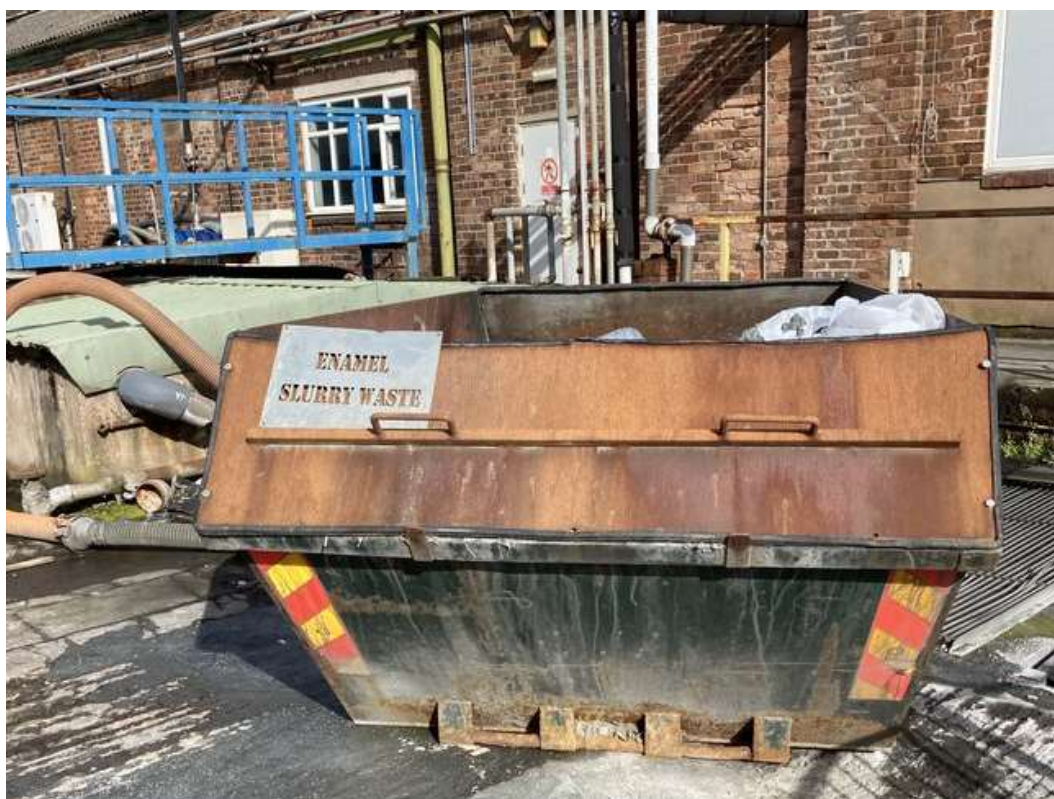
PLATE 2 ENAMEL SLURRY WASTE STORAGE AREA (FACING SOUTH)

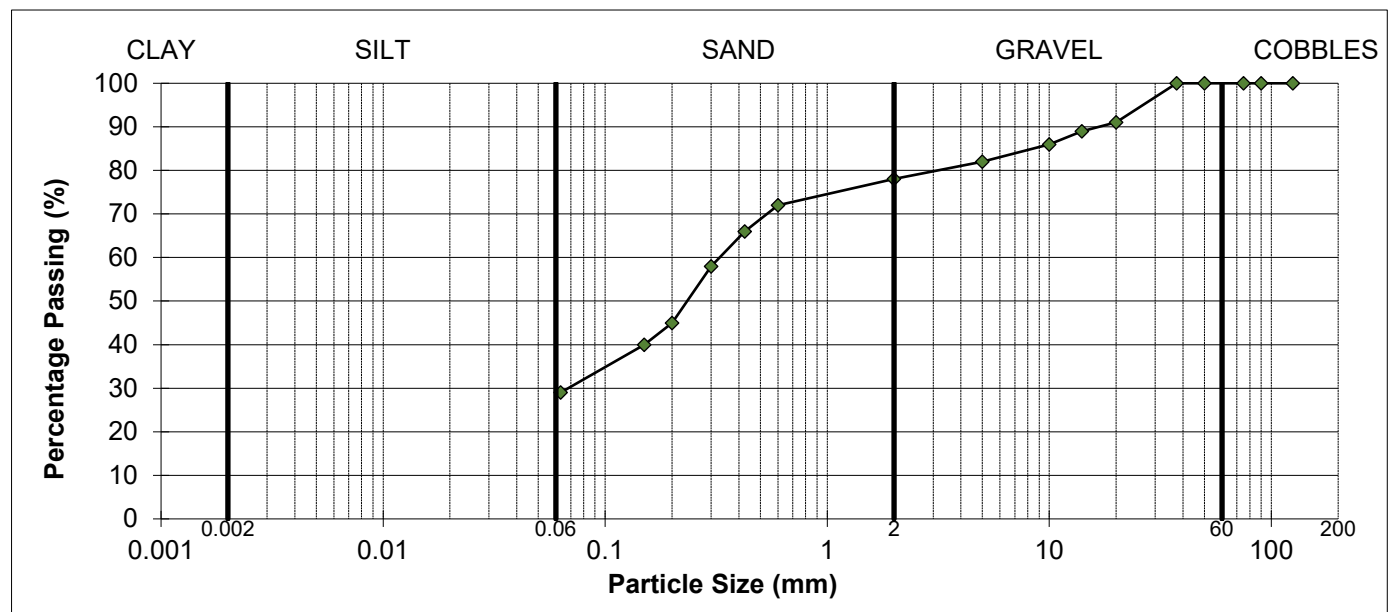
| SOIL FRACTIONS | | | |
| COBBLES | 0% | SAND | 49% |

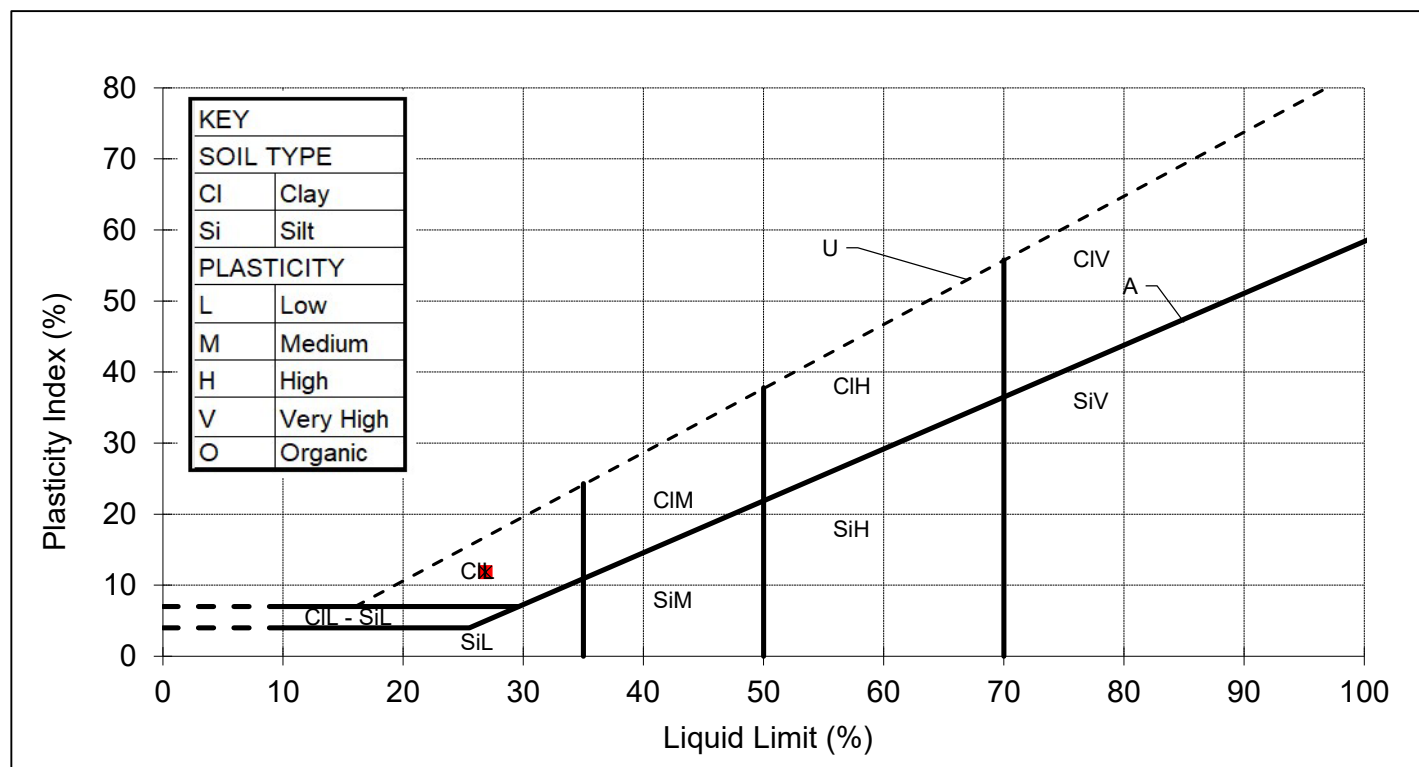
| Natural Moisture Content (%) | Liquid Limit (%) | Plastic Limit (%) | Plasticity Index (%) | Passing 425 micron (%) |
|---|---|---|---|---|
| 15.7 | 27 | 15 | 12 | 97 |

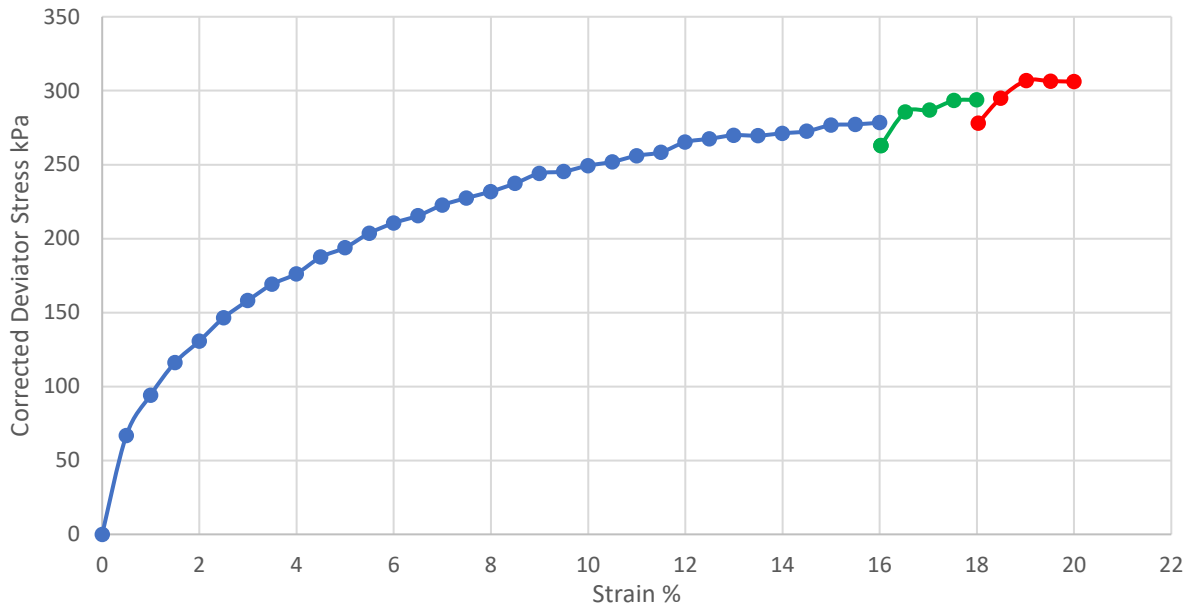
CORRECTED DEVIATOR STRESS vs AXIAL STRAIN

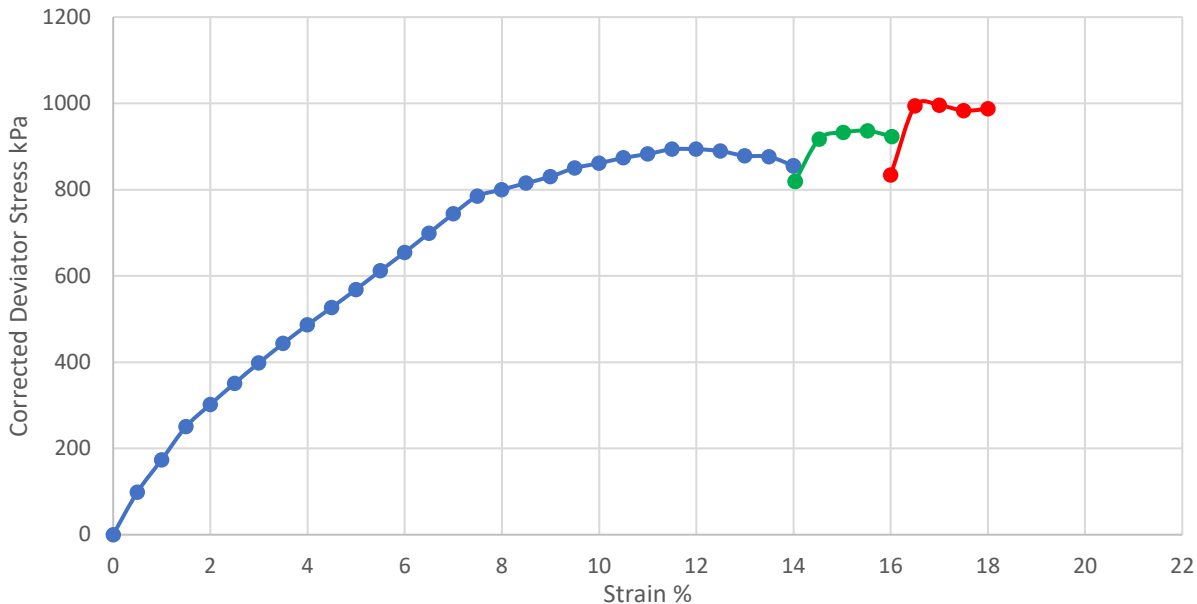
### CORRECTED DEVIATOR STRESS vs AXIAL STRAIN

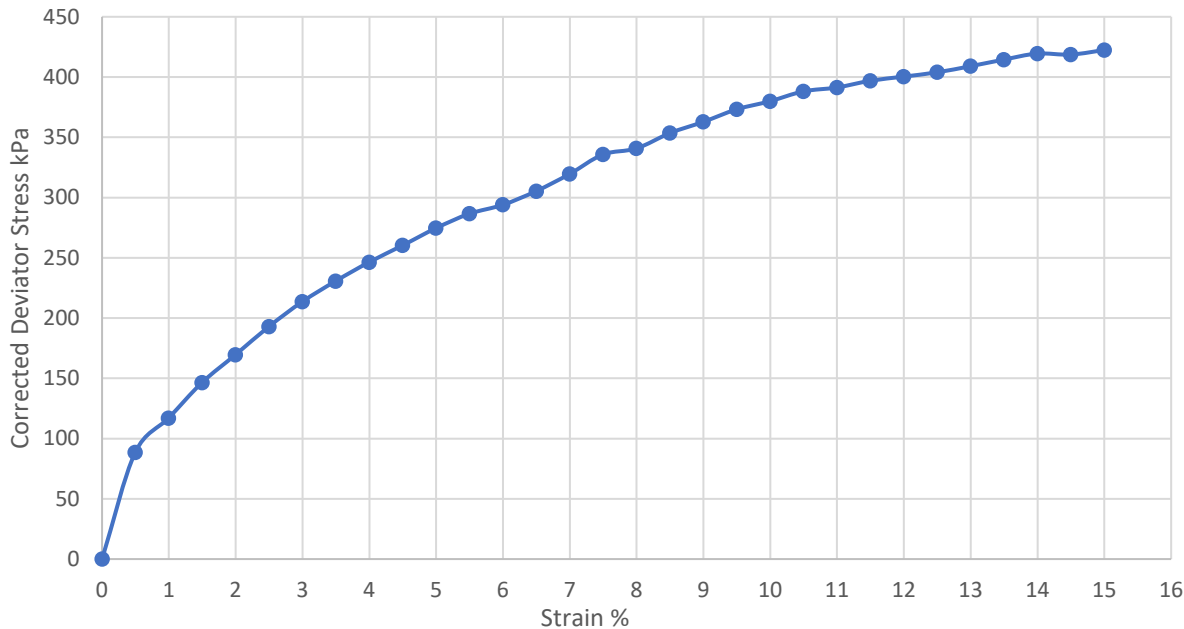
### CORRECTED DEVIATOR STRESS vs AXIAL STRAIN

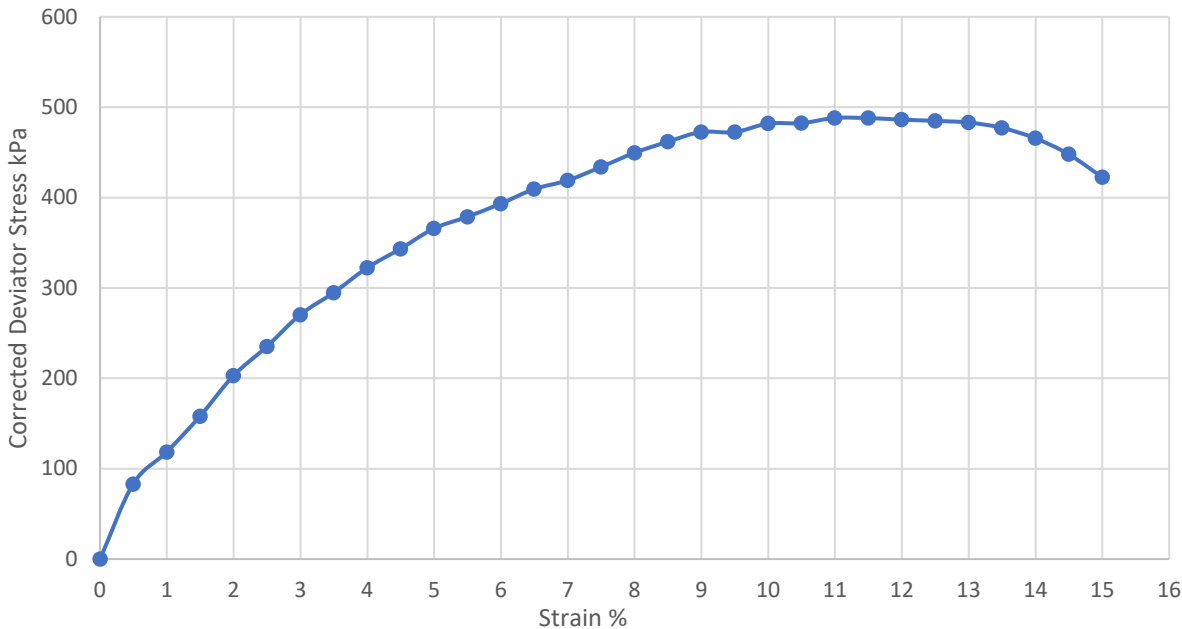
### CORRECTED DEVIATOR STRESS vs AXIAL STRAIN

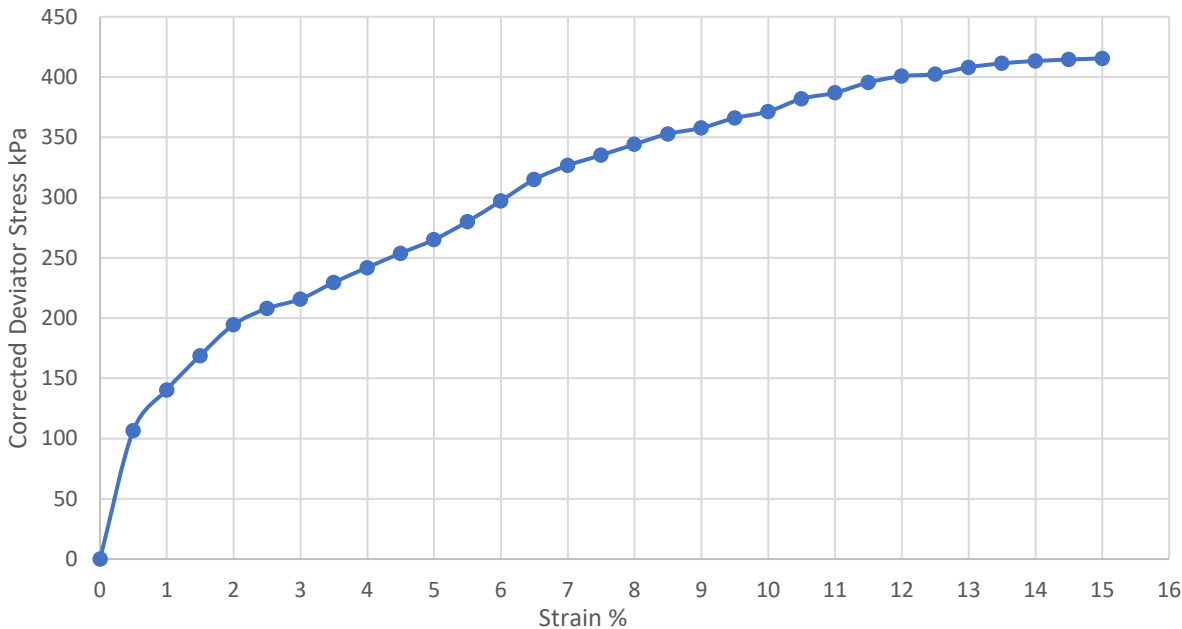
### CORRECTED DEVIATOR STRESS vs AXIAL STRAIN
