**Wilson Road, Huyton**

**Updated Bat Survey Report**

| <b>Document:</b> | <b>BOW17.1593 Wilson Road, Huyton Updated Bat Report August 2024</b> | | | |

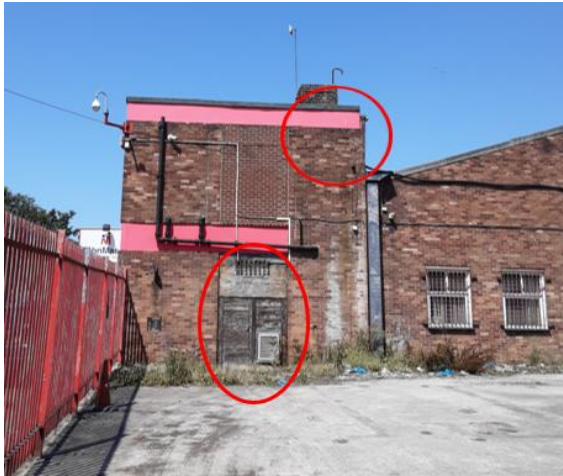
| Building & elevation | Description | Photograph |
|---|---|---|
| Office/warehouse,<br>South-eastern elevation | <p>Primarily constructed from red brick with red PVC fascia, the structure of this building is in moderate condition. The roof is flat, with a felt covering. This appears in good condition with no lifting noted. The timber door, however, is in poor condition with missing slats forming potential roosting features (PRFs), along with a timber board covering the upper most half of the door and wall, which has several circular gaps allowing access to a small crevice between the wooden board and the wall. Other PRFs on this elevation include missing mortar on degraded brickwork near to the top of the building.</p> | |

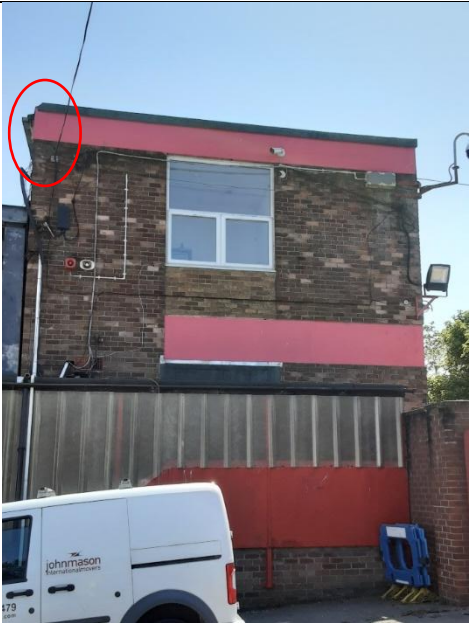
| Office block, north-western elevation | <p>Primarily constructed from red brick with red PVC fascia, the structure of this building is in moderate condition. The roof is flat, with a felt covering. This appears in good condition with no lifting noted, likewise the PVC window is well-sealed. A timber soffit located on the eastern elevation of this section (where the guttering is attached, overlooking the warehouse unit), appears degraded with several splinters and gaps presenting PRFs. Plastic corrugated sheeting is attached to the bottom half of the structure; whilst corrugated sheeting can provide PRFs for bats, in this case the transparent material is unsuitable, likely providing wide ranging temperature fluctuations and light levels. A large flood light is also present, likely lowering the suitability of the PRFs present.</p> | A photograph showing the north-western elevation of a two-story brick building. The upper floor has a single window with a white frame. The lower floor is partially obscured by a white van and a red wall. A red circle highlights a small area on the upper floor's facade. |

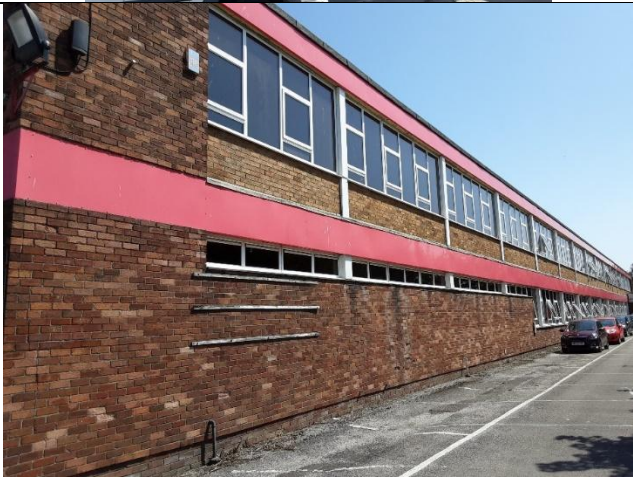
| Office block, western elevation | <p>This section of the building faces a relatively busy road, on a street lined with streetlamps; scattered semi-mature trees also line this section of the pavement. The building is primarily constructed from red brick with red PVC fascia's, the structure of this building is in moderate condition. The roof is flat, with a felt covering. This appears in good condition with no lifting noted, likewise the PVC windows all appear well sealed. No PRFs were noted on this elevation.</p> | A photograph showing the western elevation of the same brick building. It features a long row of windows on the upper floor and a red PVC fascia running along the roofline. The building is situated next to a paved road. |

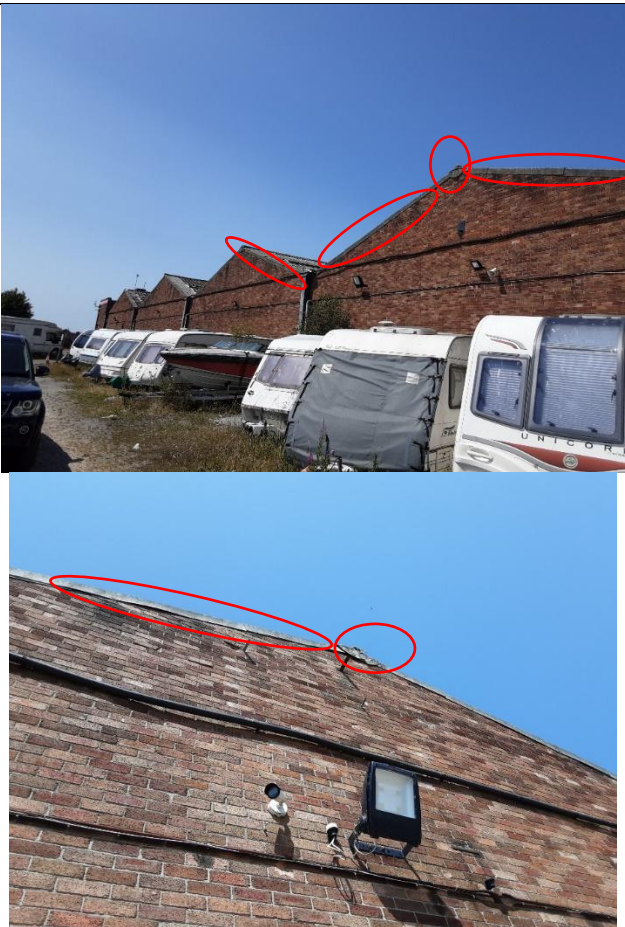
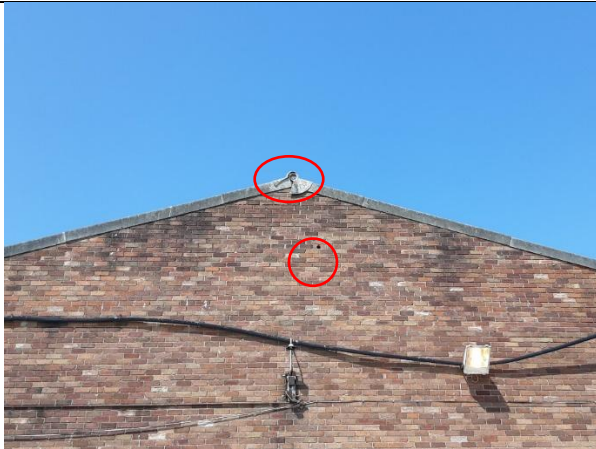
| Warehouse, south-eastern elevation | <p>This building is primarily constructed from red brick, with several pitched roofs on steel frames that are covered with asbestos sheeting. Some of the pitches have sky lights present; there is no loft space. The brickwork is in relatively good condition; however the roof structure/materials appear to be deteriorating. Several PRFs were noted across this elevation, including lifting lead flashing along the roof verges, Missing/damaged verge apex caps, and holes in the brickwork. However, extensive floodlighting across this elevation likely lowers the value of these features for roosting bats.</p> | |

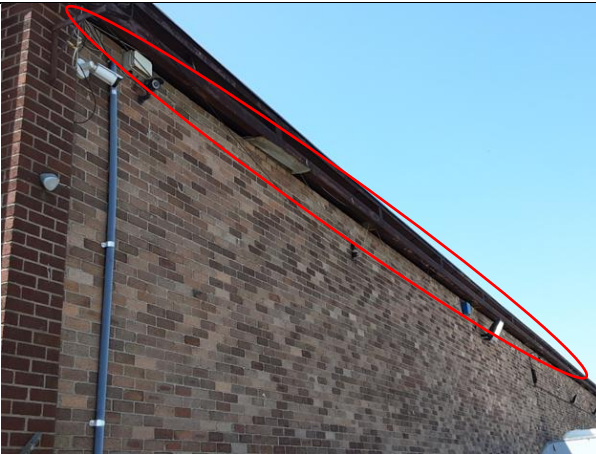
| Warehouse, eastern elevation | <p>This building is primarily constructed from red brick, there are several pitched roofs with steel frames that are covered with asbestos sheeting. Some of the pitches have sky lights present; there is no loft space. The brick work on this elevation is in excellent condition. There is a large gap between the top of the wall and the roof that spans the length of the building, here the steel frame is exposed. This provides entry into the building. However, due to the nature of the storage facility on site, the internal structure of the building is unsuitable for roosting void dwelling bats (brown long ear, maternity roosts) due to constant noise, light, and vibrational disturbance. Furthermore, floodlights present across the elevation will likely deter bat presence.</p> | |

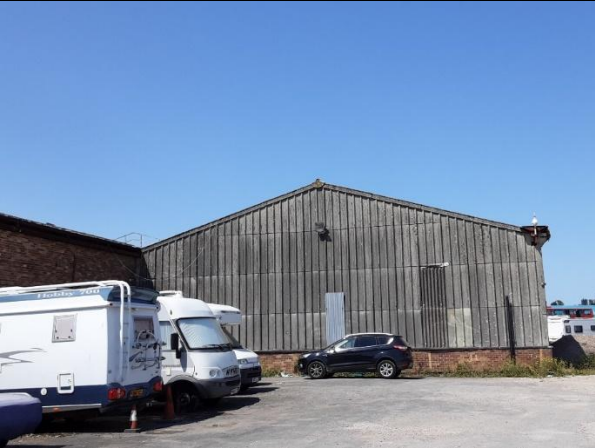
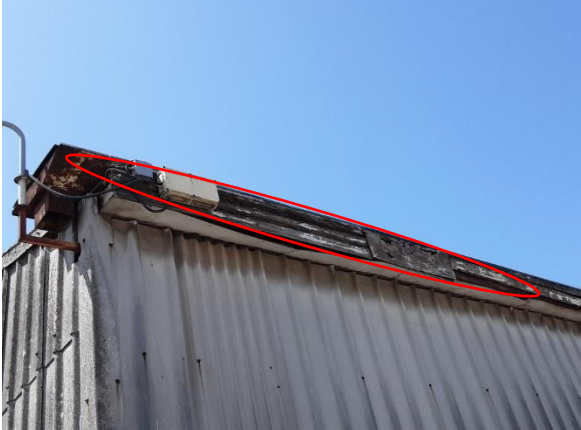
| <p>Warehouse, south-eastern and eastern elevation.</p> | <p>This section of the warehouse is constructed from a red brick base with asbestos sheeting both on the walls and roof structure. The roof is pitched with several skylights present. The building is in poor condition. Corrugated asbestos sheeting provides limited PRFs suitable for crevice dwelling bats. In addition, a splintered timber soffit on the eastern elevation provides a PRF. However, floodlights present across the elevations will likely deter bat presence.</p> | |

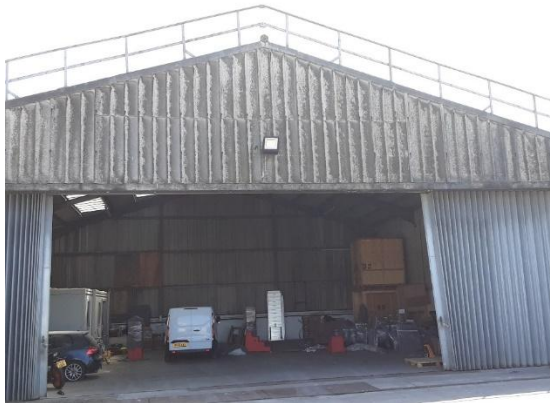
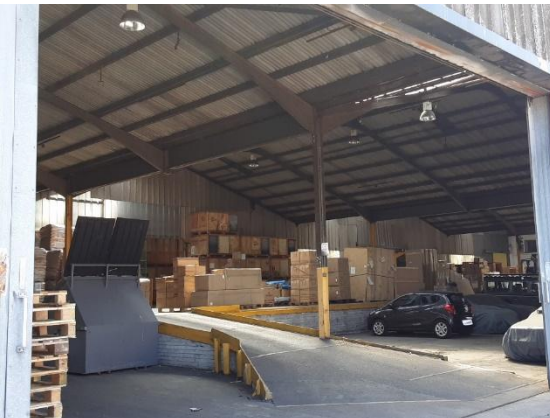
| Warehouse, north-eastern elevation | <p>This section of the warehouse is constructed almost entirely from asbestos sheeting on large steel frames, with metal concertina style shutter doors on the openings. These shutters are open for most of the day and there is constant activity inside the buildings. Asbestos sheeting provides limited PRFs. The potential of these features is lowered due to disturbance and the presence of flood lighting.</p> | |

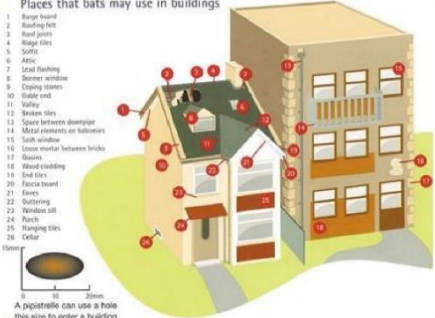
### Places that bats may use in buildings

1. Barge board  
2. Roofing felt  
3. Roof joints  
4. Ridge tiles  
5. Soffit  
6. Attic  
7. Lead flashing  
8. Dormer windows  
9. Coping stones  
10. Gable end  
11. Valley  
12. Broken tiles  
13. Space between downpipe  
14. Metal elements on balconies  
15. Gable windows  
16. Loose mortar between bricks  
17. Quoin  
18. Wood cladding  
19. End eave  
20. Facia board  
21. Eave  
22. Gutters  
23. Window sill  
24. Porch  
25. Hanging tiles  
26. Cavity

0 10 20m  
A pipistrelle can use a hole this size to enter a building
