## Overarching Geo-Environmental Site Summary

Parcel C, Prescott Miller  
13-158-R1  
October 2020

# OVERARCHING GEO-ENVIRONMENTAL SITE SUMMARY

Parcel C  
Carr Lane  
Prescot  
L34 1JZ

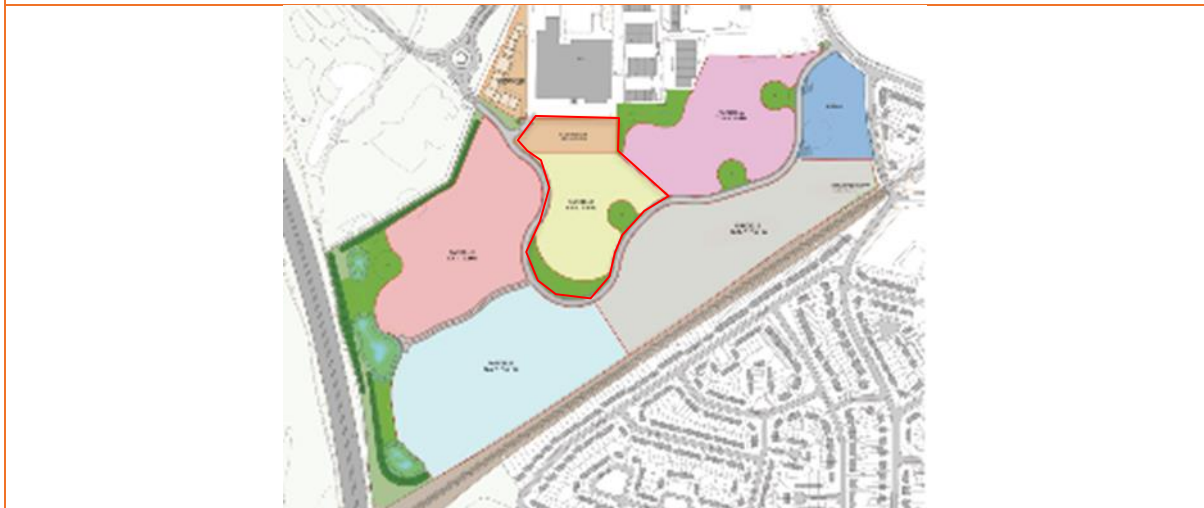
FIGURE 1.1 SITE PARCEL PLAN

For the avoidance of doubt, E3P can confirm that the parcel of land refers to the red-line boundary as indicated in Figure 1.1 below:

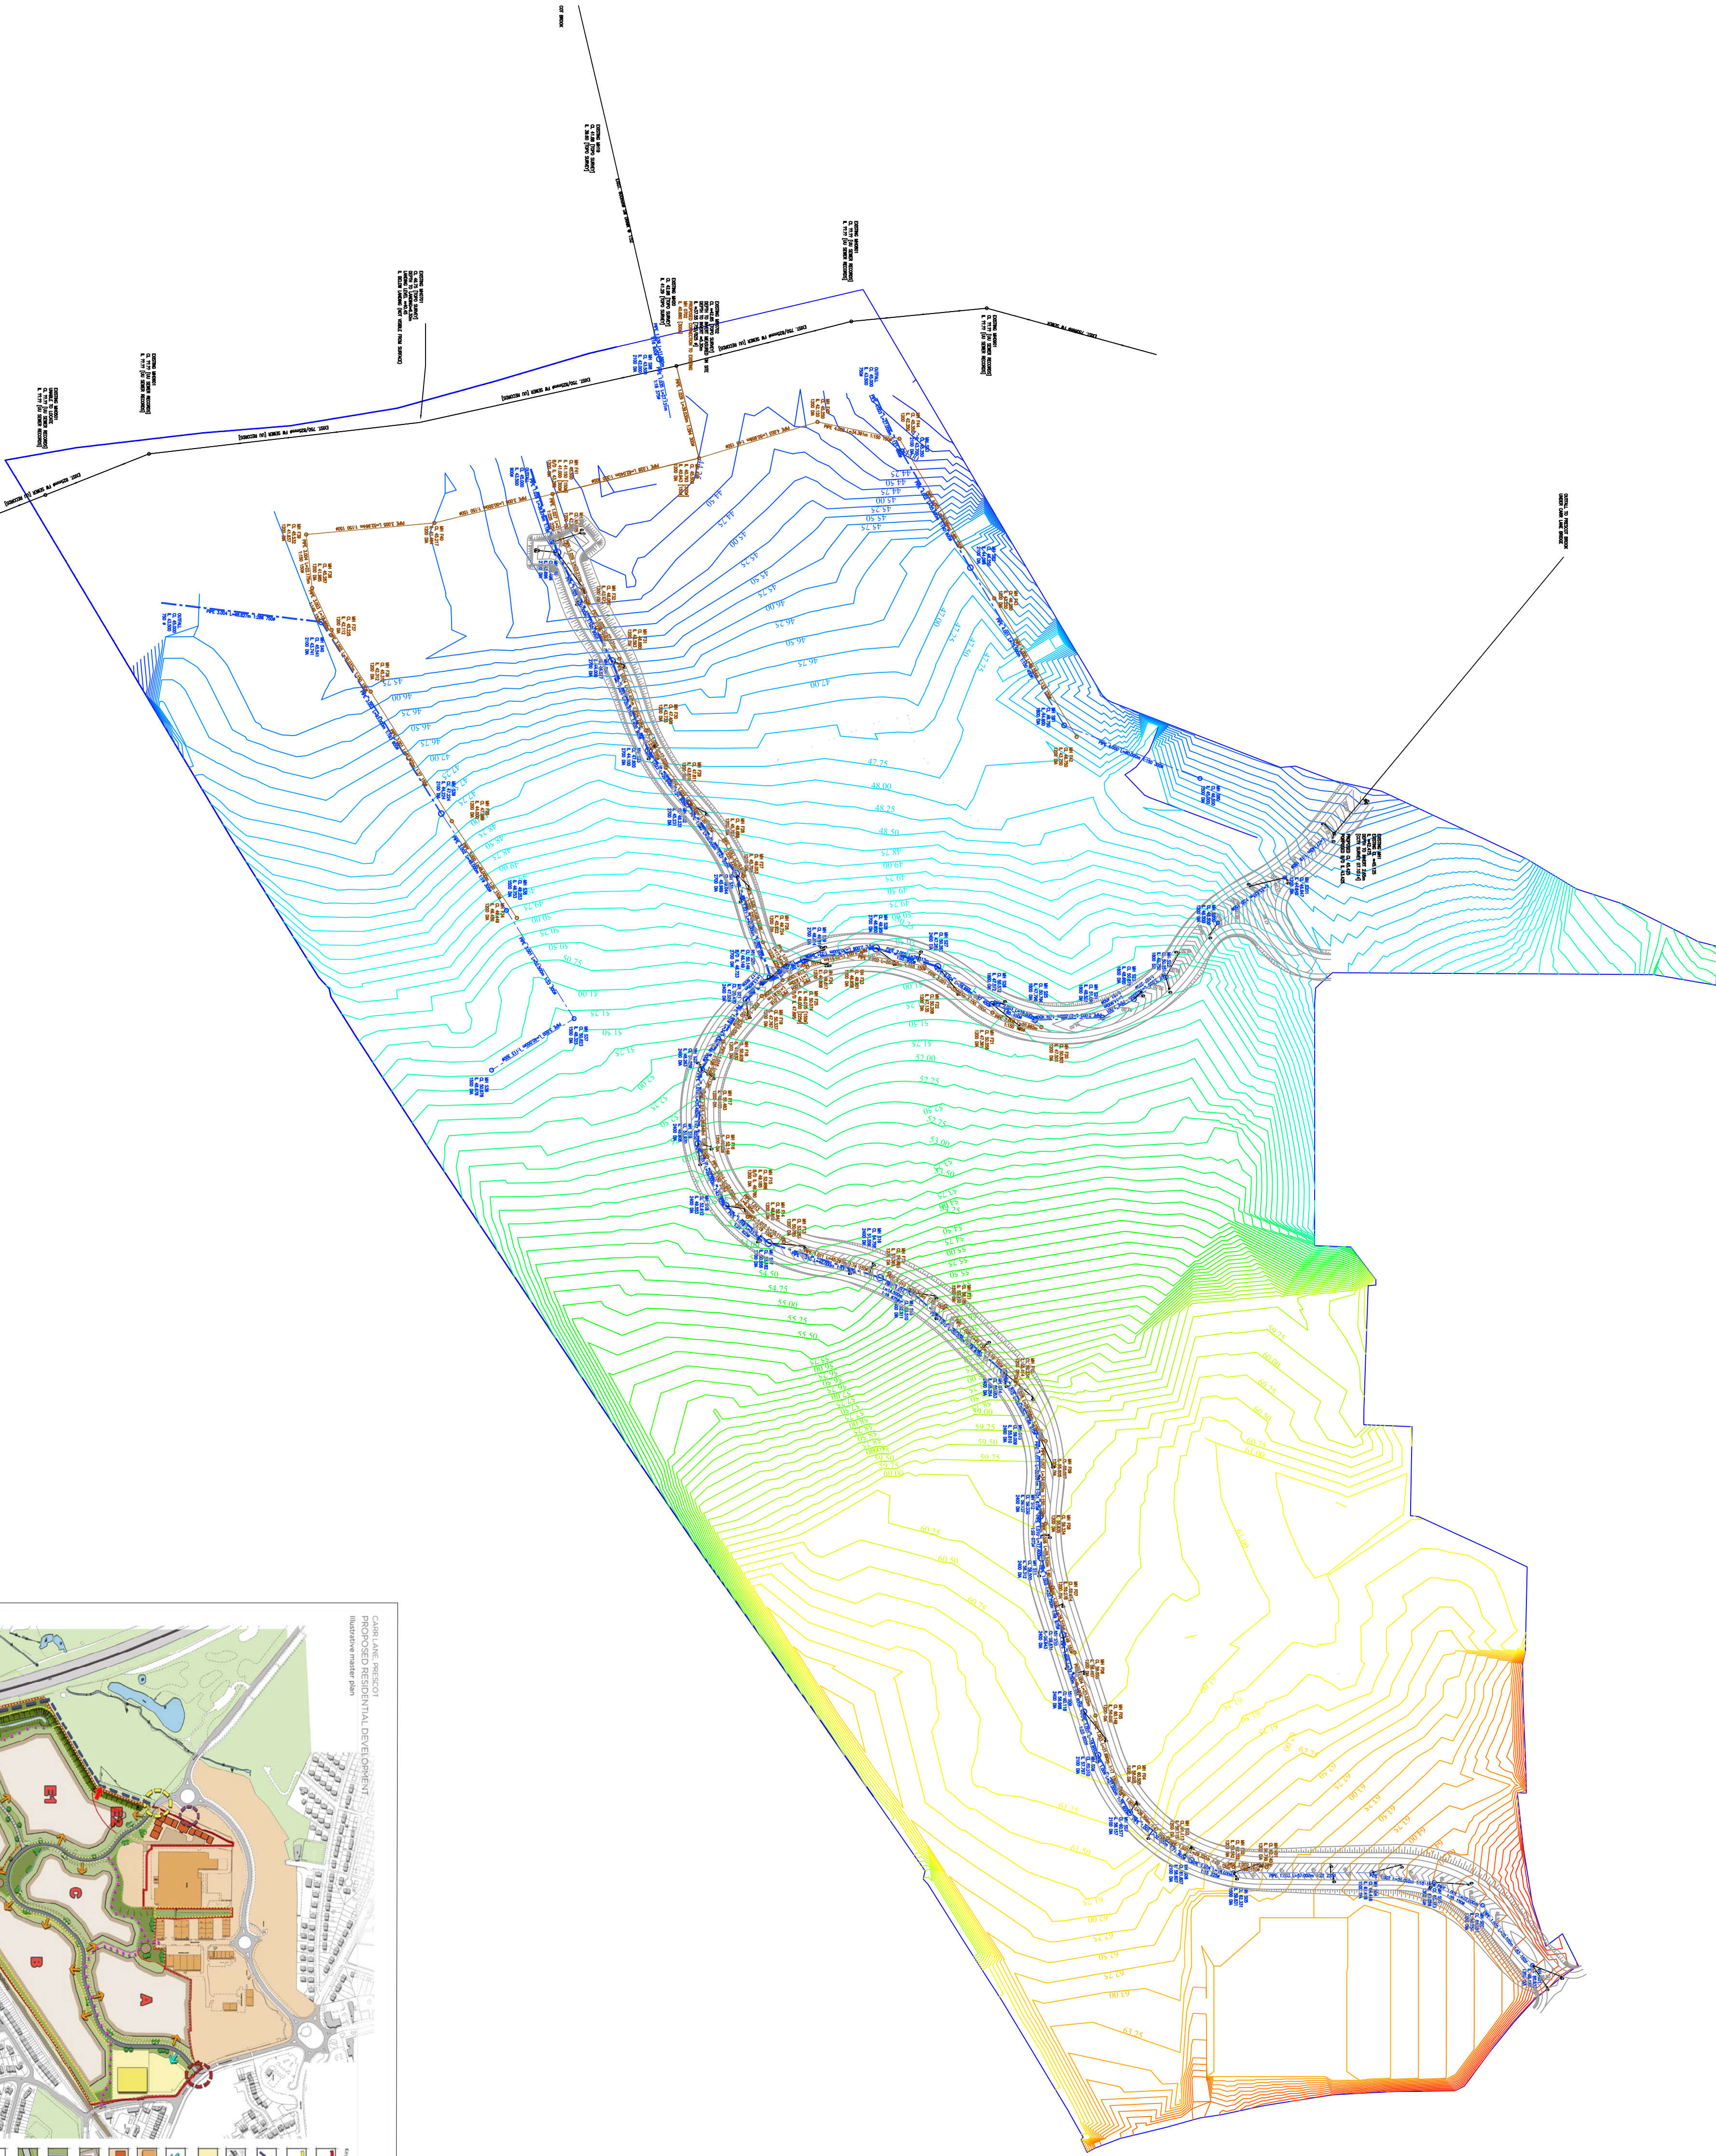
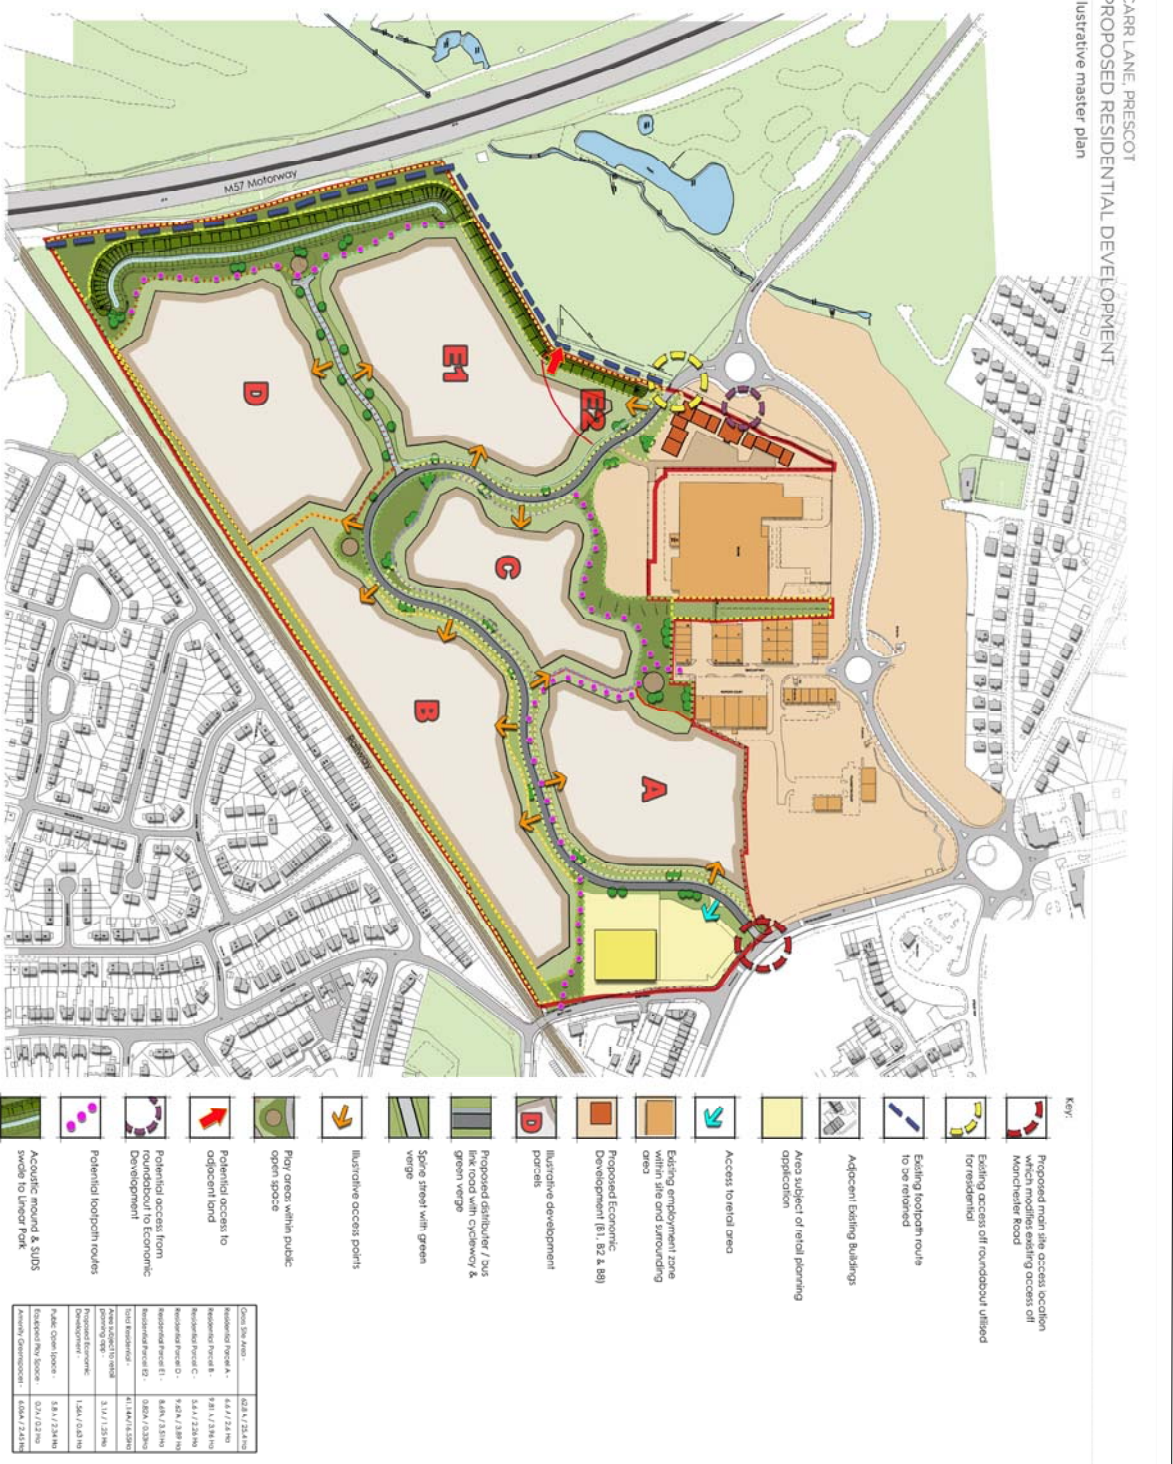
- XX.XX Indicative Regrade Level (500mm Construction Allowed for in Volumetrics)
- Designed Gradient/Assumed Gradient Direction
- Fill from OGL to Formation Level
- XX.XX Cut from OGL to Formation Level

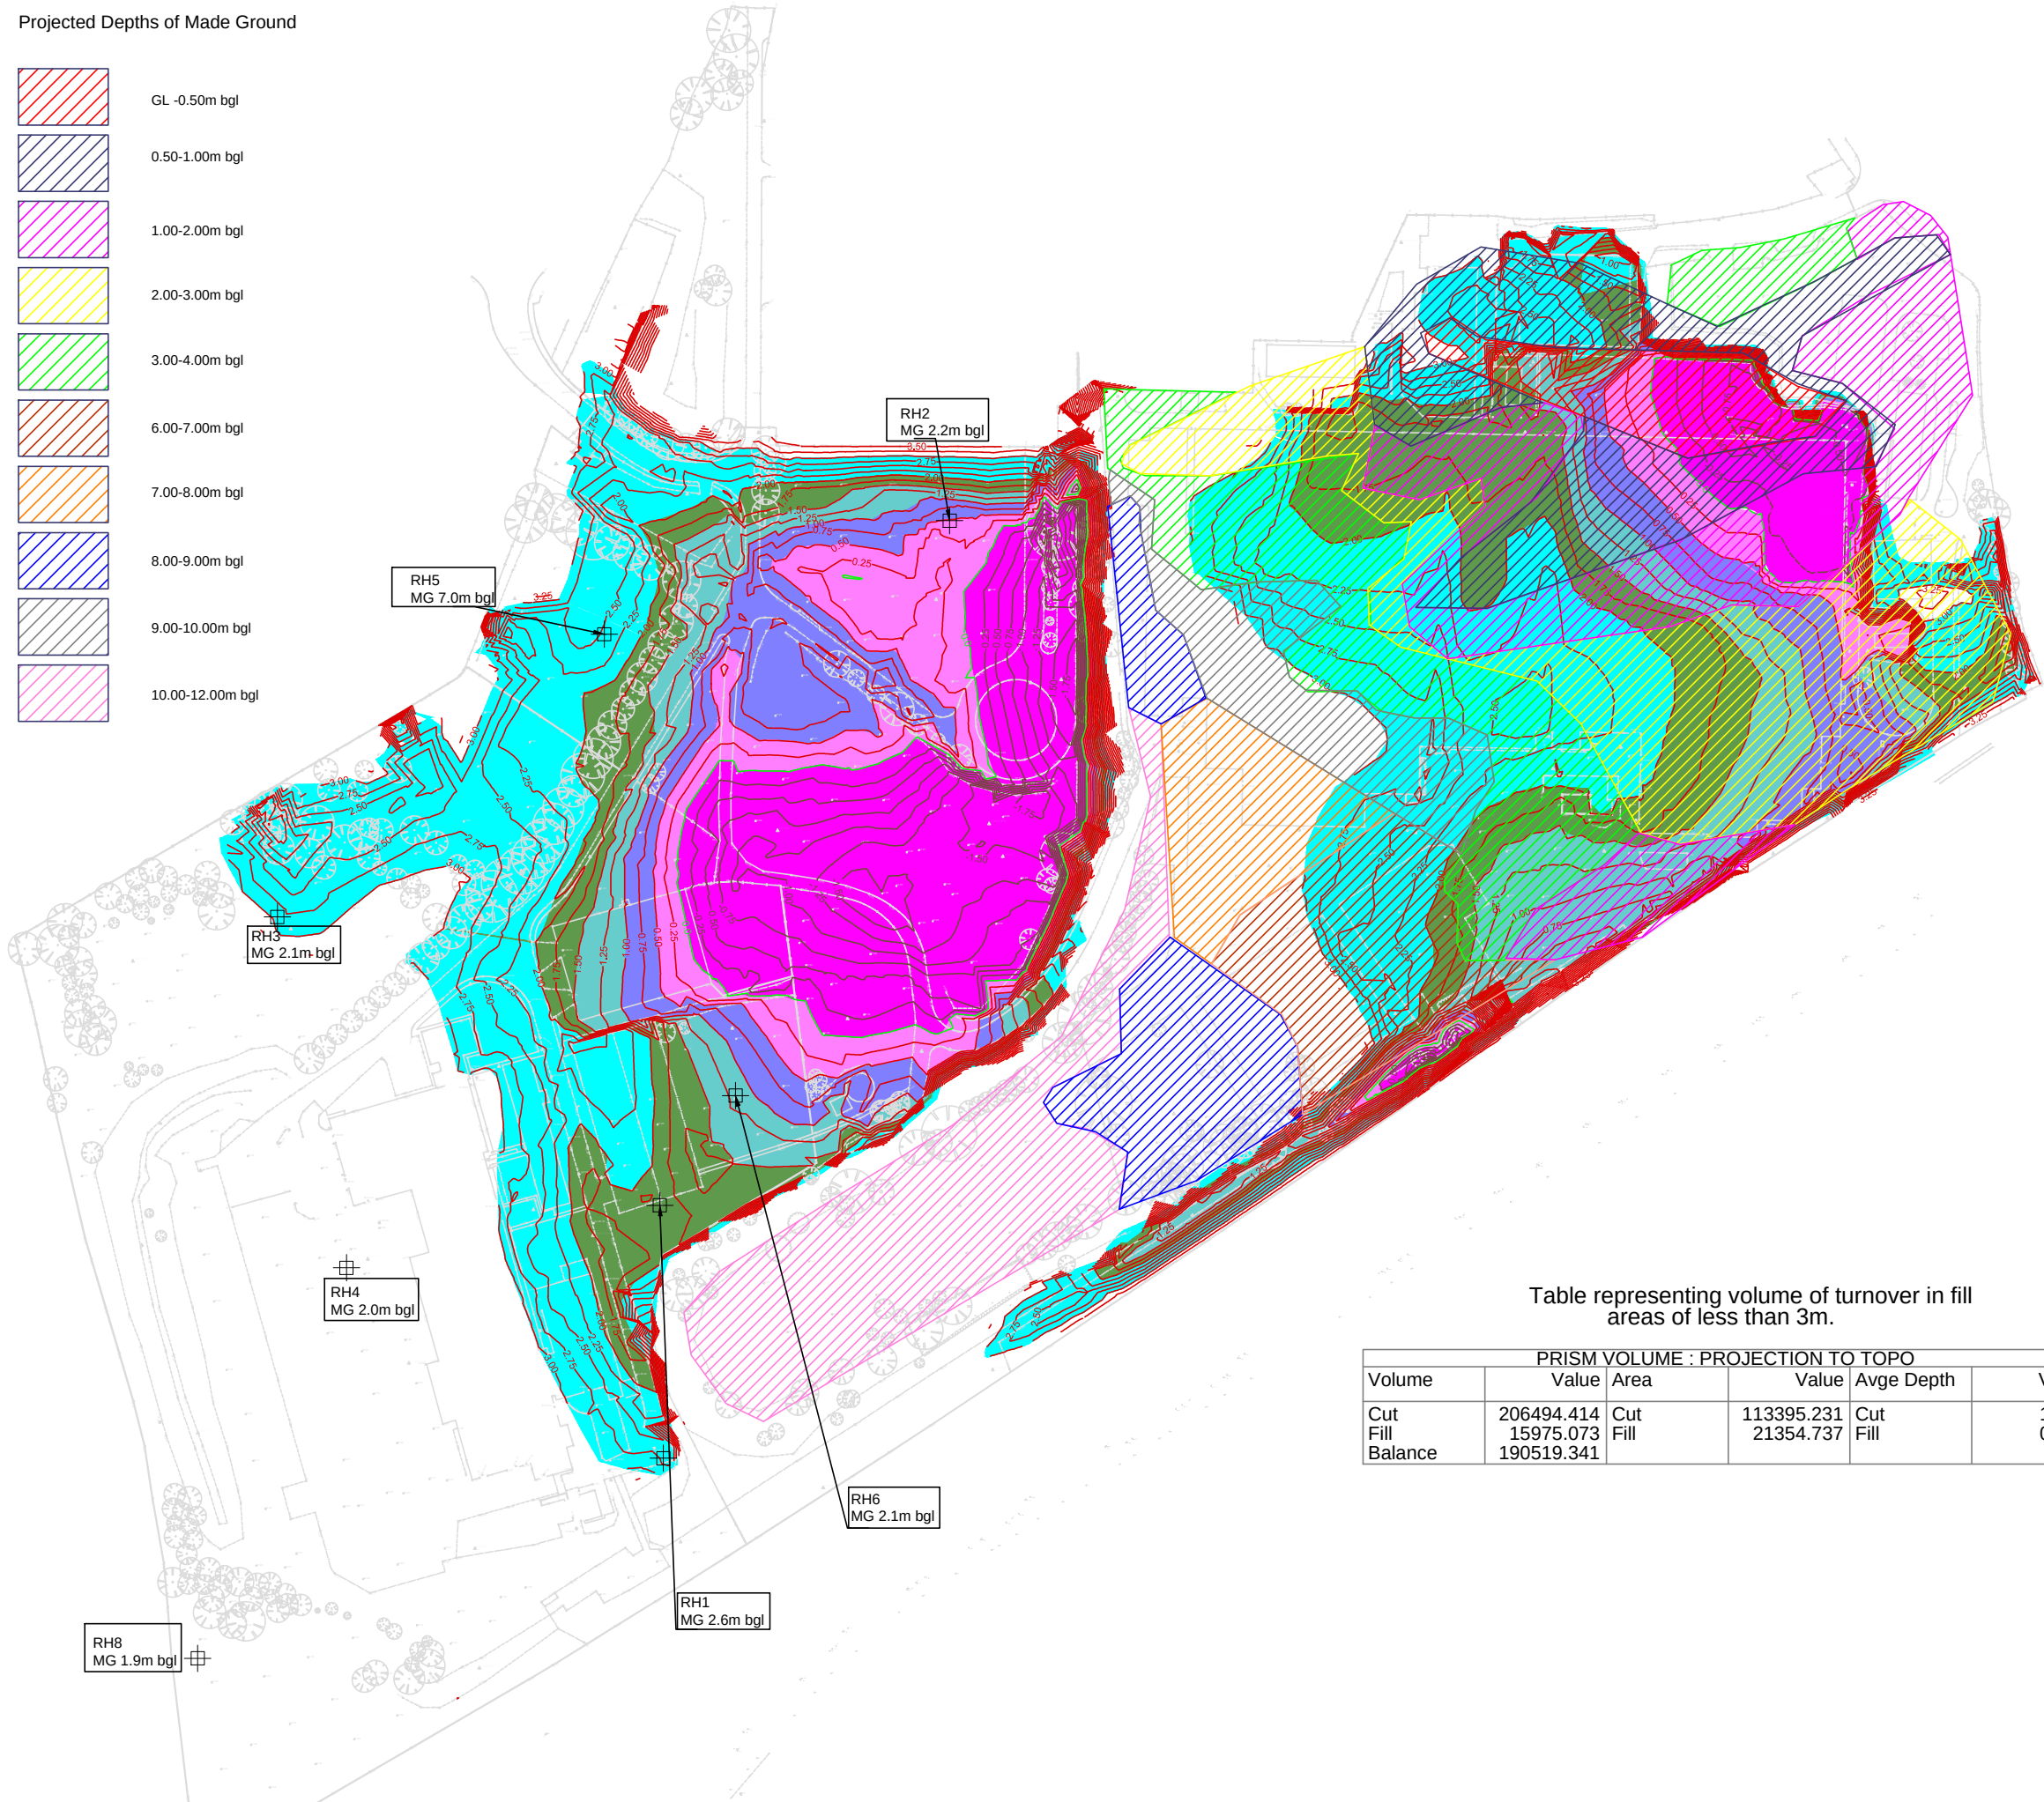
Projected Depths of Made Ground

Table representing volume of turnover in fill areas of less than 3m.
