## REMEDIATION AND ENABLING WORKS VALIDATION REPORT

**Parcel C**

**Former Prysmian Cable Works,  
Carr Lane,  
Prescot**

**E3P Report: 10-021-R12-Rev 1  
Issued: February 2017**

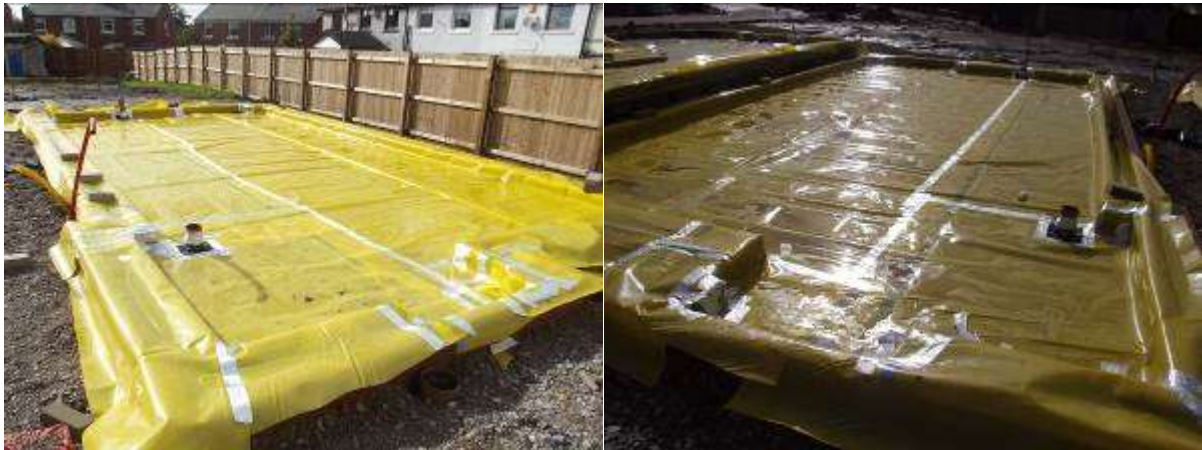
*Photographs 1 and 2: Check general condition of membrane for punctures / tears etc*

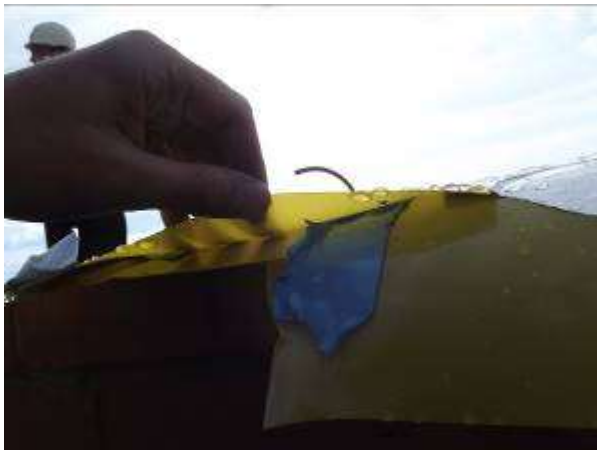
*Photograph 3: Confirm membrane product type and check joints between rolls of membrane to ensure 150mm overlap and presence of double sided butyl tape (by touch – may not be visible) and girth jointing tape.*

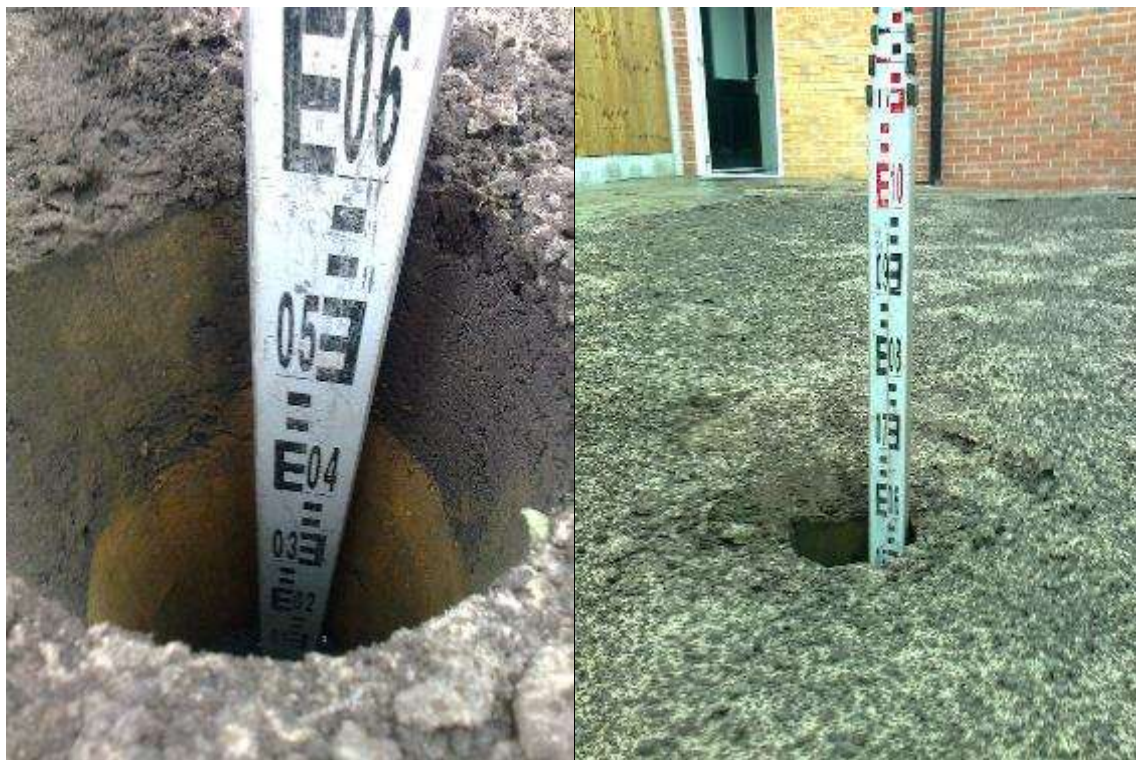
*Photographs 1 and 2: Examples of validation photographs demonstrating clean cover.*

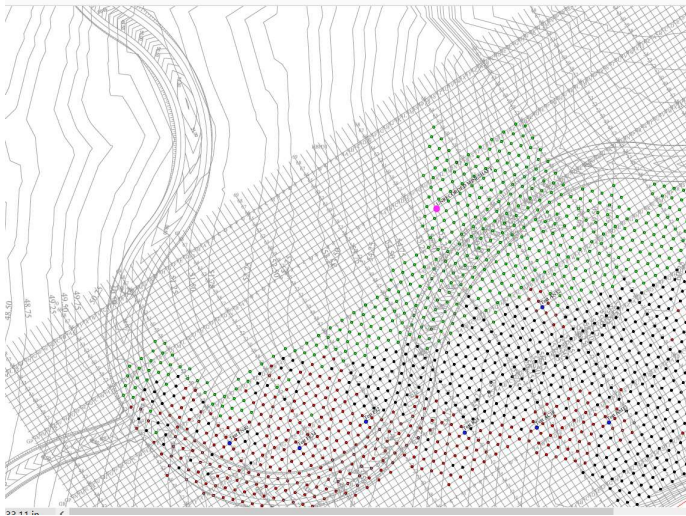
**Figure 6.1 Area of Drill & Grout Pertinent to Parcel C**

In light of the detailed information obtained from the Drill & Grout Operations, it was determined that the Wigan Five Feet Seam (Bastian) had been mispositioned by the BGS & Coal Authority as was suggested within the E3P Specification for the Consolidation of Abandoned Mine Workings.

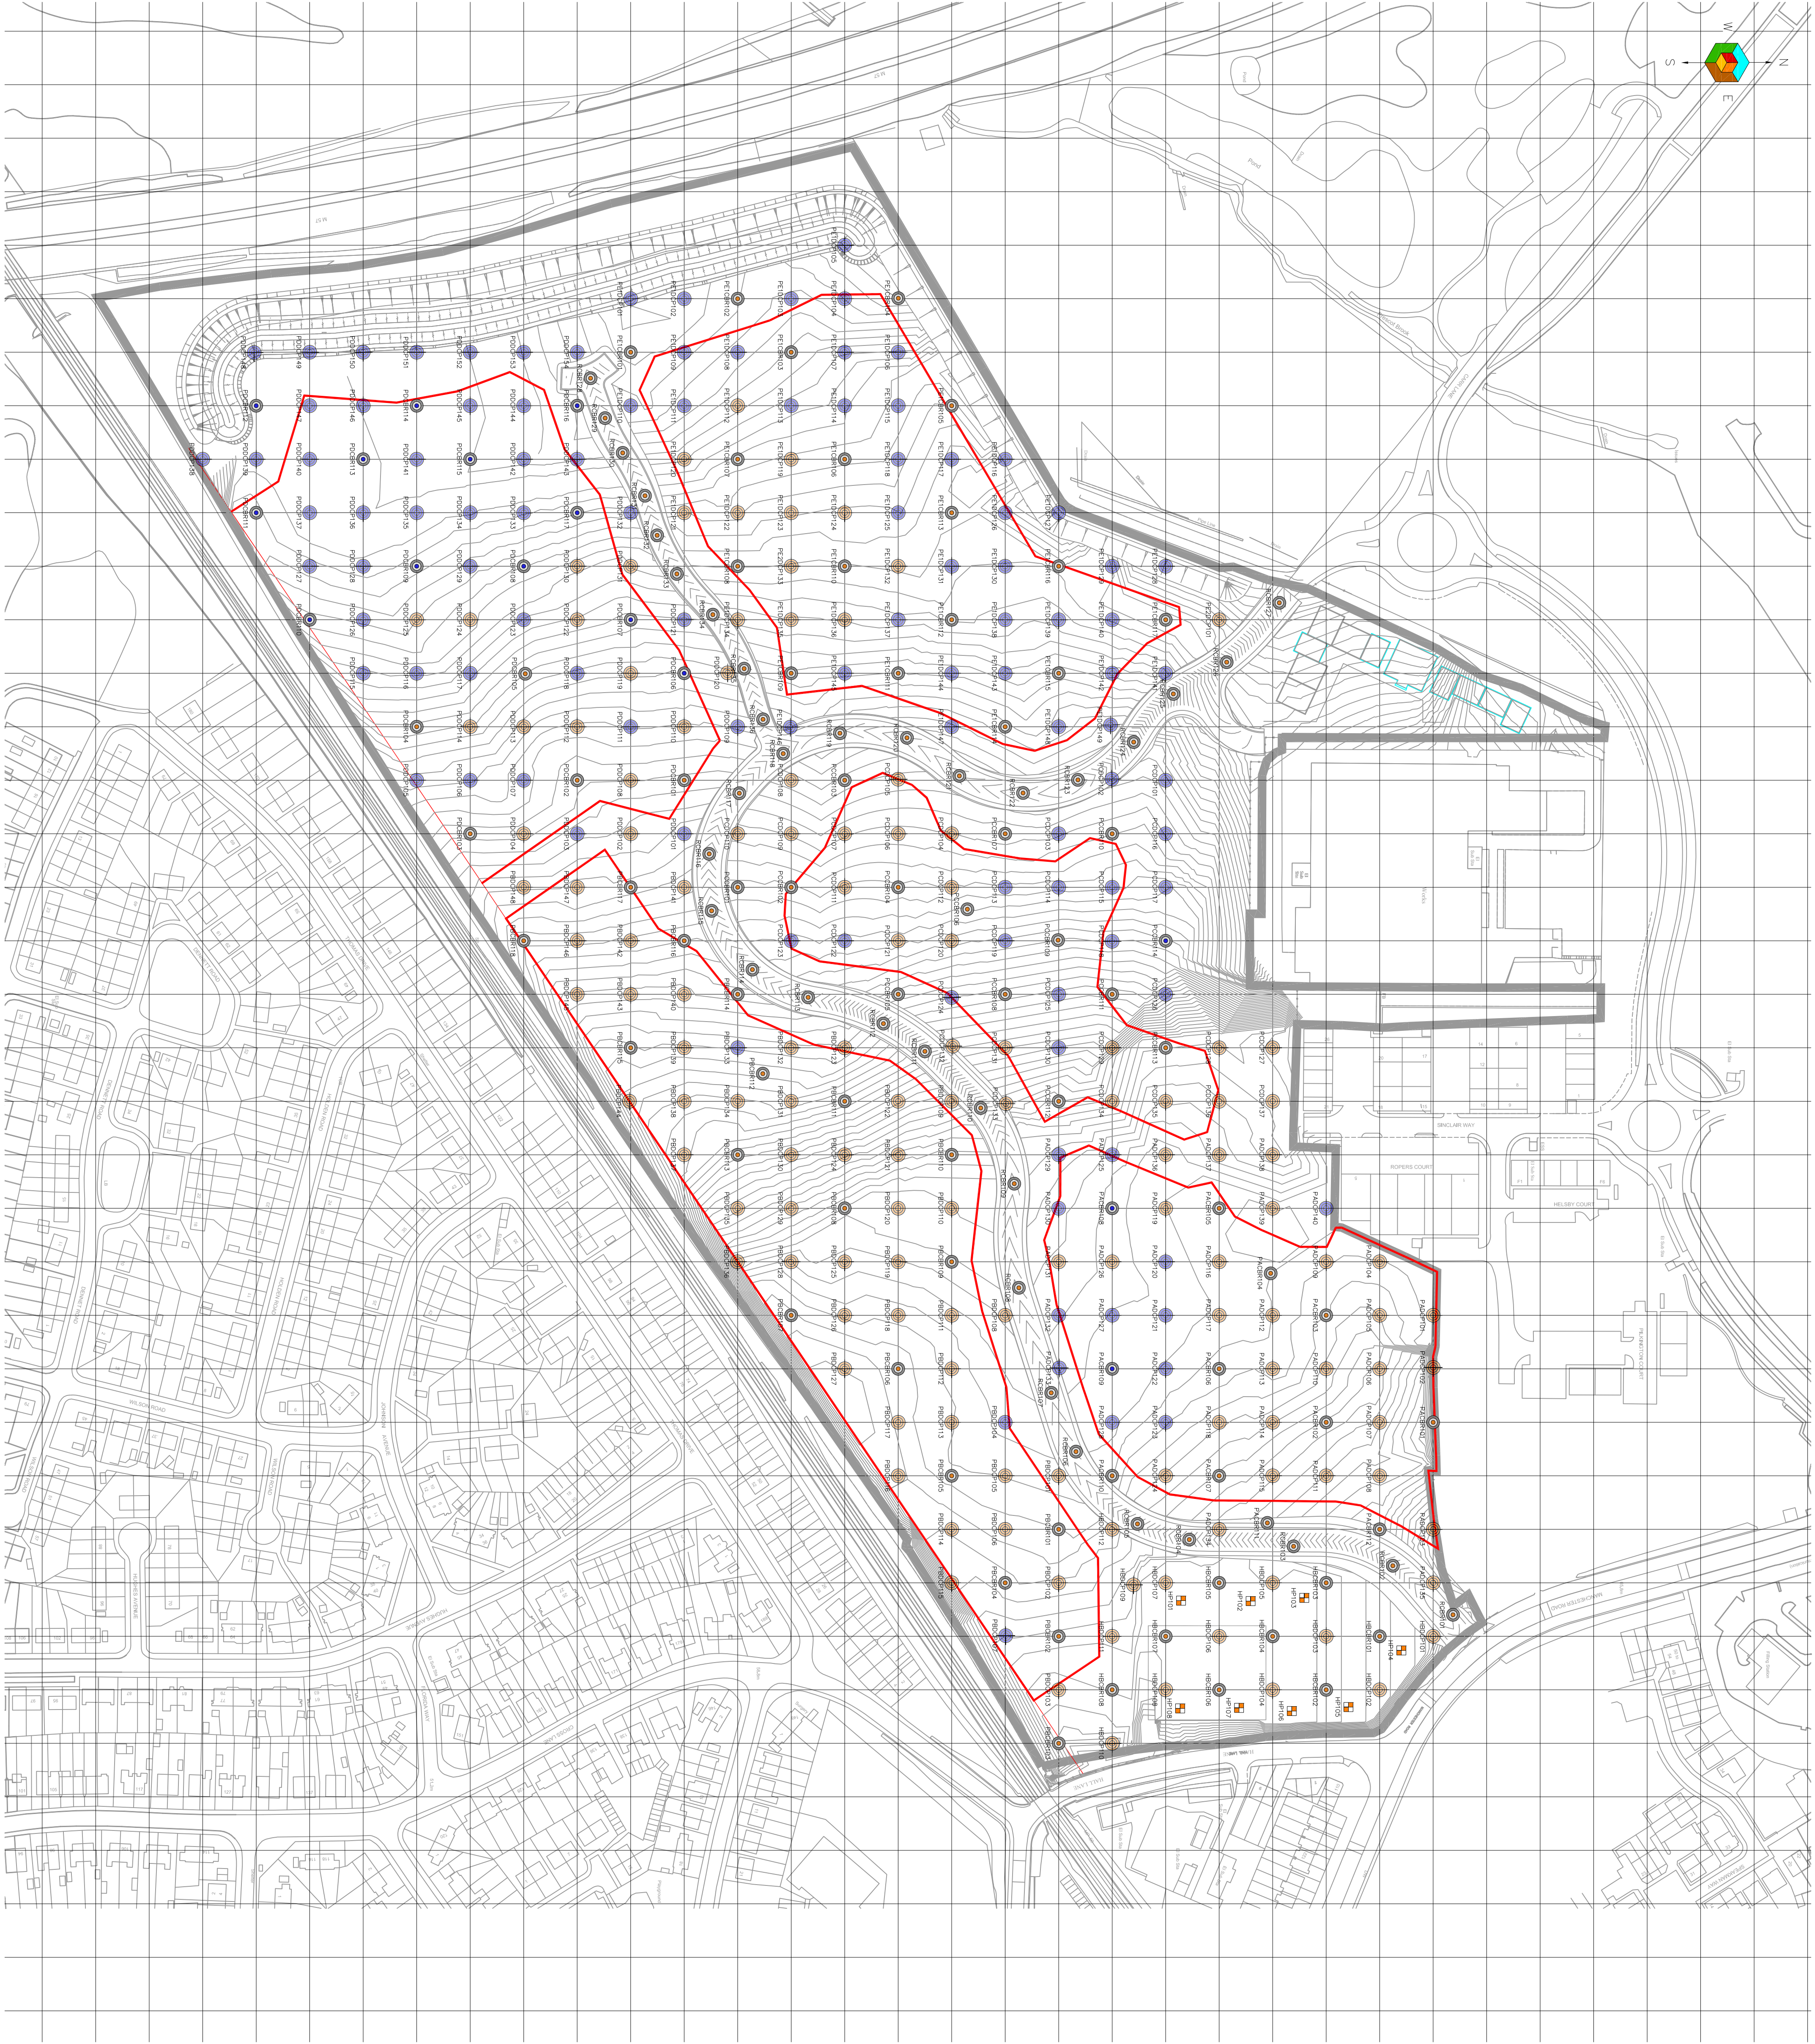
| Pyrsnian Cables, Prescot | Geo-Technical Testing Location Plan |

- Approximate Plate Load Test Location
- Approximate Dynamic Cone Penetrometer Test Location
- Approximate Hand Pit Location
- Approximate Plate Load Test Location (Unable to Investigate)
- Approximate Dynamic Cone Penetrometer Test Location (Unable to Investigate)

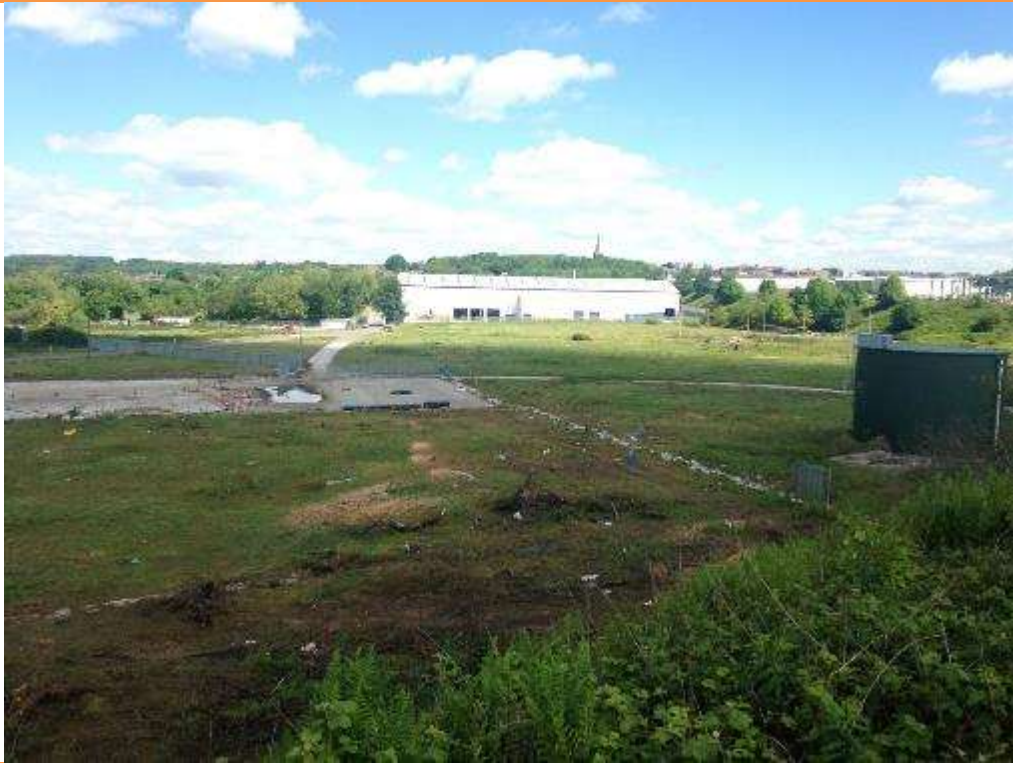
**PLATE 1 – POST REMOVAL OF VEGETATION OF PARCEL C**

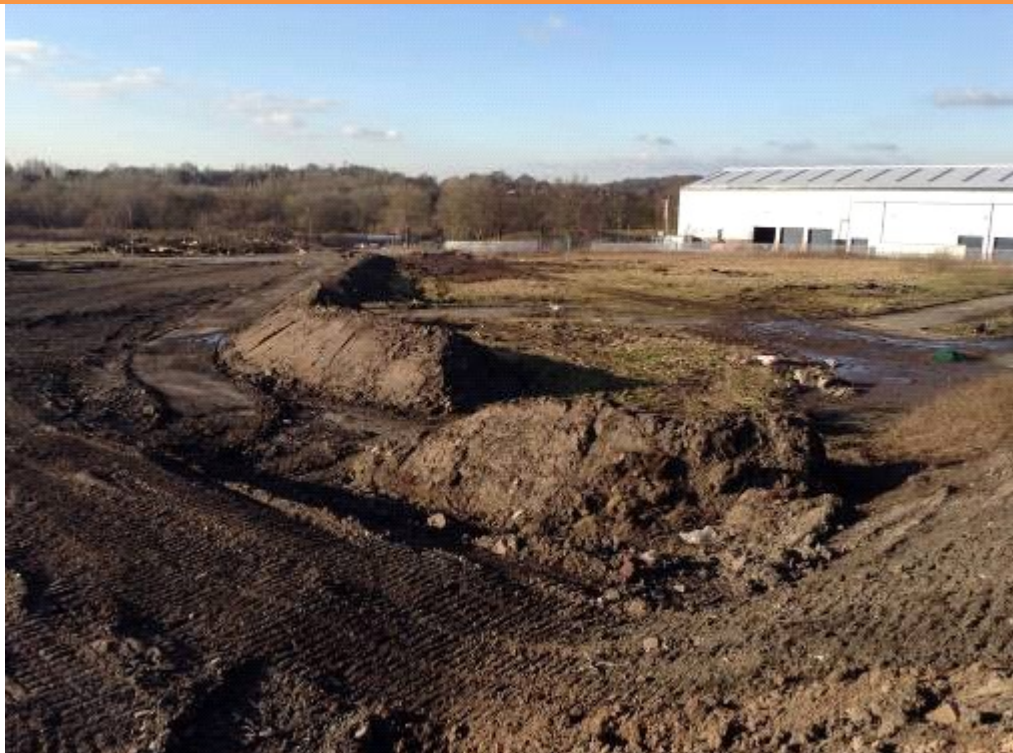
**PLATE 2 – REMOVAL OF VEGETATION STRIP IN PROGRESS**

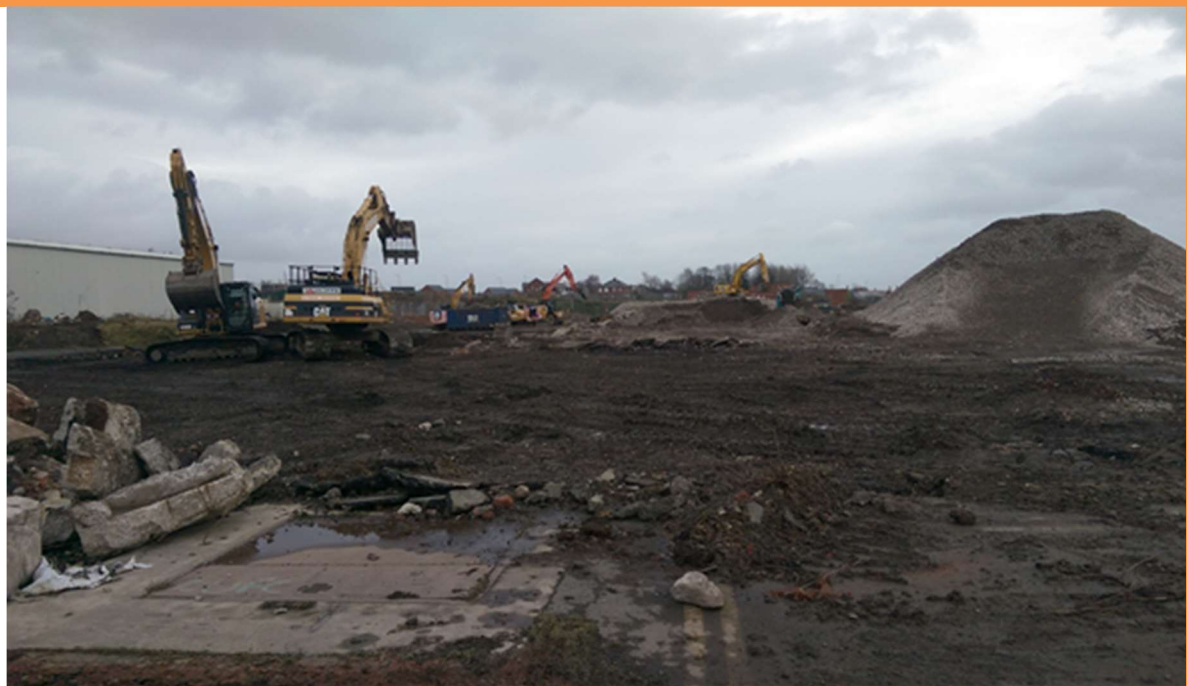
**PLATE 3 –PRE-REMEDIATION LOOKING EAST FROM CENTER OF PARCEL C**

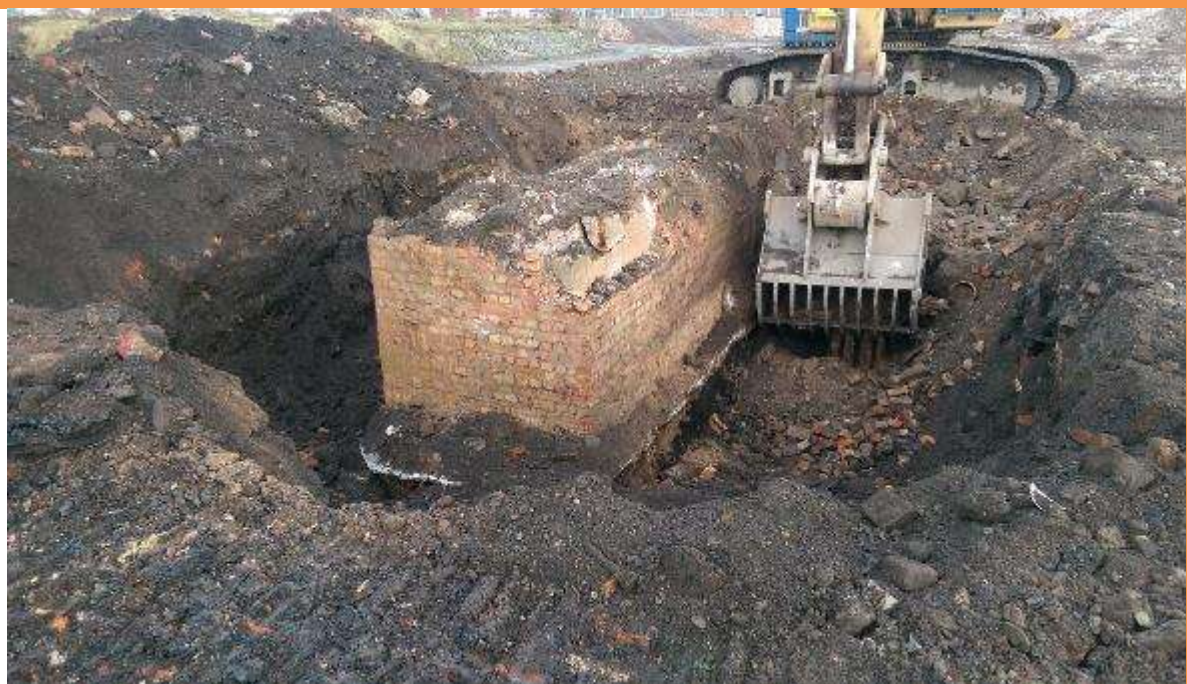
**PLATE 4 - TURNOVER OF REMOVAL OF RELIC STRUCTURES IN UPPER EAST OF  
PARCEL C**

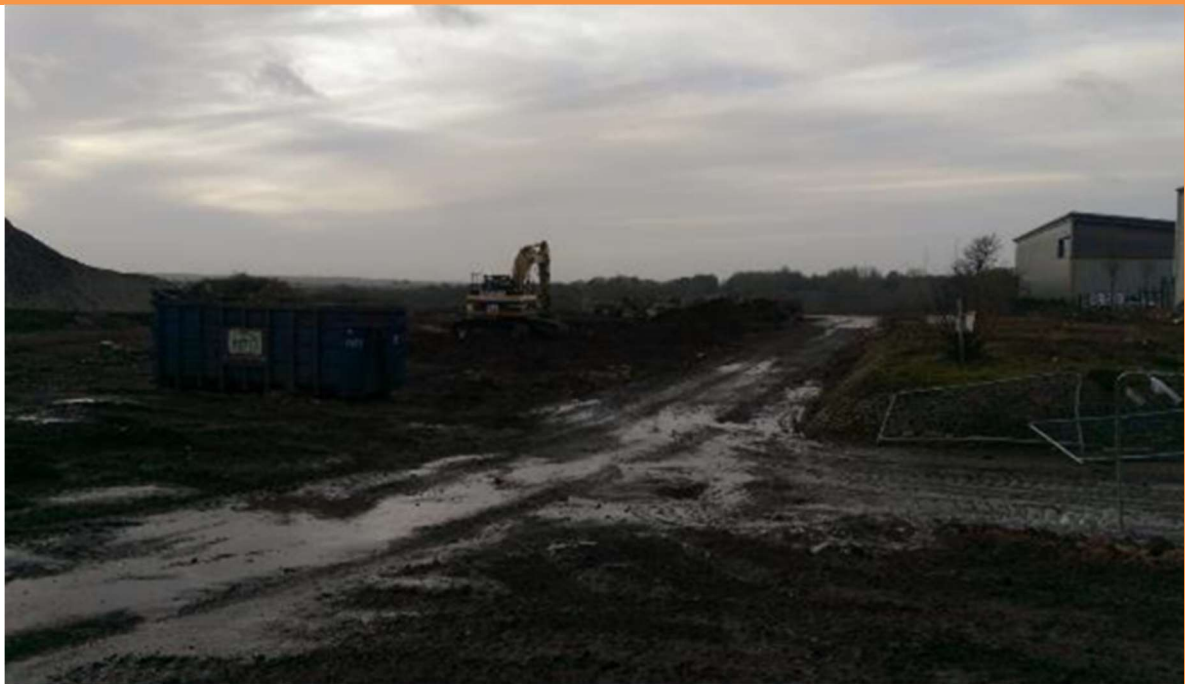
**PLATE 5 – COMMENCEMENT OF REMEDIATION WITHIN UPPER AREA OF  
PARCEL C**

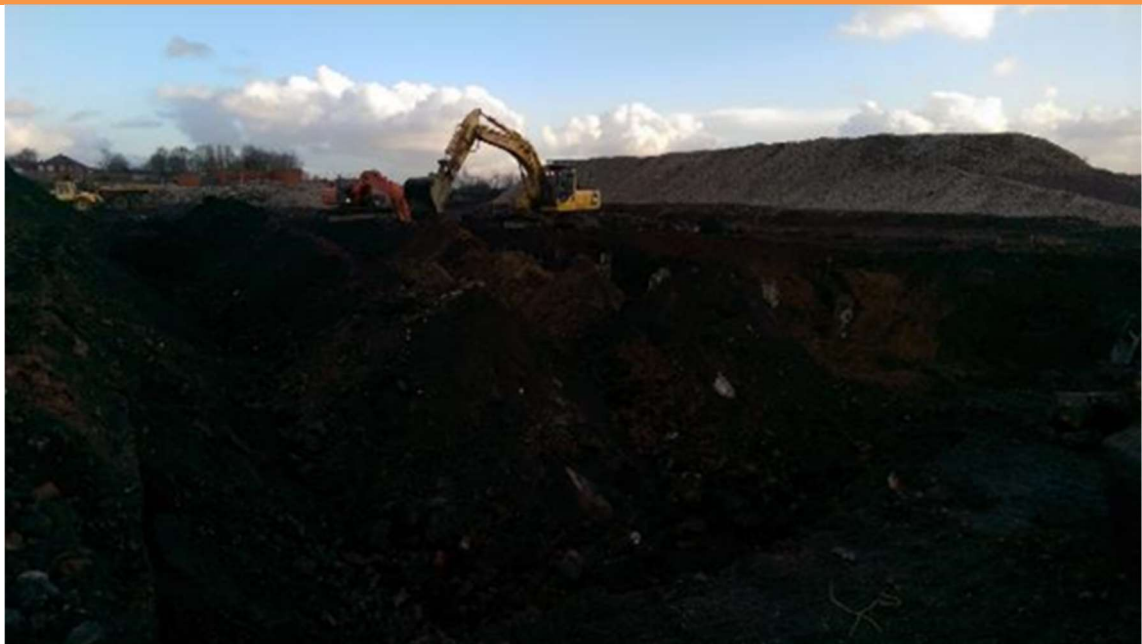
**PLATE 6 – TURNOVER AND REMOVAL OF RELIC STRUCTURES**

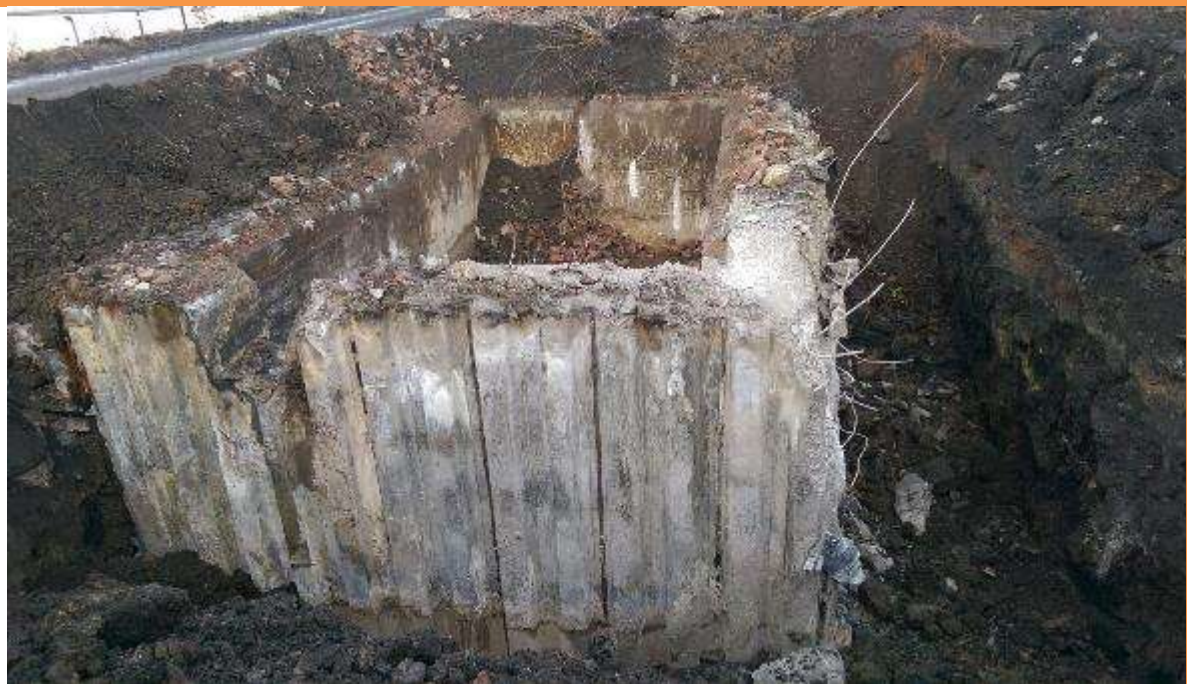
**PLATE 7 – REMOVAL OF CONCRETE BELOW GROUND STORAGE TANK**

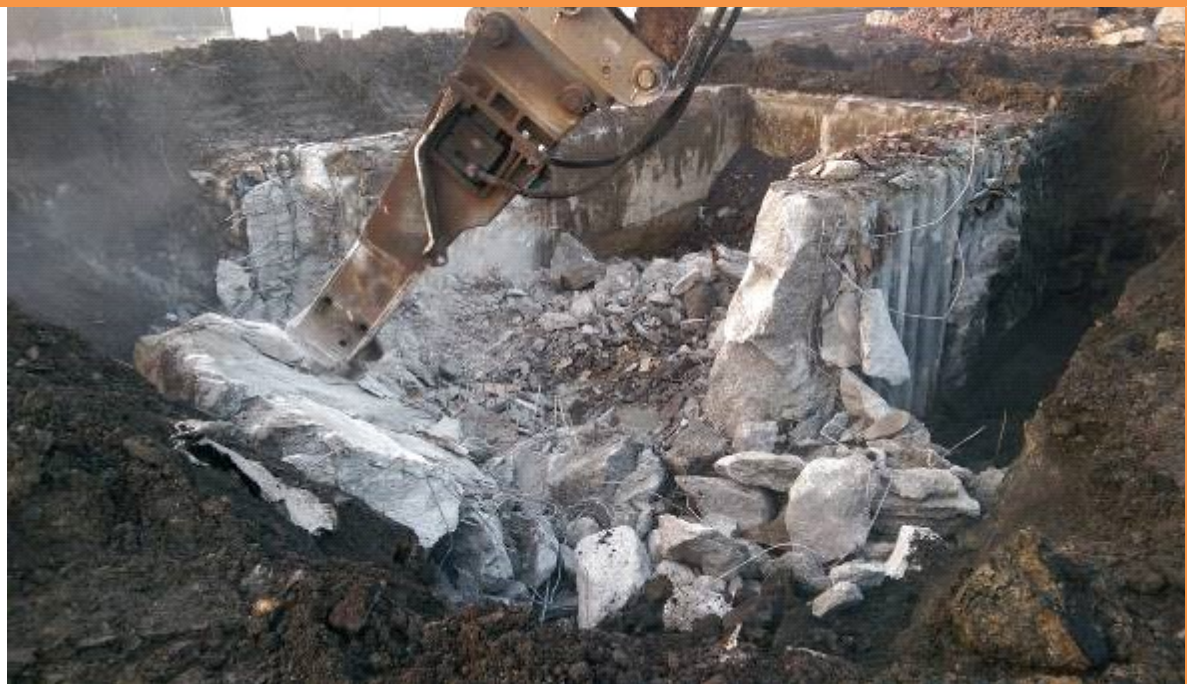
**PLATE 8 – LARGE UST BEING BROKEN TO AID IN THE REMOVAL OF THE TANK**

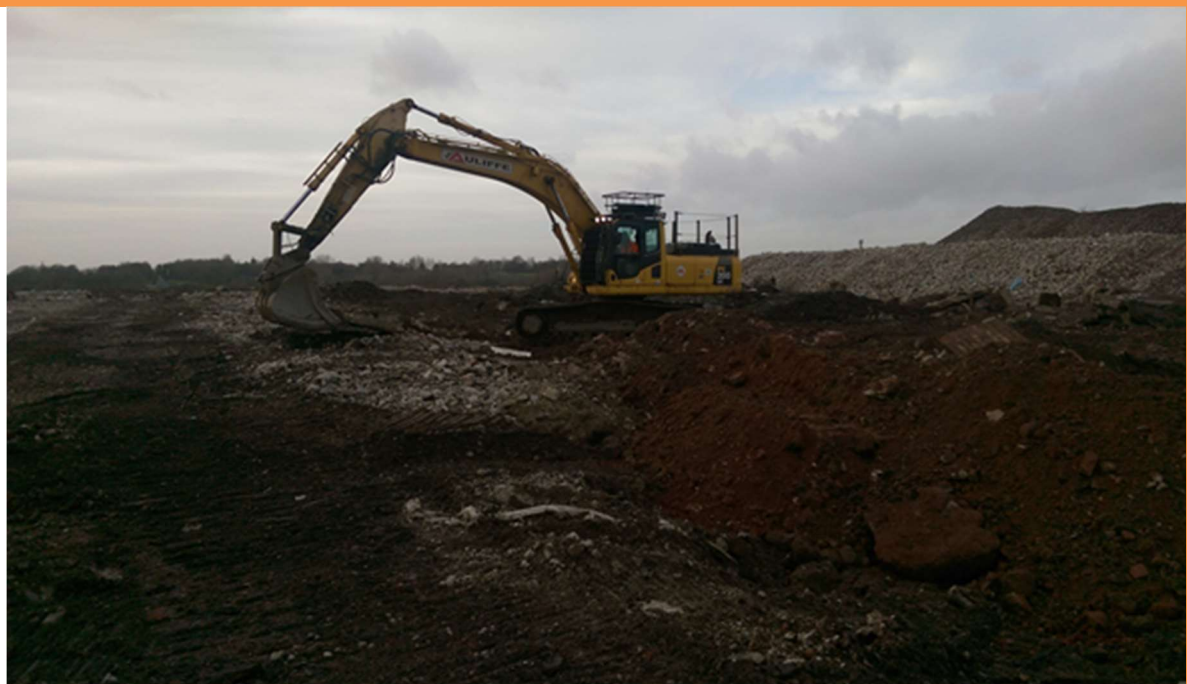
**PLATE 9 - LAST REMAINING AREA OF TURNOVER WITHIN UPPER PORTION OF  
PARCEL C**

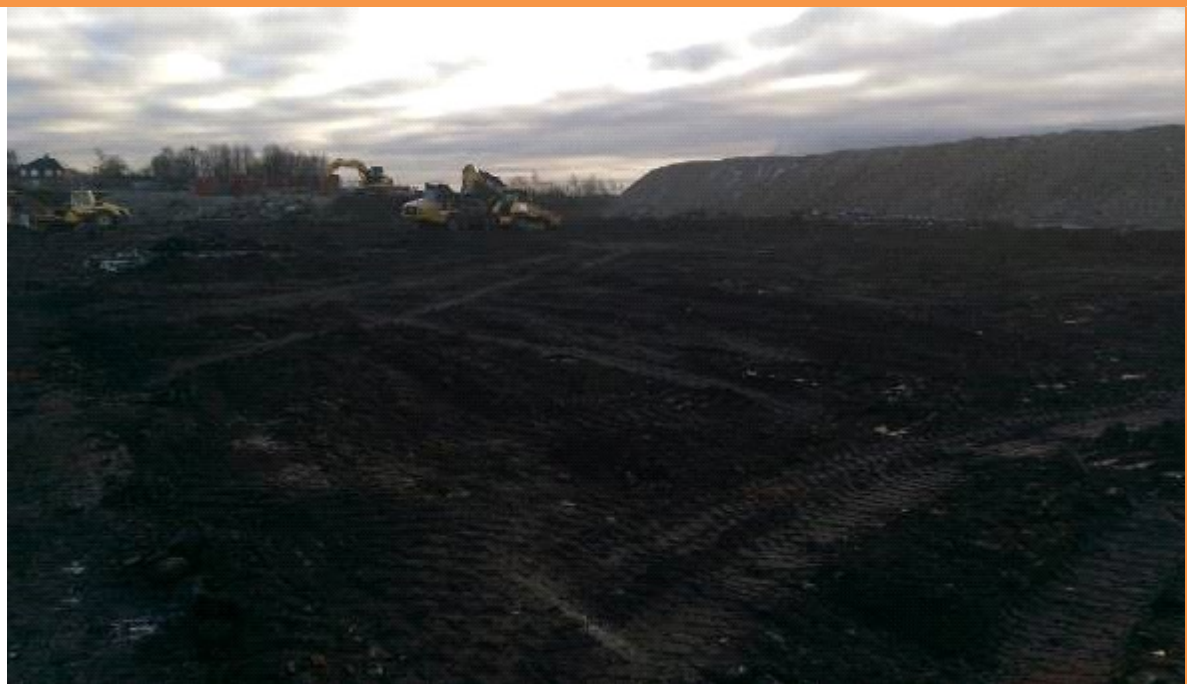
**PLATE 10 – REMEDIATION AND TURNOVER COMPLETE IN UPPER AREA OF  
PARCEL C**

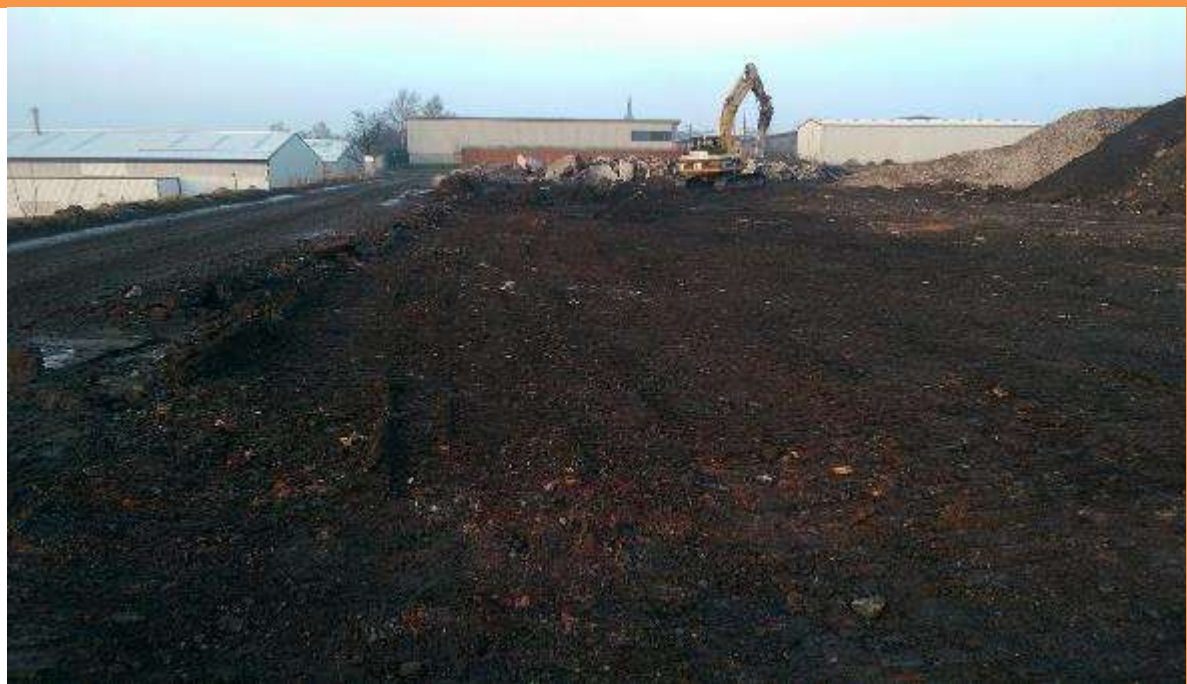
**PLATE 12 – REMEDIATED SOILS BEING RE-GRADED TO FORMATION LEVELS**

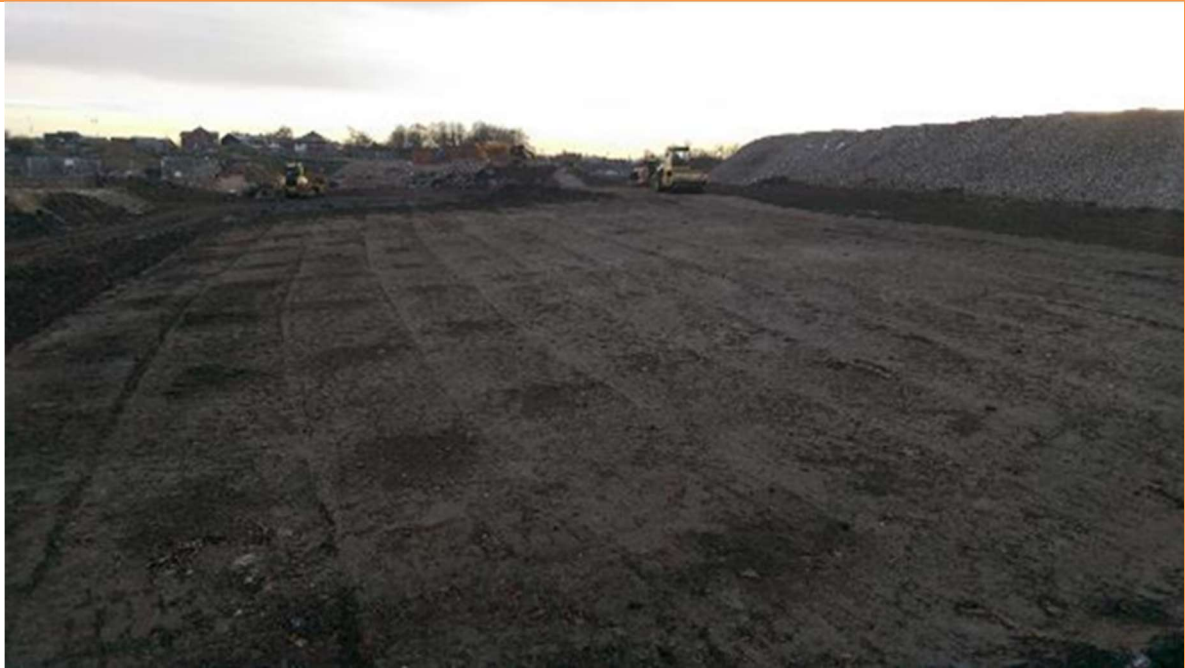
**PLATE 13 – VIEW EAST FROM PARCEL C REMEDIATION COMPLETE**

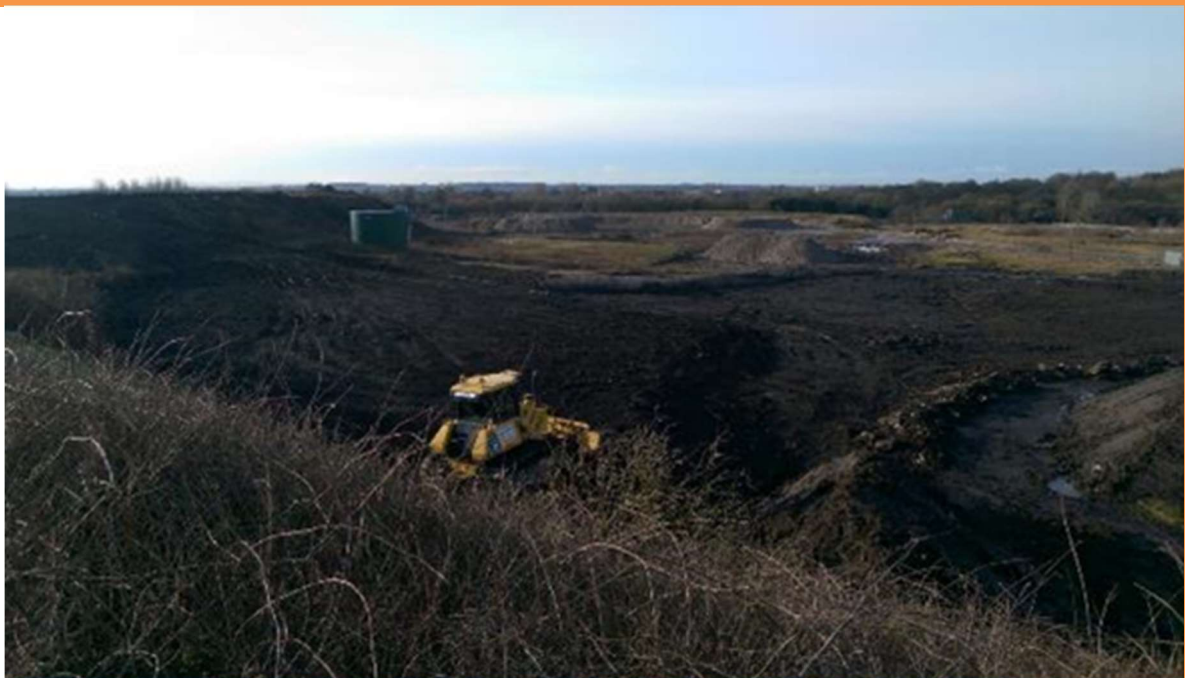
**PLATE 14 – VIEW WEST OF LOWER PARCEL C WITH TURNOVER OF >1.50BGL COMPLETED TO NATURAL STRATUM**

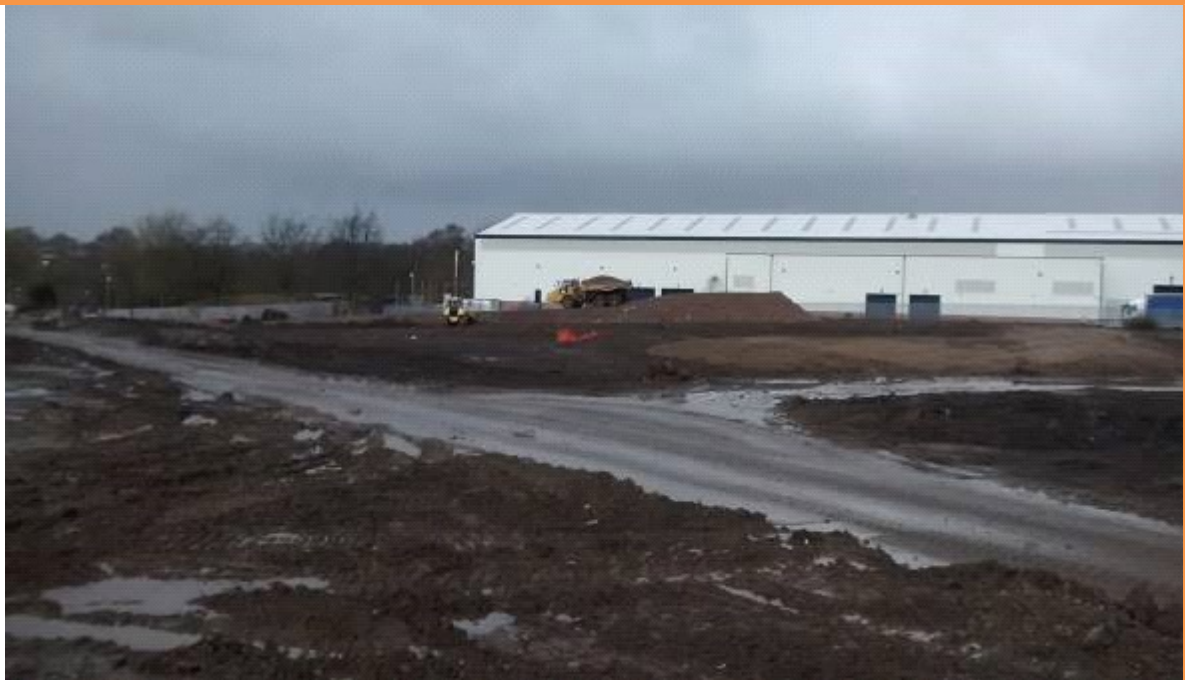
**PLATE 15 – LOWER PARCEL C TURNOVER COMPLETE WITH SOILS BEING IMPORTED TO RAISE PARCEL**

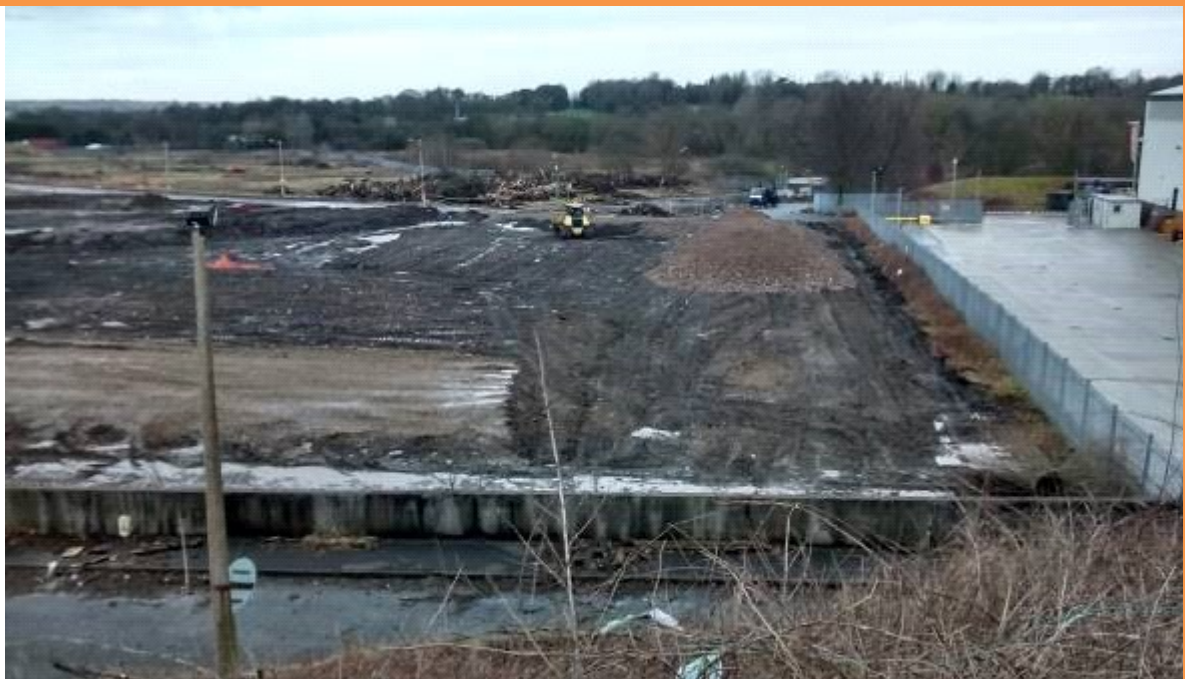
**PLATE 16 – NORTHERN LOWER AREA OF PARCEL C WITH COMPOUND BEING CONSTRUCTED**

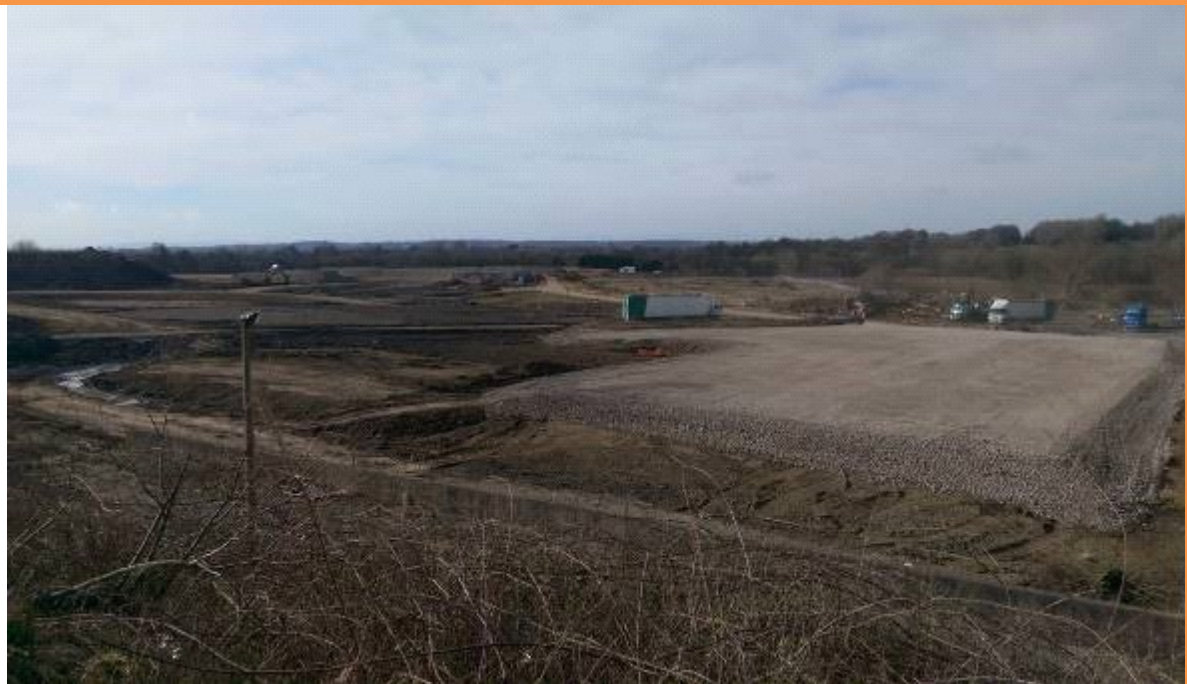
**PLATE 17 – LOWER PARCEL C AFTER REMEDIATION SITE RAISING IN PROGRESS**

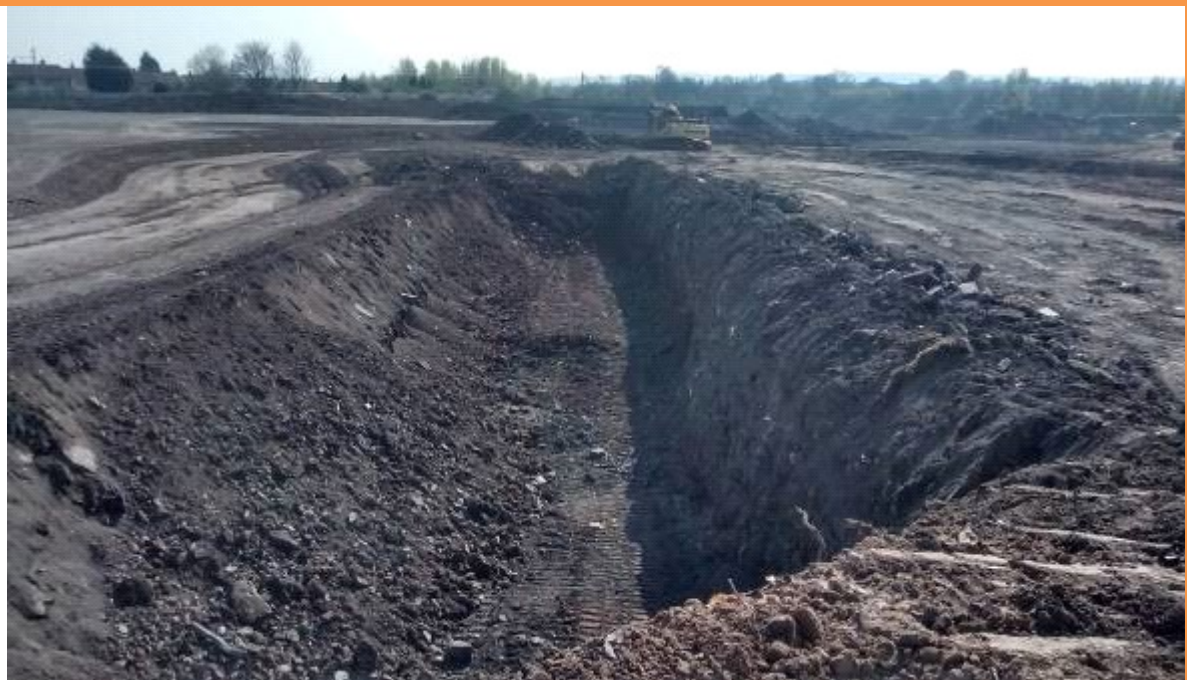
**PLATE 18 – PARCEL C SOUTHERN BOUNDARY TURNOVER IN PROGRESS  
ADJACENT TO CONSTRUCTED SPINE ROAD**

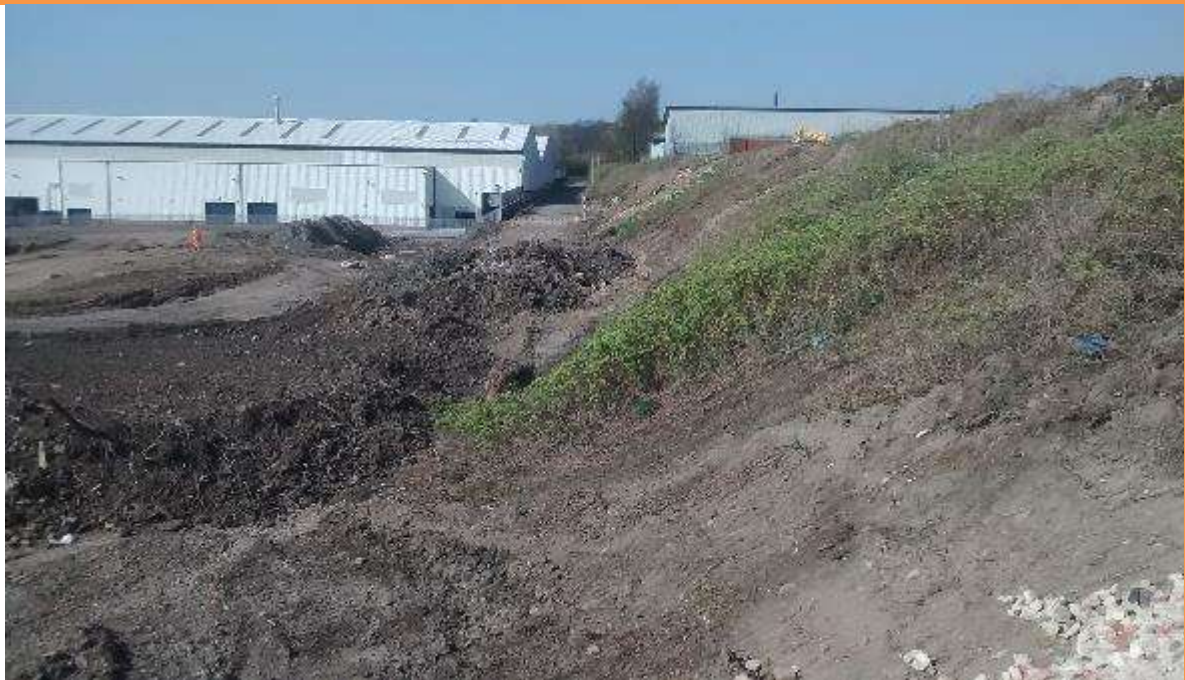
**PLATE 19 – VEGETATION STRIP OF EMBANKMENT DISSECTING PARCEL C**

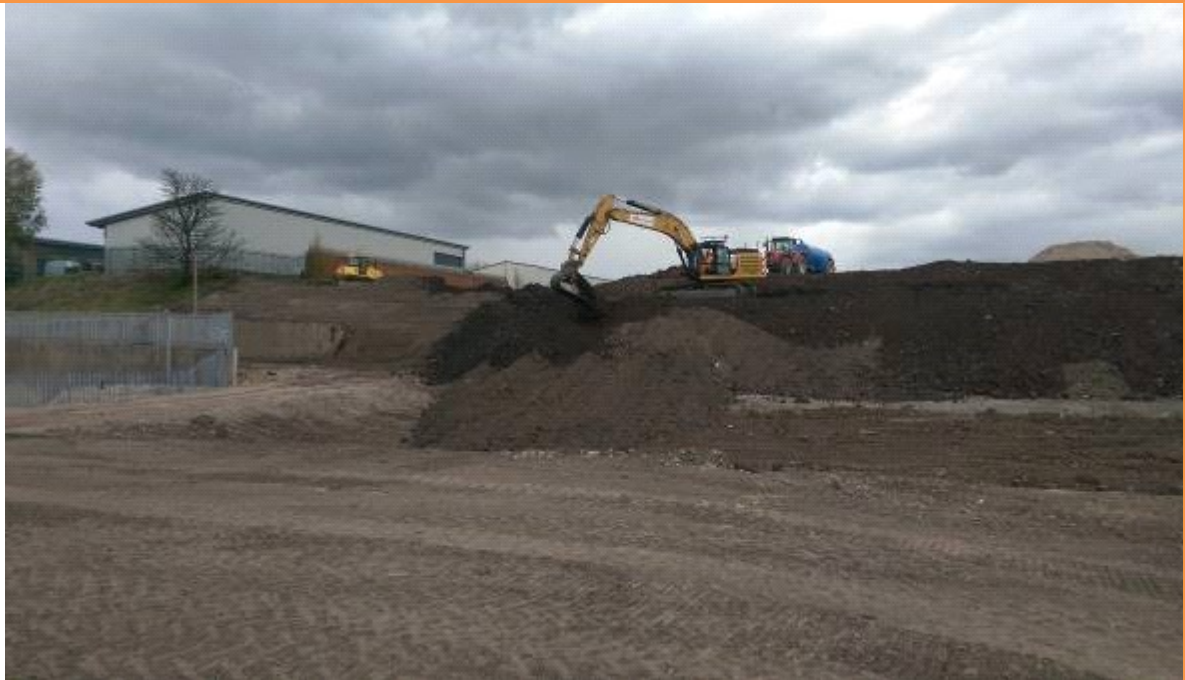
**PLATE 20 – TURNOVER OF THE EMBANKMENT AFTER RETAINING STRUCTURES REMOVED**

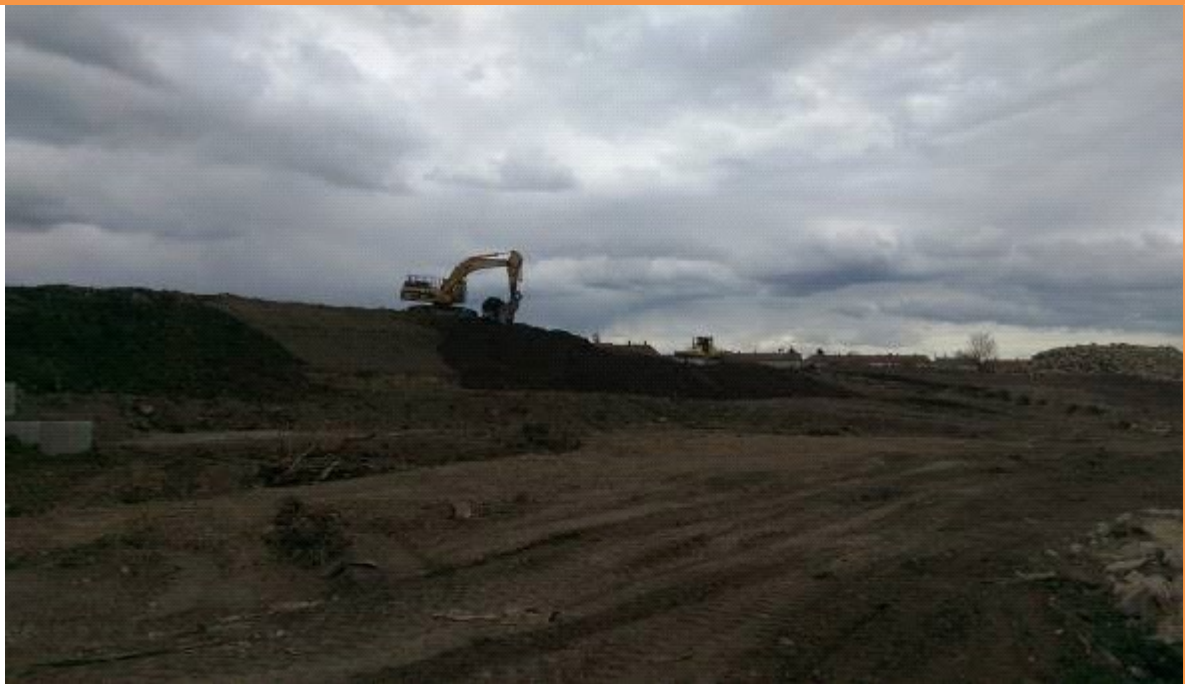
**PLATE 21 – TURNOVER OF EMBANKMENT TO REDUCE THE SITE INTO ONE PLATEAUX**

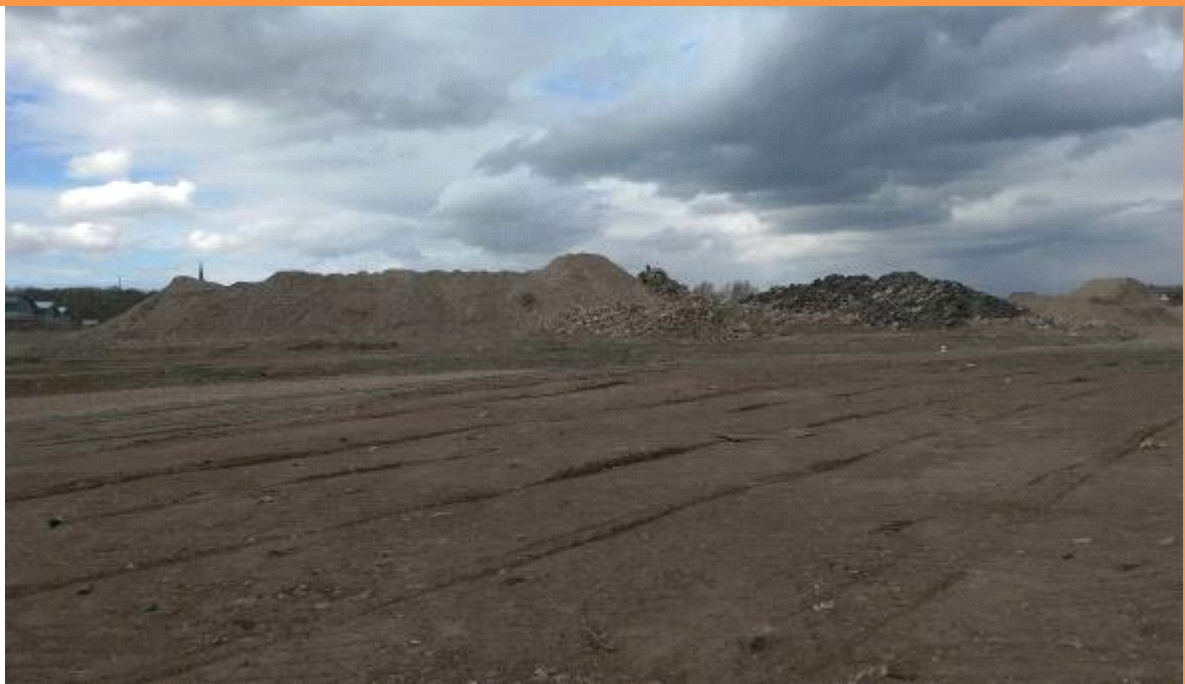
**PLATE 22 – CONCRETE STOCKPILE LOCATED ON PARCEL C**
