## REMEDIATION AND ENABLING WORKS VALIDATION REPORT

**Parcel C**

**Former Prysmian Cable Works,  
Carr Lane,  
Prescot**

**E3P Report: 10-021-R12-Rev 1  
Issued: February 2017**

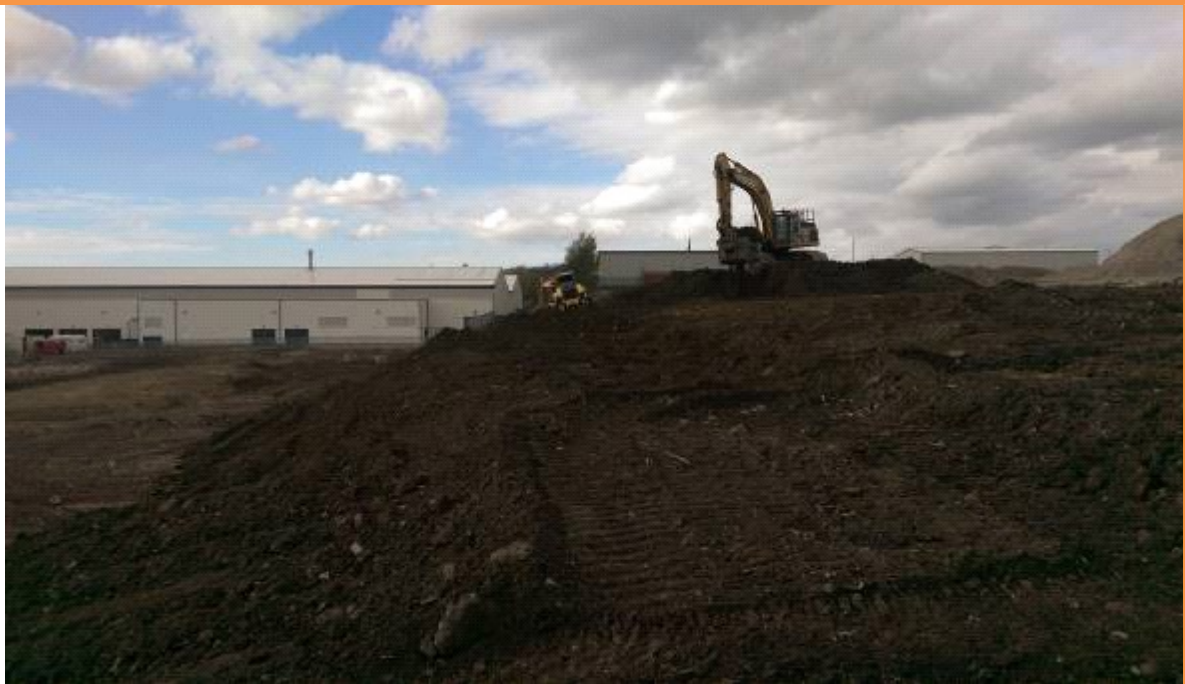
**PLATE 23 – THE CENTRAL SECTOR OF PARCEL C BLENDING THE TWO SITE LEVELS INTO ONE**

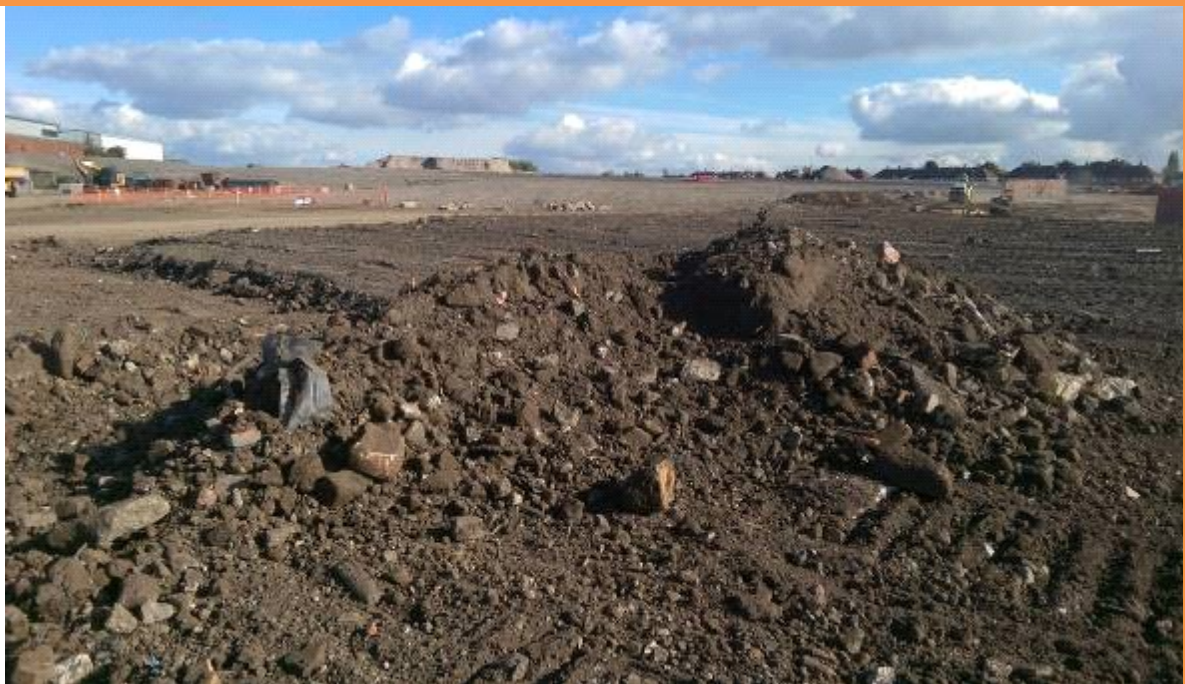
**PLATE 24 – PARCEL C IN DISTANCE WITH REMEDIATION COMPLETE TO FORMATION LEVEL**

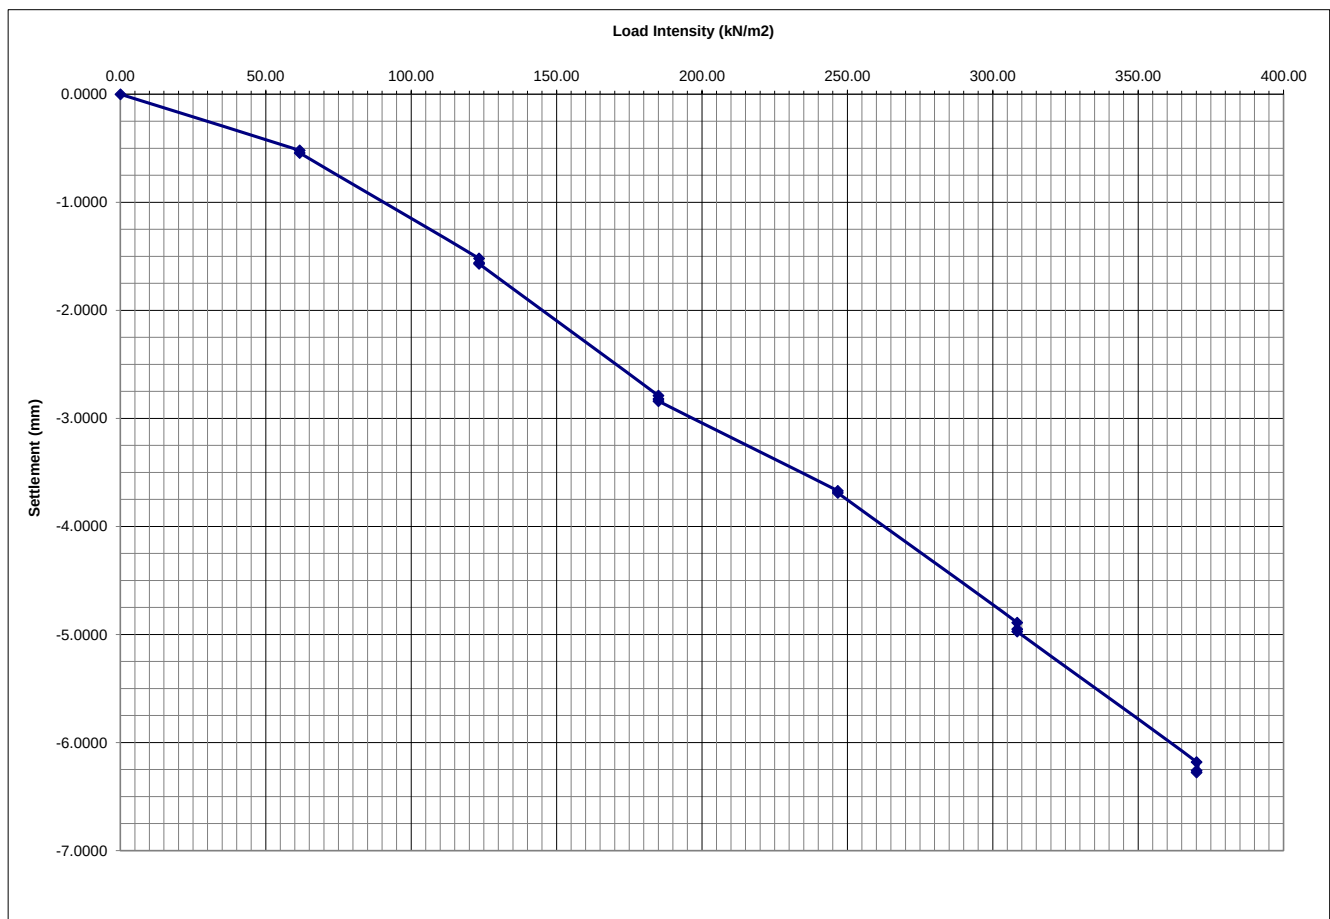
### Equivalent CBR Value of 10%

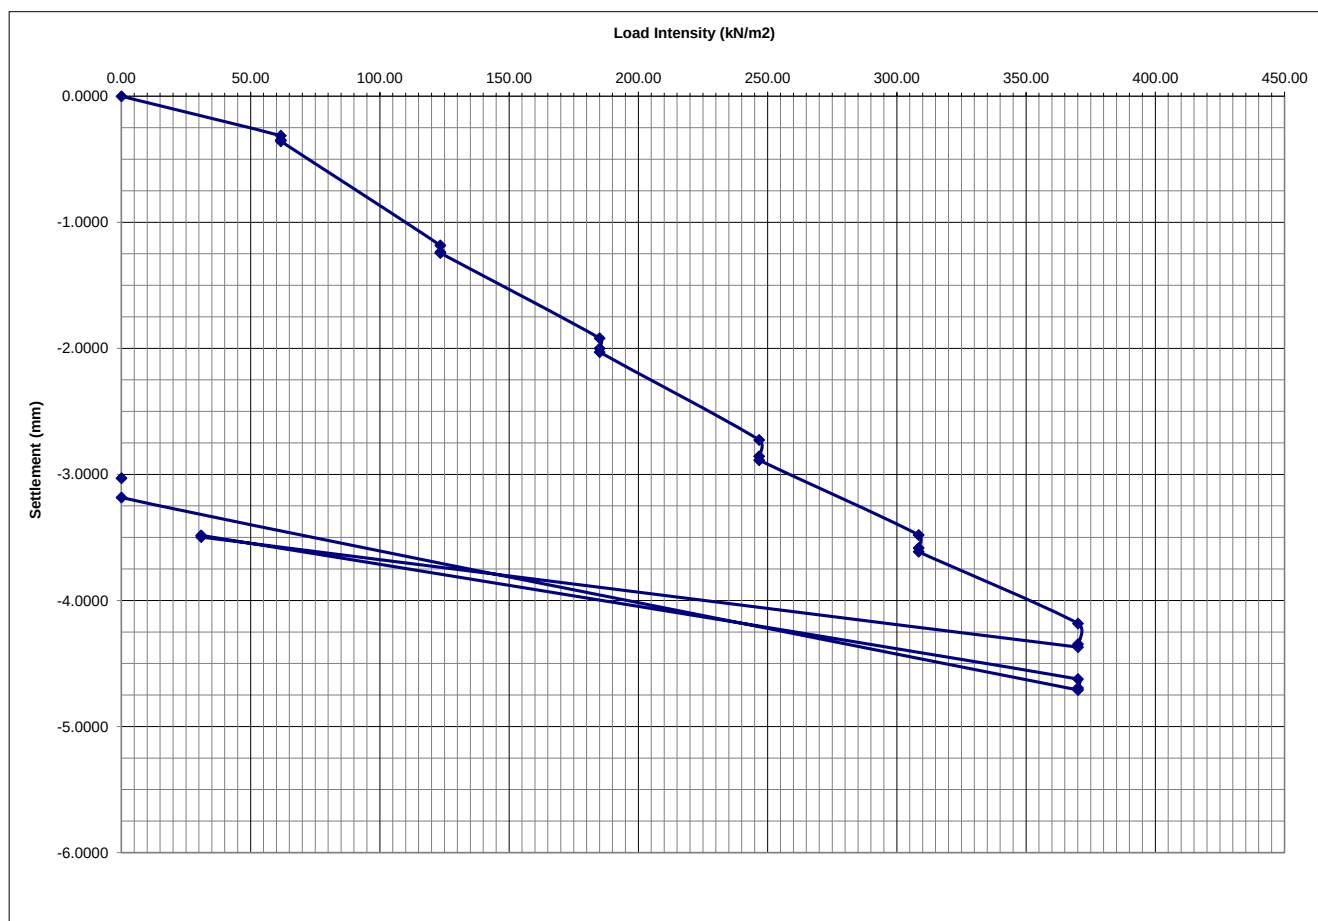
## Equivalent CBR Value of 13%
