# WE KNOW SERVICES

## ECOLOGY SURVEY AND ASSESSMENT

VALLEYFIELD  
NORTH END LANE  
HALEWOOD  
KNOWSLEY  
L26 5QB

APRIL 2021

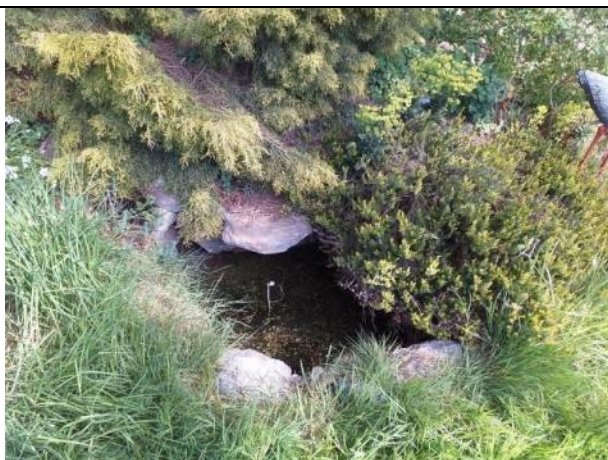
**Photograph 7.1:** Pond 1

- 3.2.10 A single ornamental pond is present on site (refer to **Photograph 7.1**). The pond is situated within a planting bed and is constructed from a rubber liner with stones stacked around all sides. The pond is less an 1m<sup>2</sup> in size. Duckweed (*Lemna minuta*) is present within the waterbody.

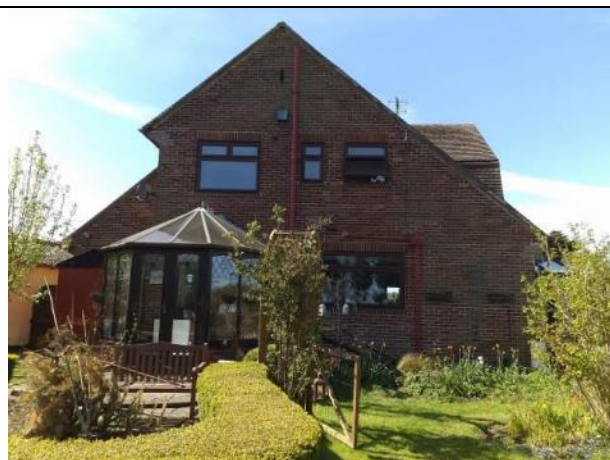
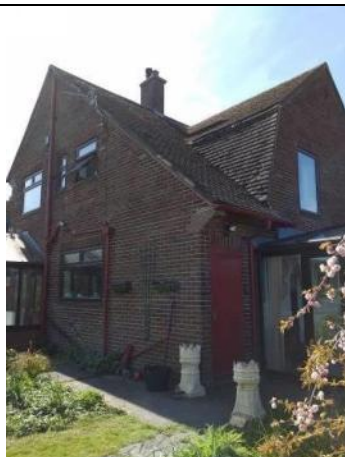
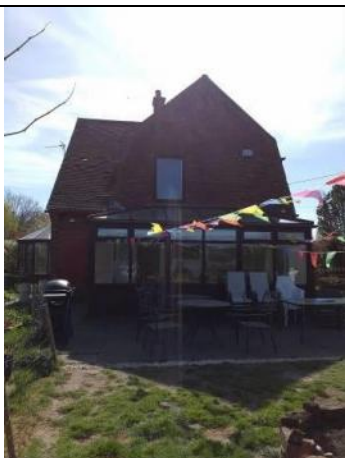
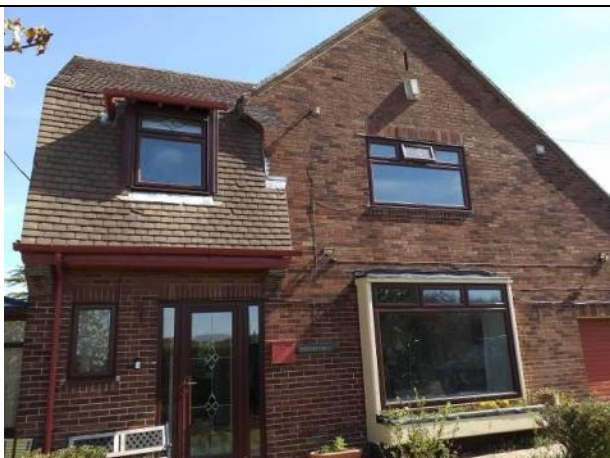
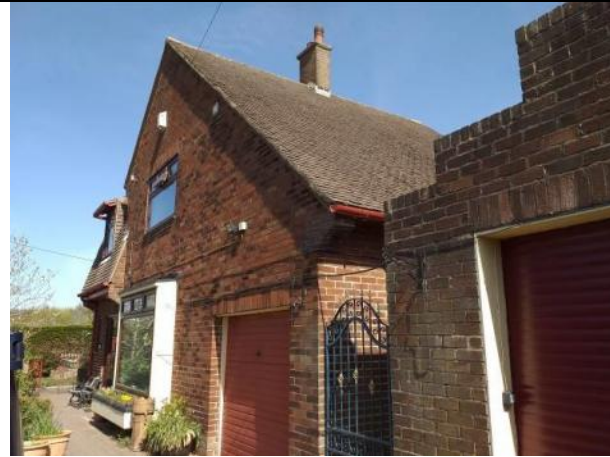
- 3.2.11 Refer to **Photographs 7.2 to 7.8**.
- 3.2.12 The detached two-storey dwelling is constructed from mortared brick walls with a pitched roof of clay tiles. There are two conservatories attached to the dwelling on the north-eastern and north-western

elevation. Adjoining the dwelling is an oil tank (to the north-east) and garage (to the south-east). The dwelling supports one brick chimney, one dormer window and one bay window. The roof is supported by traditional timber purlins and rafters.

- 3.2.13 Lifted tiles were observed on the north-western and north-eastern roof elevations. In addition, gaps are present at the roof verge (edge of roof as it meets the gable end) where mortar has fallen away, and open vents provide access into the roof void from the building's exterior.

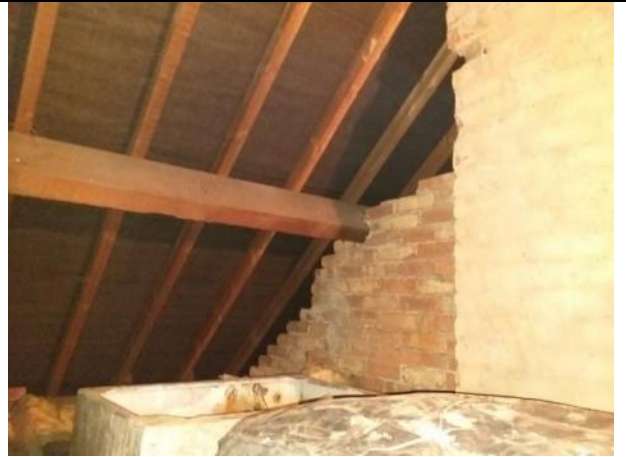
**Photograph 7.8:** Existing Dwelling Loft

- 3.3.2 No bats or signs of bats were detected at the external elevations or internal areas of the building of the dwelling or garage.
- 3.3.3 It is acknowledged that part of the roof space within the dwelling provides adequate space for free flight and opportunities for shelter suitable for use by loft dwelling species such as brown long-eared bats (*Plecotus auritus*). However, no physical evidence suggesting the presence of this species was identified.

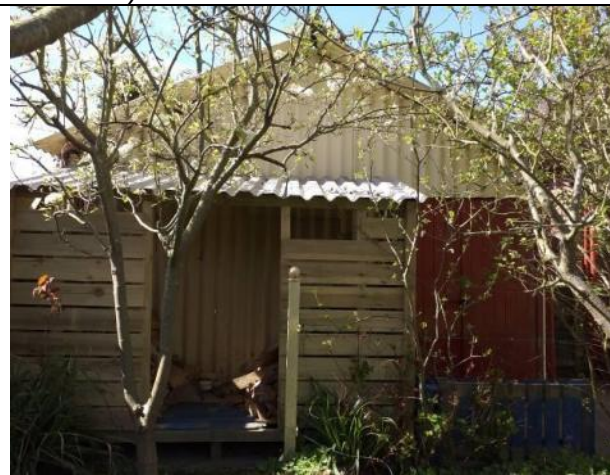
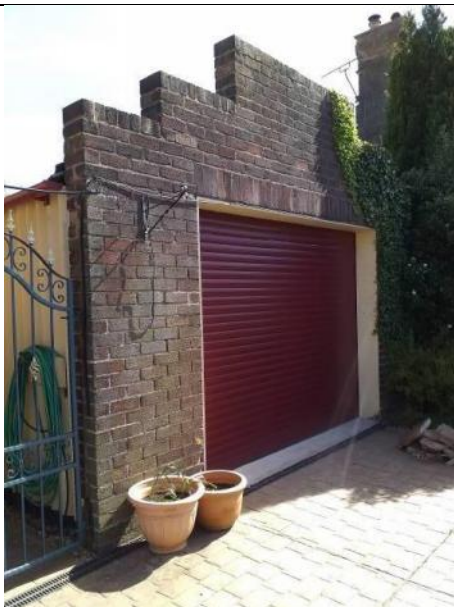
- 3.2.14 Refer to **Photographs 7.9** and **7.10**. Adjacent to the dwelling is a single storey garage which is constructed from walls of brick and corrugated sheeting with a pitched roof of corrugated asbestos. Attached to the garage is a timber woodstore covered with corrugated metal sheeting. This structure does not support a loft space.

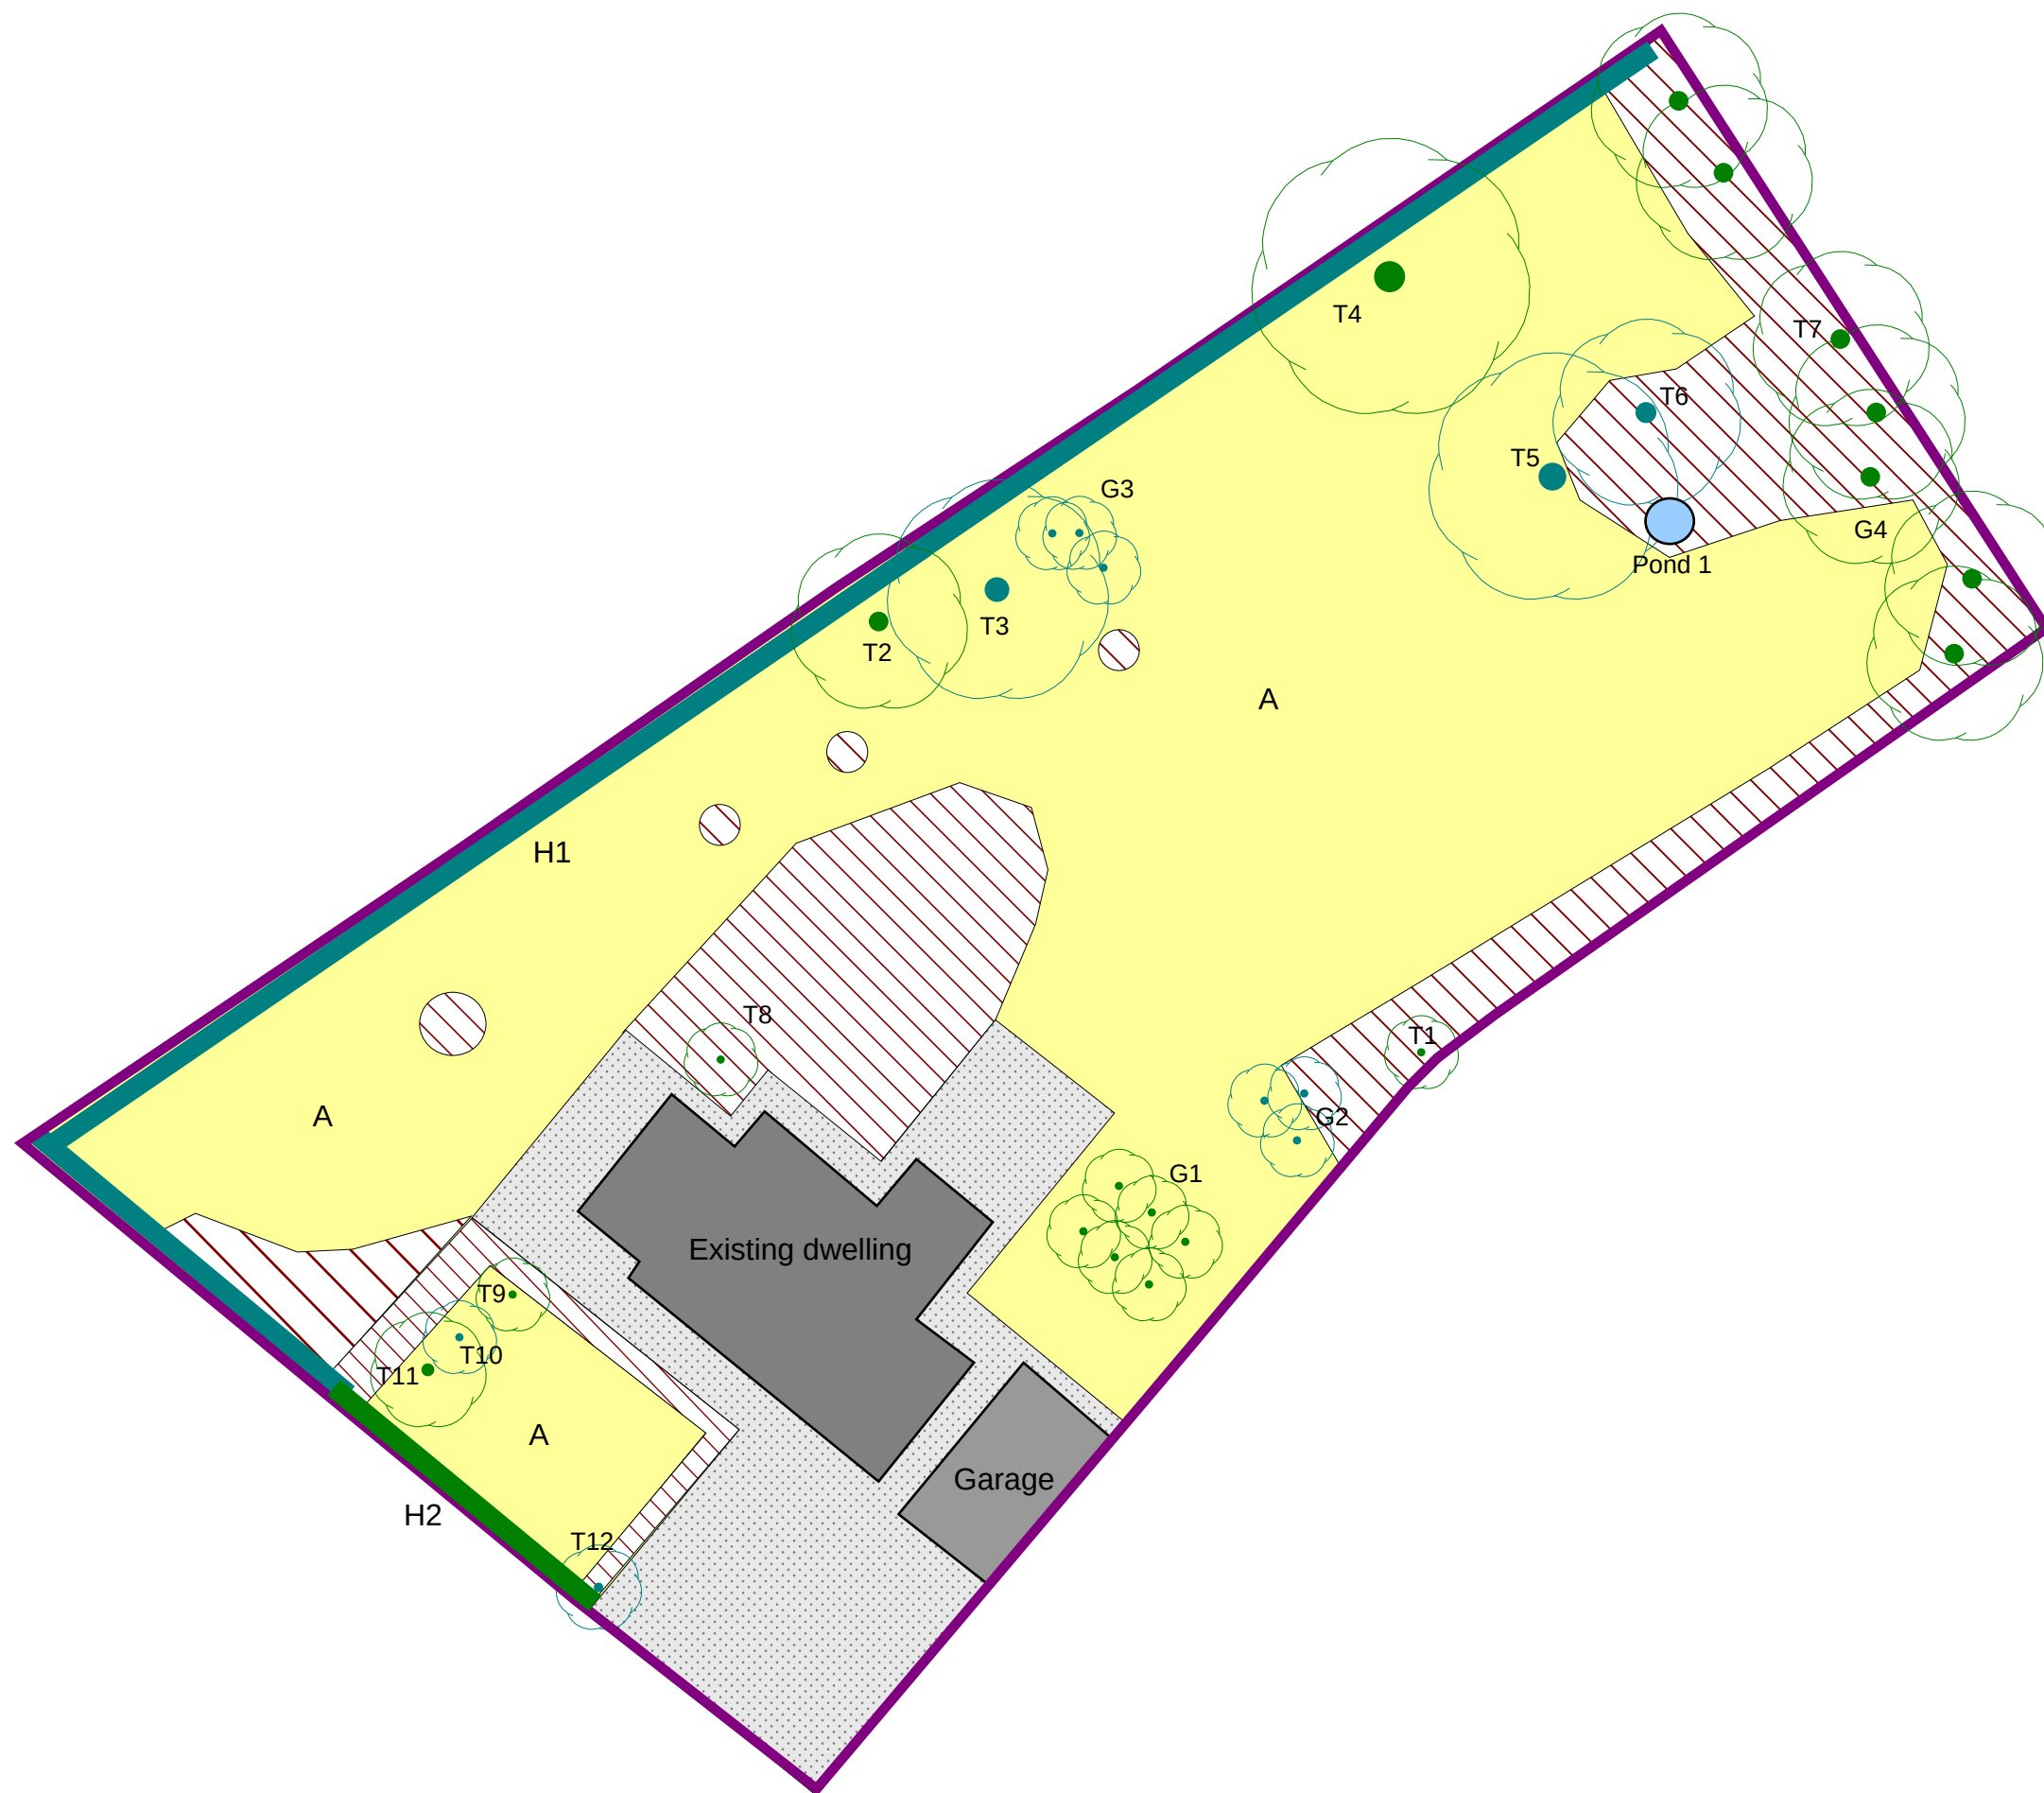
- 2.2.2 A habitat map (**Figure 7.1** at **Appendix 1.0**) was produced for the site based on the methodology as detailed in *Handbook for Phase 1 Habitat Survey: A technique for environmental audit* (JNCC, 2010).

3.2.3 A Phase 1 Habitat map is appended at **Figure 7.1**

- 3.2.7 Hedge 1 (refer to **Figure 7.1**) defines the western boundary. The hedge is approximately 80 metres long, one metre wide and 2.0 metres high. The hedgerow comprises entirely of Leyland Cypress (*Cupressus x leylandii*). The comprises locally abundant Ivy (*Hedera helix*), frequent Cleavers (*Galium aparine*) and Yorkshire Fog (*Holcus lanatus*) as well as occasional Creeping Thistle (*Cirsium arvense*) and Bramble (*Rubus fruticosus* agg.).

- 3.2.8 Hedge 2 (refer to **Figure 7.1**) is situated on the southern boundary. The hedge is approximately 8 metres long, 0.5 metres wide and 2.0 metres high. The hedge comprises entirely of Garden Privet (*Ligustrum Ovalifolium*). There are no understorey plants.
