# Dusk Survey Results with inclusive pre-dusk inspection

**Project Reference: PR-0416-24**

**Knowsley Village Hall**

**Knowsley Village Hall, School Lane, Knowsley, L34 9EN**  
**Dusk Survey Results in Relation to Bats**

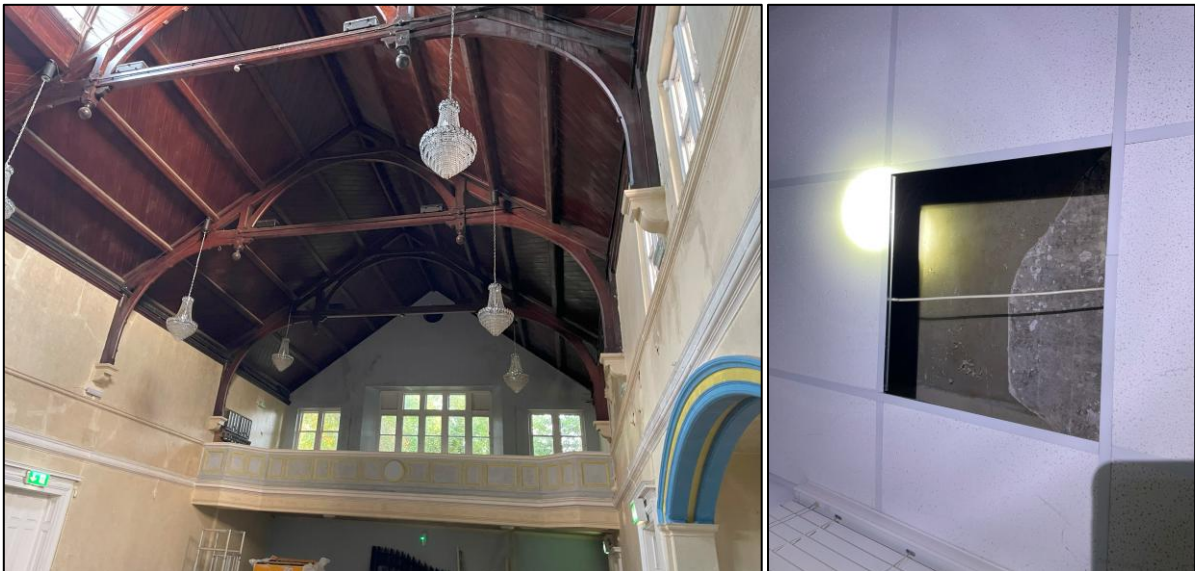
- 4.2 Internally the building includes several rooms and spaces (see **Figure 4.1**), the largest of which is the village hall which features a raised stage to the northern end, a vaulted ceiling of wooden boards, and numerous windows along each side, which fully illuminate the space. The flat roofed extensions feature false ceilings of hanging tiles and are partially illuminated via windows. A series of rooms understood to have historically functioned as a caretaker's flat are located on the first floor at the northern end of the building; above these is a loft space accessible via a single hatch.

**Figure 4.1** – Character of the hall with vaulted ceiling (left) and flat roofed extension with false ceiling (right)

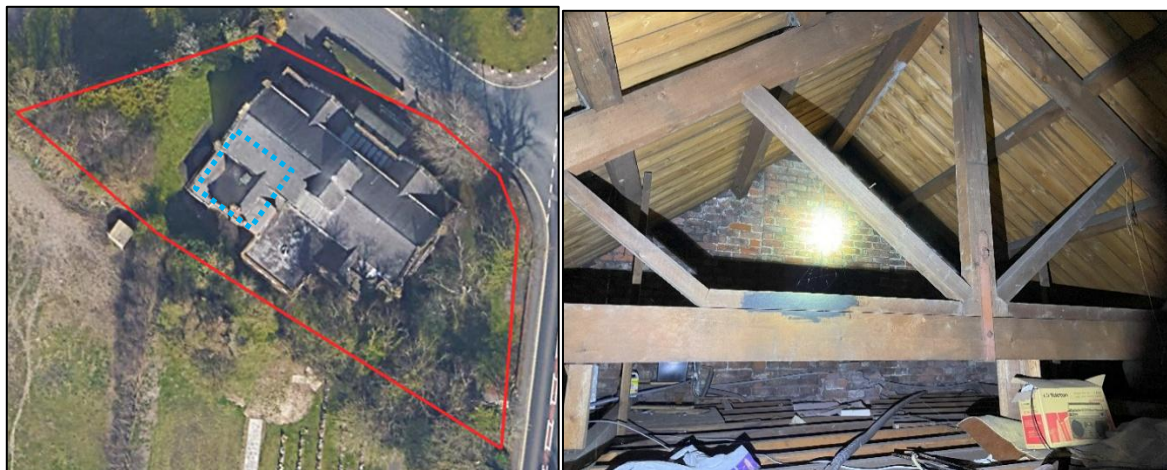
- 4.3 The loft space (see **Figure 4.2** overleaf) was found to be dark, open, and somewhat warm and draught-free, with abundant cobwebbing throughout. No light ingress was visible, and the wooden sarking board which lines the roofing materials appeared tightly fitted and in good condition; as such, it is unlikely bats would be able to easily access the loft. Based on the above characteristics, the loft could provide suitable conditions for the breeding purposes of loft-dwelling species such as the brown long-eared (*Plecotus auritus*), which prefer warm, dark and spacious lofts with consistent thermal conditions. However, the abundant cobwebbing and tightly fitted sarking boards indicate a likely absence of such species, though no meticulous search for evidence of either loft- or crevice-dwelling bats could be undertaken due to access restrictions.

Figure 4.2 – Location of loft space (left) and character of the loft space (right)

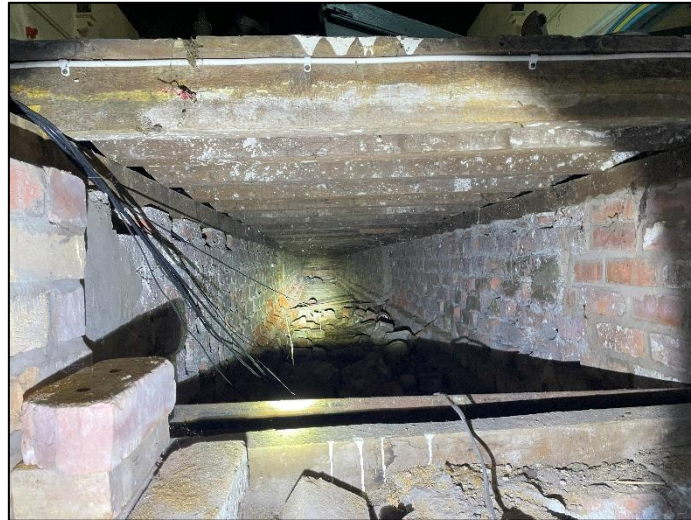
**Figure 4.3** – *Character of the foundations*

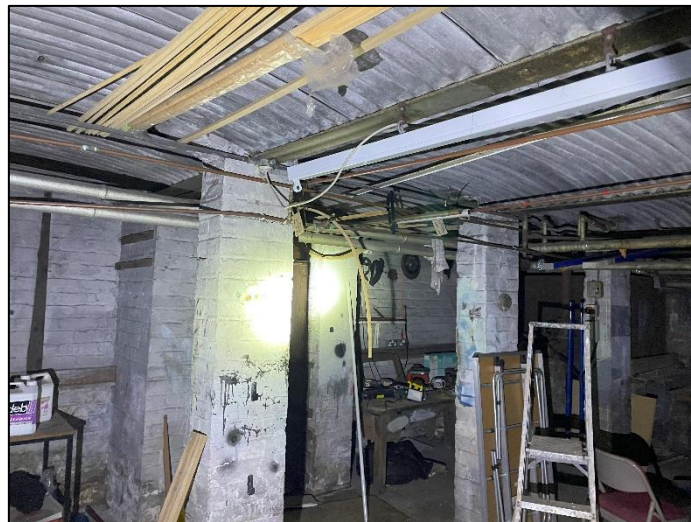
- 4.7 A cellar is also present at the northern end of the building, externally accessible via steps leading to a doorway. It is understood the cellar has not been frequently accessed since the building fell into disuse, though the presence of white goods and landscaping/caretaking equipment suggest that during the buildings occupation it may have been disturbed regularly. Along with the aforementioned features, cellar is host to pipework associated with the hall above, a cement floor and a corrugated and arched steel roof which is understood to line concrete above (see **Figure 4.4** overleaf).

**Figure 4.4** – *General character of the cellar*

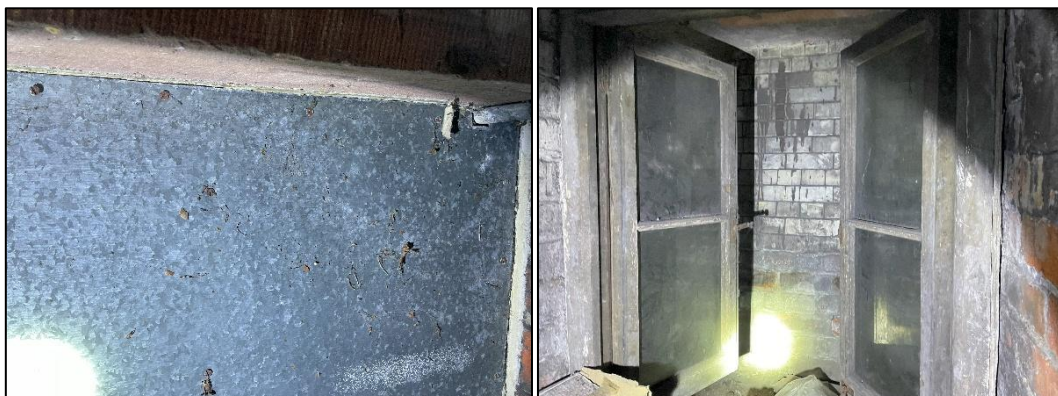
- 4.8 Two windows are present (see **Figure 4.5**), the first of which leads out to the stairwell, but which has been fully blocked externally by steel sheeting. It is not known at what point the steel sheeting was added, but given the aging it appears to have been in place for well over a year and was likely installed to prevent vandalism. Historically this window could have provided access but is now fully sealed. The second faces directly into subterranean brickwork and does not appear to lead anywhere or provide an ingress opportunity.

**Figure 4.5** – *Steel sheeting over cellar window (left) and second window leading nowhere (right)*

- 5.5 Consideration has been given to the recommendation for hibernation surveys; however, the lack of viable access for bats and the extremely aged nature of the droppings encountered is interpreted to indicate a historic change in the character of the cellar which has reduced or removed its suitability for hibernating bats. This is likely to have been in the form of the steel sheeting which has entirely sealed the external window; this is understood to have been present for some period of time.

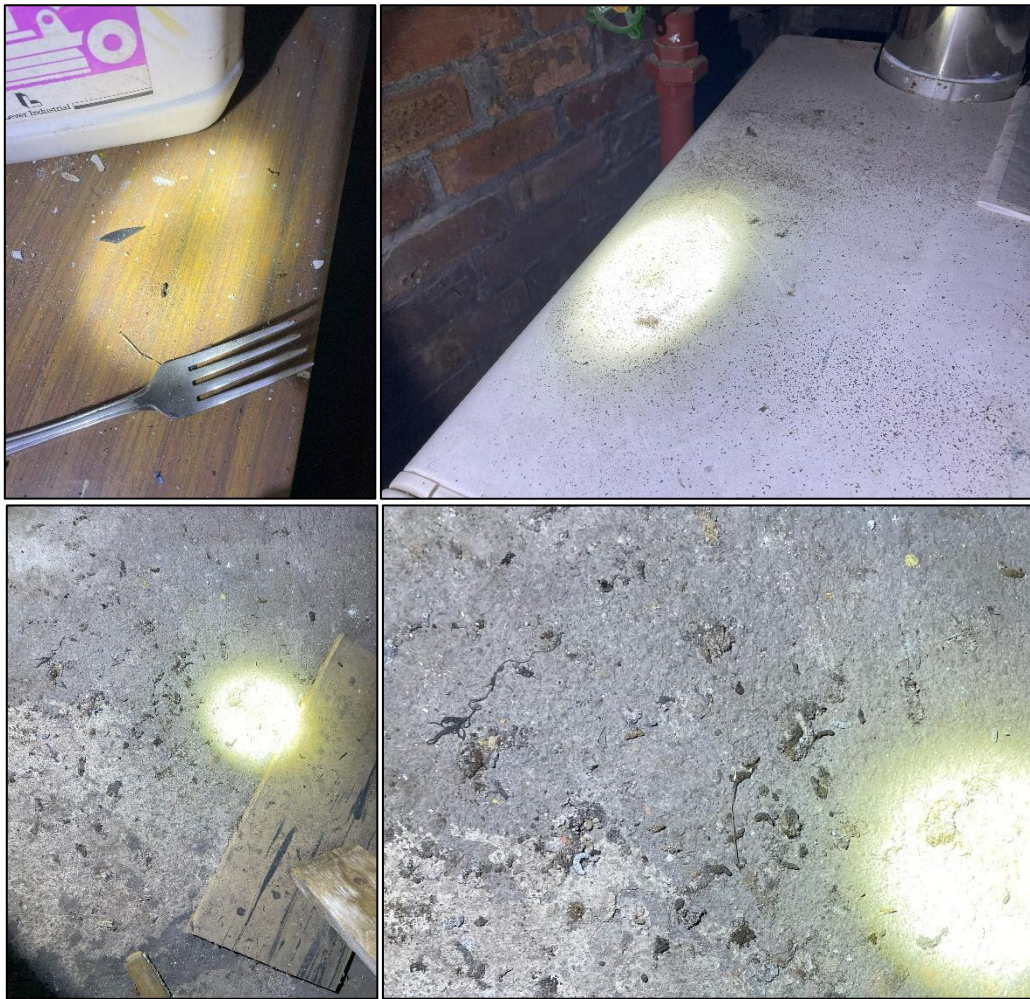
- 4.9 The cellar was cool, draught-free and fully unilluminated, and thus generally favourable for hibernating bats in regard to internal conditions. However, the corrugated steel roofing would be unfavourable for hibernating bats to grip, and with the single external window sealed there is no viable access for bats. Nonetheless a thorough inspection of interior surfaces for evidence of bats was undertaken with the aid of a high-powered torch; this revealed scattered, highly aged droppings attributable to both brown long-eared bats and bats of the *Pipistrellus* genus located on the floor and on the white goods units (see **Figure 4.6** below). The droppings were evidently historic, crumbling to the touch or mouldy, with some only evident as powdery residue.

**Figure 4.6** – Bat dropping attributable to pipistrelle bat (top left), dropping residue on white goods (top right), mixed droppings on floor (bottom left) and zoomed image showing mix of pipistrelle and brown long-eared droppings, displaying crumbly and/or mouldy state (bottom right)

- 5.3 The cellar accessed via an external stairwell was found to be internally suitable for the hibernation purposes of bats, though no viable access points were found that would currently allow such use. Historic droppings, attributable to brown long-eared and pipistrelle bats were found scattered throughout the cellar, indicating that the space had at some point been utilised by bats.

- 5.6 A precautionary approach is instead therefore recommended, in the form of a Precautionary Working Method Statement (PWMS). This PWMS should include, as a minimum:

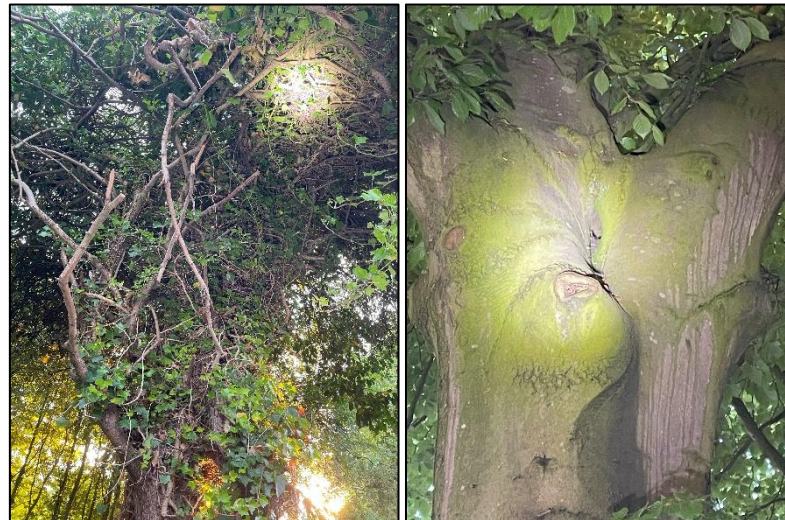
- 4.10 The application site is host to multiple mature and semi-mature trees (see **Figure 4.7**), including lime (*Tilia x europaea*), holly (*Ilex aquifolium*), beech (*Fagus sylvatica*) and hawthorn (*Crataegus monogyna*). Trees were assessed from ground level with the aid of a high-powered torch, and were generally found to be absent of PRFs with the exception of four individuals as described below.
- 4.11 Numbering of the trees on site is as per the Tree Removal Plan (Rainfords Arboricultural, 2024) available on the Knowsley Council planning portal. T11 is a hawthorn at the south-western boundary which is clad in a heavy layer of ivy (*Hedera helix* agg.), which could obscure PRFs within the trunk of the tree. T14 and T15 are similarly ivy-clad, mature lime

trees located to the south-west of the village hall building; again, the ivy could obscure PRFs. Finally, T23, a large beech located to the east of the hall, is host to a cavity where two boughs have grown together; the extent of this cavity is not visible from ground level, but it could feasibly provide suitability for low numbers of roosting bats.

**Figure 4.7** – Ivy T11 covered hawthorn (left) beech T23 with cavity (right)

- 4.12 T11, T14, T15 and T23 are therefore duly categorised as pertaining to a bat roost suitability of ‘**FAR**’ (further assessment required) in line with BCT guidance. All other trees are collectively categorised as pertaining to a roost suitability of ‘**None**’.

- 5.9 As such, no further surveys are recommended in relation to trees at this time; however, should the development proposals be altered to include the felling or management of T11, T14, T15 or T23, then the advice of a suitably experienced ecologist should be sought in relation to additional aerial inspections of each tree.
- 5.10 Nonetheless, the applicant might consider implementing a bat-sensitive lighting plan to avoid impacts to bats foraging above the site. Several options to consider have been listed below, though the reader is referred to the Bat Conservation Trust's 'Bats and Artificial Lighting at Night' guidelines (August 2023) for further information.

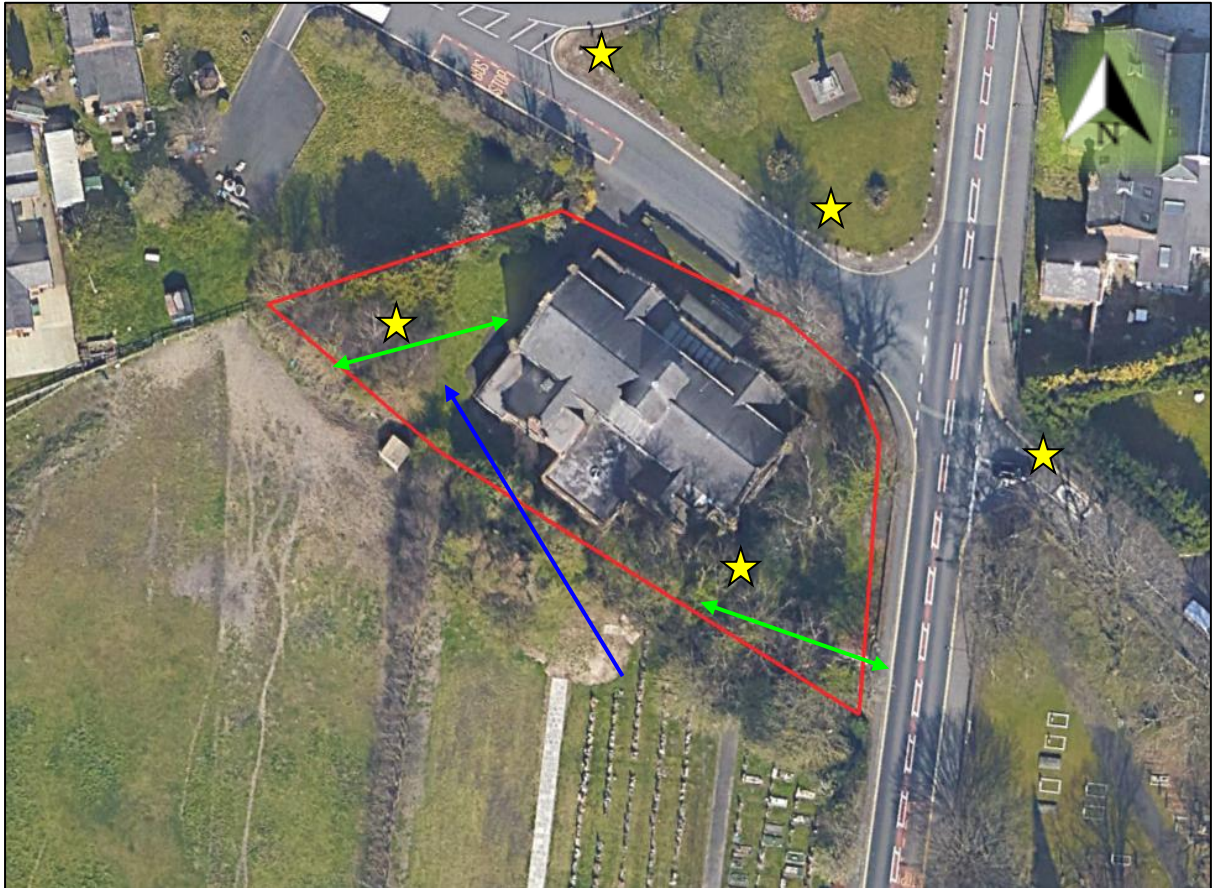
**Figure 4.8 – Visual Aid – Dusk survey results with Key**

Survey Dates	Time	Activity
21/05/2025	2055 – 2245	<p><b>No emergence of any bat species from the target building during the survey.</b></p> <p>2140-2142 hrs: a common pipistrelle (CP) foraged under the tree canopy at the southern perimeter of the site.</p> <p>2142 hrs: a CP was recorded but not observed.</p> <p>2152-2159 hrs: a CP entered the site from the south-east to forage amongst the trees to the north of the hall.</p> <p>2232 hrs: a CP was recorded but not observed at the southern end of the site.</p> <p>General activity comprised of sporadic foraging by a single common pipistrelle bat.</p>
10/06/2025	2118 – 2308	<p><b>No emergence of any bat species from the target building during the survey.</b></p> <p>2155-2213 hrs: a CP was sporadically recorded foraging in the trees to the south of the site.</p> <p>2223 hrs: a CP foraged above the green to the east of the site before commuting west.</p> <p>2230 hrs: a CP foraged above the green to the east of the site before commuting west.</p> <p>General activity comprised of sporadic foraging by a single common pipistrelle bat.</p>

**Dusk Survey 1 – 21/05/2025**

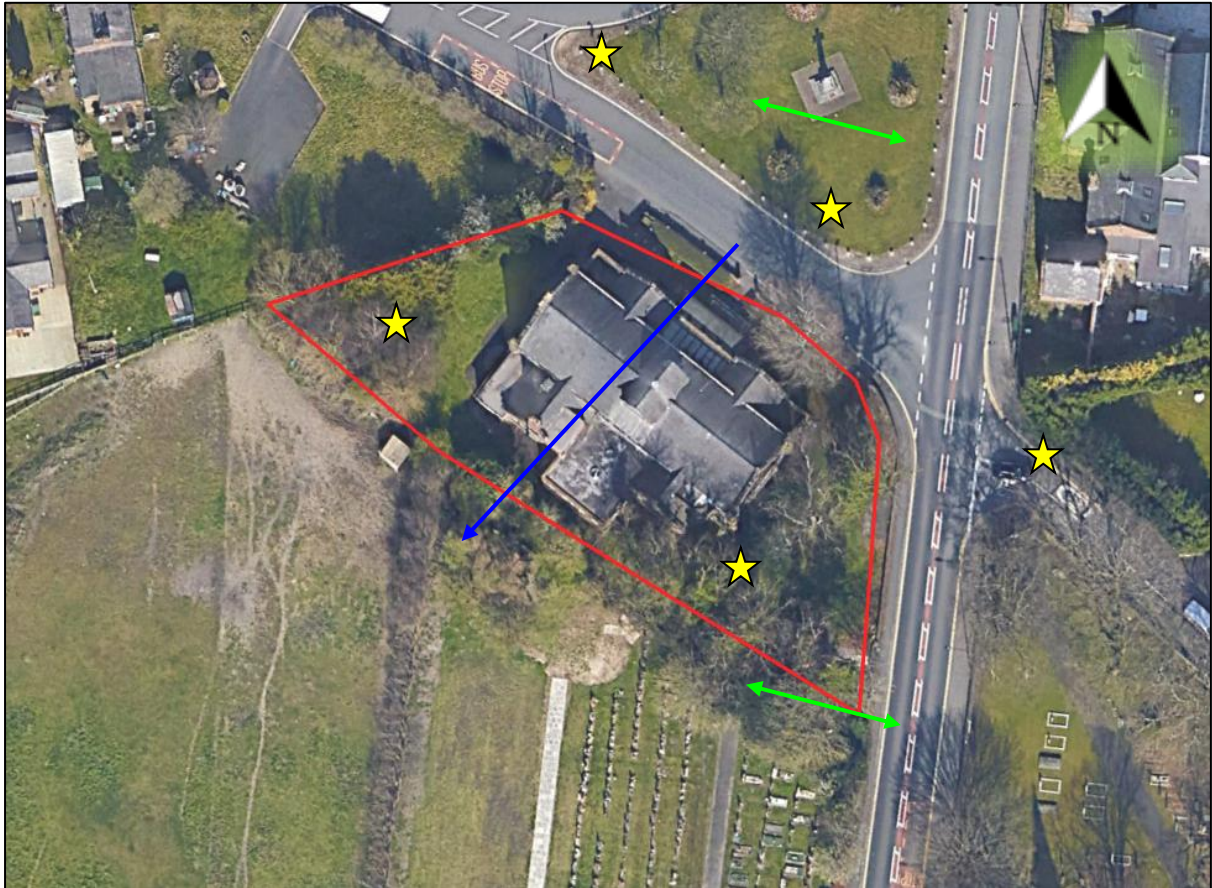
**Dusk Survey 2 – 10/06/2025**

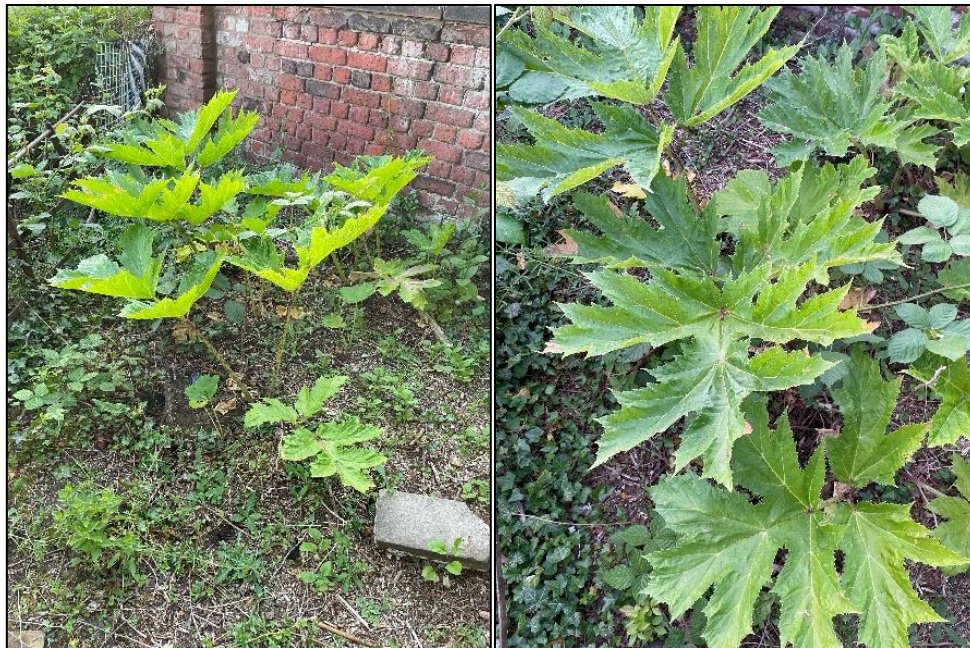
- 4.14 During a Biodiversity Net Gain Assessment (Tyrer Ecological Consultants Ltd, January 2025) of the site, an Invasive Non-Native Species (INNS), was identified in the form of rhododendron (*Rhododendron ponticum*), a species listed under Schedule 9 of the Wildlife and Countryside Act 1981 (as amended).
- 4.15 During the first pre-dusk inspection, giant hogweed (*Heracleum mantegazzianum*), a species listed under Schedule 2 of the Invasive Alien Species (Enforcement and Permitting) Order 2019, was also identified, located at the northernmost corner of the site (see **Figure 4.10**).

**Figure 4.10** – Giant hogweed identified in the northmost corner of the application site

- 5.16 Two INNS, giant hogweed and rhododendron, were identified within the application site boundary. Whilst it is not illegal to host such species within an ownership boundary, it is illegal to spread or allow the spread of them outside of the boundary, and authorities may require eradication or management of these INNS regardless. Furthermore, giant hogweed is dangerous to humans in that contact of the skin with its sap can result in extreme photosensitivity, in which sunlight causes severe burns.

- 5.17 It is therefore recommended that eradication of these INNS by a suitably experienced and qualified invasive species contractor be undertaken prior to commencement of works at or in proximity to that area of the site. Eradication would both prevent risk of harm to contractors during the construction phase and occupiers during the operational phase of the development and prevent risk of spread of these plants off-site.

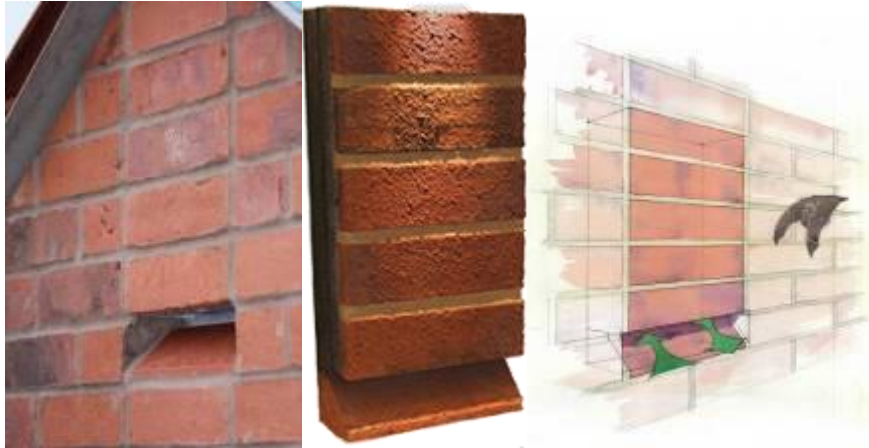
The Habitat Bat Box is a solid box made of insulating concrete with internal roosting space. The box blends seamlessly into brick-built properties and may be incorporated into the fabric of buildings, being best placed on gable elevations.

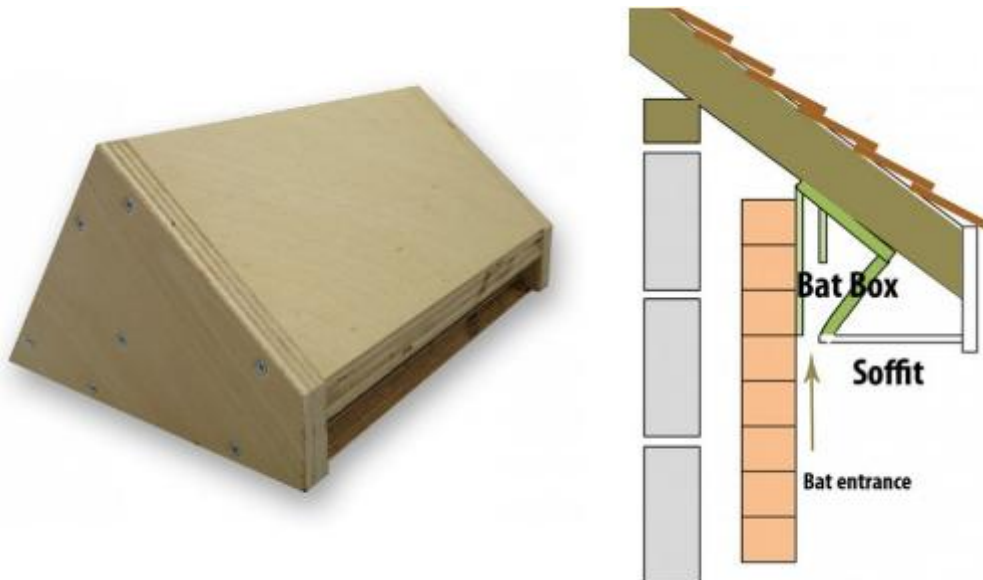
Where soffits are instated at gable elevations, roost provision may be instated in the form of a soffit bat box with internal roosting space.

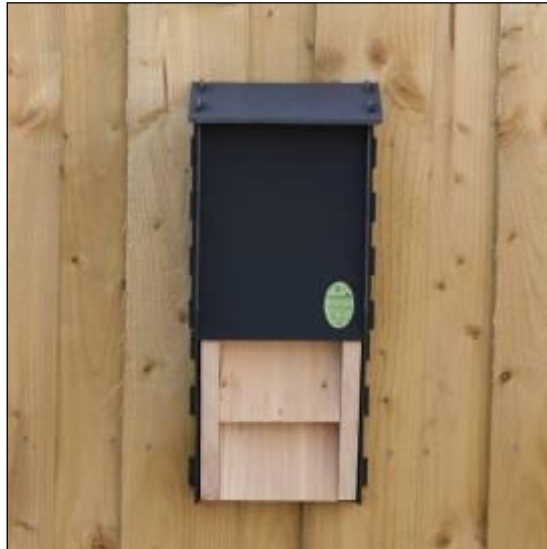
A large number of externally fitted box models for bats exist for buildings and trees. Suitable models for both buildings and trees may include the Eco Kent Bat Box.

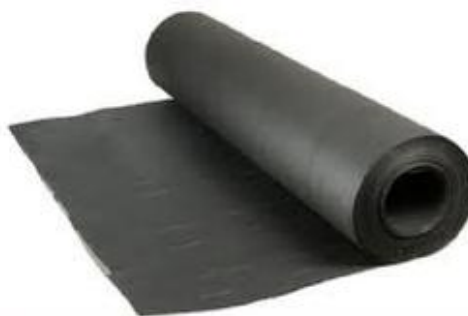
Where appropriated, ridge tile access should be made with the incorporation of traditional Bitumen 1F underfelt immediately beneath ridge tiles. Breathable BRM membrane can cause significant problems where bats are in contact with it, whereby their fine claws become entangled within the fibres of the membrane, entrapping and killing bats.
