# **PHASE I GEO-ENVIRONMENTAL DESK STUDY**

## **JAGUAR LAND ROVER, HALEWOOD, EASTLANDS**

| PROJECT ID: | LW25-136 |
| REFERENCE: | LW25/136/DS |

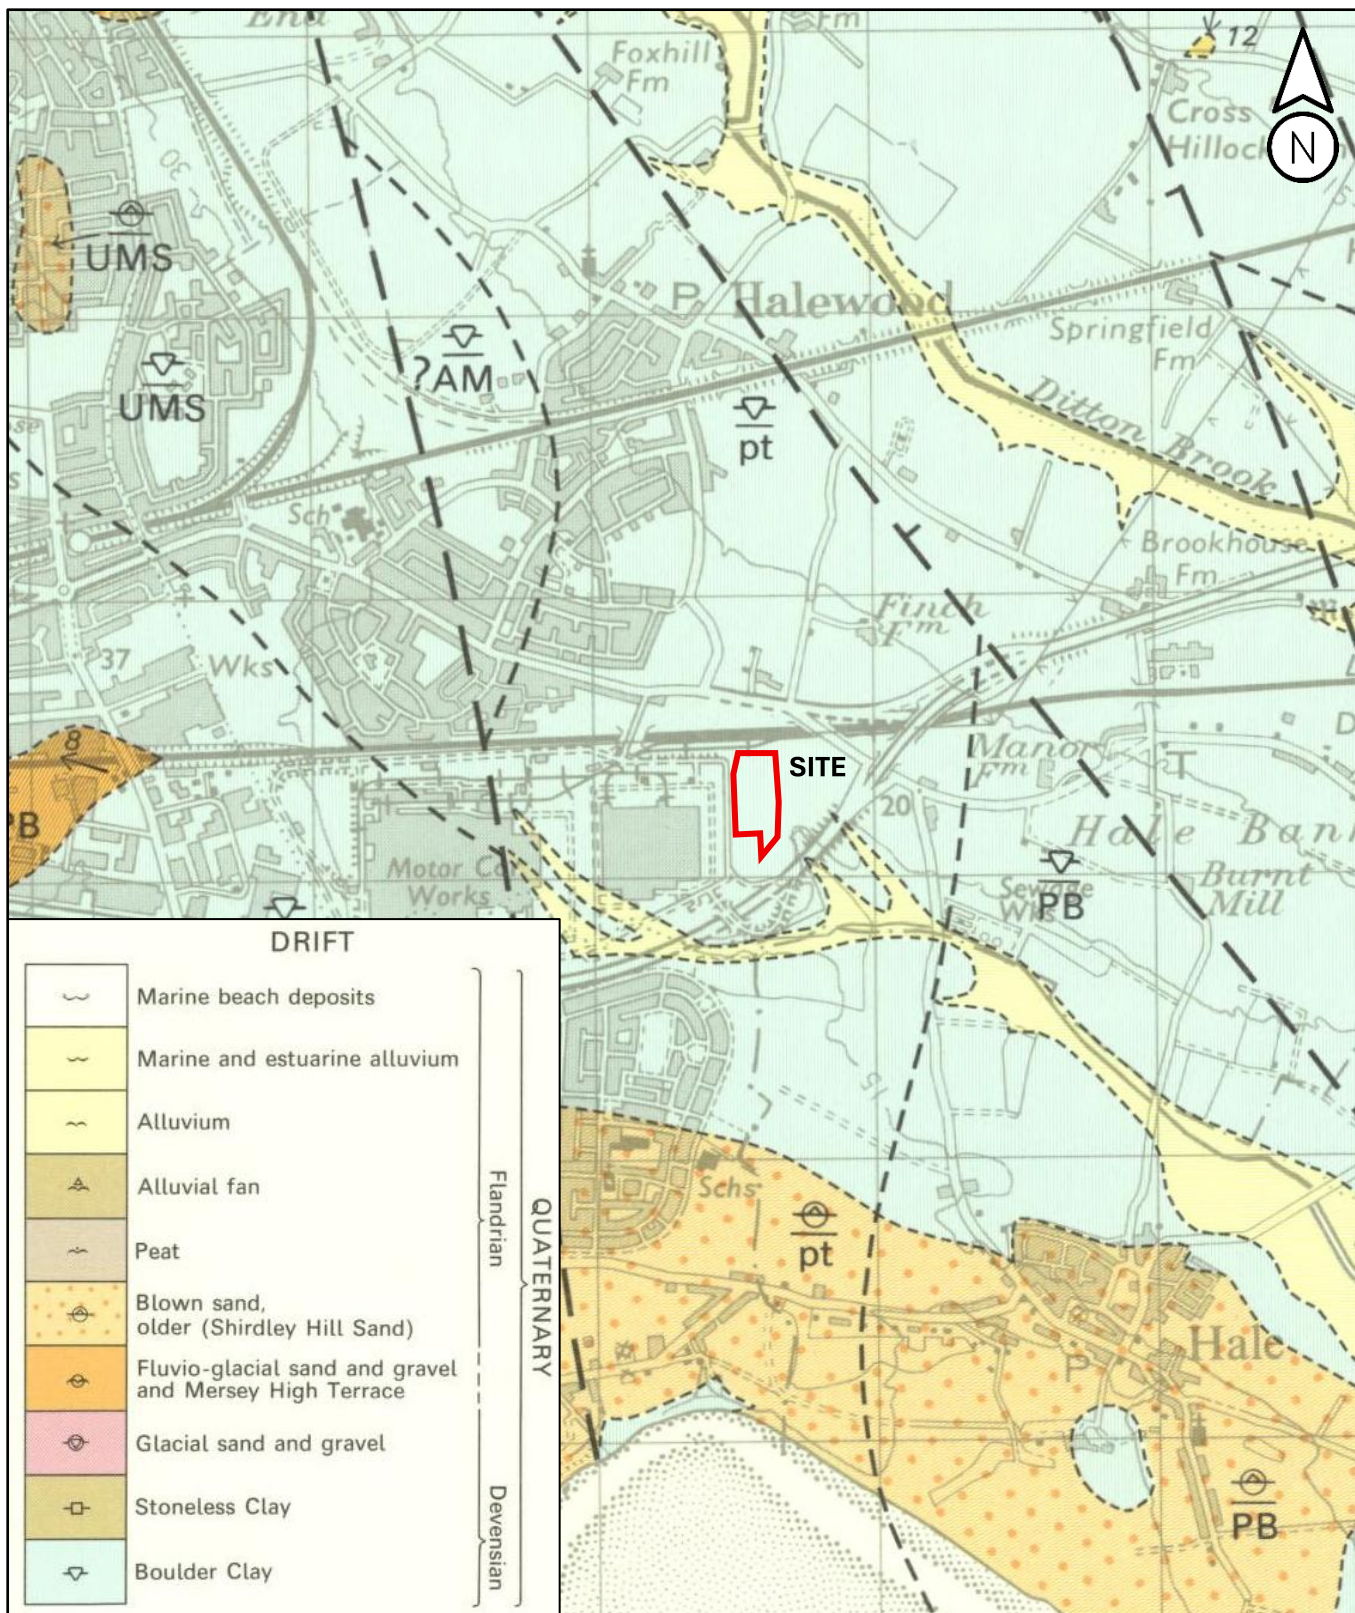
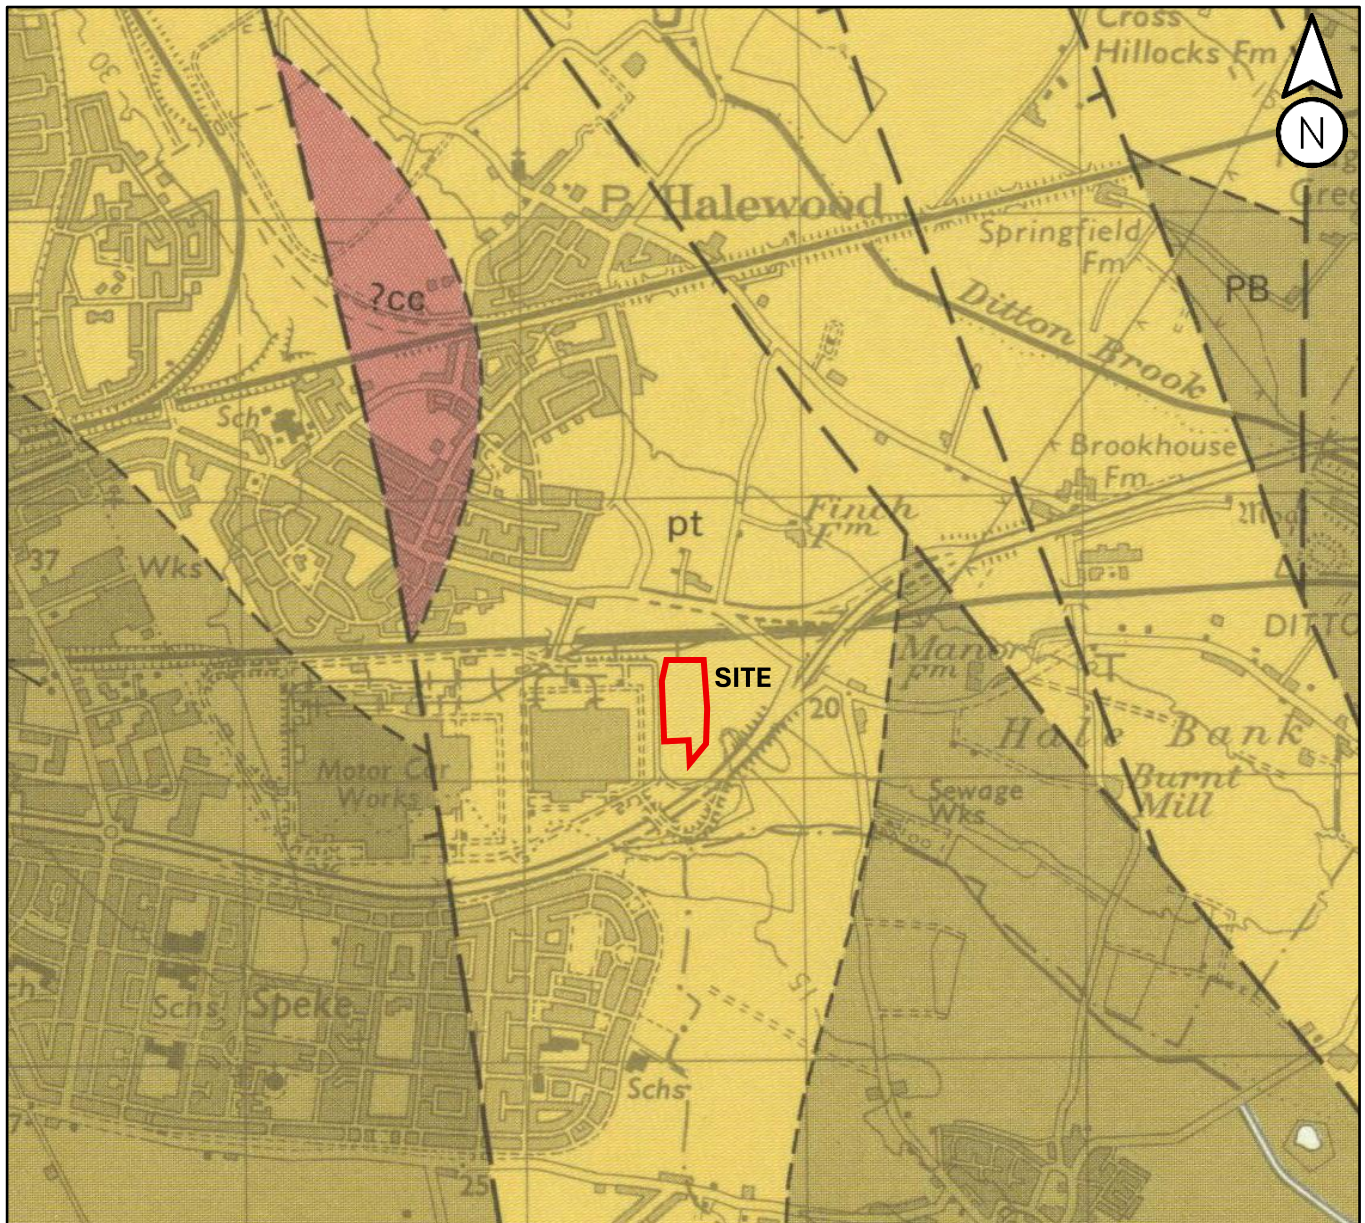
Extract from BGS © - Runcorn Sheet 97

PERMIAN AND TRIASSIC  
Scale 1:20 000
