## ARBORICULTURAL IMPACT ASSESSMENT

7 WREN GROVE  
HALEWOOD

MAY 2021

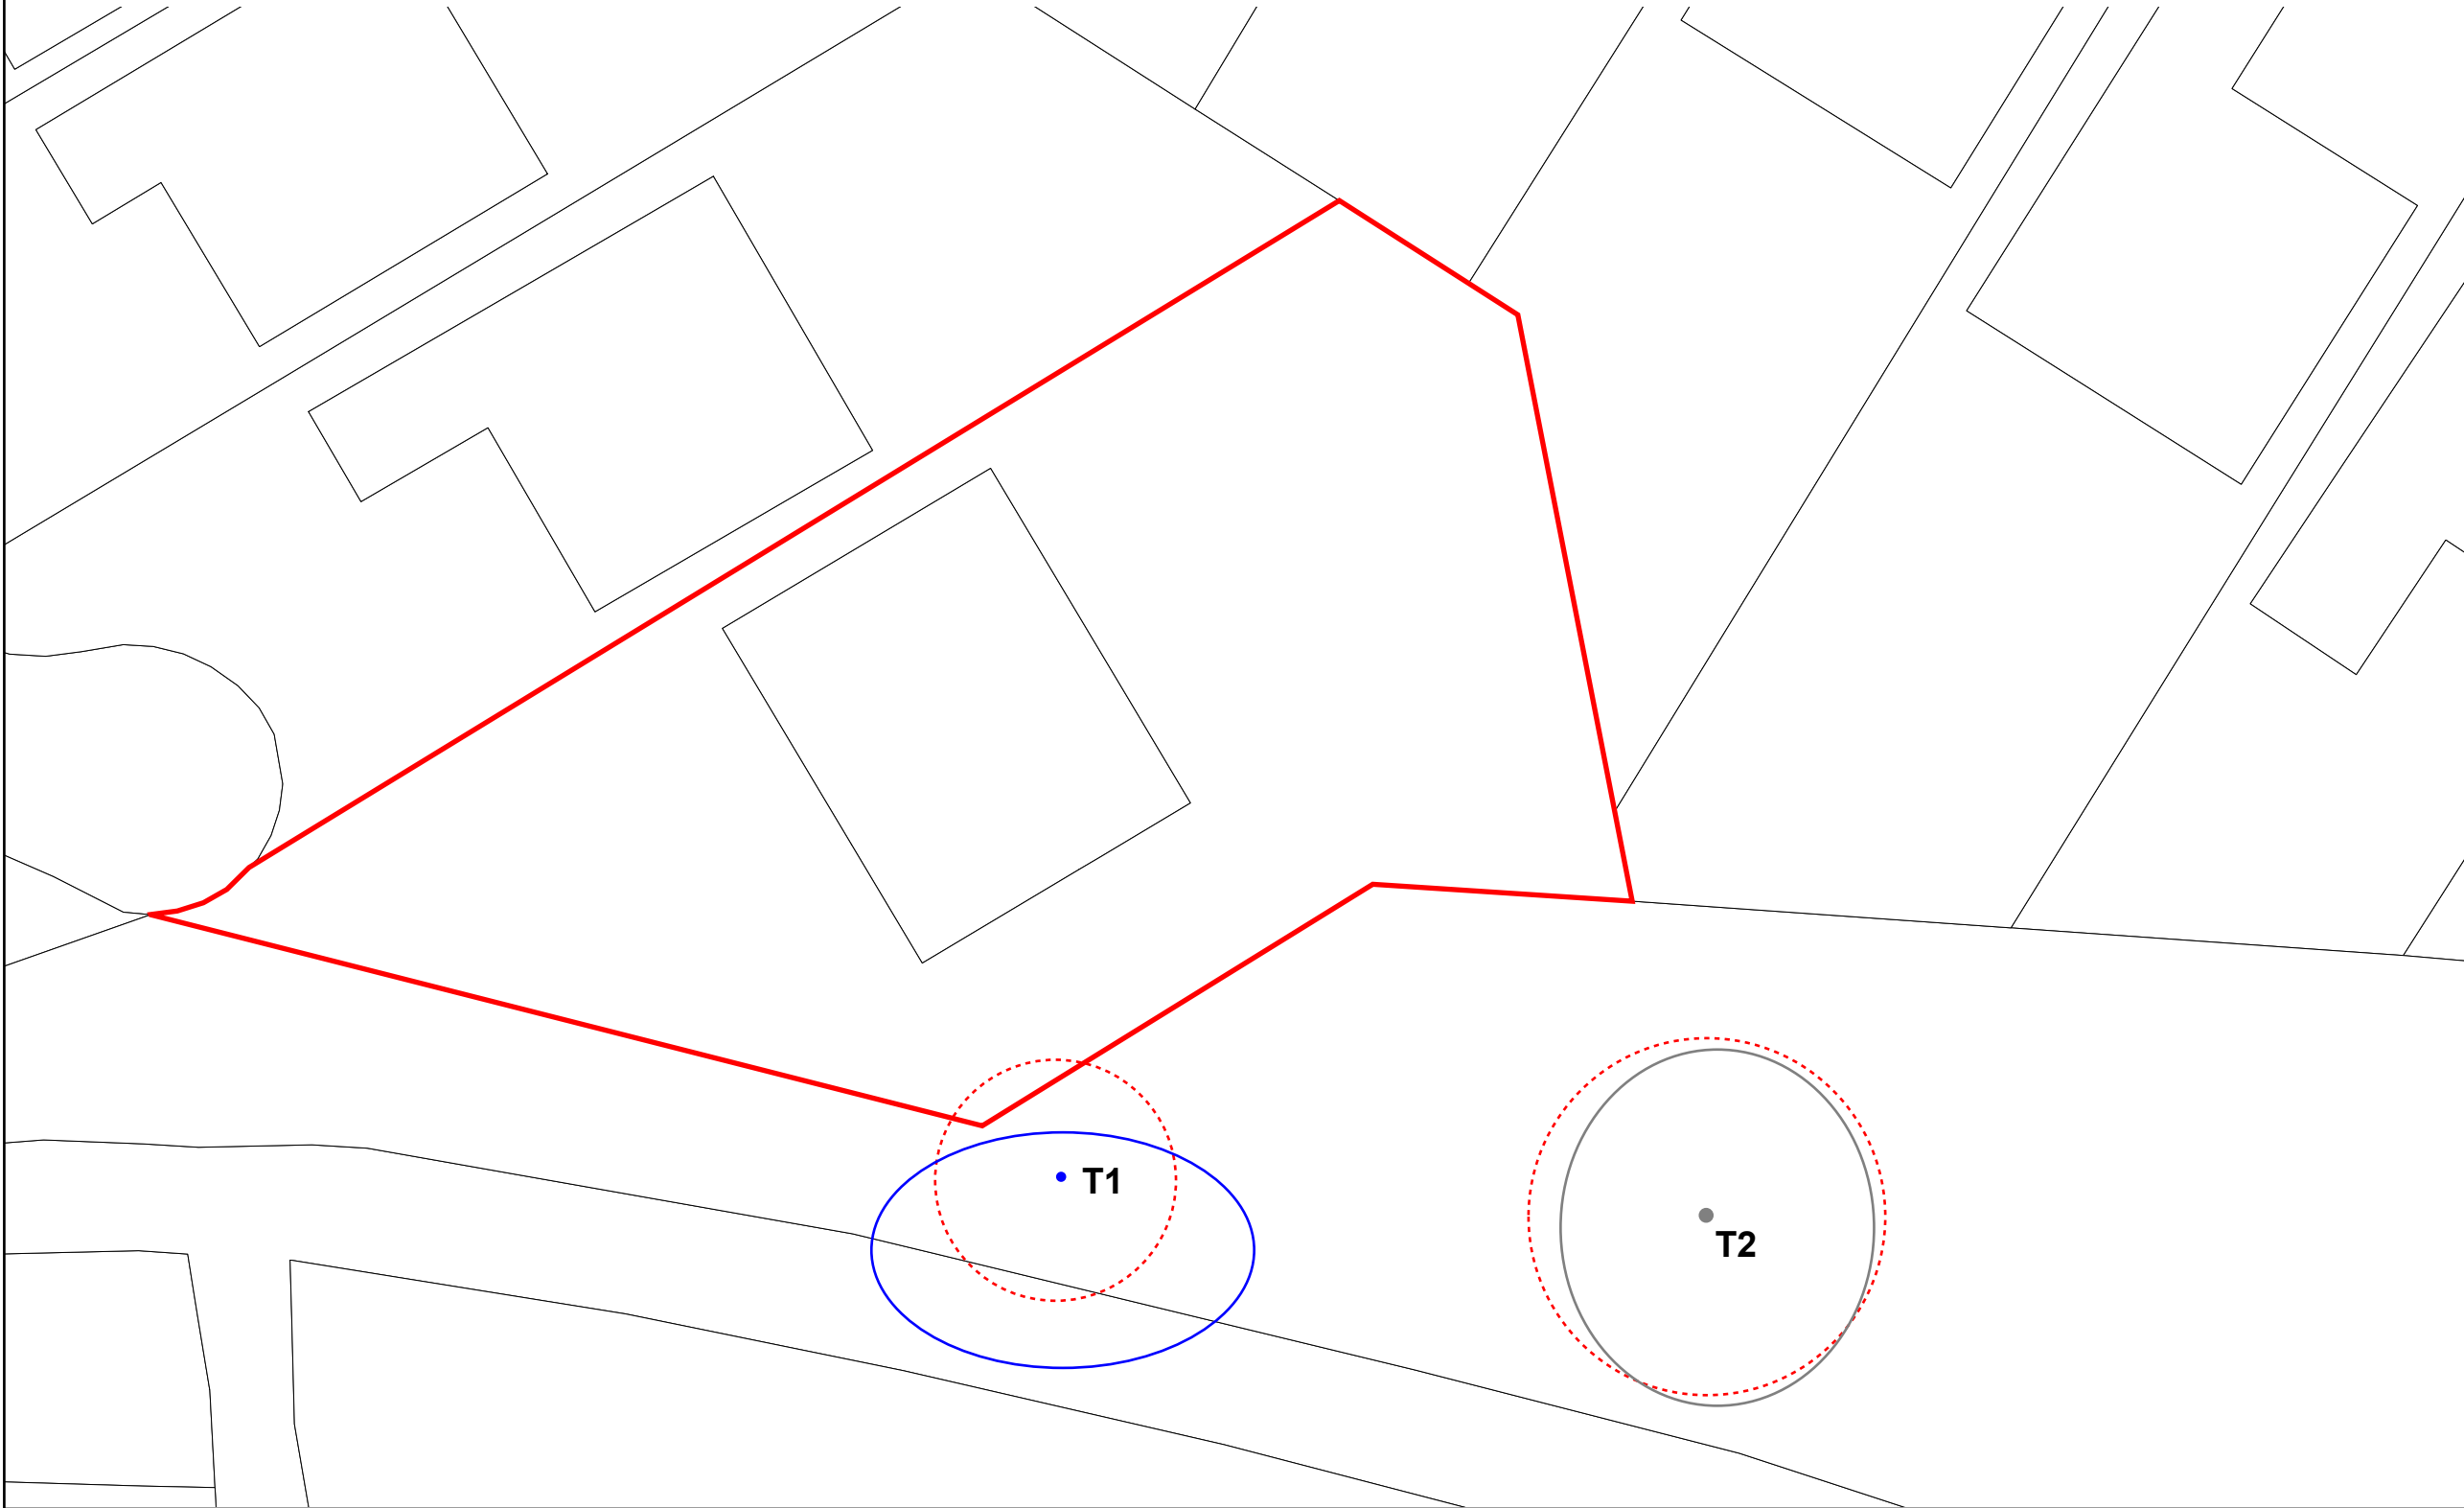
Drawing Title: BS5837 Plan      Drawing No: 21/00024/BSP

- 3.1 The site layout plan within Appendix 3.0 identifies the trees in relation to the proposed development.
- 3.2 To fully assess the impact of the proposals an Impact Table (**Table 3.1**) has been created detailing each tree, which shows the proximity of the associated works.
- 3.3 This can then be assessed in accordance with BS 5837:2012 to determine whether proposals will have a detrimental impact on the health of each tree. Once this has been determined remedial measures can be detailed to reduce the impact the proposals will have on the treescape.

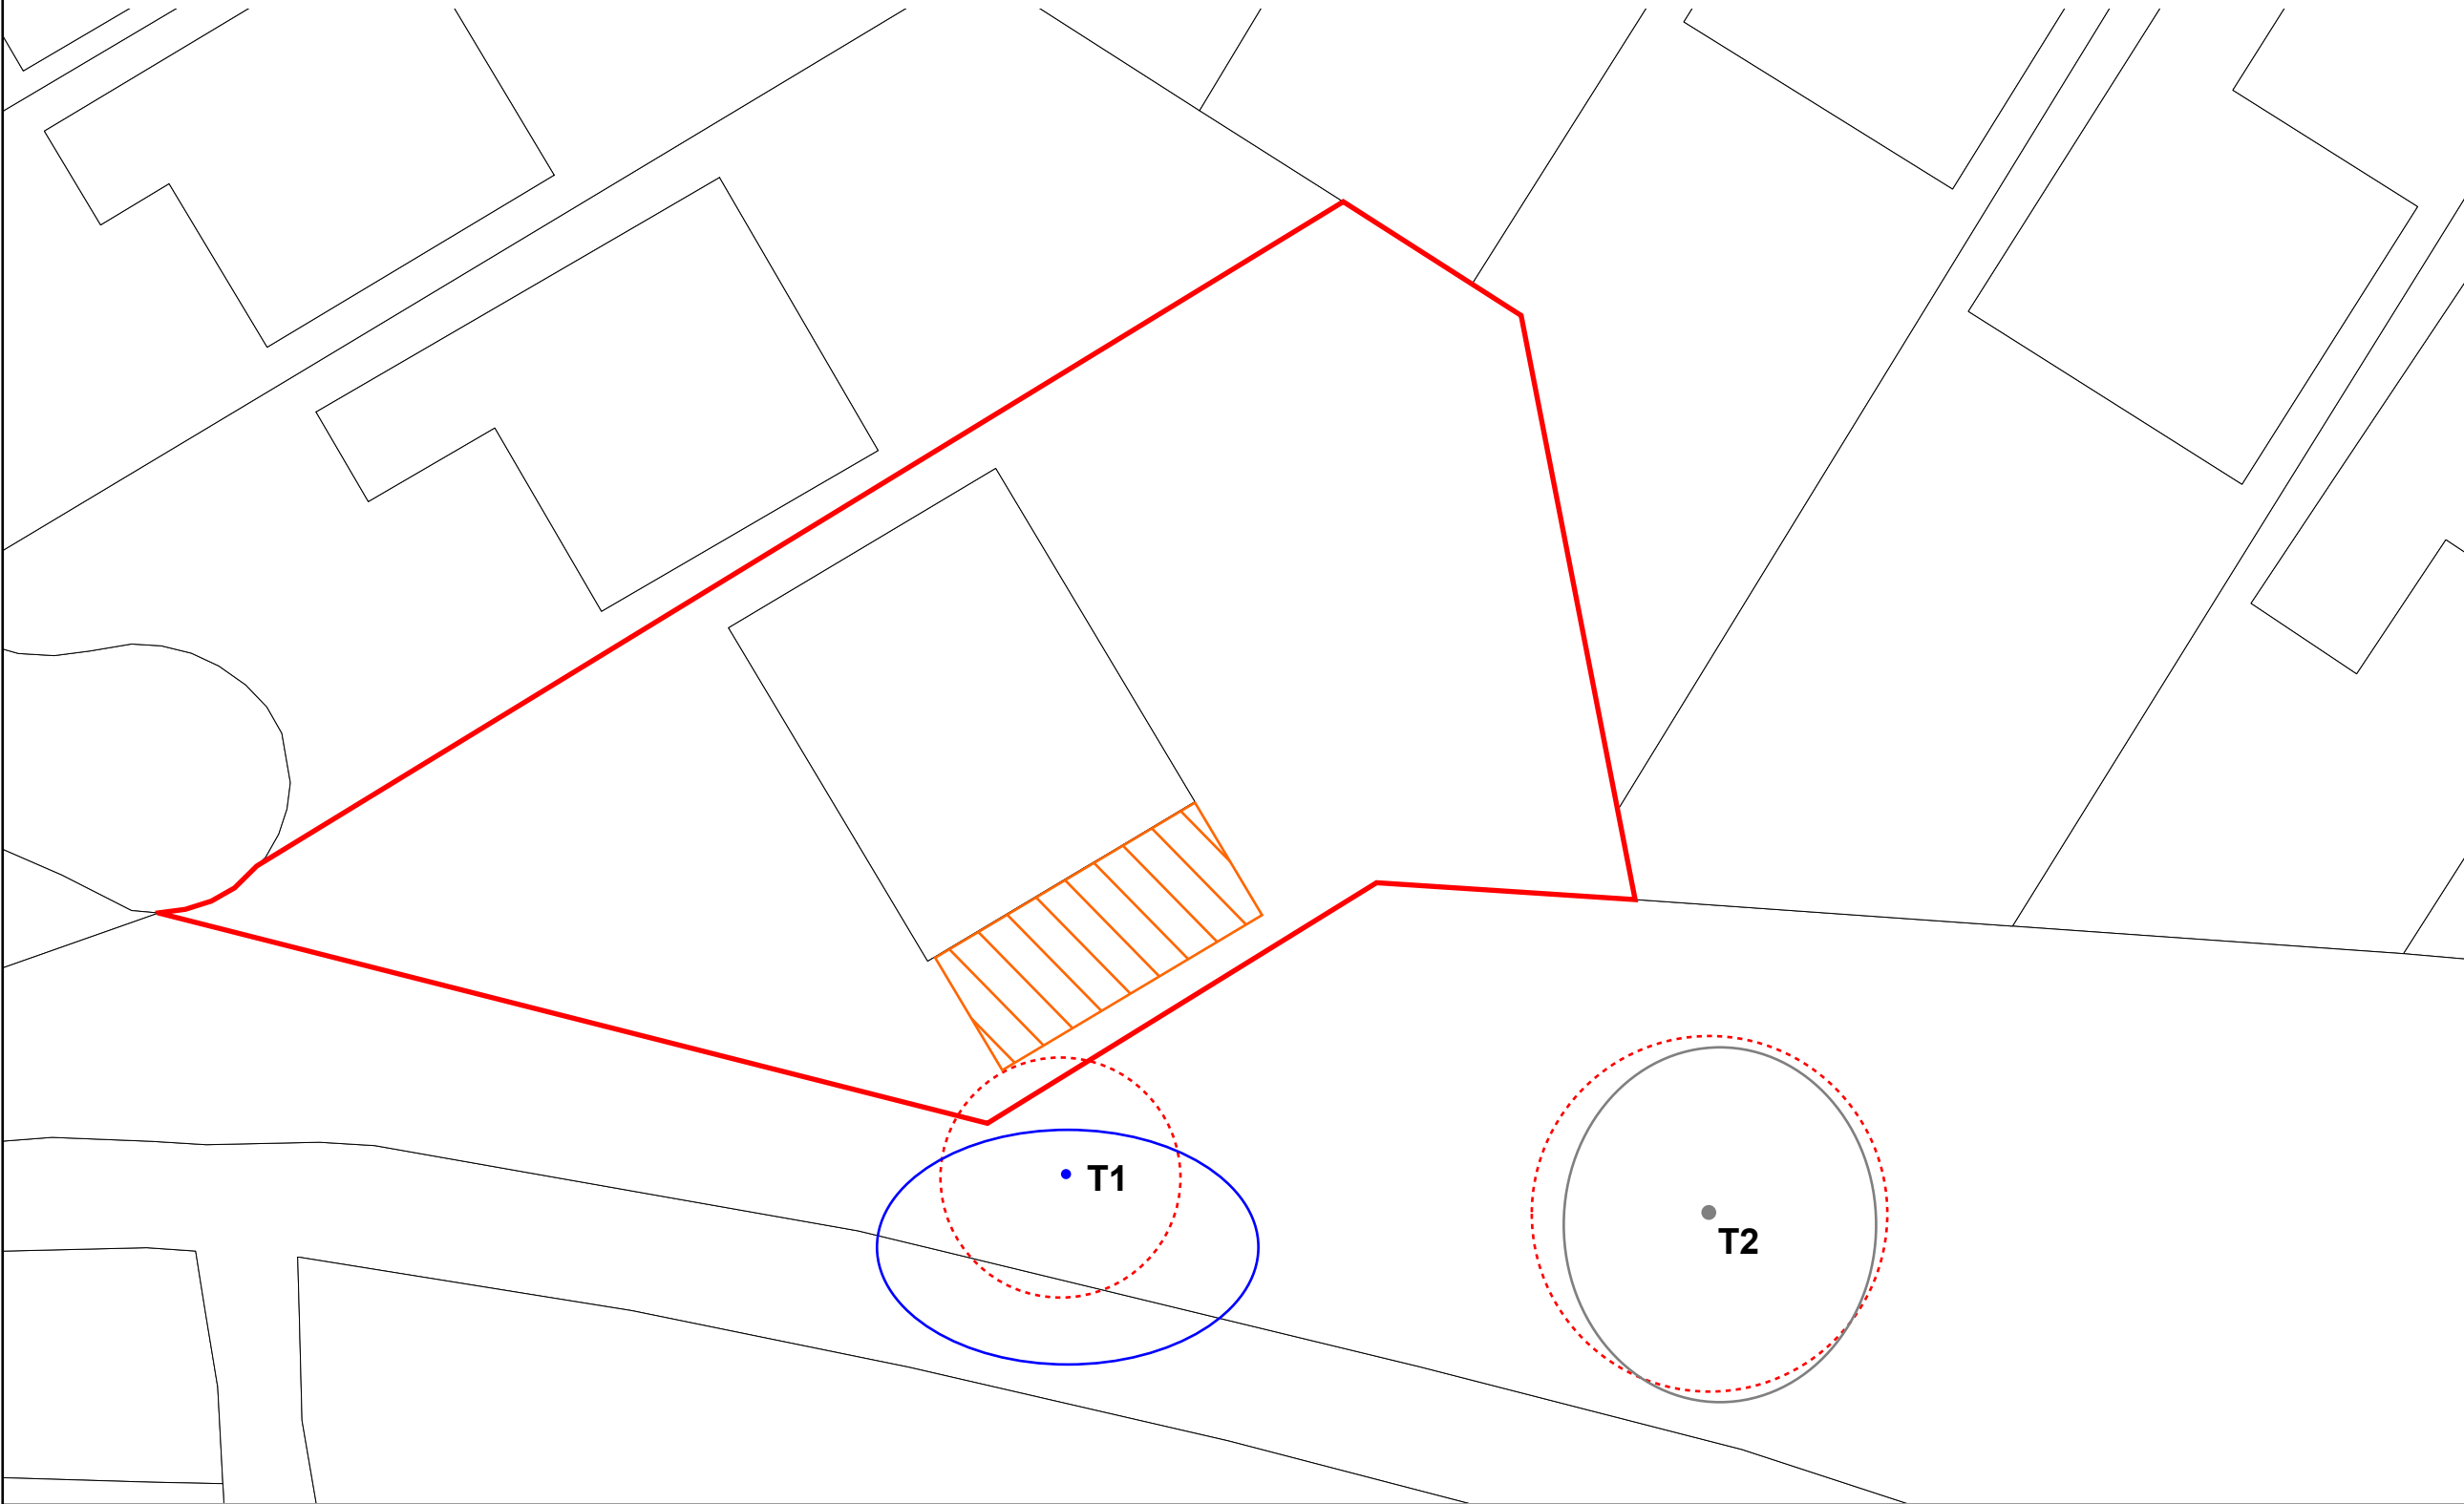
Drawing Title:  
Impact Assesment

- 3.4 The proposed development will cause no encroachment into the root protection area of T1 and T2. Both trees can be successful retained without any adverse effects.
