## BOW17.1593: Preliminary Roost Assessment (PRA) - Update

This report provides an updated Preliminary Roost Assessment (PRA) of the site at Wilson Road, Huyton, Liverpool (NGR: SJ 45755 90004). It has been prepared in relation to planning application (DN 25-00205-FUL), to inform: proposed building demolition; and to confirm whether any changes have occurred since the previous bat surveys undertaken in 2021 and the updated bat survey report completed in August 2024.

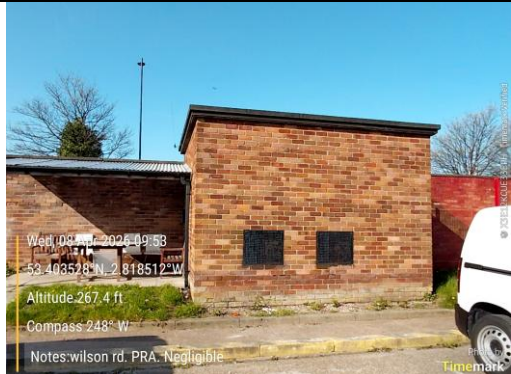
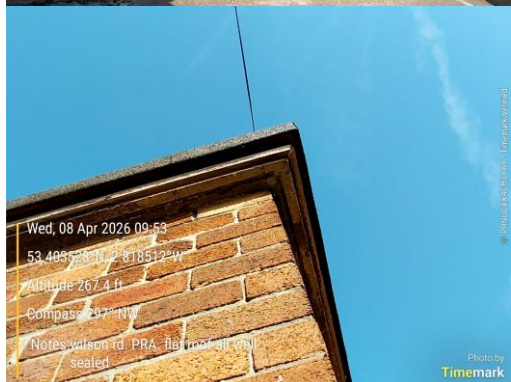
| Photograph | Description |
|---|---|
| | <p>Outbuilding in good condition, flat roof well-sealed. Negligible bat risk.</p> |

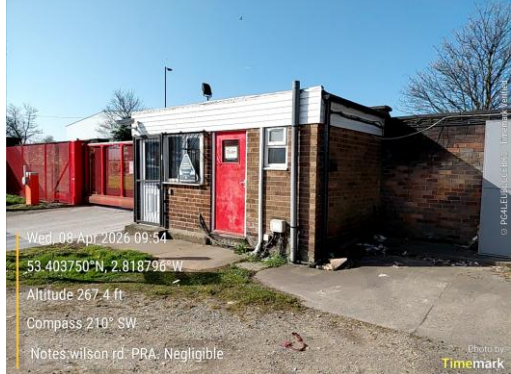
| Photograph | Description |
|---|---|
| | <p>Security outbuilding in moderate condition, though negligible bat risk.</p> |

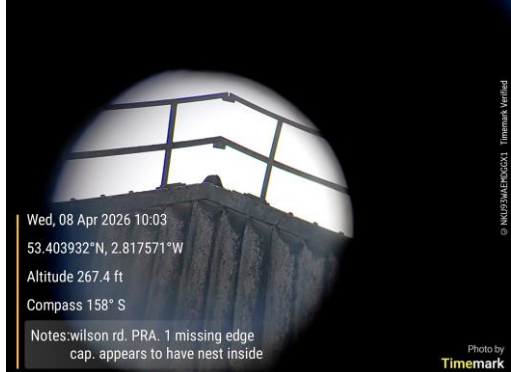
| Photograph | Description |
|---|---|
| | <p>Birds nest in missing edge cap.</p> |

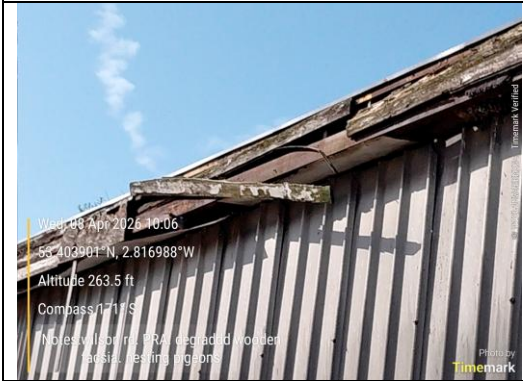
| <p>Wed, 08 Apr 2026 10:06<br/>53.402901°N, 2.816988°W<br/>Altitude 263.5 ft<br/>Compass 171°S<br/>Notes: wilson rd. PRA. degraded wooden fascia. Pigeons on roof.</p> | <p>Degraded timber fascia. Nesting feral pigeons are within and significant pigeon roosting evidence. Flock of pigeon noted on site.</p> |

A significant number of herring gull (*Larus argentatus*) and other gull species were present on the roof during the survey. It appeared that there were several nesting pairs, alongside nesting feral pigeon (*Columba livia domestica*). Nesting birds, including feral pigeon, are protected by law (Appendix D) during the nesting season (March – August inclusive). Therefore, the building must not be demolished, or any other works begin on the building outside of current operations, during this period. It's clear that this is a regular site for these species, thus nesting birds are likely to be an annual constraint. This reinforces winter timing for the demolition of the building.

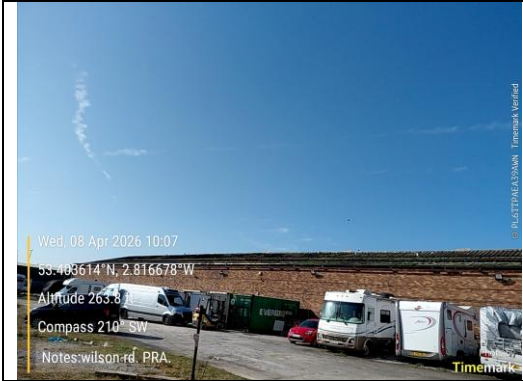
| <p>Wed, 08 Apr 2026 10:07<br/>53.403614°N, 2.816678°W<br/>Altitude 263.8 ft<br/>Compass 210° SW<br/>Notes: wilson rd. PRA.</p> | <p>External flood lighting spanning the length of the building. This is on at all times during darkness.</p> |

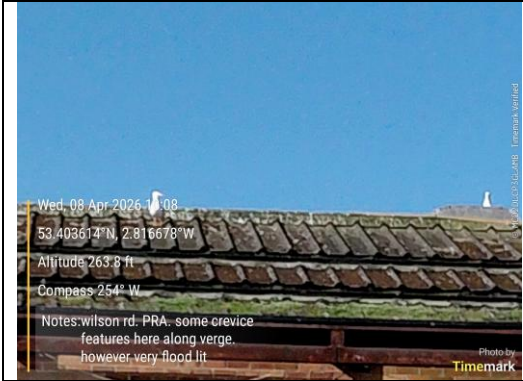
| <p>Wed, 08 Apr 2026 10:08<br/>53.403614°N, 2.816678°W<br/>Altitude 263.8 ft<br/>Compass 254° W<br/>Notes: wilson rd. PRA. some crevice features here along verge. however very flood lit</p> | <p>Small crevices in roof tiles, potential limited crevice space.</p> |

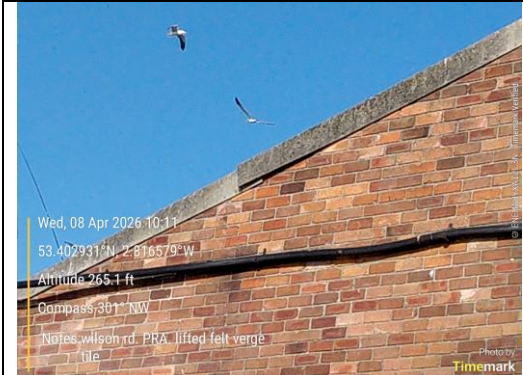
| <p>Wed, 08 Apr 2026 10:11<br/>53.402931°N, 2.816579°W<br/>Altitude 265.1 ft<br/>Compass 301° NW<br/>Notes: wilson rd. PRA. lifted felt verge tile</p> | <p>Lifted felt verge tile.</p> |

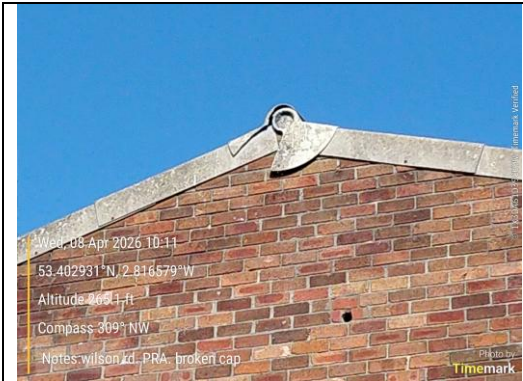
| <p>Wed, 08 Apr 2026 10:11<br/>53.402931°N, 2.816579°W<br/>Altitude 263.1 ft<br/>Compass 309° NW<br/>Notes: wilson rd. PRA broken cap<br/>Photo by Timemark</p> | <p>Broken capping.</p> |

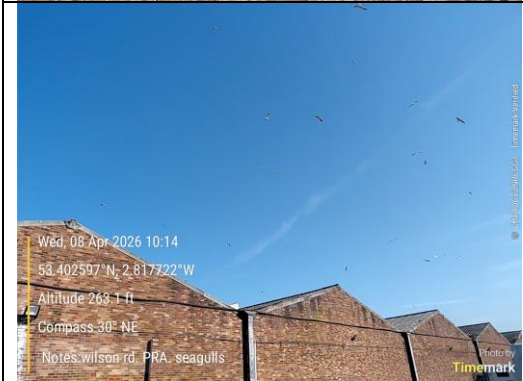
| <p>Wed, 08 Apr 2026 10:14<br/>53.402597°N, 2.817722°W<br/>Altitude 263.1 ft<br/>Compass 30° NE<br/>Notes: wilson rd. PRA seagulls<br/>Photo by Timemark</p> | <p>At least 30 gulls present during the survey.</p> |

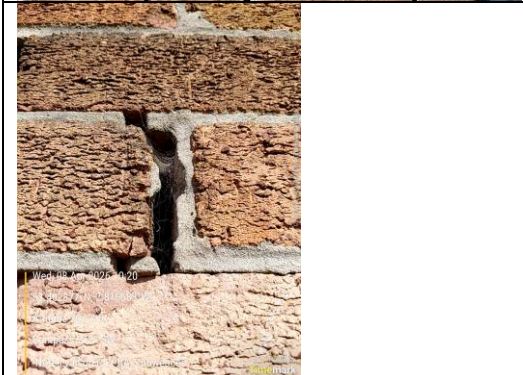
| <p>Wed, 08 Apr 2026 10:20<br/>53.402597°N, 2.817722°W<br/>Altitude 263.1 ft<br/>Compass 30° NE<br/>Notes: wilson rd. PRA cobwebbed mortar<br/>Photo by Timemark</p> | <p>Cobwebbed gaps in mortar.</p> |
