## Phase I Preliminary Risk Assessment (PRA)

85 Baileys Lane  
Halewood  
L26 0TY

Reference: 34494-SUT-ZZ-00-RP-G-7101

Date: April 2025

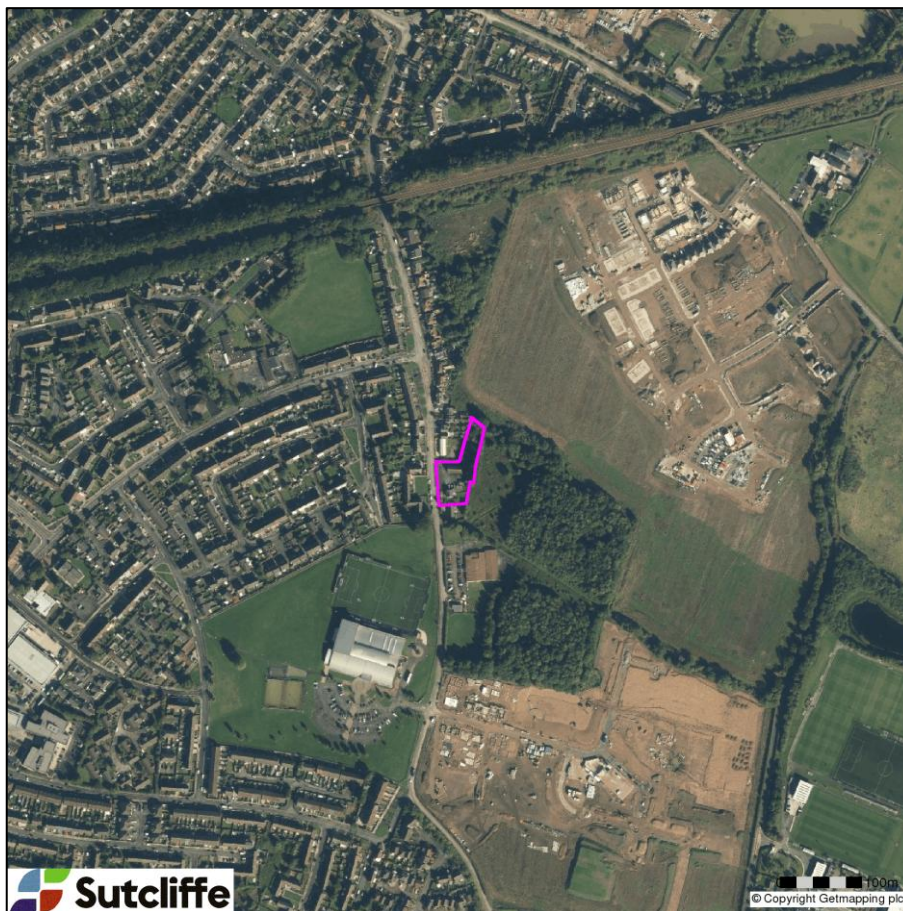
Figure 3: Aerial Photograph

Location plans of varying scales are presented as *Figures 1 & 2* and an Aerial Photograph is presented as *Figure 3*.

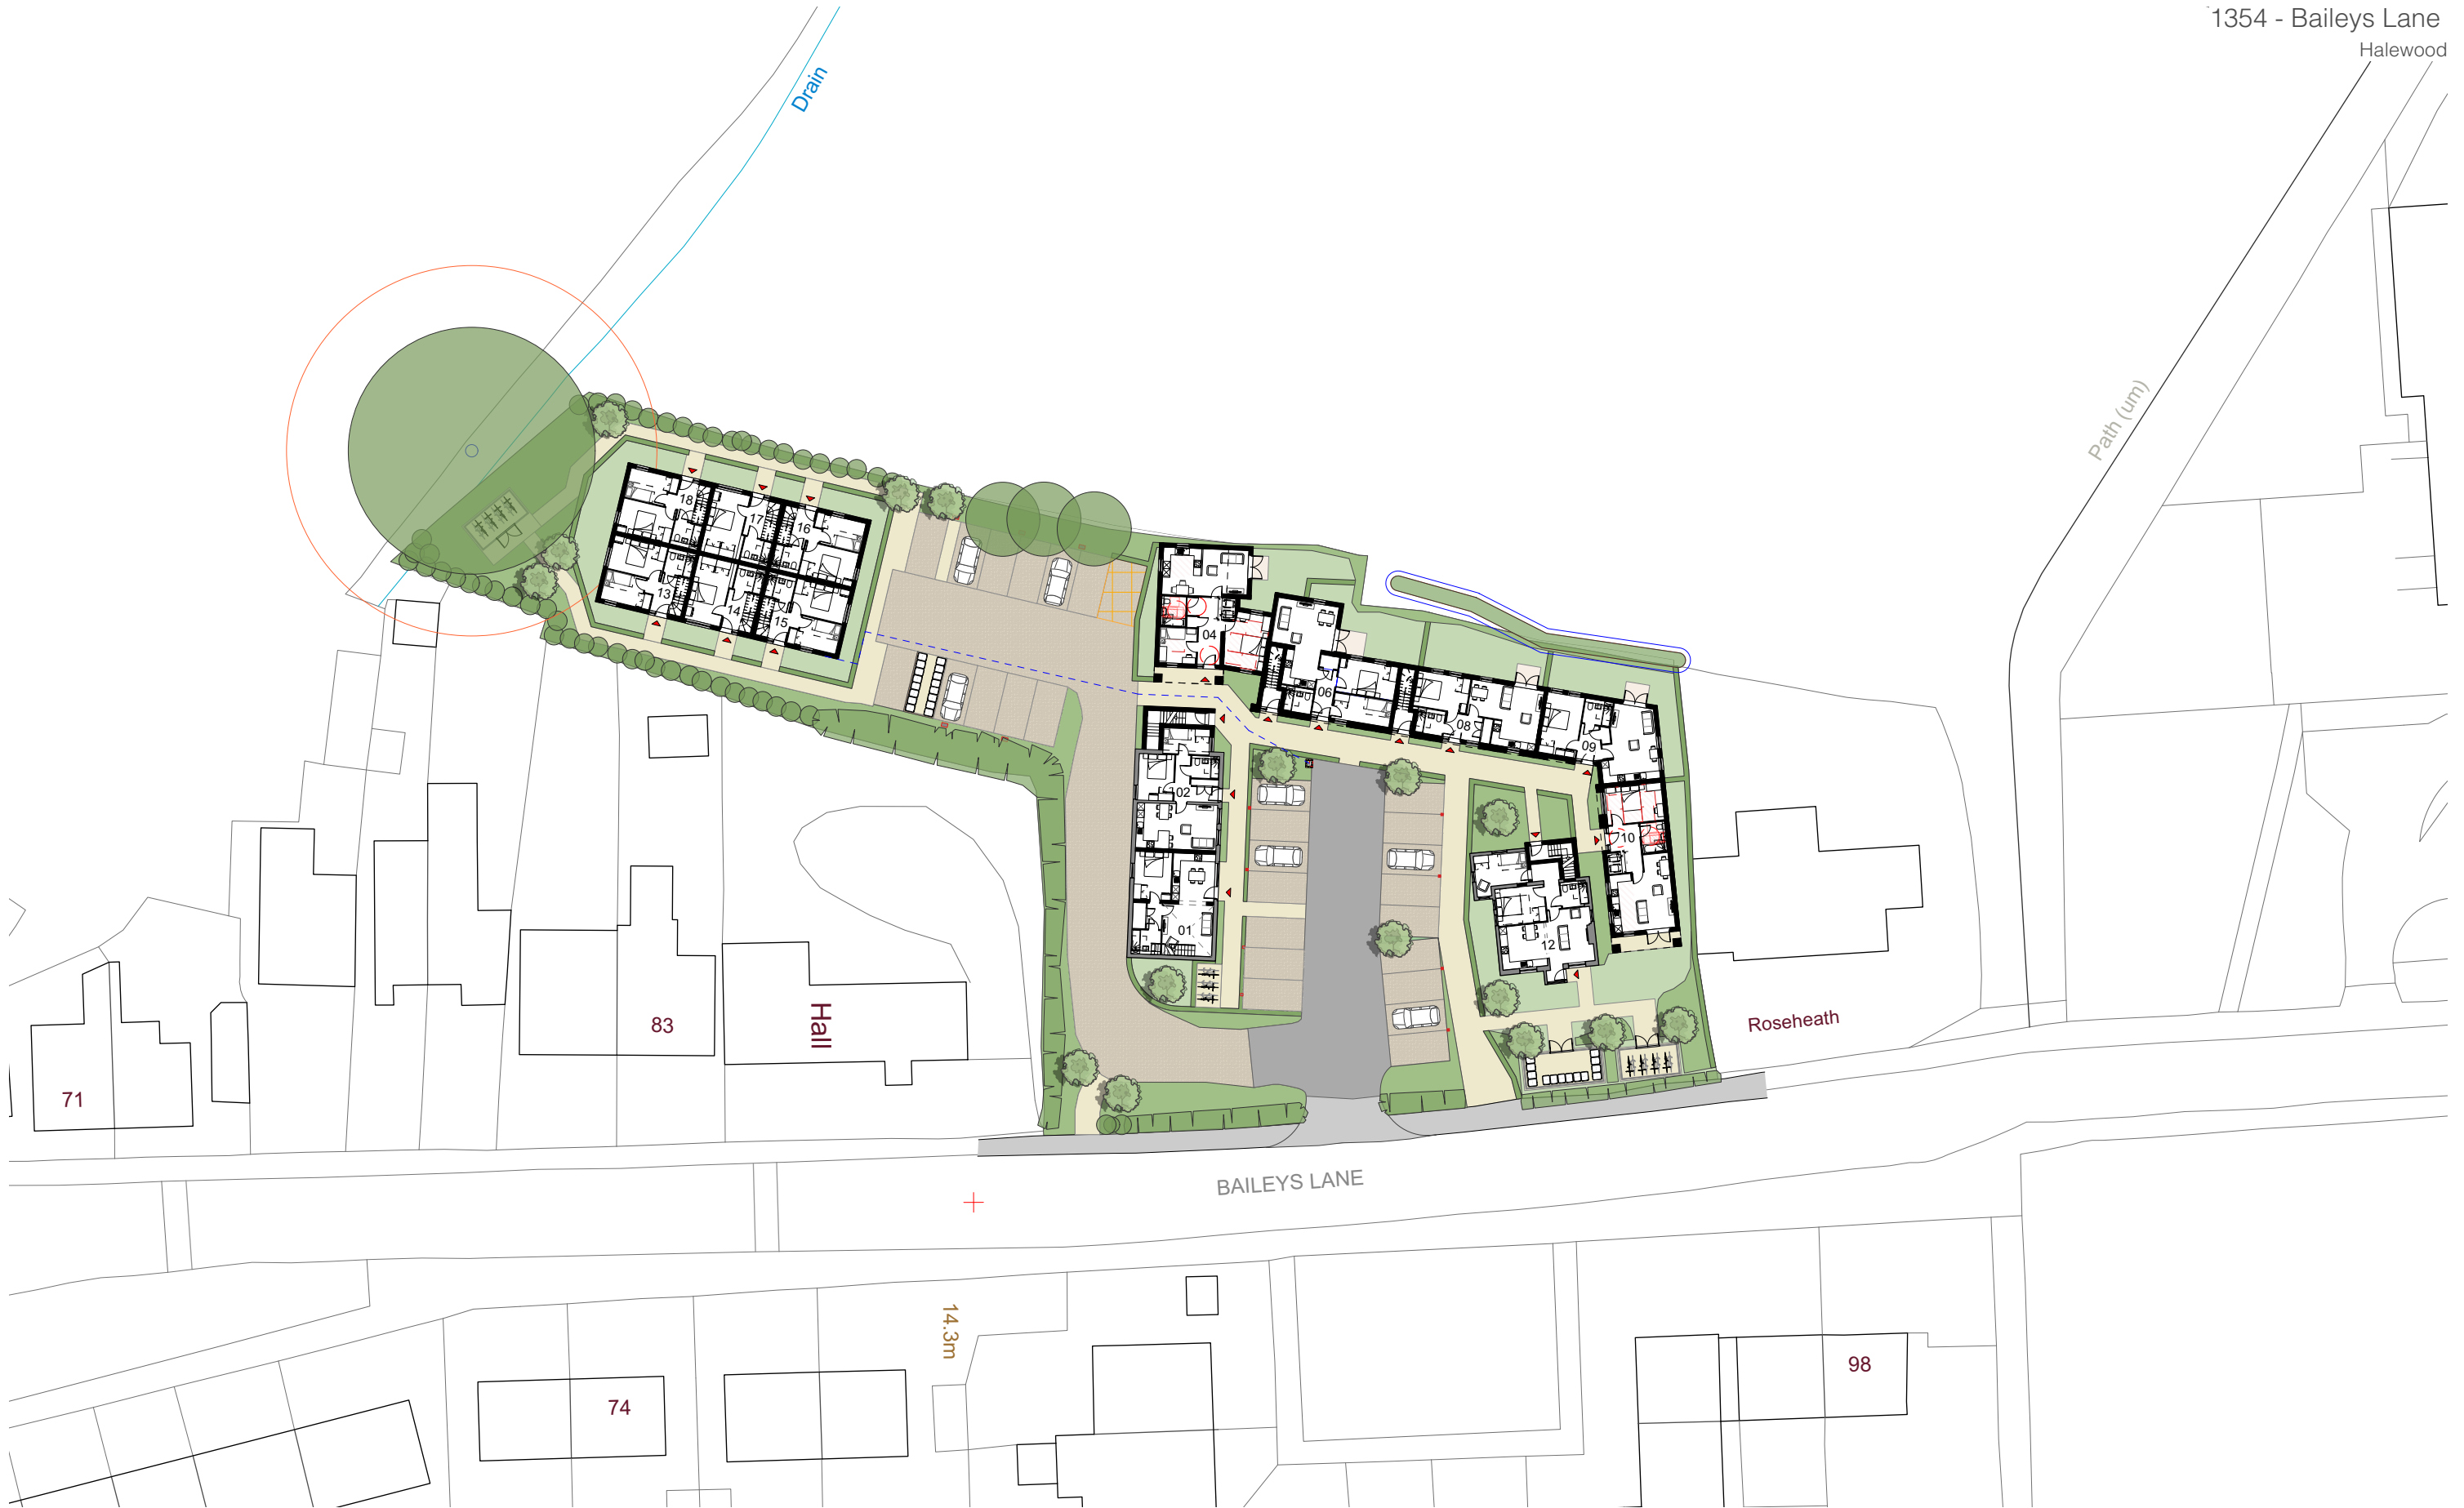
## Drawing Ref. – 1354-010 (Proposed Development)

Drawing Title: Proposed Site Plan  
Date: 20.03.2025  
Drawing no: 1354 - 010  
Scale: 1:1000 @ A3  
Drawn: KJ

revision: A  
revision notes: A 15/04/2025 Updated to align with building survey information
