## **'SPRINGFIELD STABLES, GARNETTS LANE, TARBOCK GREEN, PRESCOT'**

### **BUILDINGS PROTECTED SPECIES SURVEY & BUILDINGS APPRAISAL FOR BAT ROOST POTENTIAL REPORT 2024**

**[SURVEY REPEATED AND REPORT UPDATED 2025]**

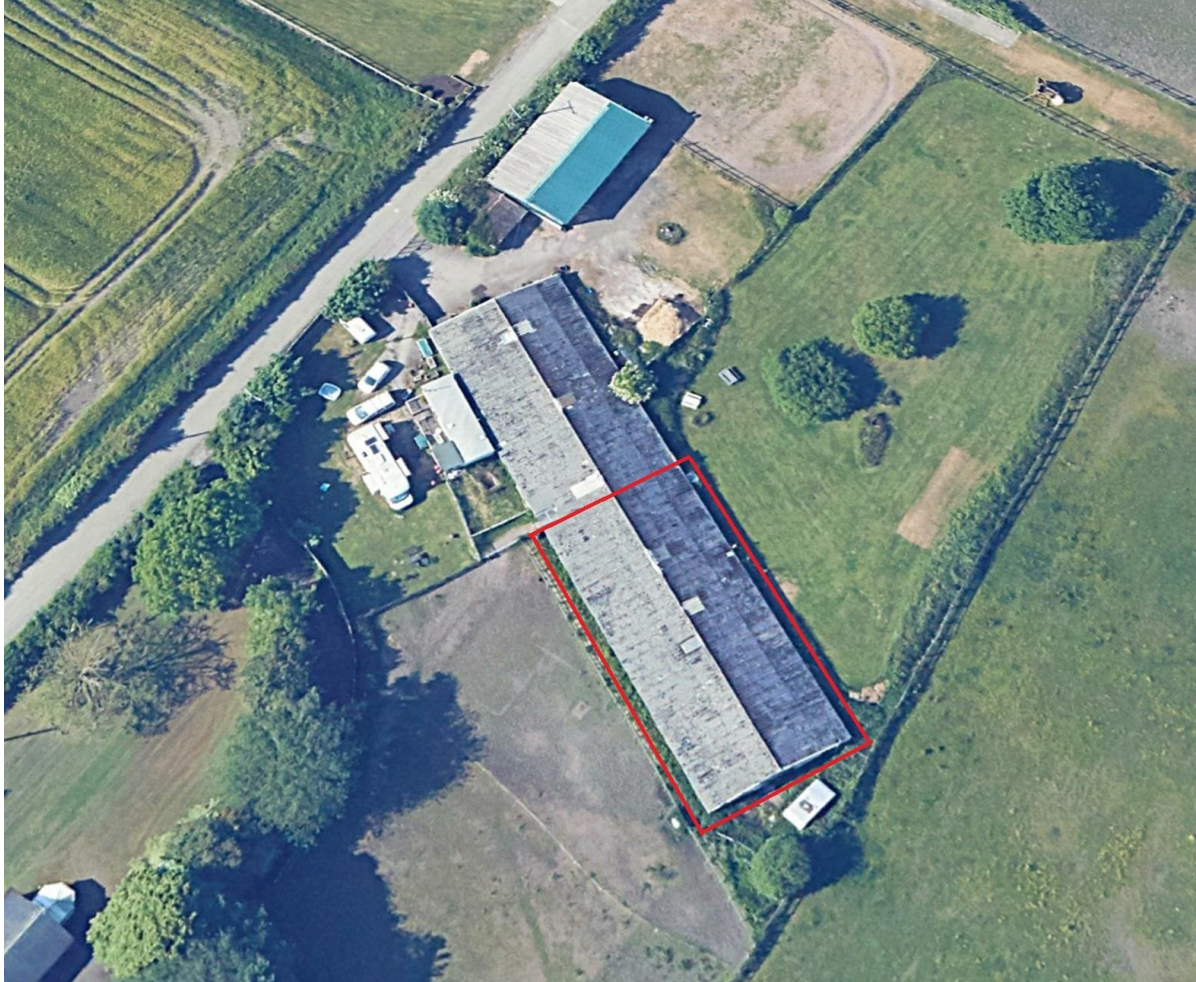
**Figure 1: Aerial view of Surveyed Building & Surrounds.**

The building measures approximately 55m long x 14m wide by 4.5m high to roof apex. Under current plans, only approximately 30m of the southern end of the building will be demolished (Figure 1); the remaining northern end of the building to continue to serve as a stables facility.

*Note: Only the southern end of the current building (indicated by red boxing) is scheduled for demolition. The northern end of the building will be retained and continue to serve as a stables facility.*

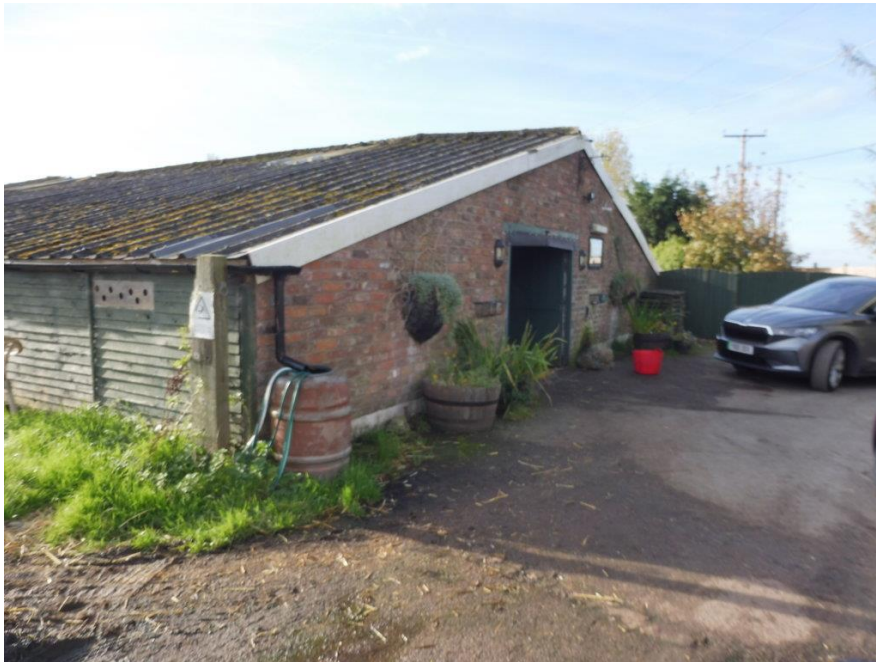
**Photograph A: General view of main entrance front (north facing) to surveyed building.**

The structure to be subject to demolition works is a long detached single storey out building of timber frame construction, timber panel covered walls, and pitched corrugated fibre cement roofing (Photographs A, B & C). The northern gable end has a brick façade (Photograph A), all other frontages are timber clad (Photographs B & C).

*Note: This end of the building will be retained.*

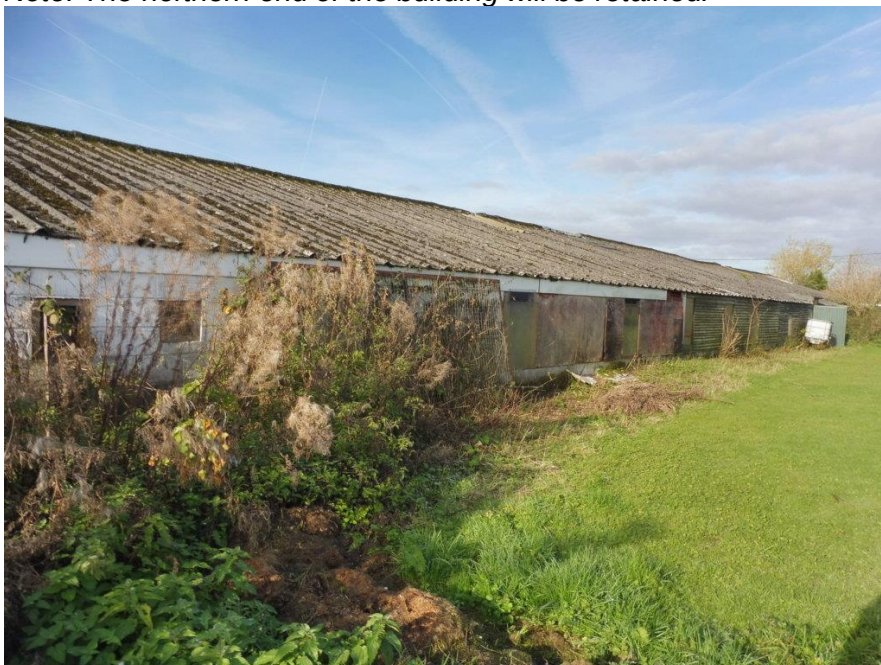
**Photograph B: General view of northern end to east facing frontage to surveyed building.**

*Note: The northern end of the building will be retained.*

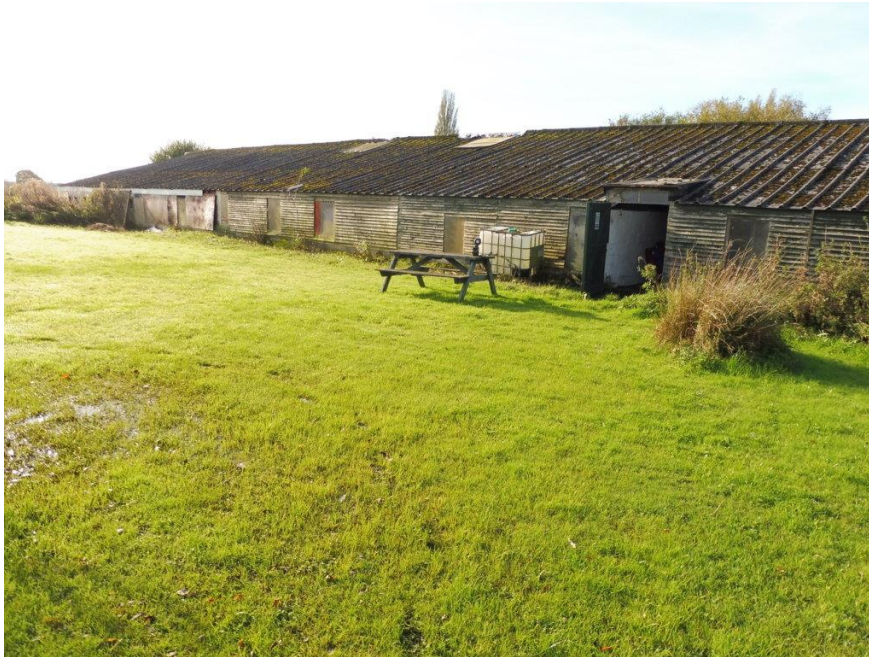
**Photograph C: View of southern end of east facing frontage the surveyed building.**

*Note: The southern end of the building, from approximately the open doorway onwards, is scheduled for demolition.*

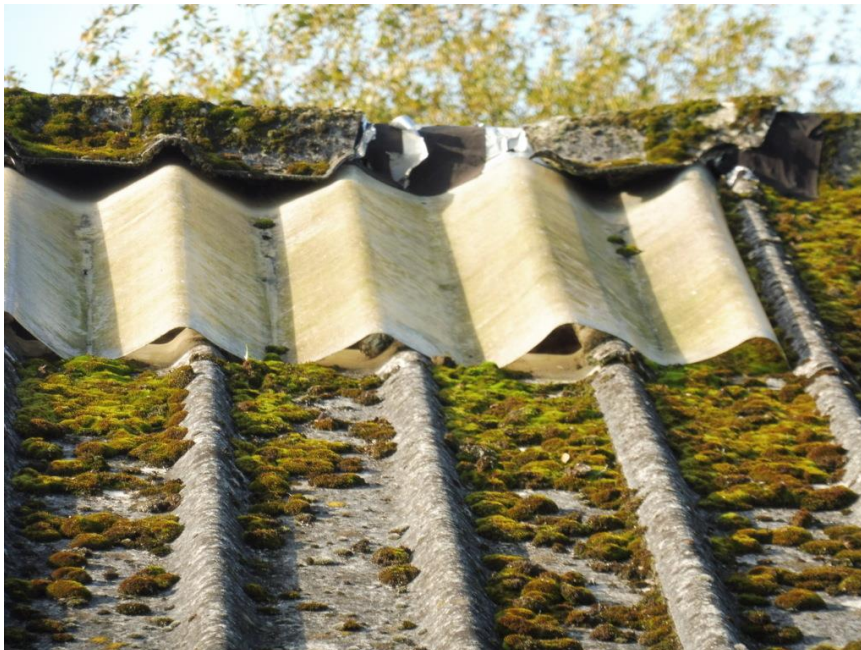
**Photograph F: View of corrugated plastic covering one of the roof lights.**

*Note: The gapping below the plastic constitutes one of the few direct openings through the roofing into the internal chambers below.*

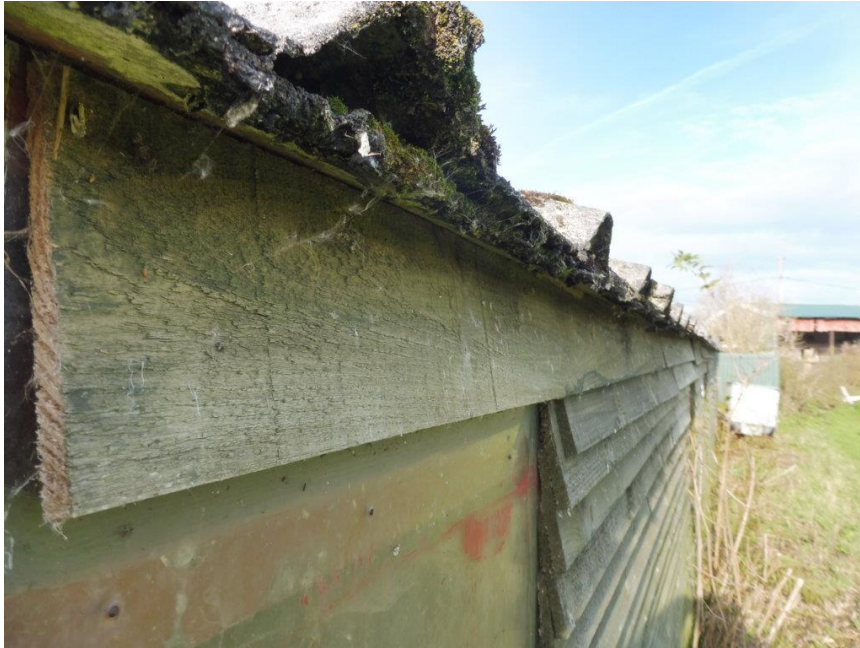
**Photograph G: Close up sample view of roof overhang.**

*Note: The simple roof overhangs with timber barge boarding are in good repair with no significant gapping recorded.*

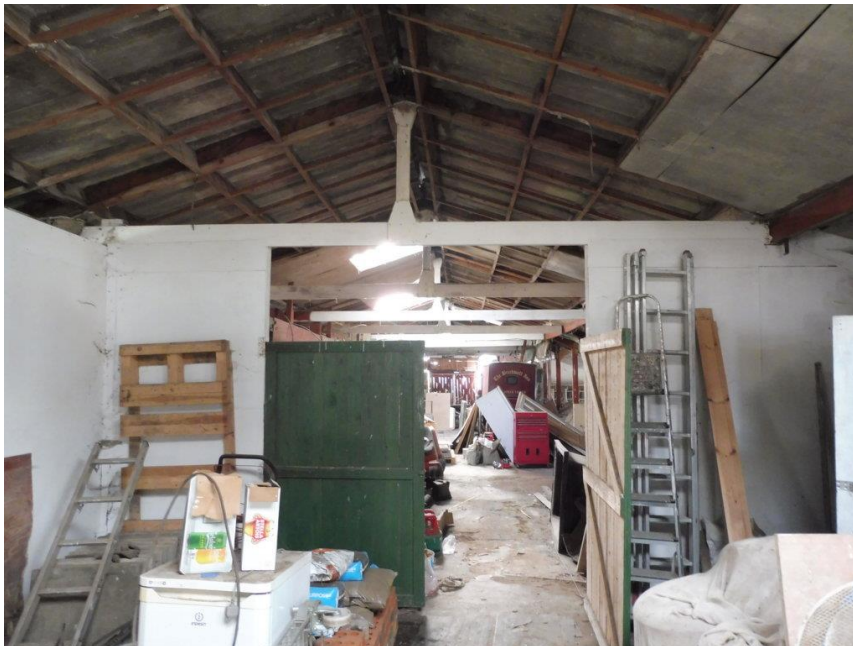
**Photograph H: General view looking along length of internal chambers to be lost.**

Internally the building is divided up into chambers by panel boarding (Photograph H). The roof voids remain open and linked above the panel boarding divides. The cement panel roofing is either exposed internally (Photograph I) or hidden behind panel boarding (Photograph J). There are no enclosed roof chambers. The southern end of the building currently serves as a storage facility for agricultural and miscellaneous items (Photograph H).

*Note: The multiple chambers are separated by boarding to top of wall level only.*

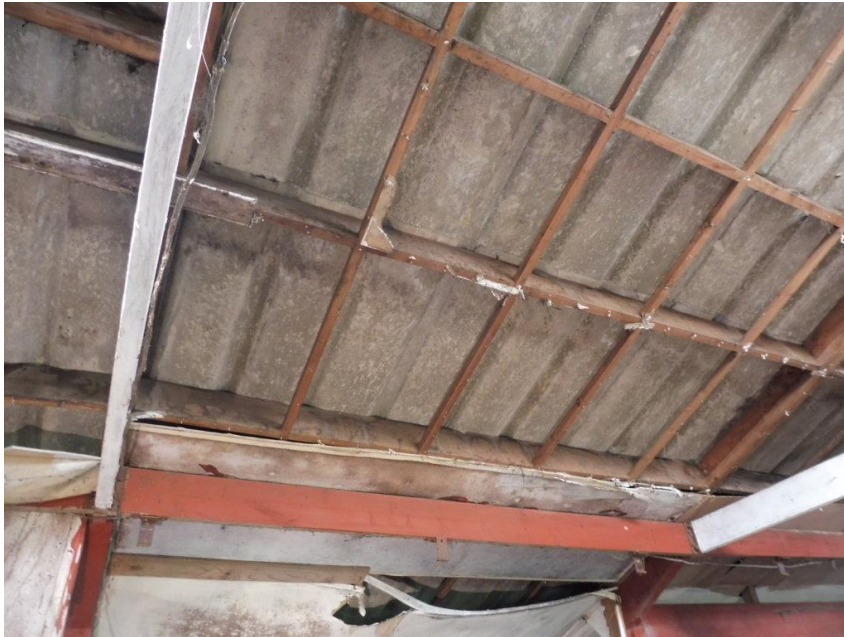
**Photograph I:** Close up sample view of internally exposed cement panel roofing.

*Note: The panels are in good repair and well-sealed.*

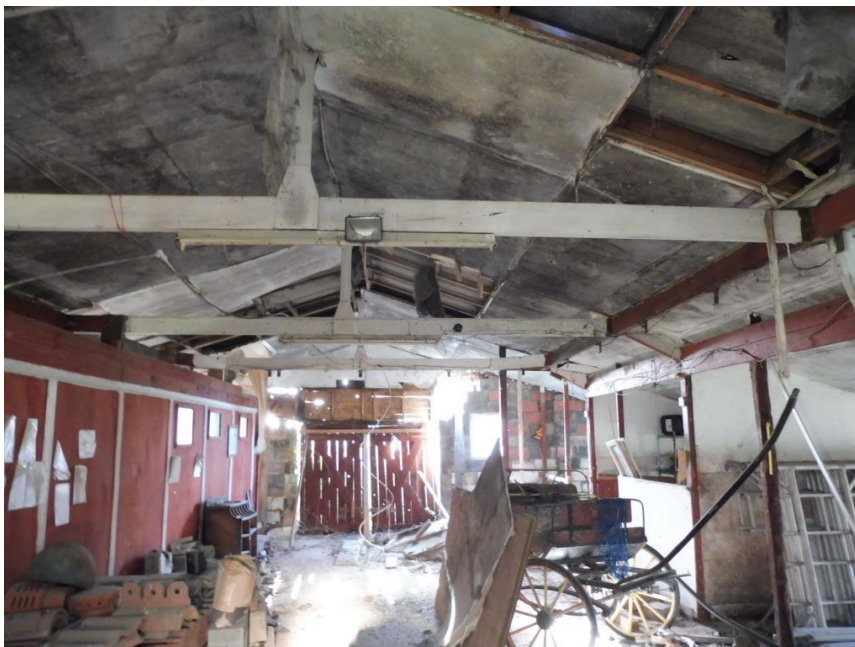
**Photograph J:** View of the southern end to the building.

*Note: At this end of the building the roofing is partially screened behind boarding. Day light penetration can be seen through the timber slated doorway to the rear of the image.*

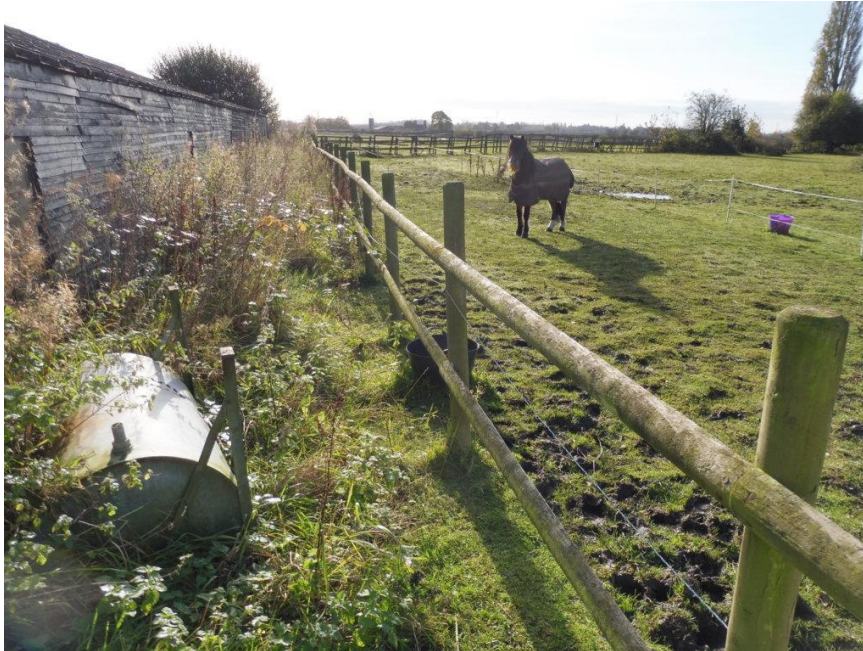
**Photograph L: View of west facing frontage to building.**

*Note: The fencing standoff from the building has allowed tall ruderal plants to establish next to the building.*

The risk to hedgehogs (*Erinaceus europaeus*) from the proposed demolition works is assessed as low to moderate. The species is common in the local rural area and the thin belts of tall ruderal plants and grassland found to the building margins (Photograph L) could currently offer foraging opportunities and attract the species to the building. Hedgehogs may also seek refuge and under the external building margins or even within the building itself if access can be achieved. The species is also known to be attracted to excavation works, within which individuals can become entrapped.

*To reduce the risk to hedgehogs to near negligible levels, searches of the building margins should be completed by a suitably qualified person prior to commencement of demolition works. Recovered individuals to be translocated to an appropriate safe receptor area. Demolished materials should be quickly removed off site or stored in skips to minimise the risk of hedgehogs seek refuge with the arisings. To prevent the entrapment of hedgehog associated with excavation works, temporary escape ramps should be fitted leading out of excavations during nocturnal hours and when the site is abandoned for extended periods.*

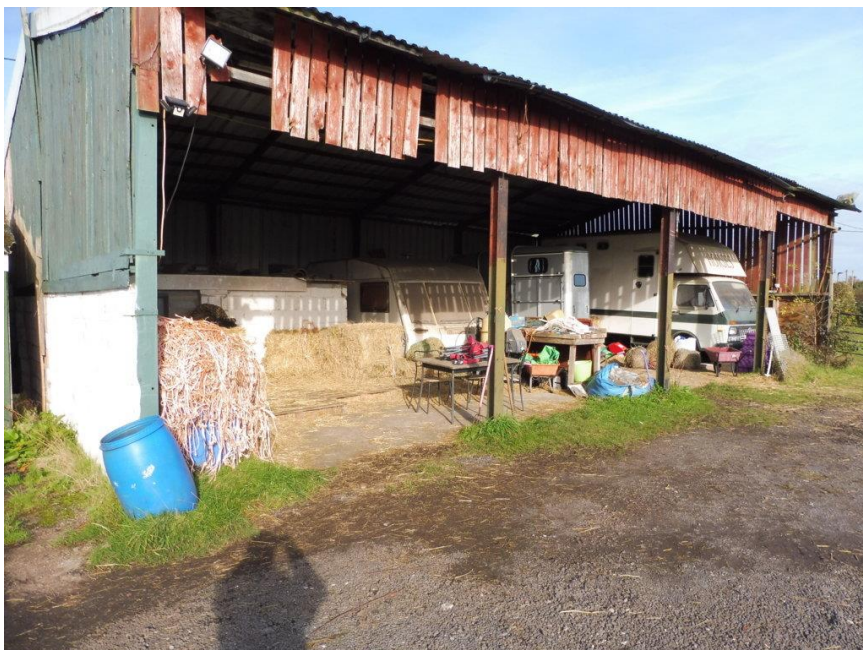
**Photograph M: View of a large open fronted shed located to the north east of the target building.**

Further agricultural out buildings and caravans (offering temporary accommodation) are present within the wider site (Figure 1). A large open fronted barn (Photograph M) was assessed to have moderate potential to support breeding birds however it is located approximately 35m to the north of the length of target building to be demolished, and therefore the risk of harmful disturbance is assessed as negligible. The remaining buildings are all over 5m from the target building, and therefore the risk of harmful disturbance to bats or birds which may be dependent on the structures is assessed as negligible.

*Note: The shed can be expected to attract birds and bats, however it is located approximately 40m from the nearest point of the length of target shed to be demolished.*

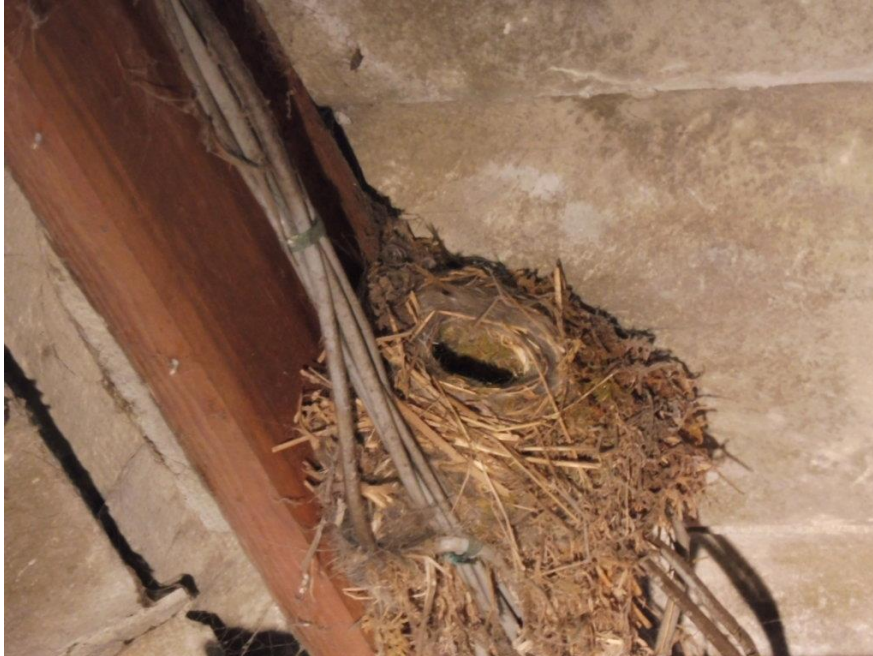
**Photograph N:** Close up view of one of several swallow nests recorded within the building.

A small number of abandoned swallow (*Hirundo rustica*) nest cups (Photograph N) were recorded against roof timber beams within the northern half of the building only.

*Note: All recorded bird's nests were located within the length of building to be retained, none were recorded within the length to be demolished however with such a large structure nests could easily have gone undetected.*

A small number of swallow nest cups were recorded within the northern end of the building, however the future return to the established breeding site by the birds is not considered under threat.

*It is recommended that demolition works on the building commence outside the official bird breeding season (1st March - 31st August in any year). If commencement of works during the bird breeding season cannot be avoided, then checks for bird nesting activity should be completed by a suitably qualified person immediately prior to commencement of works. If active nests are detected then demolition works should be delayed until nests are confirmed as abandoned.*
