HERITAGE STATEMENT - 11A HIGH STREET PRESCOT - BOUNDARY WALL ALTERATIONS

Client:               Ranaul Land (North West 4) Ltd  
Reference:       029001  
Date:               February | 2026

VSA | VINCENT STUART  
ARCHITECTURE

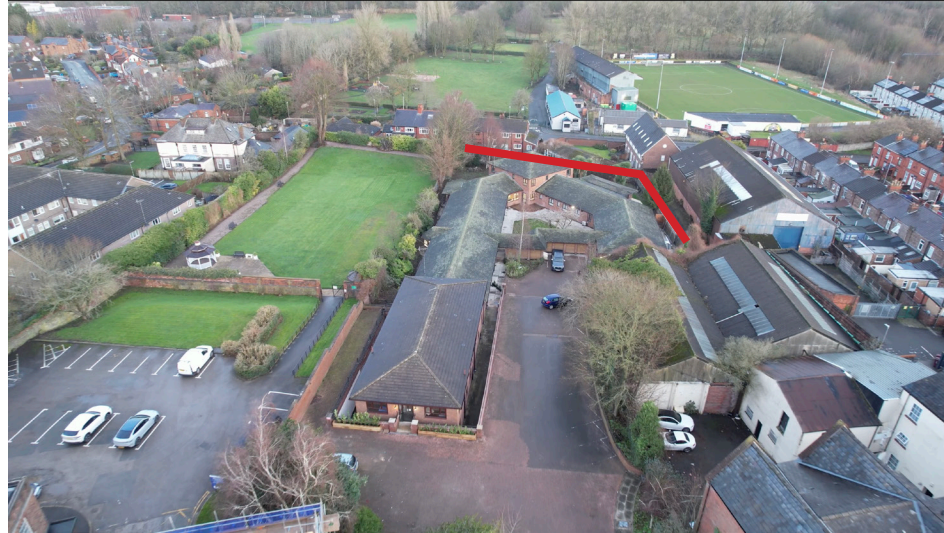
What remains of the original “town” wall is shown on the images adjacent highlighted with red lines.

View looking North from over High Street

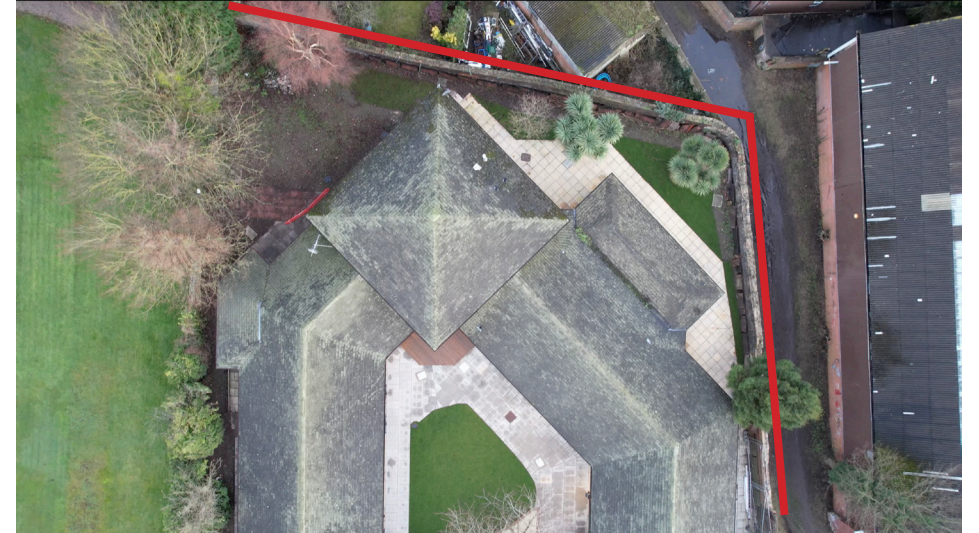
View from above at the North of Plot 11a

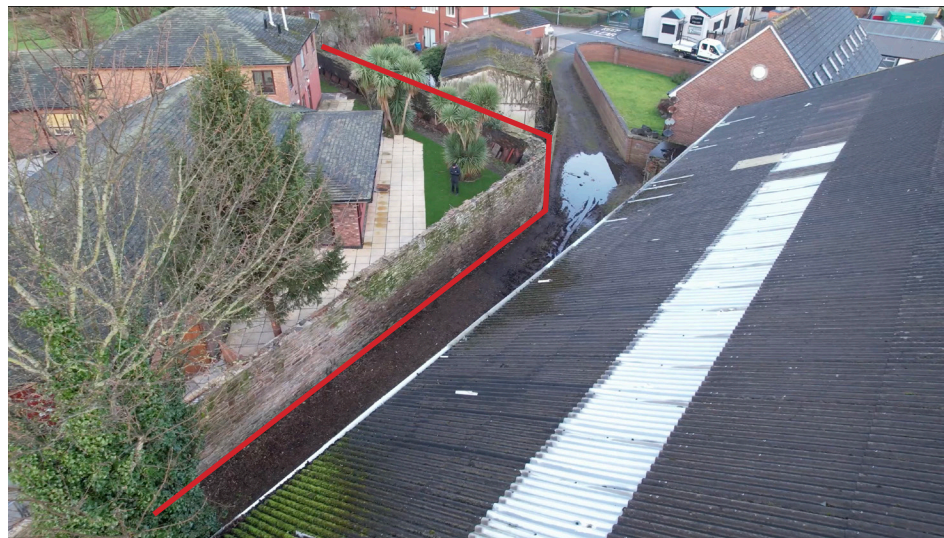
View looking down the ginel running off High Street

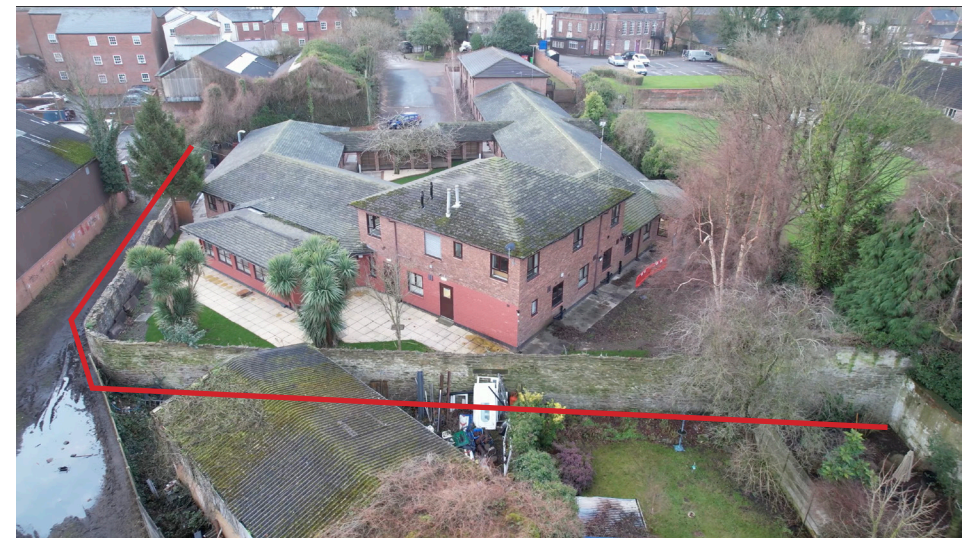
View from the North of 11a looking South

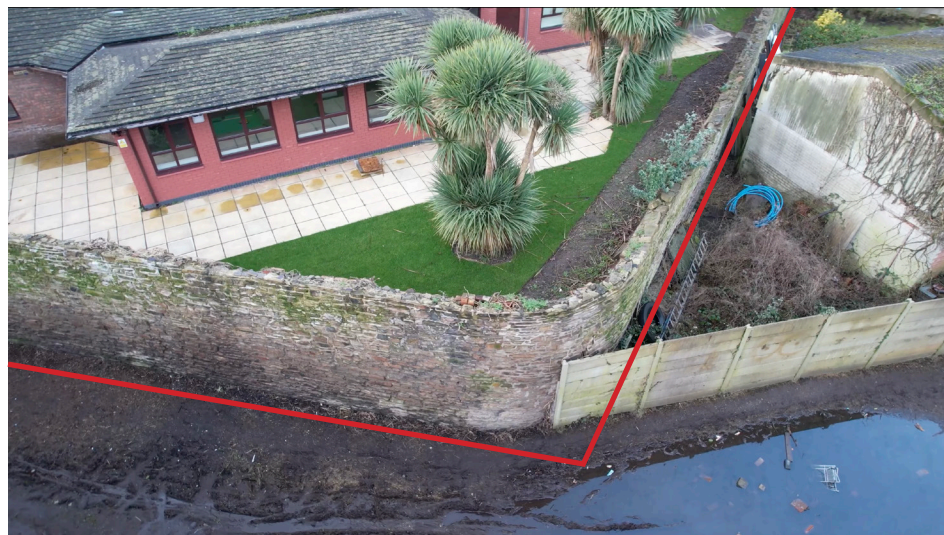
View over the ginel looking West

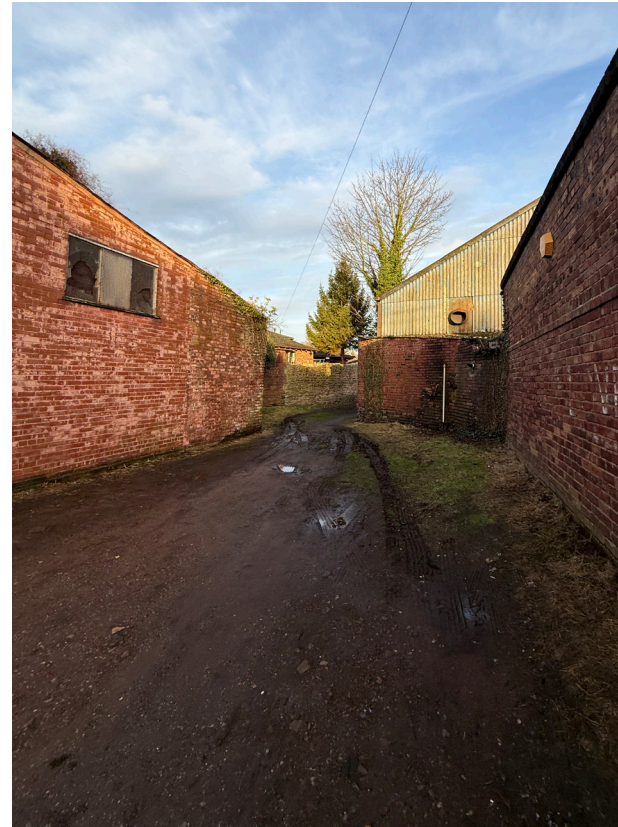
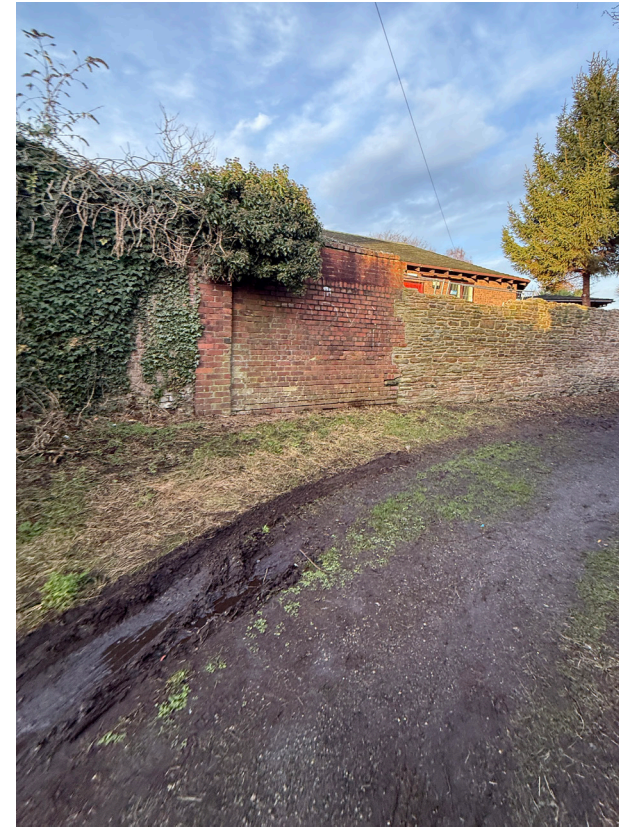
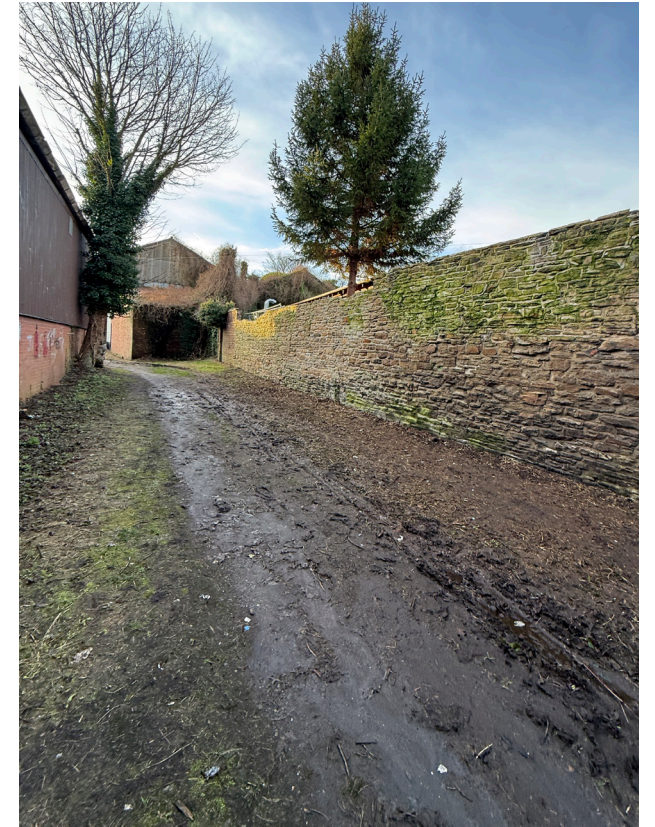
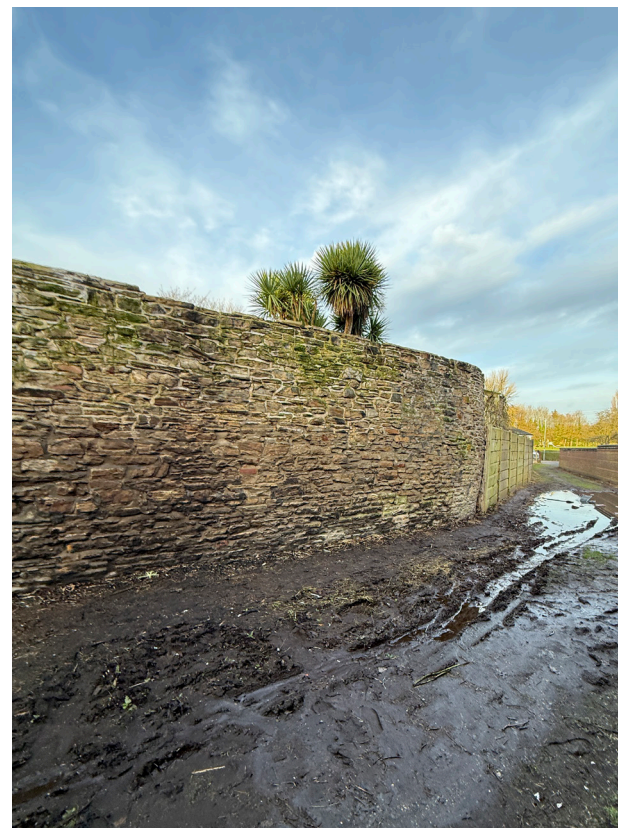
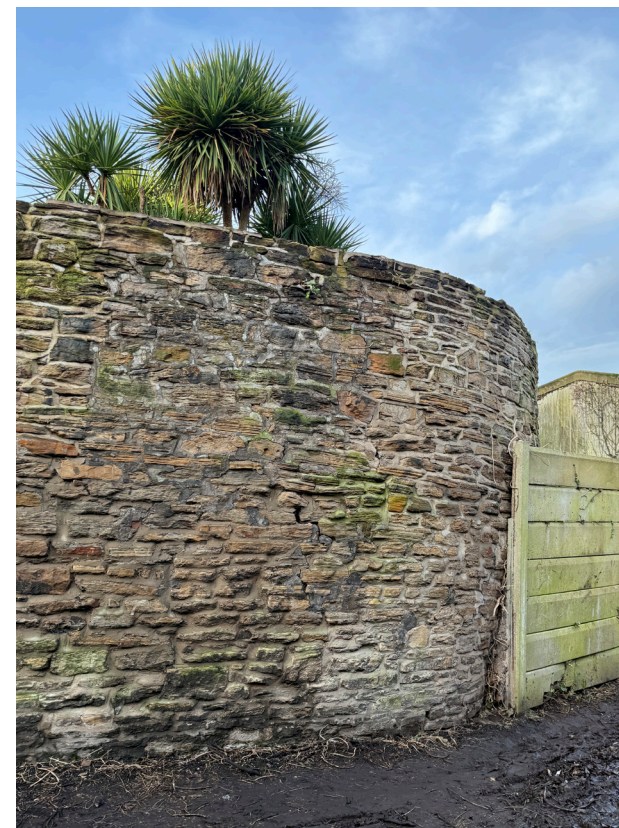
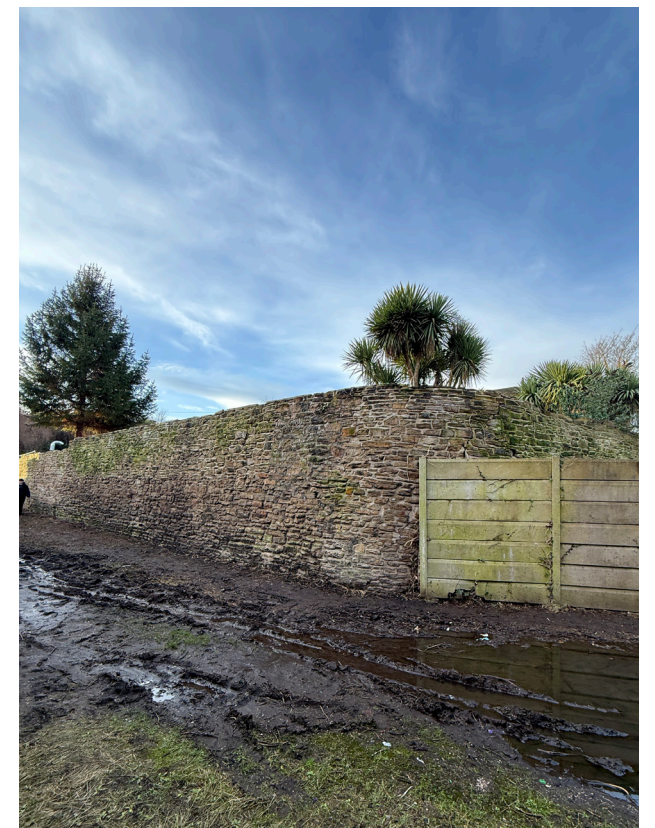
## WALL PHOTOGRAPHS

The main wall can be seen to be in a poor state of repair. Various portions have been re pointed in cement and as a result the stonework is spalling. What is a significant feature of times past has begun to deteriorate and in some places subside. Large sections bow as a result of retaining land at a higher level. This is retaining was presumably due to the historic desire for flat land which formed the walled gardens.

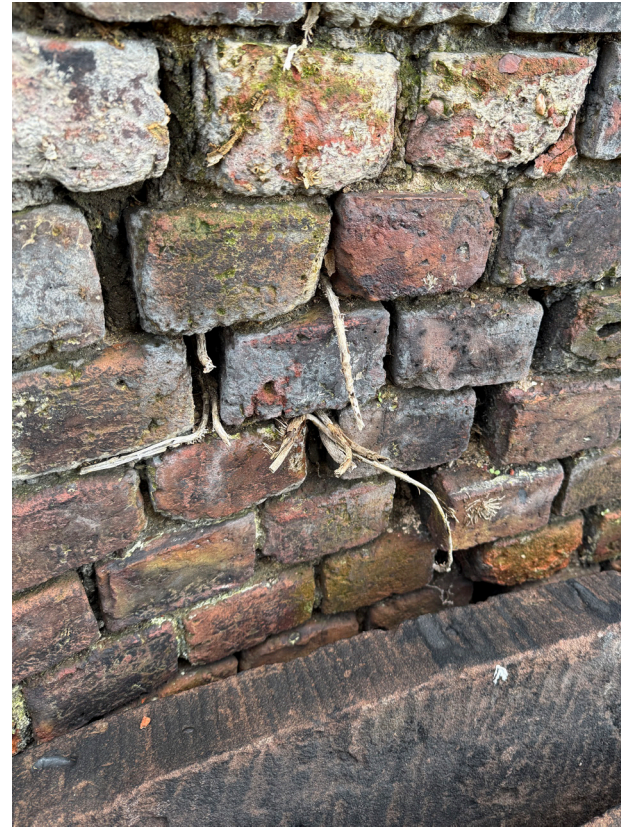
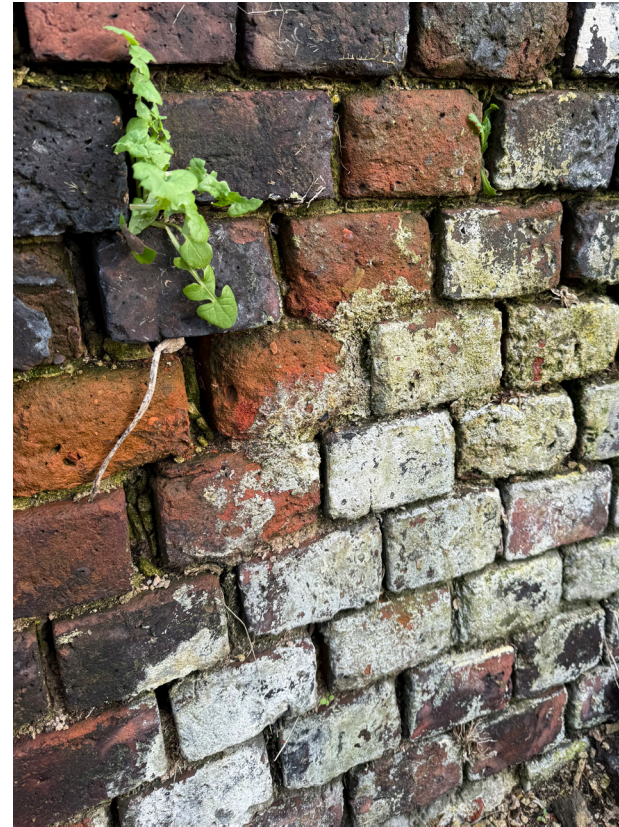
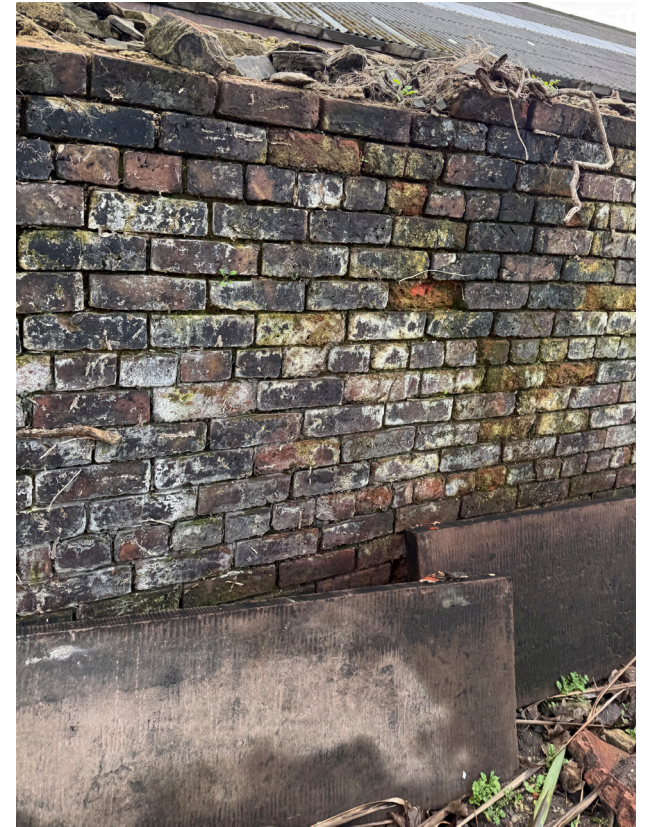
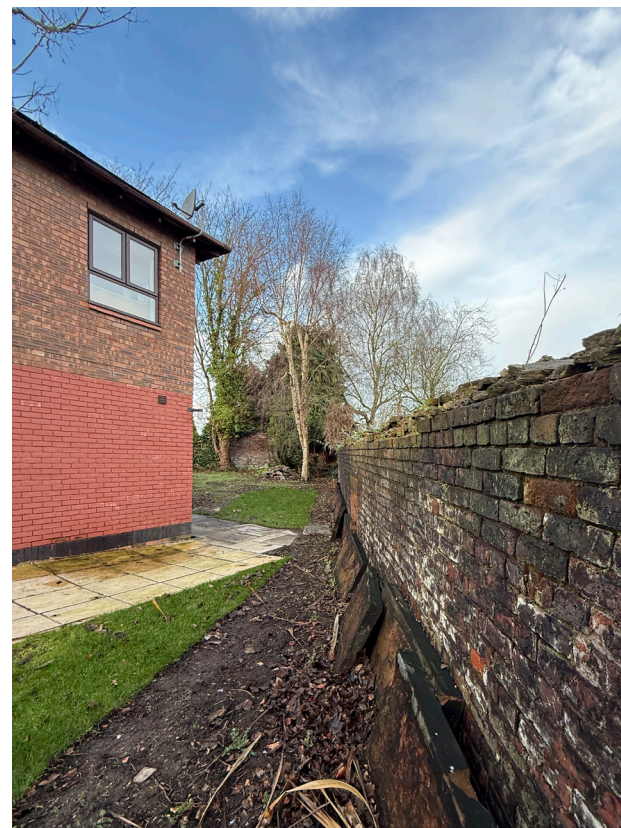
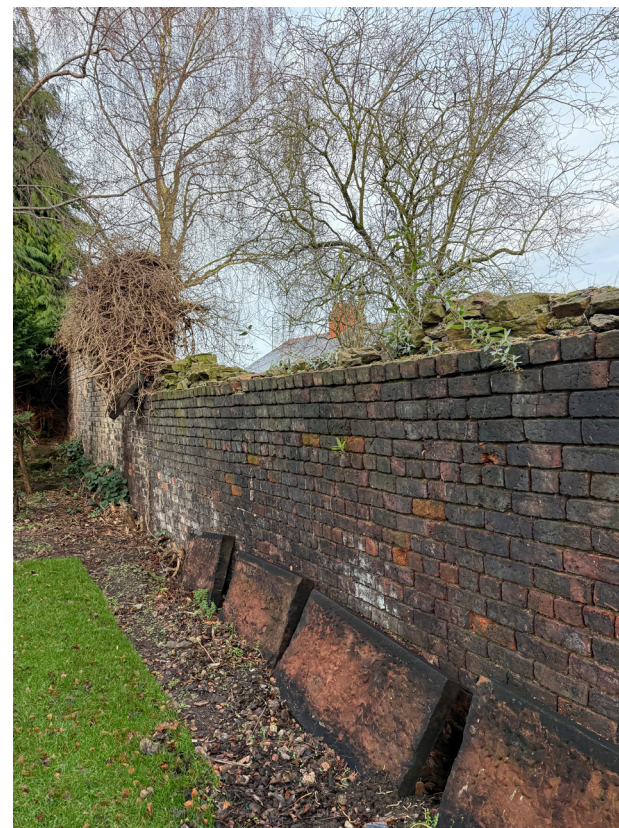
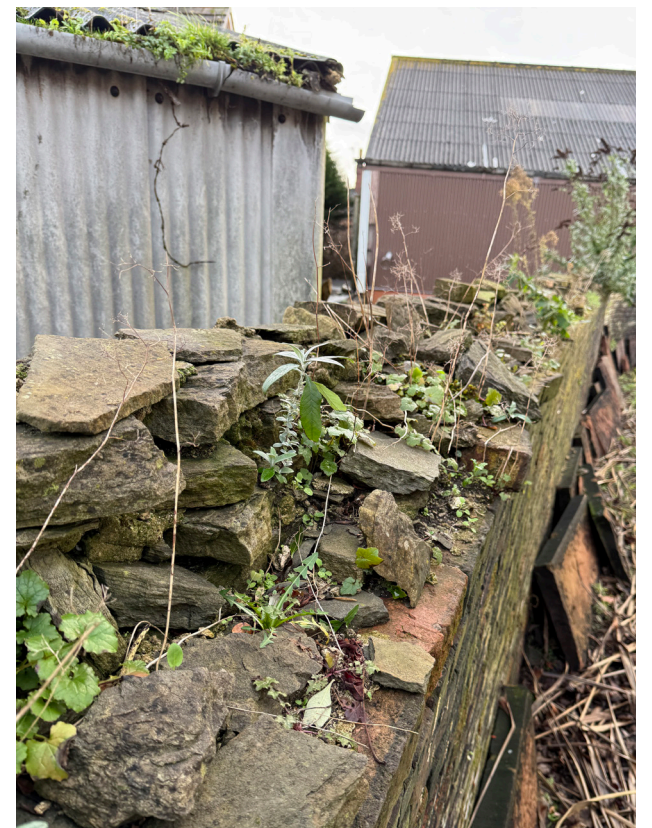
## WALL CONDITION

The inner leaf of the wall is constructed of brick work, its course in traditional English Garden wall bond with headers seen every 5 courses. The masonry is bedded on lime mortar. The 3" bricks are likely to be original and a symptom of the period of brick taxation between 1784 and 1850 which saw manufacturers producing the three inch bricks more commonly associated with Victorian times.

The passage of time has likely contributed to the over all subsidence of large portions of the wall, the upper portion land has driven out the wall at a low to medium level, this has created a belly in the wall which if left without intervention will likely see its collapse.

Segments of the wall beneath the registry office are equipped with buttresses on the taller side to stop this exact issues. The wall portions this proposal seeks to alter are unfortunately not equipped with these original structural details.
