# Water Vole Survey Report

*The Former Lawford Boarding Kennels*

*Greensbridge Lane, Tarbock Green, Merseyside*

*August 2025*

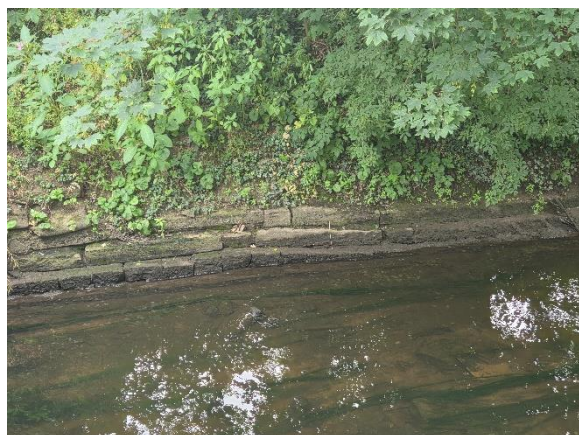
Heavily shaded banks to the northern point adjacent to the site with man-made banks

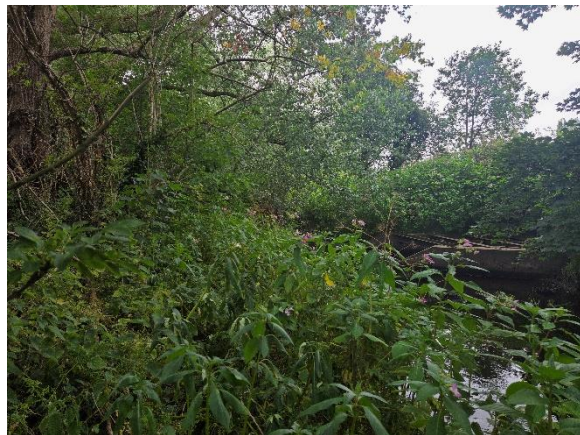
Bankside vegetation looking south from the bank adjacent to the western edge of the site. Significant shading and H.Balsam present.

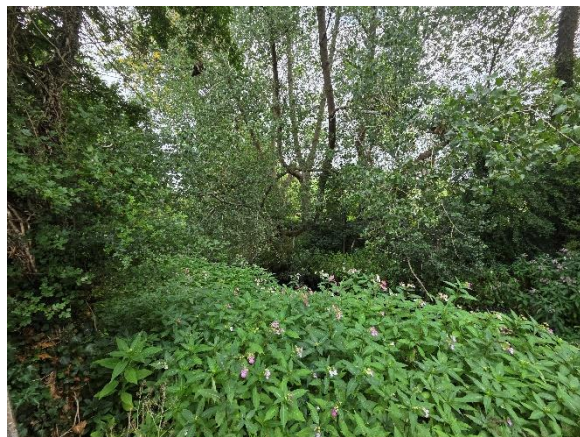
Example of shading bank H.Balsam coverage.

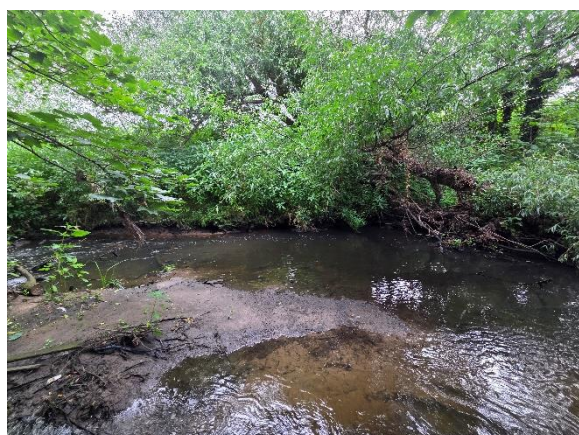
Example shallow section of stream with mudbanks and pools present. Deadfall across width of watercourse. Heavy shading and H.balsam presence. No field signs in mud banks or bankside.

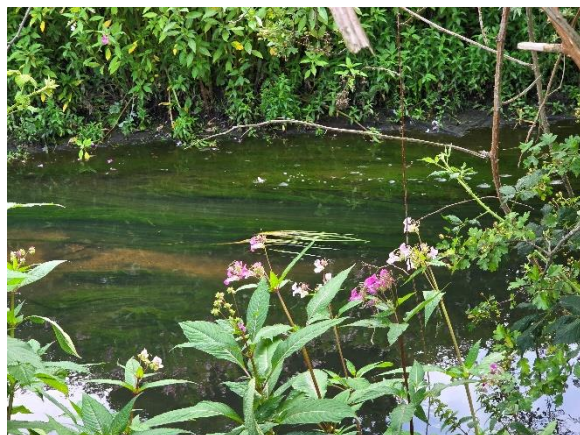
Section of watercourse beyond the site to the east opening up into Ditton Brook. Less shade with increase in aquatic plants and water clarity. No field evidence or burrows to banksides.
