# Springfield Stables, Garnetts Lane, Tarbock Green

## Bat Scoping Survey Report

2<sup>nd</sup> July 2025

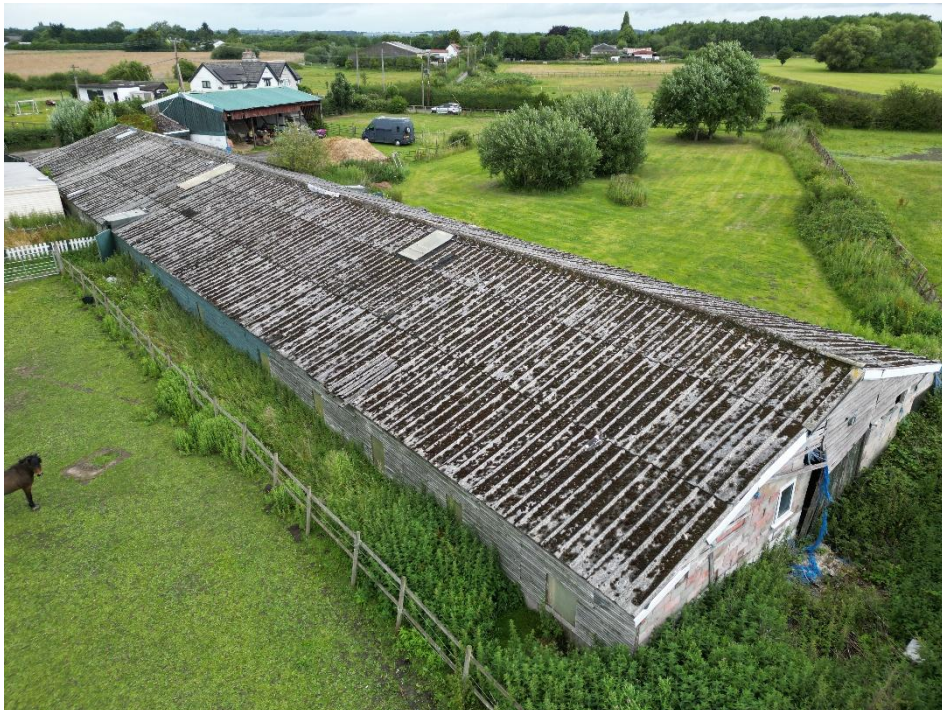
*Photograph 1- View of west and south face of outbuilding*

The south-facing gable supports further overlapping wooden panelling. There are some minor crevices where some of this boarding has warped and decayed. However, the boarding provides a single skin with the rear of the boarding/internal face able to be observed and scrutinised from the interior of the outbuilding. The warped boarding does not provide access to any significant crevice roosting features. No obvious suitable potential bats roosting habitat was identified at the building's exterior.

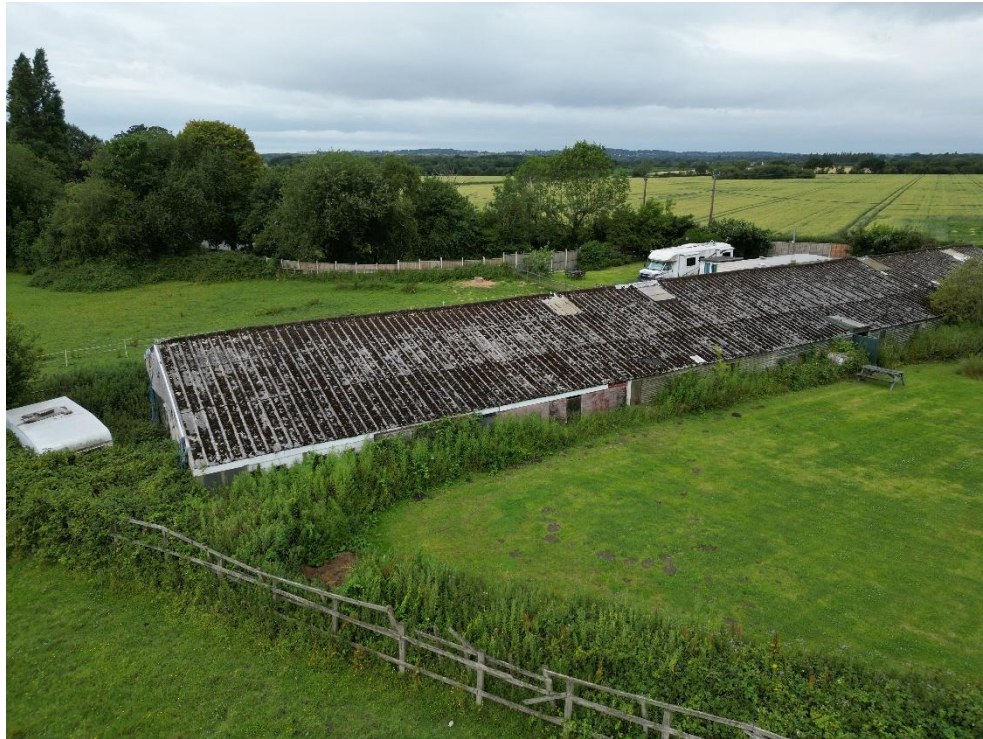
*Photograph 2- North face of Outbuilding*

Externally, the building walls are clad in tightly fitted, overlapping wooden boarding and sheets of plyboard. The outer boarding is partially overgrown with cleavers, bramble, and great willowherb. The areas of boarding do not offer any obvious suitable bats roosting habitat.

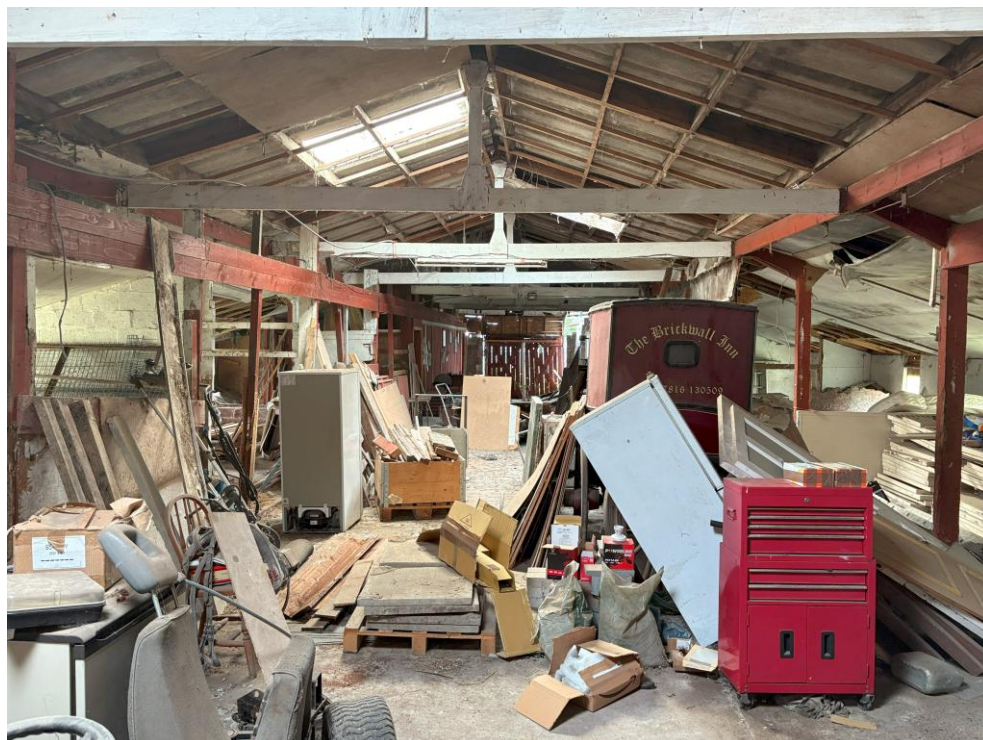
*Photograph 3- Interior of Outbuilding*

The building is constructed of breezeblock with a wooden frame, wooden roof trusses, and a corrugated fibre cement panel roof with occasional corrugated Perspex skylights. The internal face of the roof is partially enclosed with chipboard. The building does not support a separate roof void space. The building is open to its full height and the roof does not have a ridge beam.

The building interior is relatively bright, with windows on each face. The southern gable wall has large holes around an external access door, providing potential access to the building interior for bats and birds and allowing further light to enter the building.

No obvious suitable potential that roosting features were identified within the building interior and no evidence of bat activity was identified. The likely that some bat droppings would have been captured on stored materials, if the building interior was in regular use by roosting or foraging bats.
