345 Cronton Road,  
Cronton

## Bat Scoping Report

14<sup>th</sup> February 2022

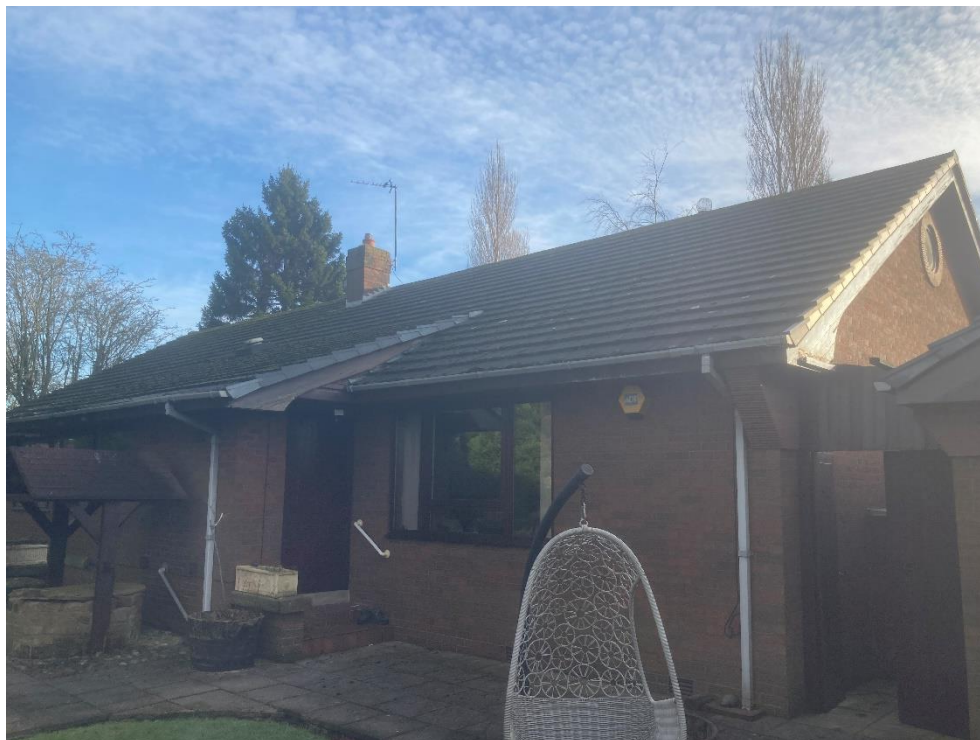
*Photograph 1- North face of bungalow*

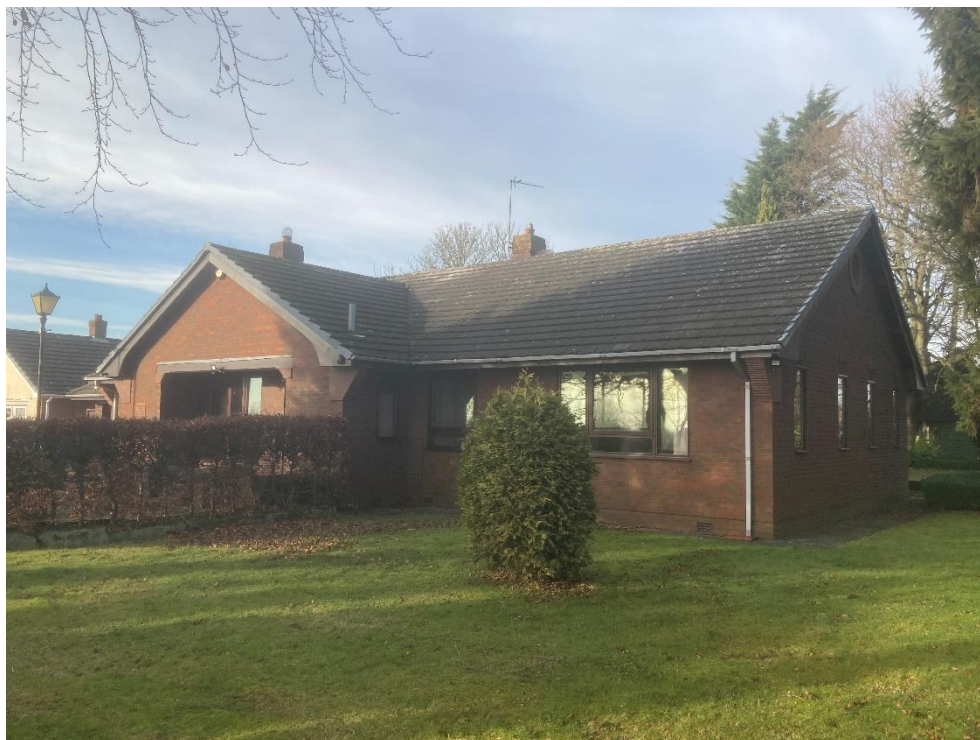
*Photograph 2- South face of bungalow*

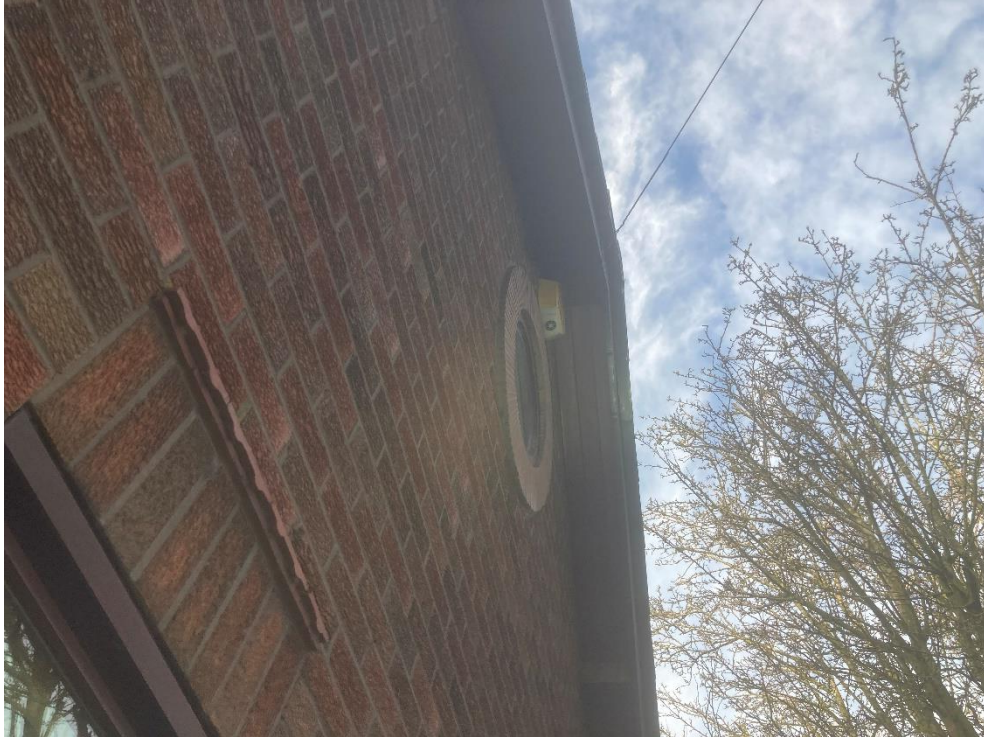
However, there are narrow crevices running between the gable soffits boxes and the masonry walls at the East, West and South faces (Target Notes 1-3).

These crevices could provide access for bats into the cavity wall and soffit box. These locations correspond with the bat droppings found within the loft space. No bat droppings or other bat field signs were observed externally.

*Photograph 3- East face of bungalow showing soffit box*

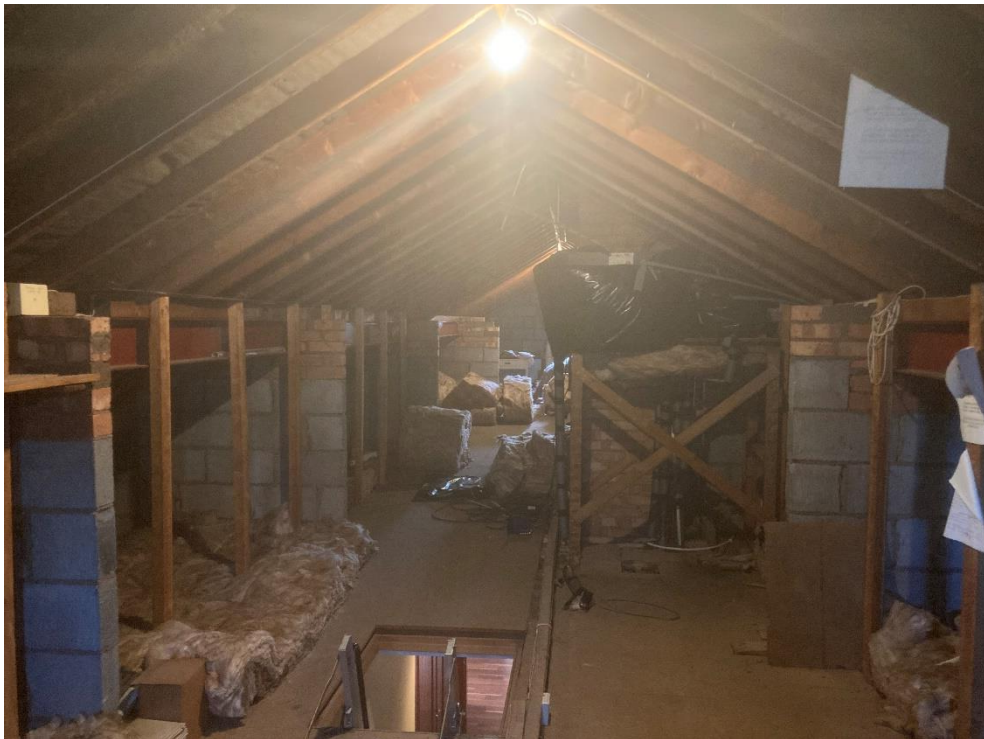
The loft space is lined with fibrous insulation felt and is boarded out. The internal face of the roof is lined with tightly fitted bitumastic hessian felt.

The loft space is open and uncluttered with no trusses spanning the roof void. The loft space has circular glazed windows at its East and West faces and so has high ambient light levels.

The internal inspection identified bat droppings at each gable. Approximately 30 x pipistrelle bat droppings were found scattered on the internal wall and on felt immediately below the gable apex at the buildings West face (Target Note 1 on Figure 2).

*Photograph 4- Loft Space looking towards west gable*
