**CCG-C-25-15207**

**GROUND STABILITY ASSESSMENT  
FOR LAND AT THE FORMER  
PRESCOT POLICE STATION  
DERBY STREET  
PRESCOT  
MERSEYSIDE  
L34  
MARCH 2025**

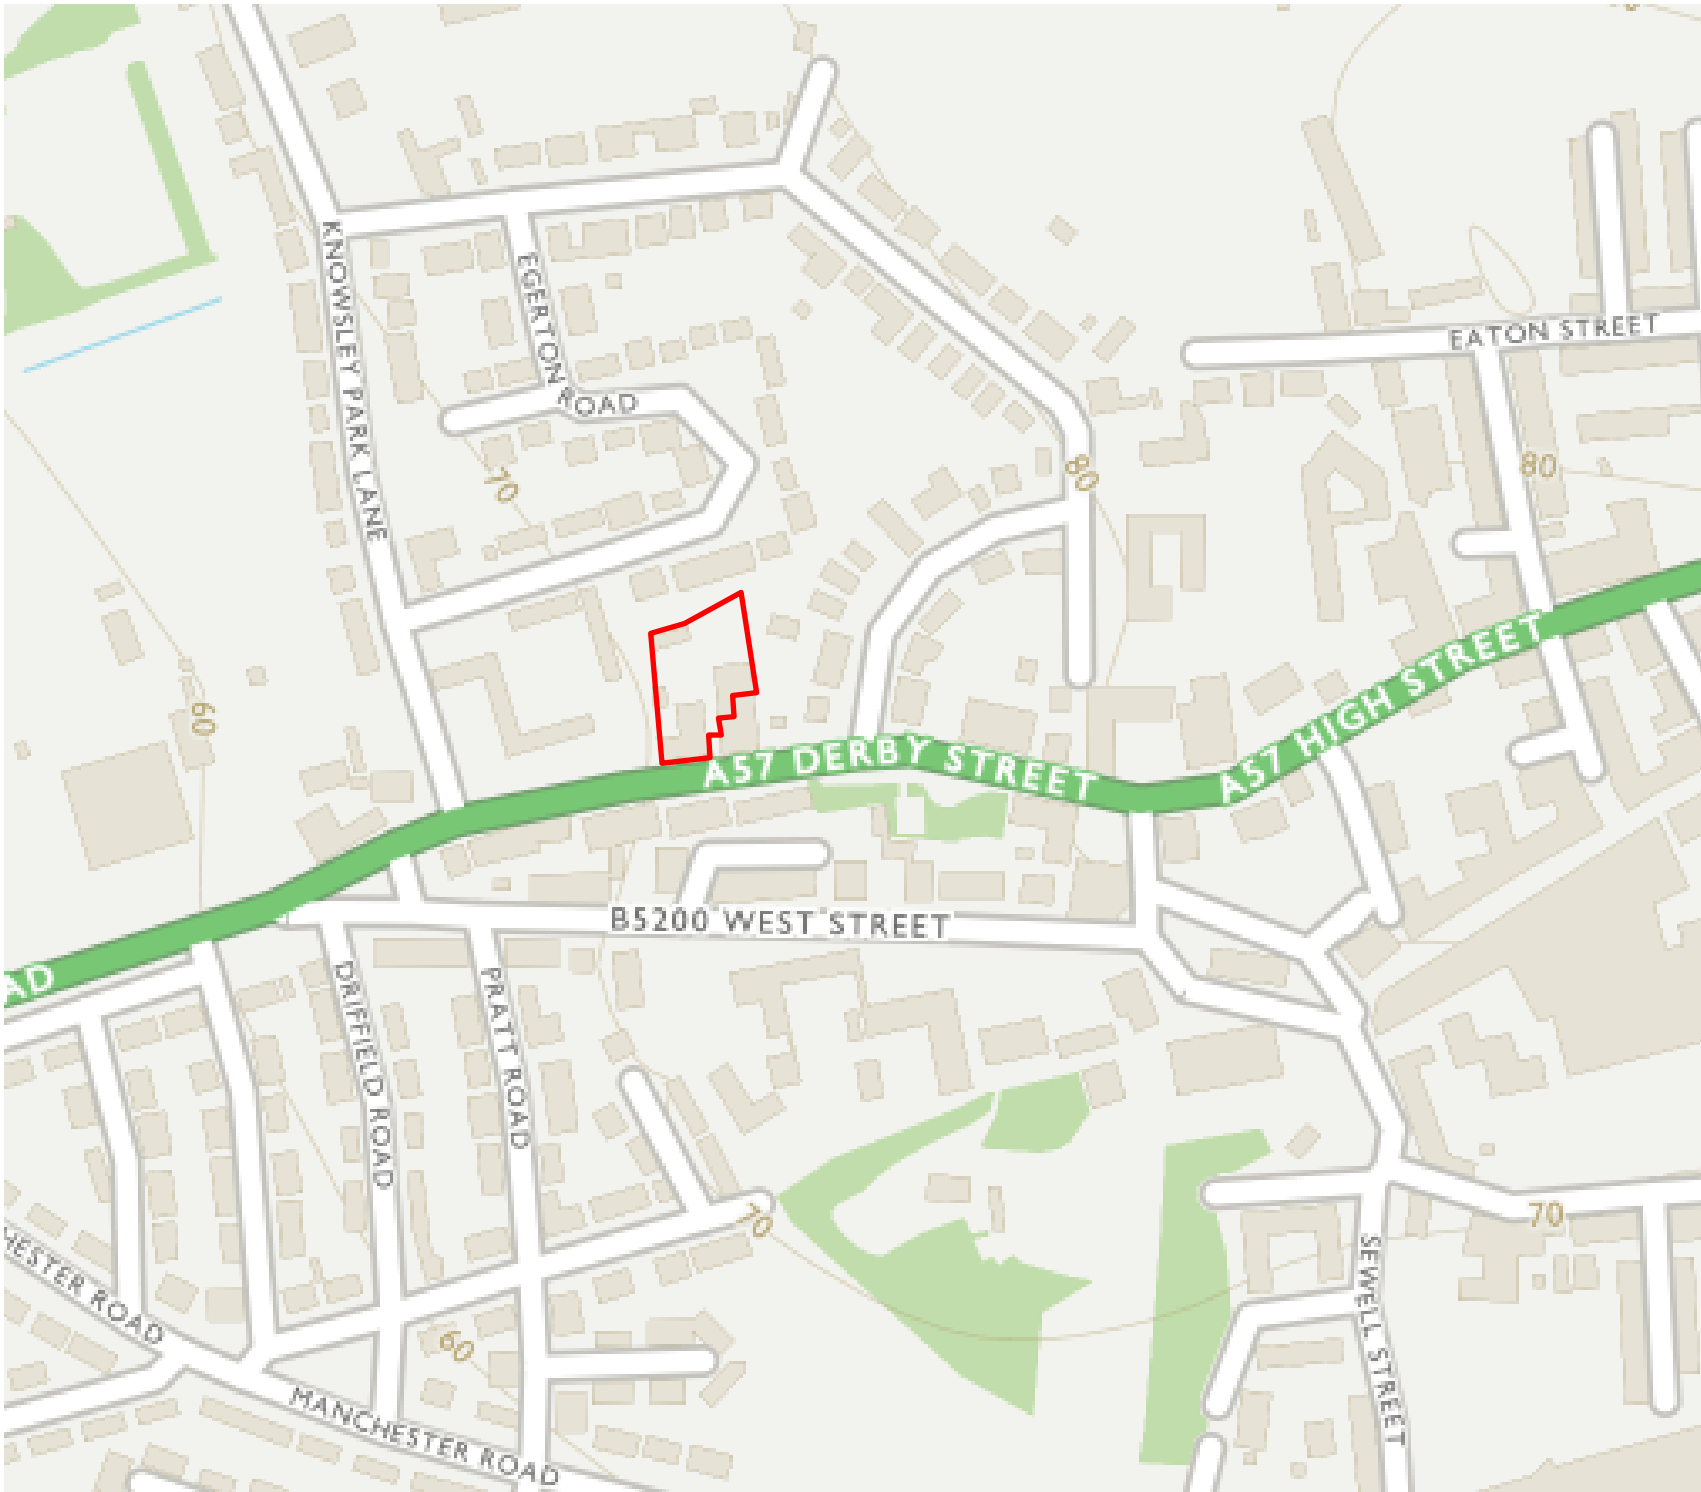
| Title:<br>Aerial Photograph | |

Notes: Study Site

The site is located immediately to the north of Derby Street, Prescott, L34 3LG as shown on **CCG** Drawing No. CCG-C-25-15207-1 contained herein.
