# Preliminary Bat Roost Assessment

Land off Archway Road, Huyton, Metropolitan Borough of Knowsley, Merseyside

A Report To: Genr8 Developments  
Report Number: RT-MME-161140-02  
Date: September 2023

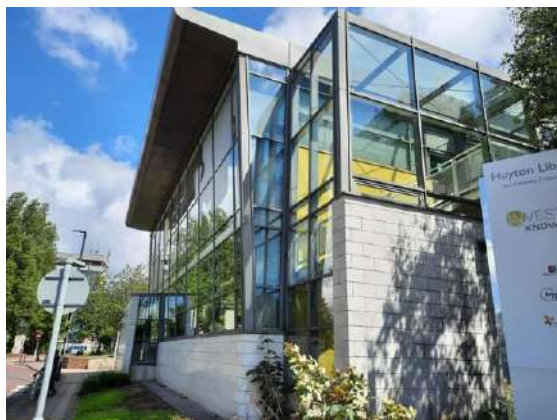
Huyton Library building was an irregular-shaped flat-roofed structure with stone block walls, but the northern-most elevation comprised predominantly of metal-framed windows (Plate 4.1). A steel canopy was present to the west which was approximately 1.25 m wide.

Metal edging was noted at the wall tops which was largely in good condition and well-sealed. One small area to the south had a small gap between the wall and the metal fascia, but this was cobwebbed, indicating no recent use by fauna. A security door with a roll-down shutter was present to the east. The north-eastern elevation was rendered, and a section of this had a mural painted on it (Plate 4.2). The render was in good condition and was well-sealed, with no suitable bat roost features identified. A walled entryway was present to the north-east, which was once again rendered. A small amount of lifted lead flashing was noted around the wall-top of this area, but this was did not extend far, and no evidence of bats was identified.

**Plate 4.1: Northern Elevation of Building B1.**

- R2 Building B1, B2 and B3:** Buildings B1, B2 and B3 were deemed to have negligible potential for roosting bats. The survey data obtained for the site is valid for 12 months from the survey date. If development works to the surveyed buildings have not commenced within this timeframe it will be essential to update the survey effort to establish if suitable features have developed and if bats have colonised the buildings in the interim. In the unlikely event that a bat is found during demolition works all works must immediately cease and a suitably qualified ecologist should be contacted.

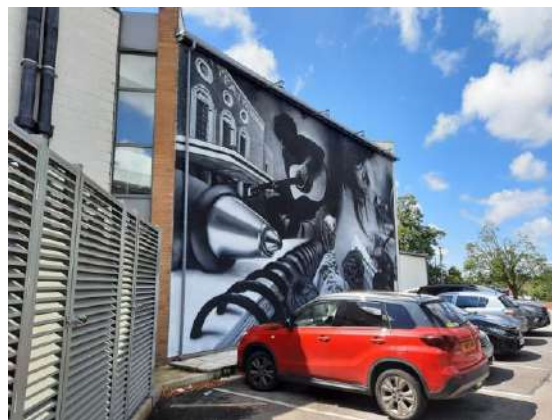
**Plate 4.2: Eastern Elevation of Building B1.**

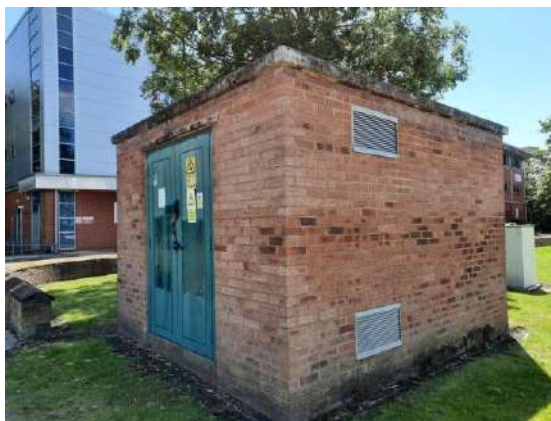
Building B2 was a small sub-station unit located in the south-east of the site. It had a flat concrete roof and walls which were of red brick construction (Plate 4.3). The roof and walls were all in good condition and well-sealed. An intact fibreglass door was present to the north-east. Two metal vents were present on the north-western elevation, but the gaps between the slats were too small to facilitate bat access to the building.

**Plate 4.3: North-western and North-eastern Elevations of Building B2.**

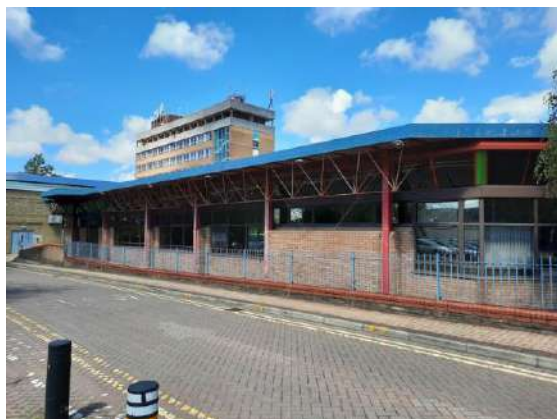
Building B3 was the Knowsley Council Building Control (KCBC) structure which was located in the east of the survey area. It was a large single-storey building, with single-skin red brick walls which were in good condition. It had intact wooden and steel-framed doors and metal framed windows. Some of the doors to the south had roller shutters installed above, which did not offer any suitable roosting opportunities. To the south-east and south-west, a steel canopy overhung the eaves (Plate 4.4), and these were up to 2 m in width. The underside of the canopy was supported by steel poles and the canopy itself comprised of metal corrugated sheeting (Plate 4.5). A line of windows was present at the wall tops below the canopy. Some of these were clear, but others had been covered with sticky-backed plastic. Two vents were protruding from the wall on the south-eastern elevation, but these were sealed with mesh. A small amount of lifting was noted around the metal work where the vents adjoined the wall, but these gaps were not substantial enough to support roosting bats.

**Plate 4.4: Western Elevation of Building B3.**

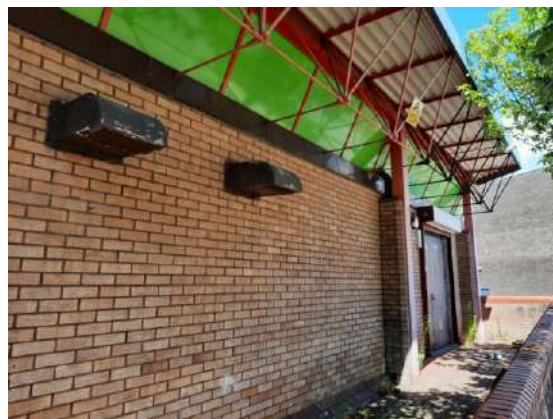
Towards the north-east corner, metal vents were present within the walls. These had mesh behind, with some small gaps, but as these were predominantly cobwebbed, they were not considered to have been in recent use by fauna.

**Plate 4.5: South-east Elevation of Building B3, with Vents in Wall and Overhanging Canopy.**

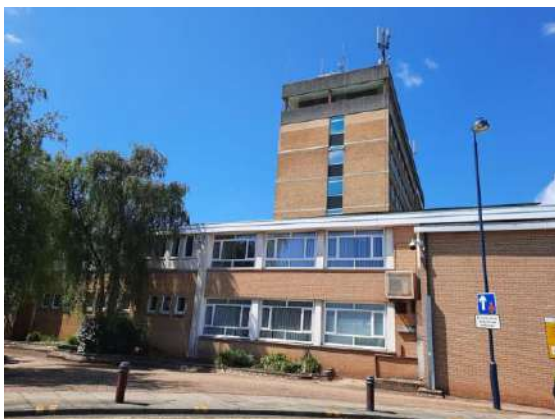
The southern section was a two-storey brick building with a pitched-roof covered with green fibreglass-type panels. The walls were a mix of solid and single-skin brick and the uPVC windows and doors were all intact and largely well-sealed (Plate 4.6). Some gaps were noted to the south, where lead flashing was lifted around the window sills, but these were largely superficial. In addition, gaps were noted in the brickwork around the base of some of the windows on the southern elevation, but these were once again superficial and generally cobwebbed. Damage was noted in the soffit board on the on this elevation (Plate 4.7), and due to the height at which it was located, this could not be fully inspected for roosting bats. On the north-east and south-west elevations, pebbledash panels were noted beneath the first-floor windows. These panels were in good condition and well-sealed.

**Plate 4.6: Section 1 of Building B4 in Foreground, with Section 2 to Rear.**

- R1 Building B4:** Both sections of Building B4 have been identified as having high potential to support roosting bats. Bat Surveys: Good Practice Guidelines published by the Bat Conservation Trust (Collins, 2016)<sup>2</sup> recommends that for structures with high bat roosting potential at least three dusk emergence and/or dawn re-entry surveys be undertaken during the bat emergence/re-entry survey season to determine the presence/absence of roosting bats within the structures. The bat emergence/re-entry survey season extends from May to September. At least two of the surveys should be undertaken during the peak season for emergence/re-entry surveys between May and August and one of the three surveys should be a dawn re-entry survey. If a roost is discovered during these surveys, a Natural England licence application may be required.

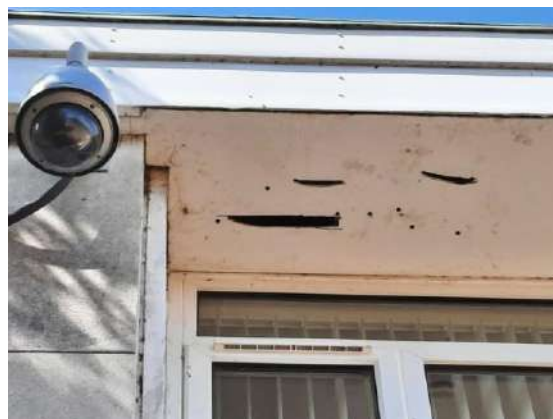
**Plate 4.7: Damaged Soffit Boarding on Southern Elevation of Section 1 of Building B4.**

A number of potential bat roost features were identified externally, including: pipework holes, damaged soffit boarding, gaps behind concrete panelling, gaps around brickwork and weep holes. Due to the height and/or aspect at which some of these features were located, it was not possible to fully inspect them for roosting bats. As such, Building B4 has been classified as having high bat roost potential.

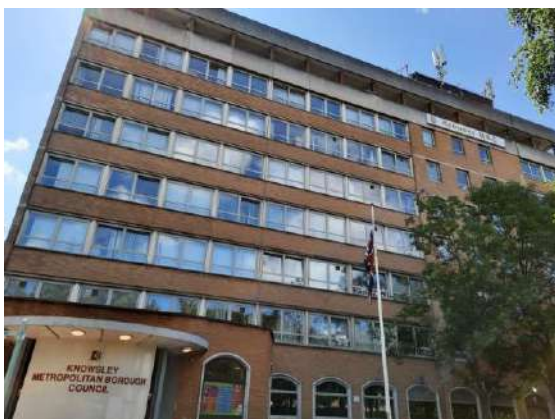
The northern section of Building B4 was a high-rise office block comprising 7-floors and an open roof-top with a brick structure with associated electrical equipment and aerials/masts (Plate 4.8). The building was a cavity walled brick structure, which had concrete panelling on all elevations at the 6<sup>th</sup> and 7<sup>th</sup> floors. Gaps were noted beneath these concrete panels to both the north-east and south-west, where mortar appeared to have come away. The building had metal and uPVC framed windows/doors which were in good condition. On the north-eastern elevation, several pipework holes were noted which appeared to extend all the way from the first to the top floor. A small gap was noted where some of the lead flashing was lifted around the north-eastern entrance to the building. On the south-west elevation of the high-rise section, weepholes were identified above the 2<sup>nd</sup> floor windows and a small amount of missing/damaged mortar was also noted in this area.

**Plate 4.8: North-east Elevation of Section 2 of Building B4.**

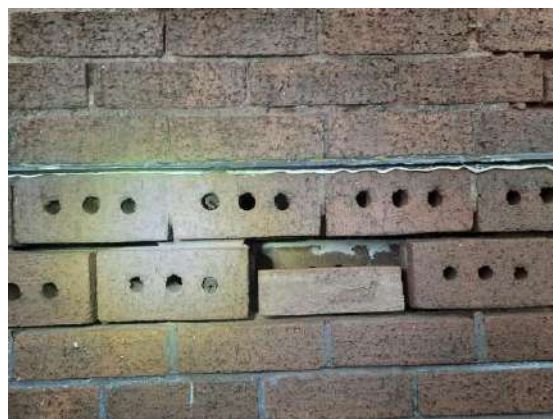
The roof area comprised a concrete floor with metal infrastructure and associated cabling/pipework. It was surrounded to all sides by a 1.5 m high concrete wall with railings above. At the north-western end, a single-storey flat-roofed brick structure was present, which had masts and aerials installed on top. Although the majority of the brickwork was intact, gaps in mortar were noted around the door frame to the north-west at a height of 2 m, and loose brickwork/bricks with holes (i.e. airbricks) were identified to the south-west (Plate 4.9). These features were inspected with no evidence of bats identified, however, the cavities associated with these gaps extended beyond the reach of the endoscope.

**Plate 4.9: Gaps in Brickwork on South-west Side of Rooftop Brick Structure.**

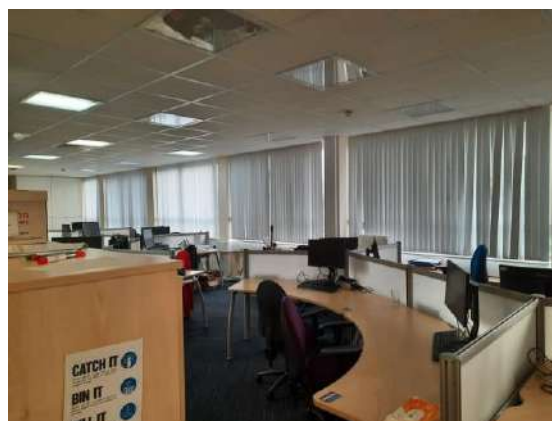
An internal assessment was undertaken within the high-rise office block, in order to facilitate access to the roof area. Each floor comprised open-plan office spaces and adjoining meeting rooms. Each individual floor had suspended ceiling tiles in place with light units fitted within them (Plate 4.11). No loft space was present and all of the office areas were in good condition and well-sealed, as a result of the building being in current use. The brick roof structure connected internally to the main high-rise block and as such, had the same internal composition as the remainder of the building.

**Plate 4.11: Open-plan Office Space on First Floor of Section 2 (Building B4).**

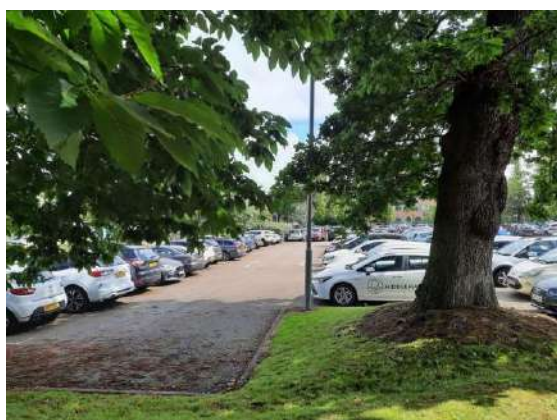
| Tree No. | Species | Description | BCT Suitability Class |
|---|---|---|---|
| T1 | English oak<br><i>Quercus robur</i> | This oak tree was present towards the western corner of the site, within an area of amenity grassland. It had several twisted branches with a small number of small knotholes. Split limbs were also noted to the north at approximately 6 m high and to the south at approximately 9 m. | Moderate |

**Plate 4.12: Tree T1.**

Bat Surveys: Good Practice Guidelines published by the Bat Conservation Trust (Collins, 2016)<sup>2</sup> recommends that for trees with moderate bat roosting potential two separate survey visits (consisting of one dusk emergence and a separate dawn re-entry survey) be undertaken during the bat emergence/re-entry survey season, to determine the presence/absence of roosting bats within the trees. The bat emergence/re-entry survey season extends from May to September. At least one of the surveys should be undertaken during the peak season for emergence/re-entry surveys between May and August. Should this survey confirm the presence of roosting bats, it will be necessary to undertake additional surveys in order to inform a Natural England licence application. In addition, should the survey identify the presence of significant levels of bat activity at the site, it may be necessary to undertake further survey visits to comprehensively assess the value of the site to bats.

Where safe to do so, trees will be climbed utilising tree climbing equipment. Any PRF will be internally searched using a torch and endoscope. If the feature on further inspection is found to be unsuitable for bats, then the status of the tree will be downgraded to low or negligible bat potential. If a roost is identified, if PRF extend beyond the reach of an endoscope, or if the PRF shows any signs of use by fauna, dusk emergence and dawn re-entry surveys will be required (as detailed in Option 1). If any trees are considered unsafe to climb, or cannot be fully inspected for safety reasons, then they should be subject to dusk emergence and dawn re-entry surveys, as detailed in Option 1.

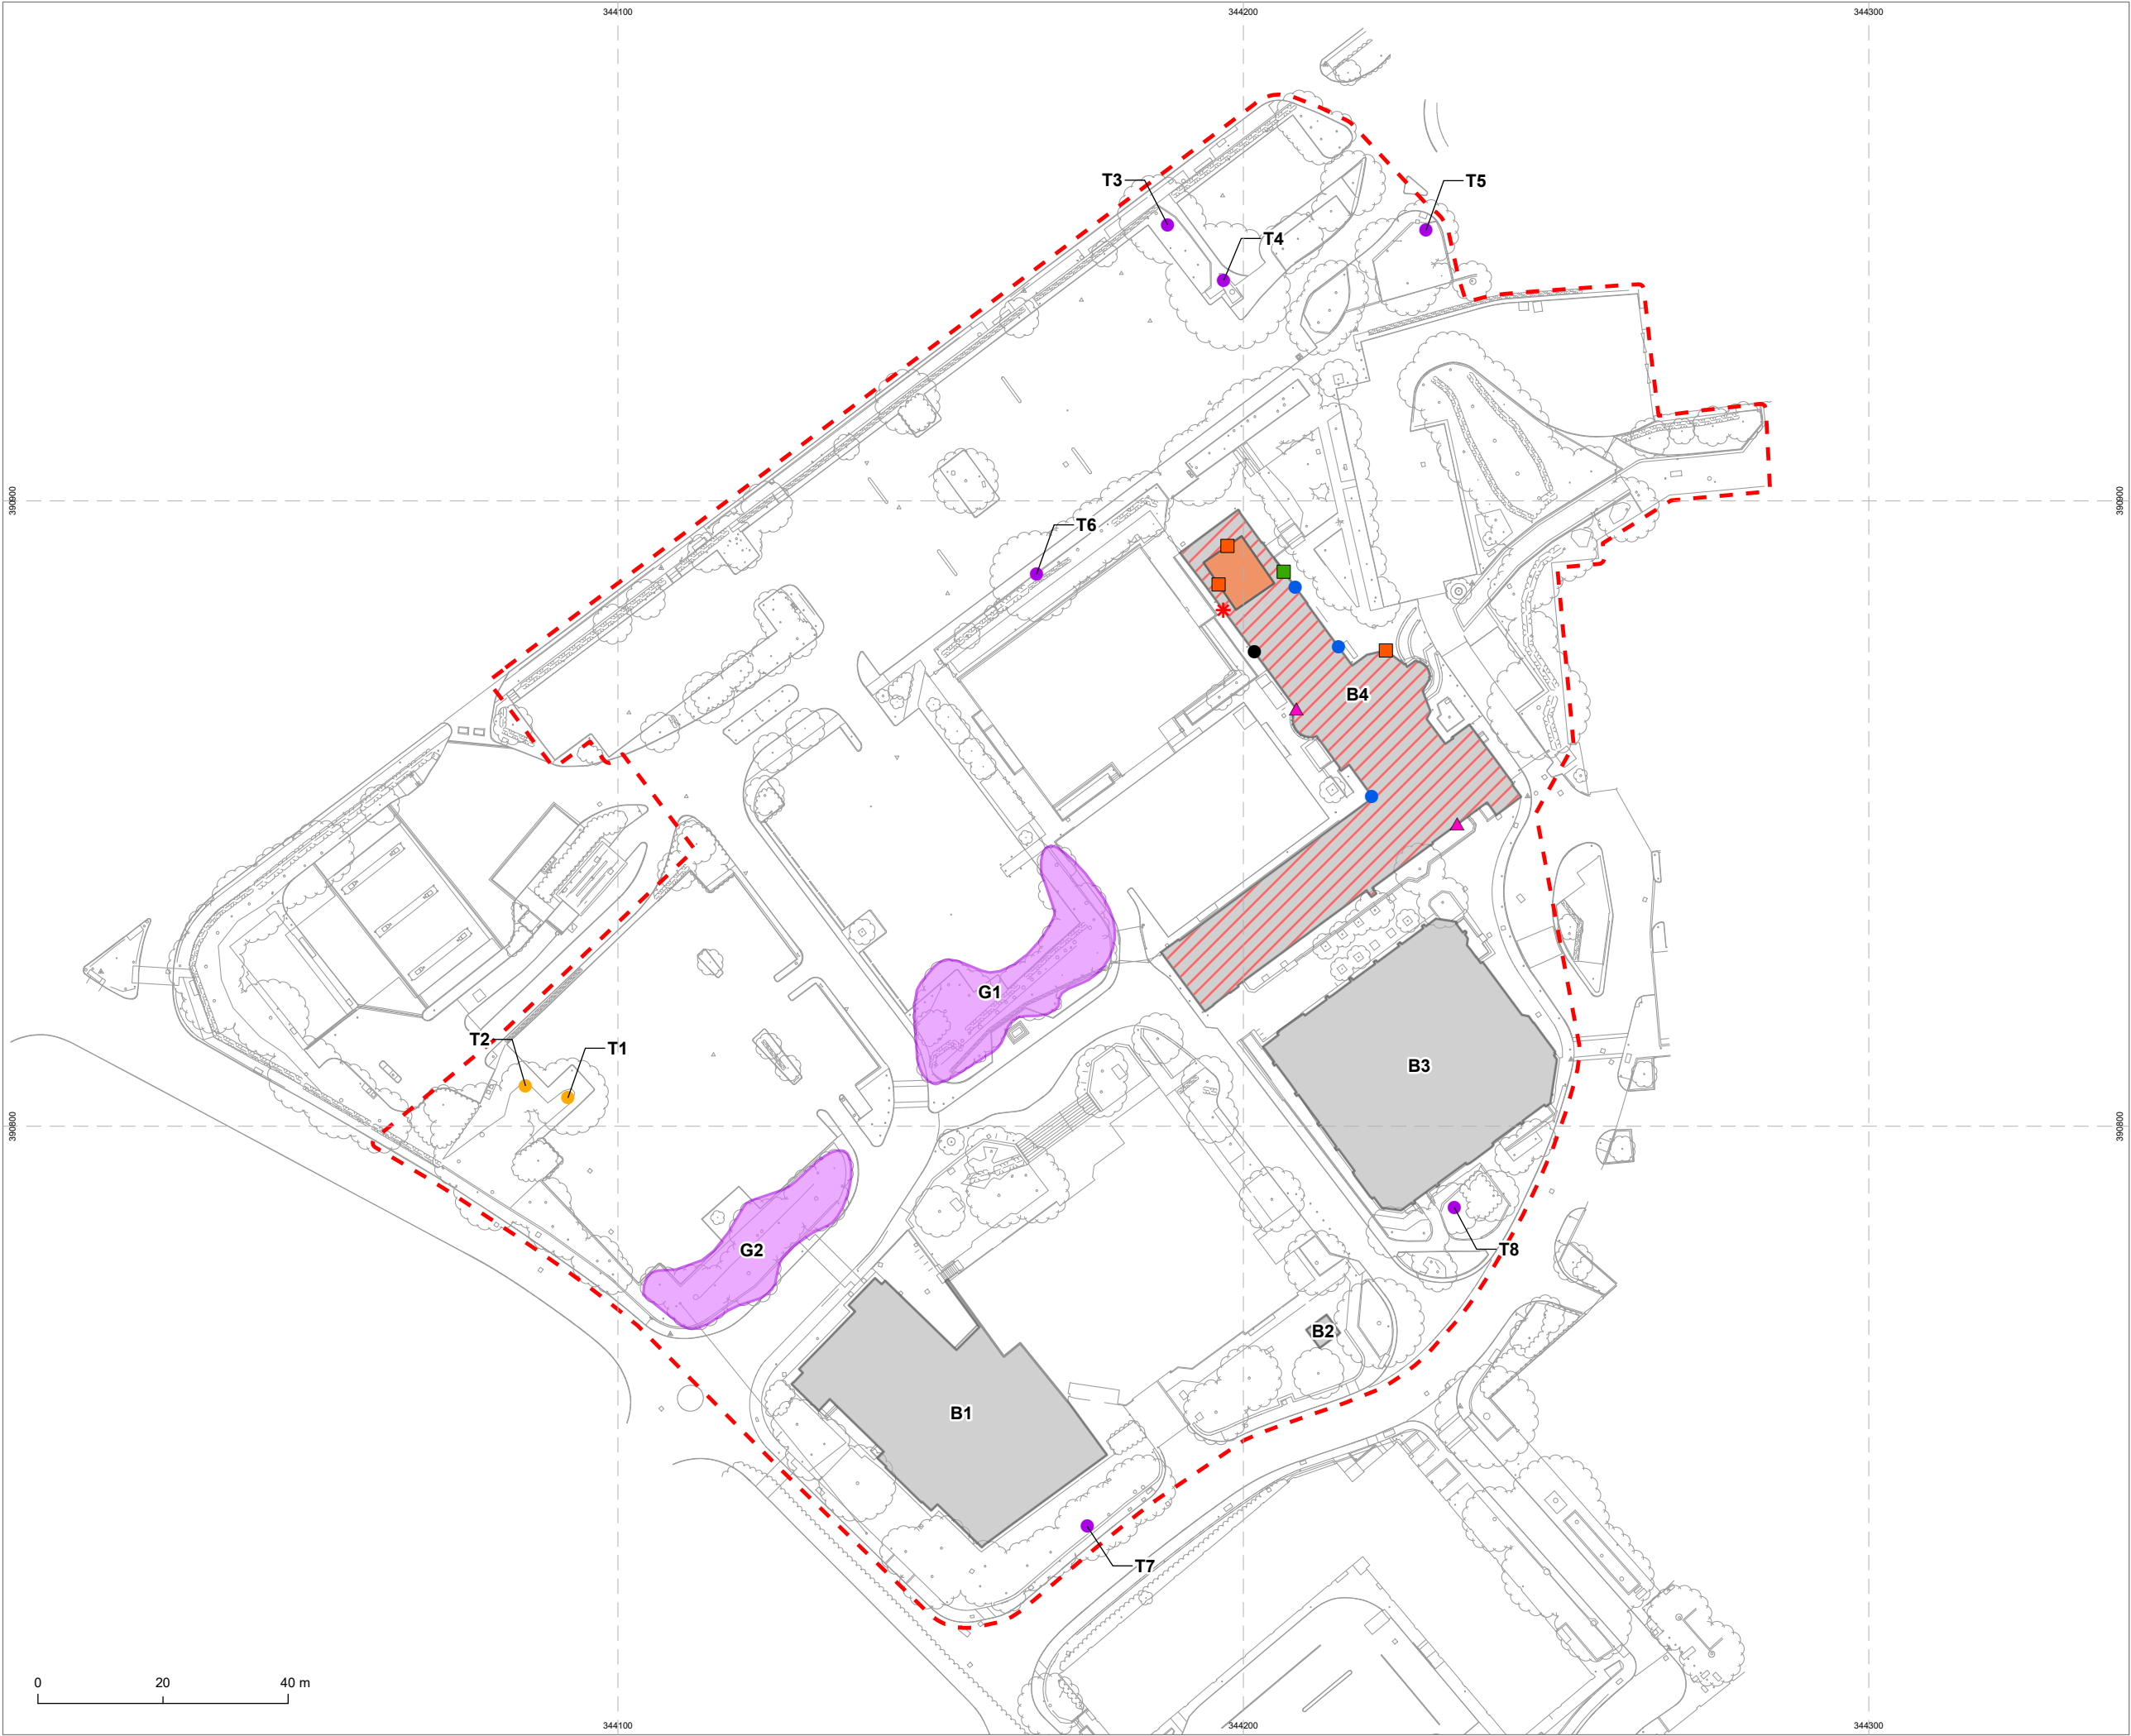
Drawing C161140-02-01 – Preliminary Bat Roost Assessment

Four buildings were identified within the survey area (B1 – B4). Building B1 was Huyton Library, Building B2 was a small substation in the south-east of the site, Building B3 was the Knowsley Council Building Control (KCBC) structure and Building B4 was the Knowsley Metropolitan Borough Council (KMBC) building. A drawing (C161140-02-01 in Chapter 7) showing the locations of the buildings and trees surveyed, and their respective bat roost values is provided in Chapter 7.
